ND 18 LANDSLIDE SLOPE STABILITY RECOMMENDATION

TO:	File
FROM:	Geotechnical Section
DATE:	12/20/2022
HIGHWAY:	ND 18
PROJECT NUMBER:	8-018(106)064
PCN:	23279
LOCATION:	8 North of Leonard, Maple River
SUBJECT:	ND 18 Landslide Slope Stability Recommendation

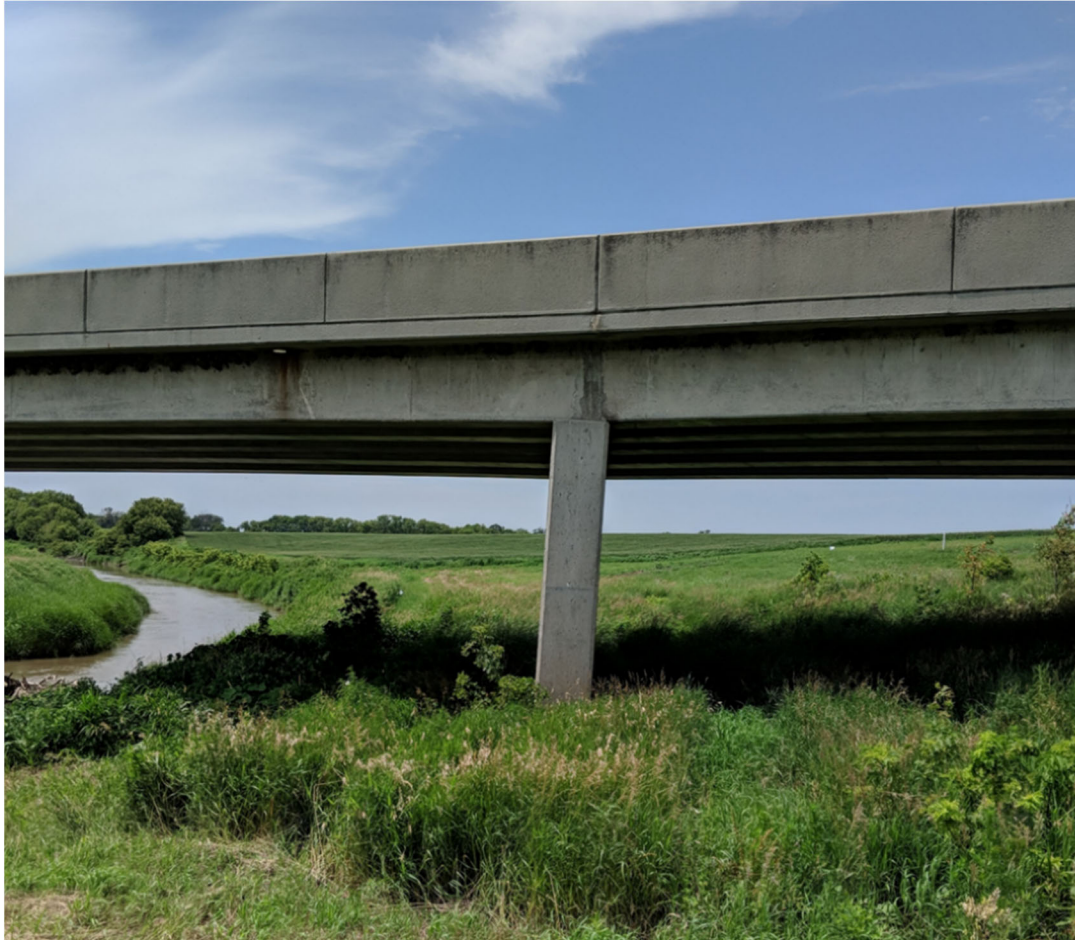
Figure 2 – North Pier Leaning from Landslide

Figure 2 below shows the damage to the existing pier located on the north side of the Maple River:

After the project was completed, the deeper landslide movement stopped and the shallower landslide movement slowed significantly, and recent surveys of the pier have shown that the pier is no longer moving. However, bridge division was concerned about the existing condition of the north pier, abutment, and approach slab permanently acting as a span. In addition, the shallower landslide was still moving and could potentially affect the structure. These concerns drove the need for another project to be completed.

The second project, 8-018(106)064, PCN 23279 is intended to fix the landslide and obtain the best factor of safety possible. This proposed project would involve replacing the damaged pier, replacing the current north abutment with a pier, and extending the bridge enough to complete the necessary excavation to remediate the landslide. Survey was completed to obtain the new existing ground (this survey confirmed the previous grading that was completed as part of the previous project). Design division also provided cross sections at three different locations that were skewed to the landslide movement and incorporated the new survey data. This new data was incorporated into the existing Slope/W model and served as the existing conditions model for the project. The cross section that was deemed critical was at Sta 0+48.92, which is on the west side of the landslide and goes through the existing abutment. This was also the location where limited excavation was completed as part of the previous project due to the existing abutment piling. Figure 4 below shows where this cross section is located:

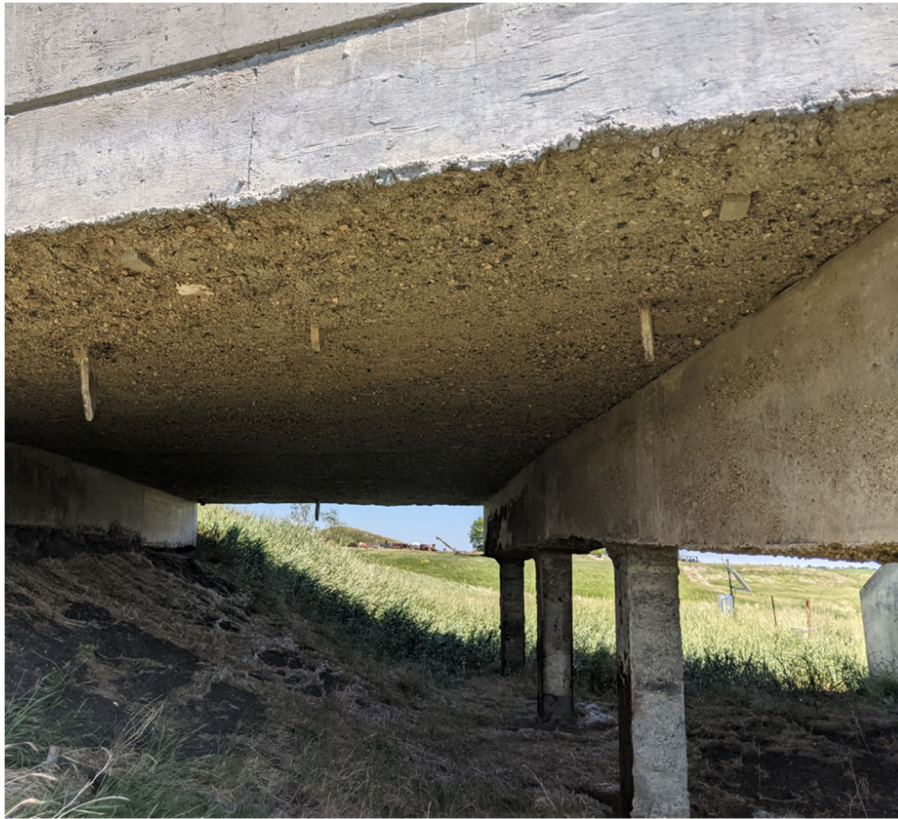
Figure 3 – Excavation Behind Existing Abutment

For the first project, 8-018(088)064, PCN 21746, the landslide fix was limited by the existing bridge and R/W. Due to these constraints and the weak soils at the project site that were unable to support a structural fix, it was decided to move forward with a dirt work project. Because of the location of the existing bridge, not as much excavation was able to be completed as desired. The area outside of the abutment could have more material removed and the factor of safety of this area was 1.26. The material behind the abutment and below the approach slab was removed as much as possible and this produced a factor of safety of 1.12. It was discussed with management and the project team that this proposed fix would improve the factor of safety, but it was unknown whether it would be enough to stop the landslide. The decision was made to move forward with this fix, and it was completed in the summer of 2018. Figure 3 below shows the excavation that occurred behind the existing abutment.
