**NORTH DAKOTA
DEPARTMENT OF TRANSPORTATION**

Experimental Study ND 98-02

**Snow Management by the
Use of Snow Fence Systems**

Final Evaluation

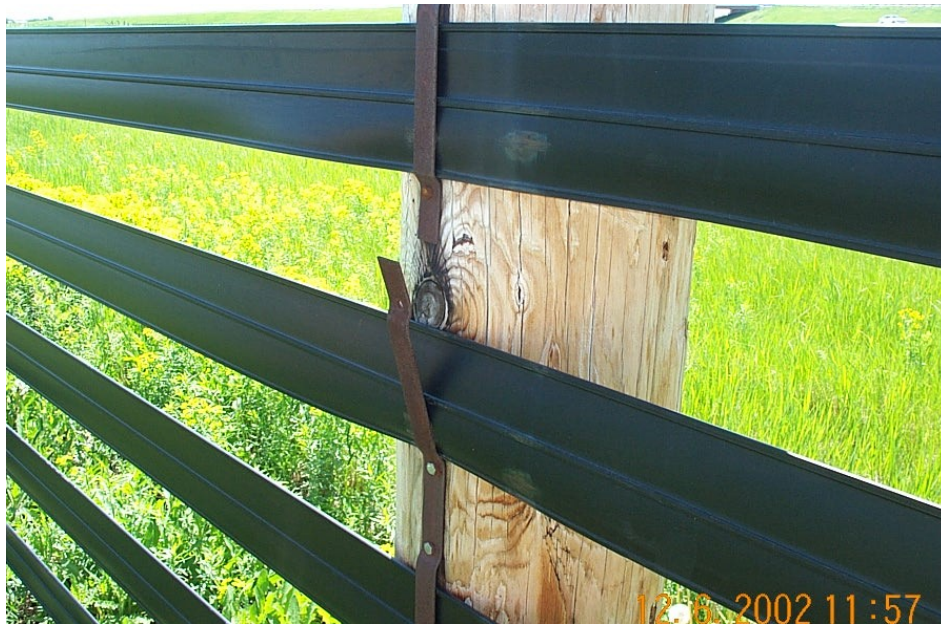
It was typical to see, that one or two brackets per fence had become loose. These brackets hold the polymer straps in position and are attached to the posts by screws. The brackets had become loose because the screws had pulled out of the posts. It appeared the screws had pulled out because the posts had cracked. The salvage posts had more cracks and loose brackets than the purchased posts. This problem could probably be addressed by using longer screws. The loose brackets didn't appear to be a problem. Photo 4 shows a bracket that had become loose.

Photo 4 - Bracket that has become loose.

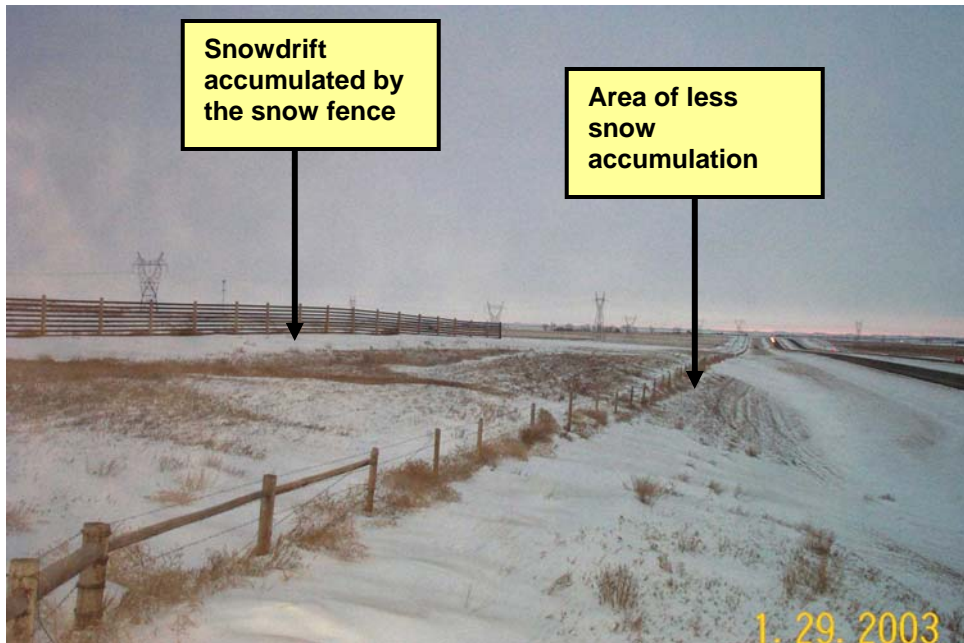
All of the snow fences had collected a drift on the downwind side of the fence and most snow fences had also collected a drift upwind of the fence. Downwind of some snow fences there was an obvious area where less snow had accumulated on the ground than in the surrounding area. Photo 8 shows a snow fence with an area of less snow accumulation at site 2.

Photo 8 - A snow fence at site 2 in January 2003.

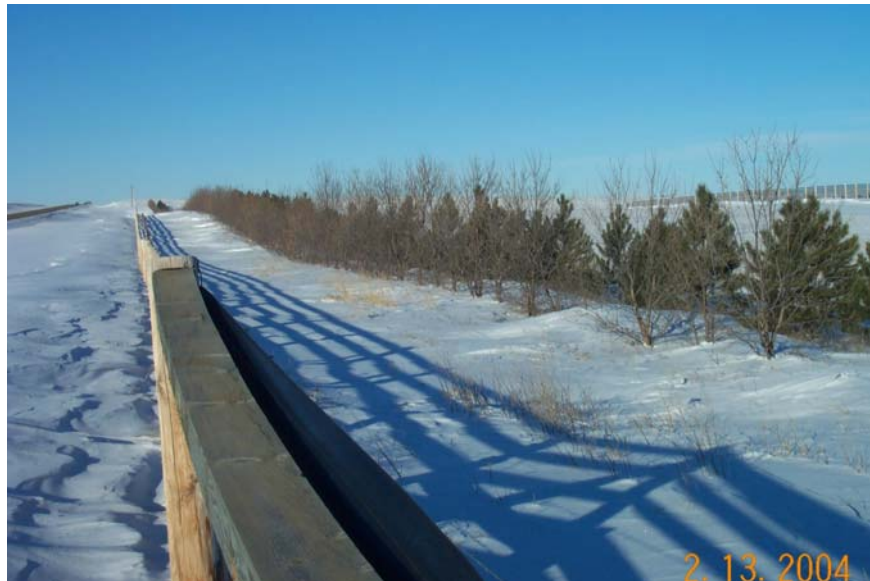
The living snow fence at Site 1 had collected snow also. The snow was mostly collected within the two rows of trees and did not appear to develop a downwind drift like the structural snow fences. This may be because the snow collected between the two rows of trees was collected by the Pine trees and the Ash trees collected little snow. The snow was approximately 1' to 2' deep within the two rows of trees. The structural snow fence that ran along the living snow fence collected drifts the same size as other snow fences and the amount of snow it collected wasn't obviously affected by its proximity to the living snow fence. Photo 12 shows the snow collected within the living snow fence.

Photo 12 – Snow collected within the living snow fence.
