**NORTH DAKOTA
DEPARTMENT OF TRANSPORTATION**

Experimental Study ND 98-02

**Snow Management by the
Use of Snow Fence Systems**

Second Evaluation

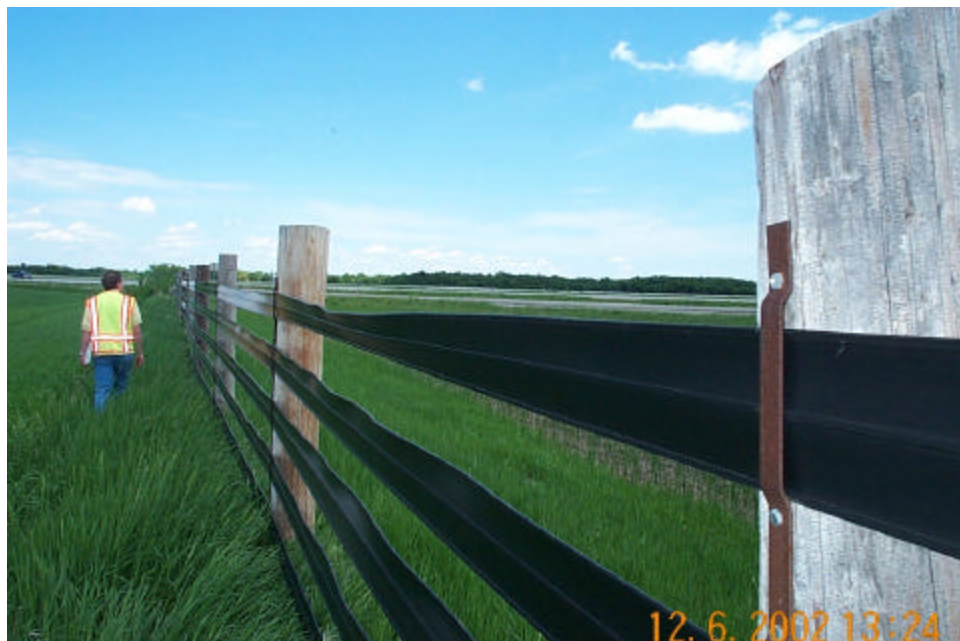
Sites 2, 3, and 4 were inspected on June 12, 2002 and site 1 was inspected on August 12, 2002. The overall condition of the snow fences was good. The ratchet hardware showed signs of corrosion but appeared to be operable. The polymer strap material showed no signs of deterioration but on most snow fences the polymer straps need to be adjusted by tensioning the straps. Photo 3 shows a fence with polymer straps that need tensioning.

Photo 3 - Loose polymer straps.

Installation of the snow fence systems went well. The structural snow fences are in good condition but do require maintenance to keep the polymer straps tensioned and to reattach the loose brackets. The living snow fence is thriving and has grown significantly.

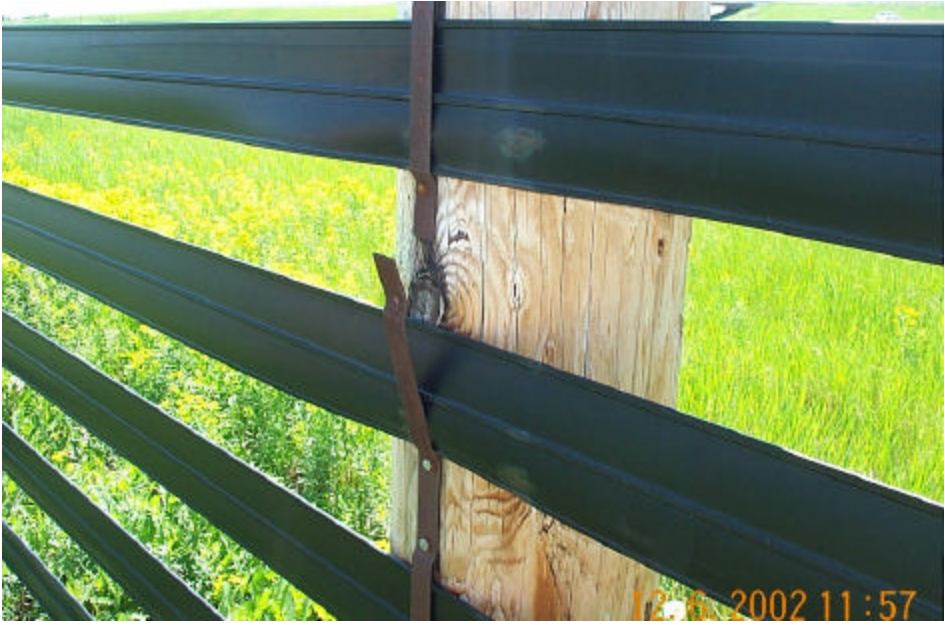
It was typical to see, that one or two brackets per fence had become loose. These brackets hold the polymer straps in position and are attached to the posts by screws. The brackets had become loose because the screws had pulled out of the posts. It appeared the screws had pulled out because the posts had cracked. The salvage posts had more cracks and loose brackets than the purchased posts. This problem could probably be addressed by using bigger screws. The loose brackets didn't appear to be a problem. Photo 4 shows a bracket that had become loose.

Photo 4 - Bracket that has become loose.

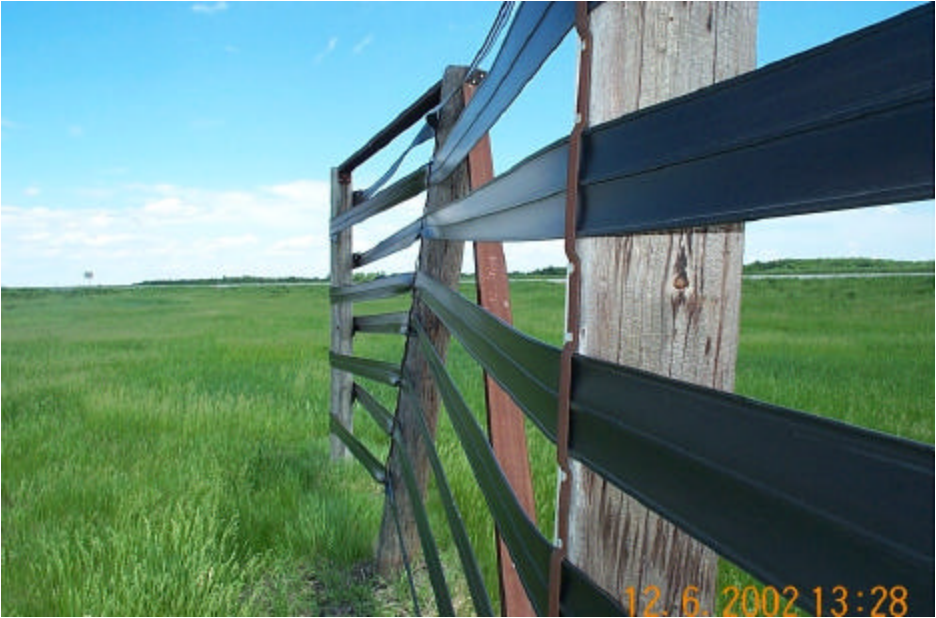
At site 4, a fence post had tilted and had caused some of the polymer straps to become loose and other straps to bind. Photo 5 shows the tilted post. This post was near the north end of an eight-foot fence that is located between Interstate 29 and the southbound exit ramp. This end of the fence is in an area that appeared to collect water and the ground at the base of the fence post was wet and quite soft.

Photo 5 - A tilted fence post at Site 4.

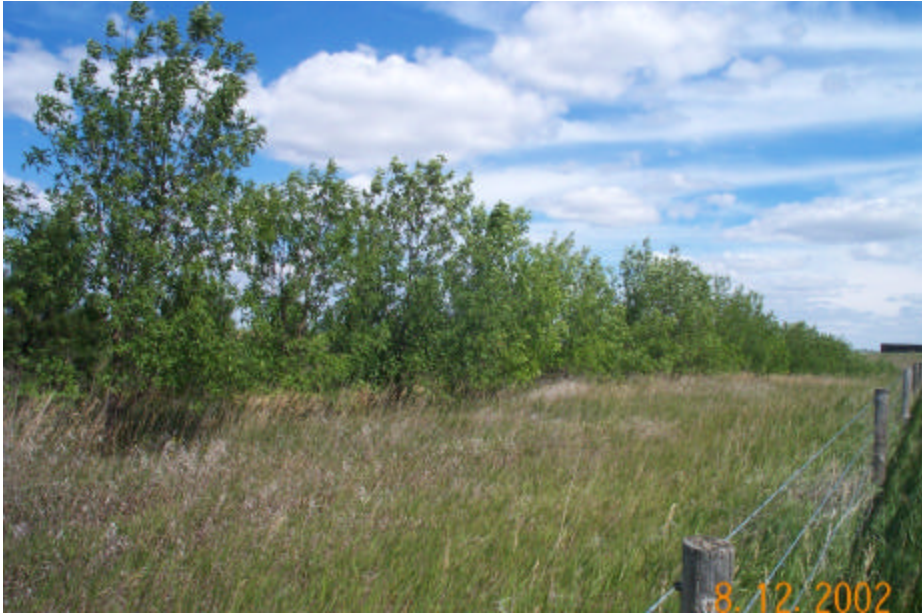
The living snow fences at site 1 appeared to be thriving and no trees appeared to have died. The Green Ash trees are approximately 12'-16' tall and the Pine trees are approximately 8'-10' tall. The condition of the living snow fence is shown in photos 6 and 7. The height of the living snow fence in 1998 is shown in photo 1.

Photo 6 - A view of the living snow fence in 2002.

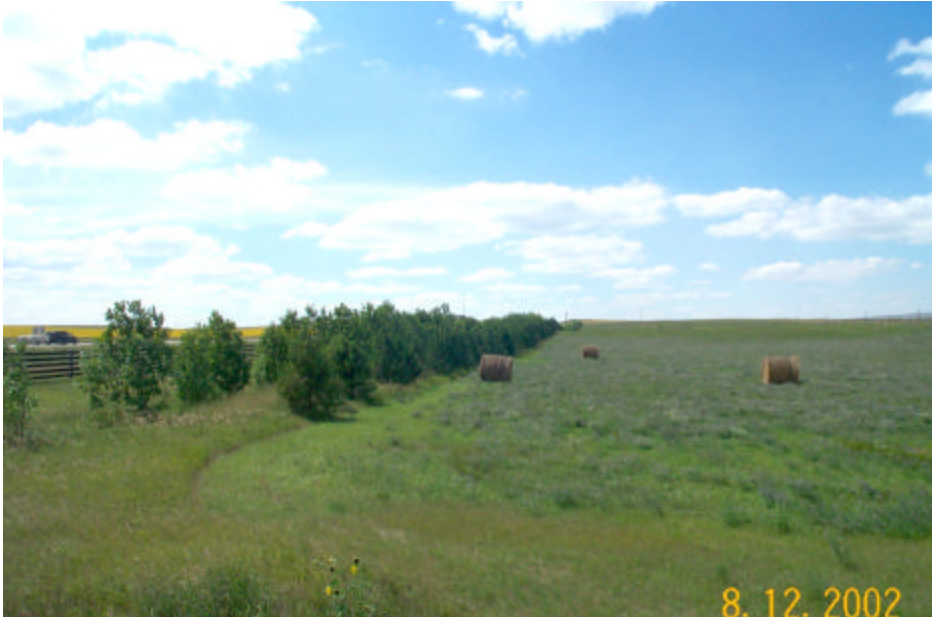
Photo 7 - Another view of the living snow fence in 2002.

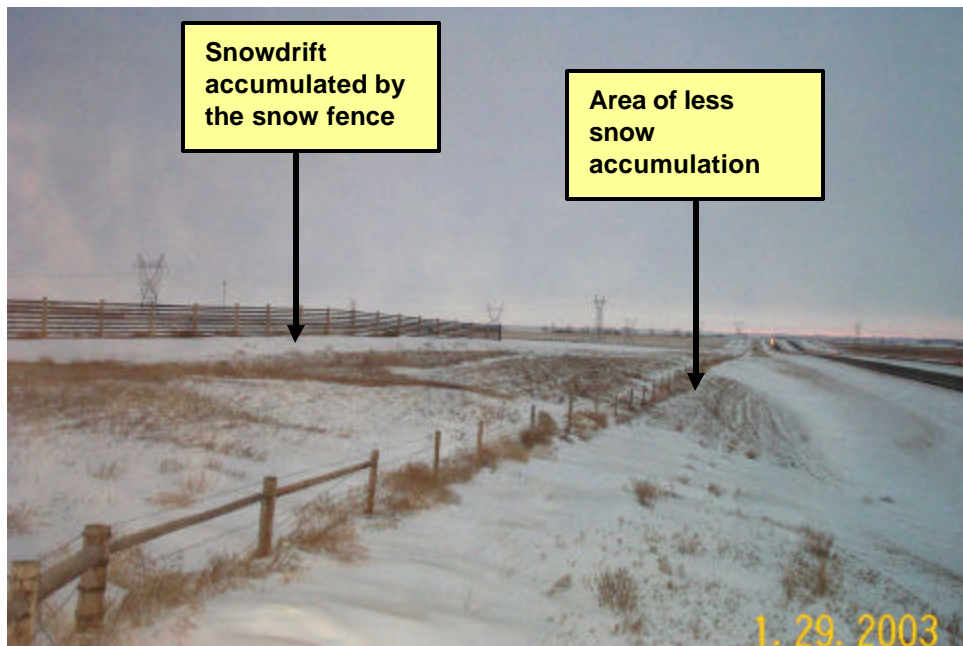
All of the snow fences had collected a drift on the downwind side of the fence and most had also collected a drift upwind of the fence. Downwind of some snow fences there was an obvious area where less snow had accumulated on the ground than in the surrounding area. Photo 8 shows a snow fence with an area of less snow accumulation at site 2.

Photo 8 - A snow fence at site 2 in January 2003.

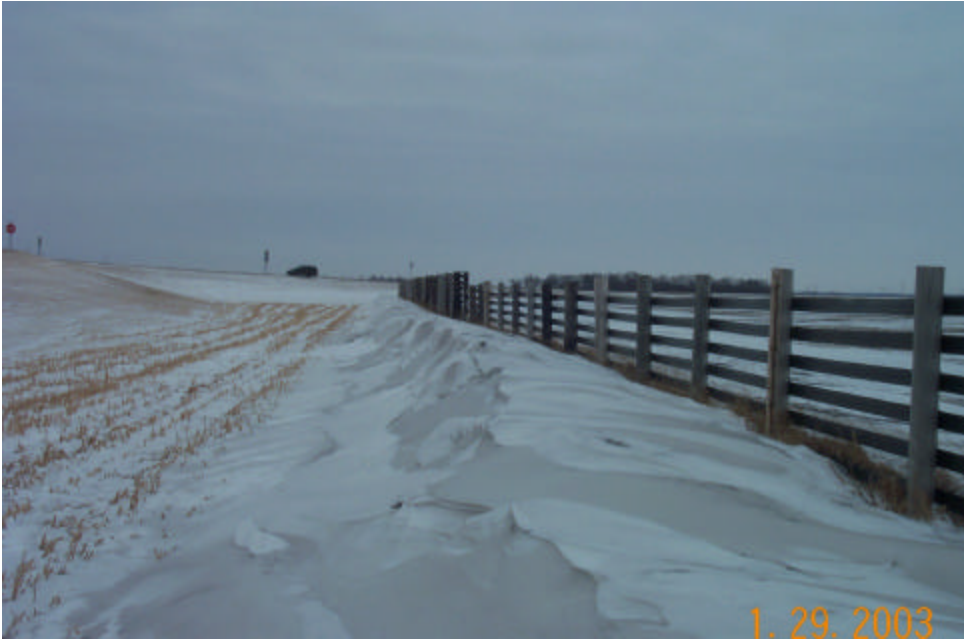
Snow fences at higher locations than surrounding areas appeared to collect more snow than fences in low areas. Photo 9 shows a large drift along a snow fence in a high location on the west side of site 3. Photo 10 shows the relatively small amount of snow collected by a snow fence in a low location at site 3.

Photo 9 - A large drift accumulated by a snow fence at a relatively high location at site 3.

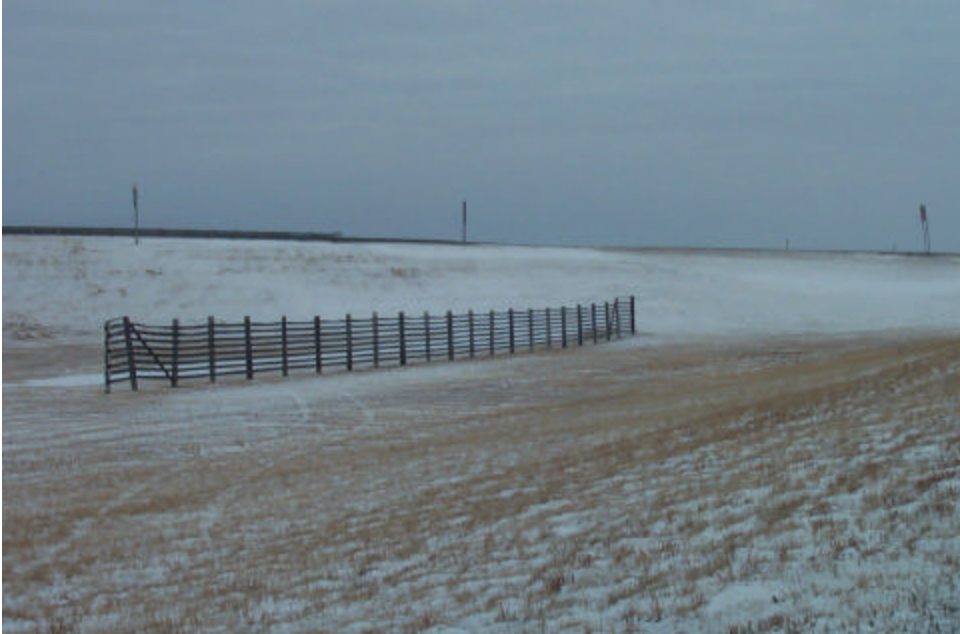
Photo 10 - A snow fence in at a low elevation at site 3 with relatively little snow accumulation.

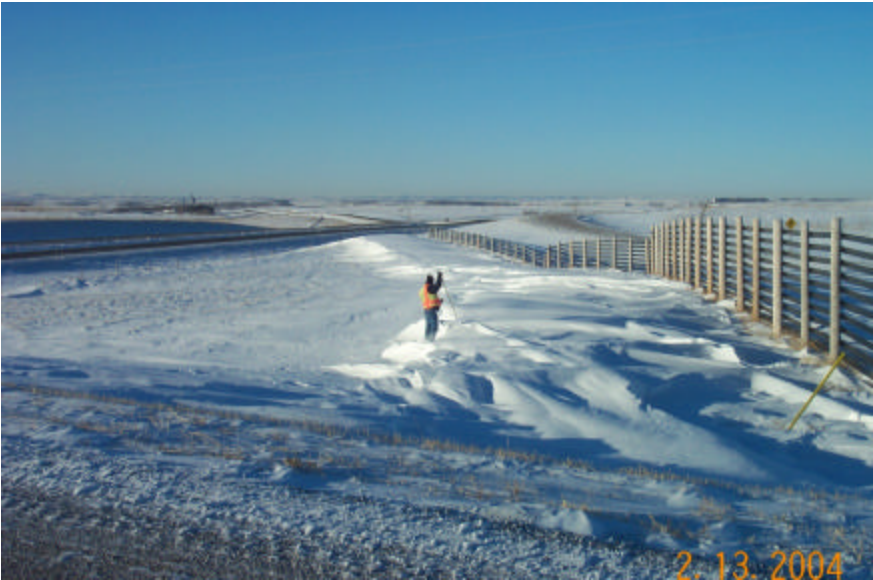
Sites 1 and 2 were evaluated on February 13, 2004 for their ability to collect snow in drifts. There had been recent snow fall and there was 6-10” of snow on the ground. The roadway had already been plowed so that there was no snow on the pavement. It appeared that the snow fences were functioning according to design. Typically, the downwind side of the snow fences had drifts 1 1/2 ft to 3 ft deep. From the shape of the drifts it appeared that the prevailing winds are from approximately the same direction as used for the design of the snow fences. Photo 11 shows a snow fence at Site 2 and the drift it created. Photo 11 was taken facing southwest.

Photo 11 – Snow drift created by a fence at Site 2

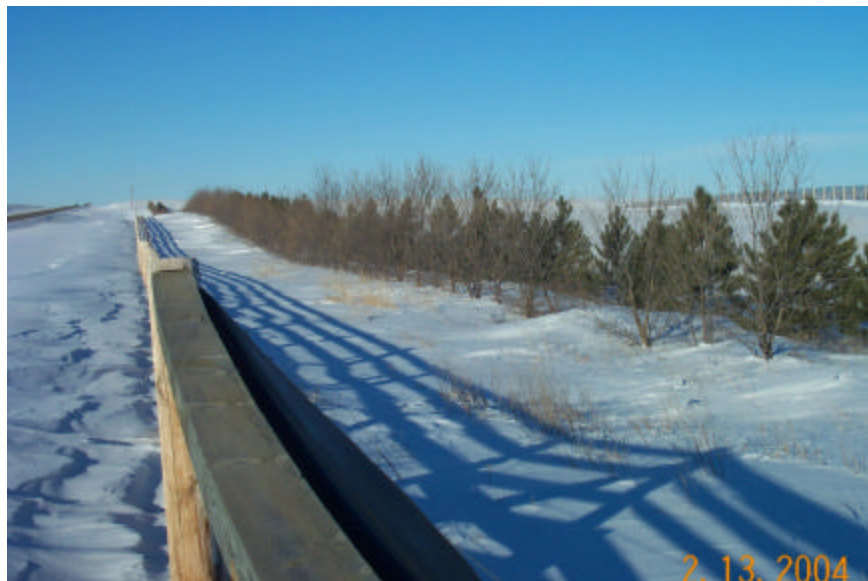
The living snow fence at Site 1 had collected snow also. The snow was mostly collected within the two rows of trees and did not appear to develop a downwind drift like the structural snow fences. This may be because the snow collected between the two rows of trees was collected by the Pine trees and the Ash trees collected little snow. The snow was approximately 1' to 2' deep within the two rows of trees. The structural snow fence that ran along the living snow fence collected drifts the same size as other snow fences and the amount of snow it collected wasn't obviously affected by its proximity to the living snow fence. Photo 12 shows the snow collected within the living snow fence.

Photo 12 – Snow collected within the living snow fence.

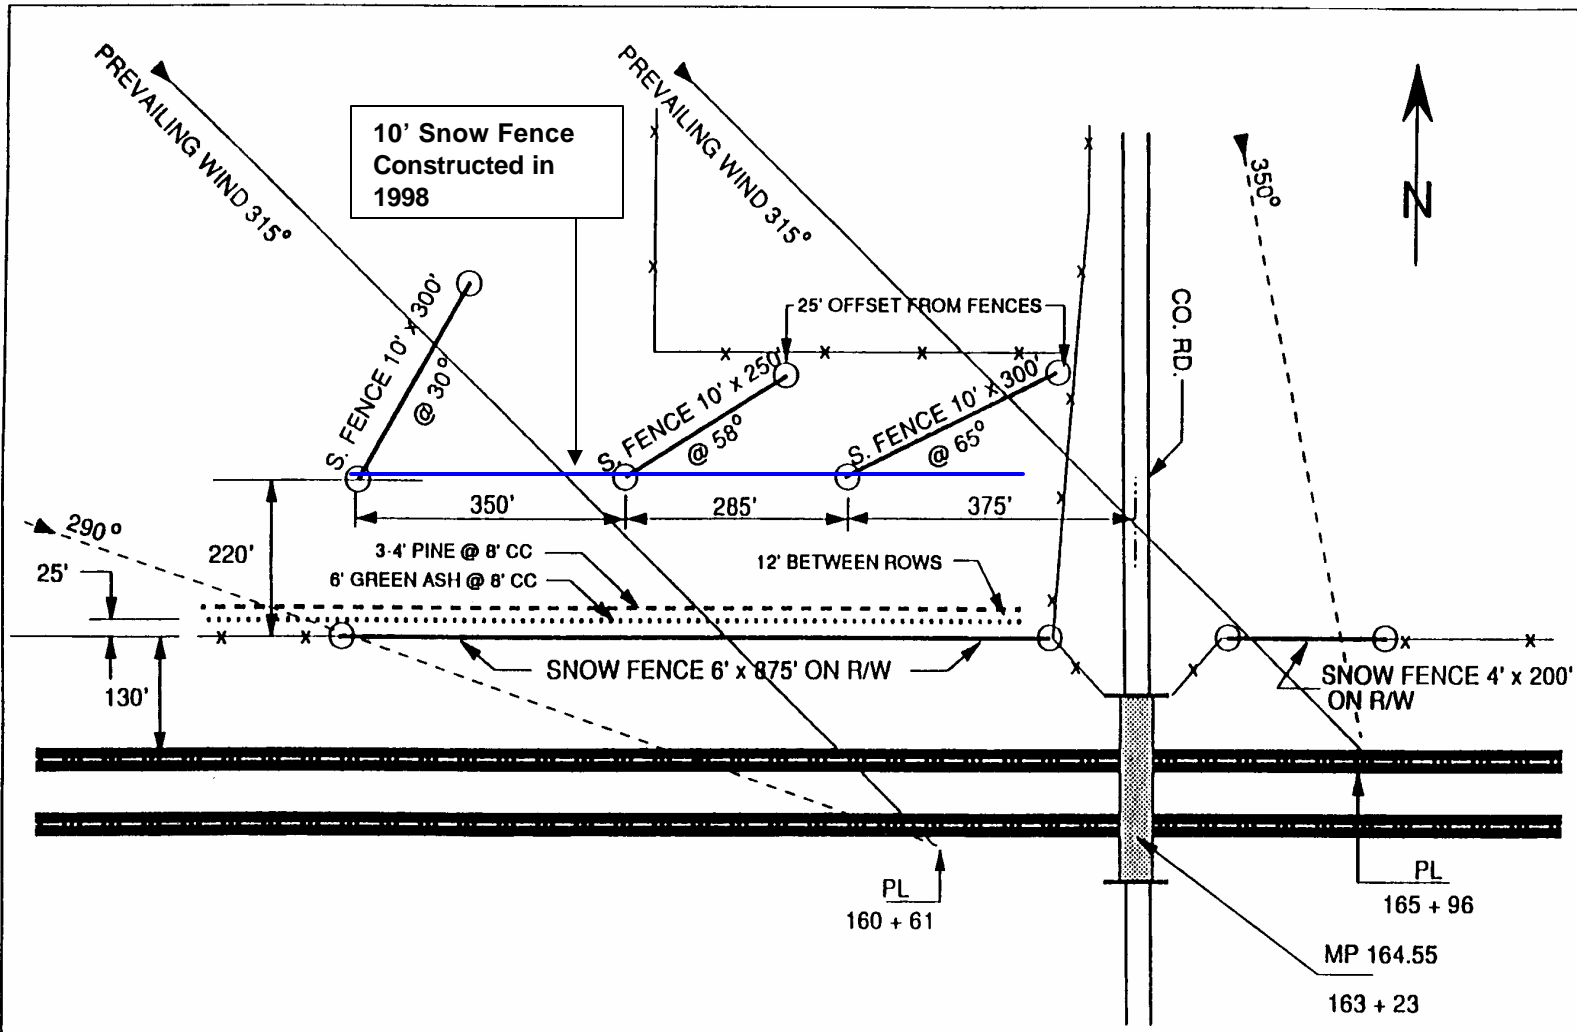
The plans for site 1 (I-94 RP 164.5) are shown in Appendix A. The six-foot and four-foot fences along the right-of-way were constructed in mid-December 1997. The plans show three ten-foot fences that are outside the right-of-way, but these fences were not constructed. Instead, a single ten-foot fence was constructed in 1998. This fence is approximately 200' north of the right-of-way and is parallel to the 6' fence constructed in 1997. The approximate location of this fence is shown in blue in Appendix A. Site 1 had an existing living snow fence that was planted in 1994. The living snow fence was planted along the right-of-way and consists of two rows of trees planted 12' apart. One row is Green Ash and the other row is Pine.

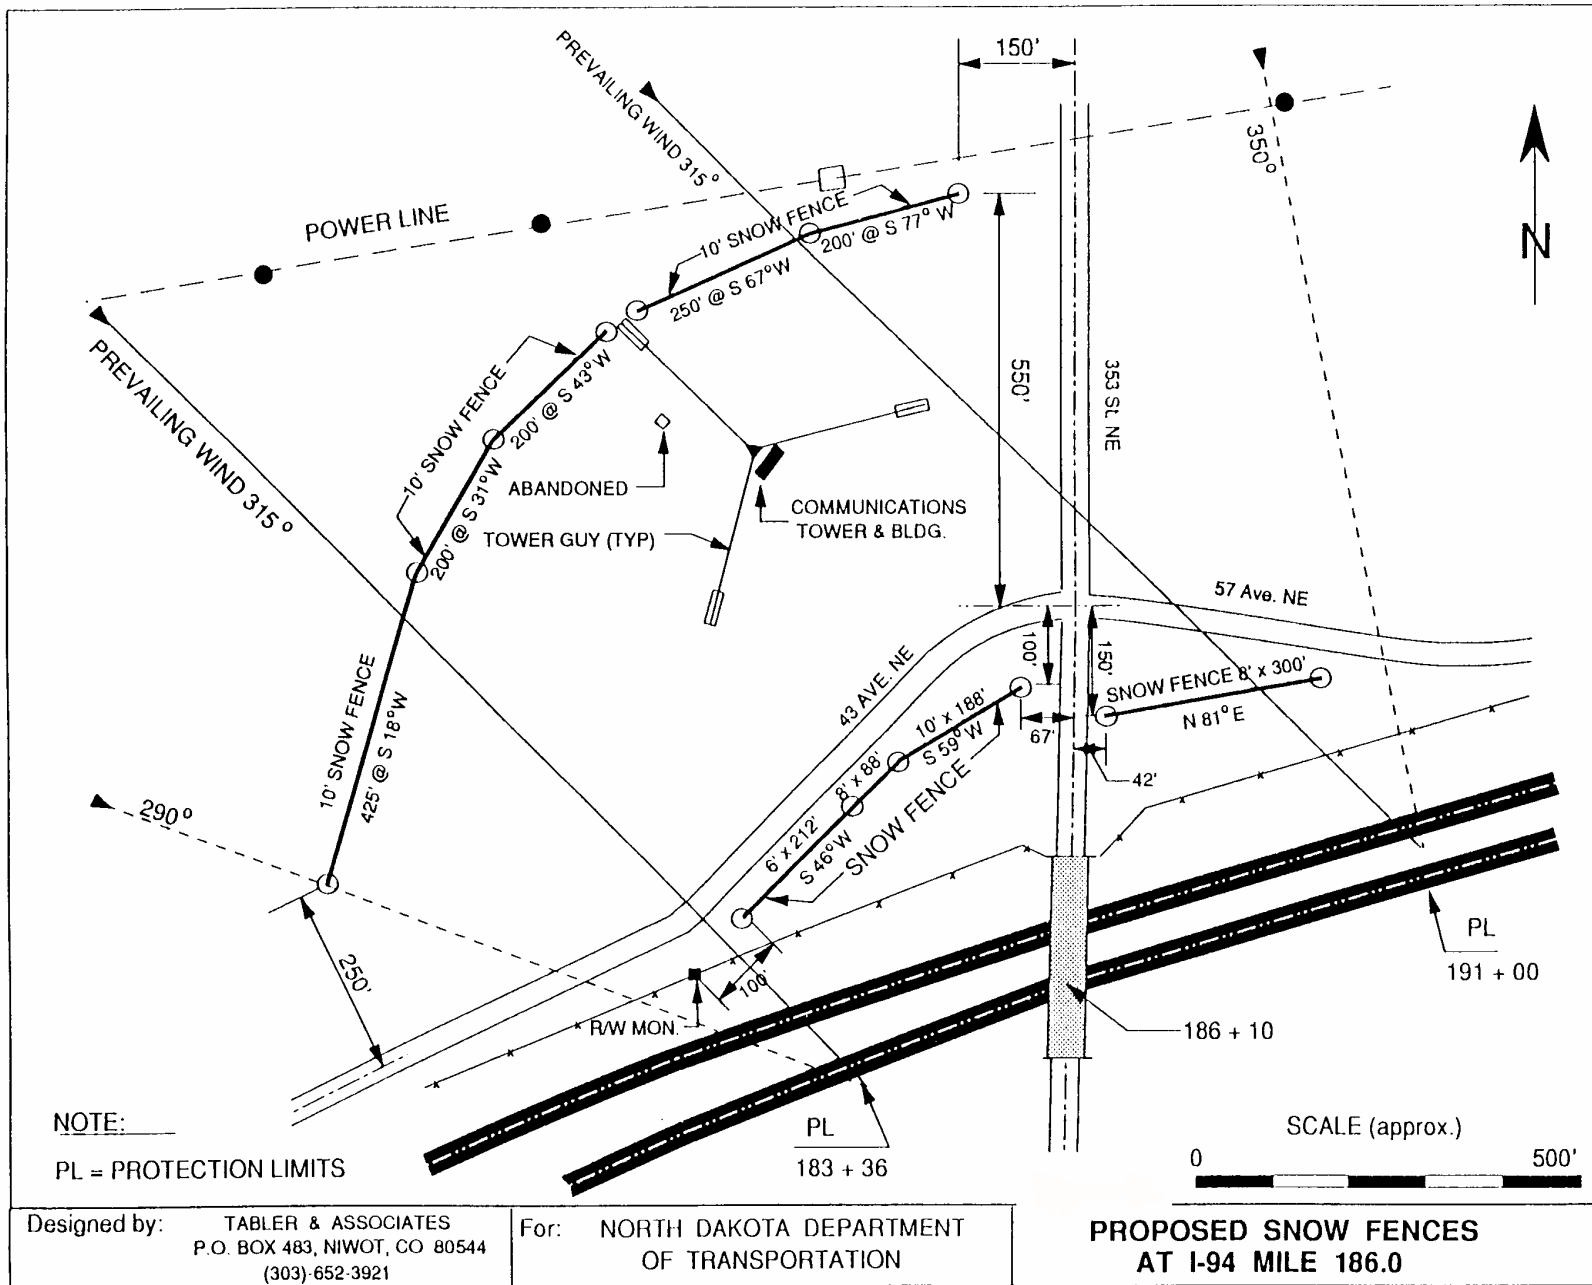
Site 2

The plans for site 2 are shown in Appendix A. The snow fences between Interstate 94 and the frontage roads were constructed in December 1997. The plans show a long ten-foot fence that is to north and west of a communications tower. This fence was never constructed.
