Route:00013 Log:192.113

District 61, Emmons County

IDENTIFICATION	
(1) State Names	North Dakota
(8) Structure Number	0013-192.154
(5) Inventory Route	00013
(2) Highway Agency District	61
(3) County Code	Emmons, North Dakota

(4) Place Code	0
(6) Features Intersected	SAND CREEK
(7) Facility Carried	ND HIGHWAY 13
(9) Location	7 WEST OF US 83
(11) Mile Point	192.113 mi
(12) Base Highway Network	Yes

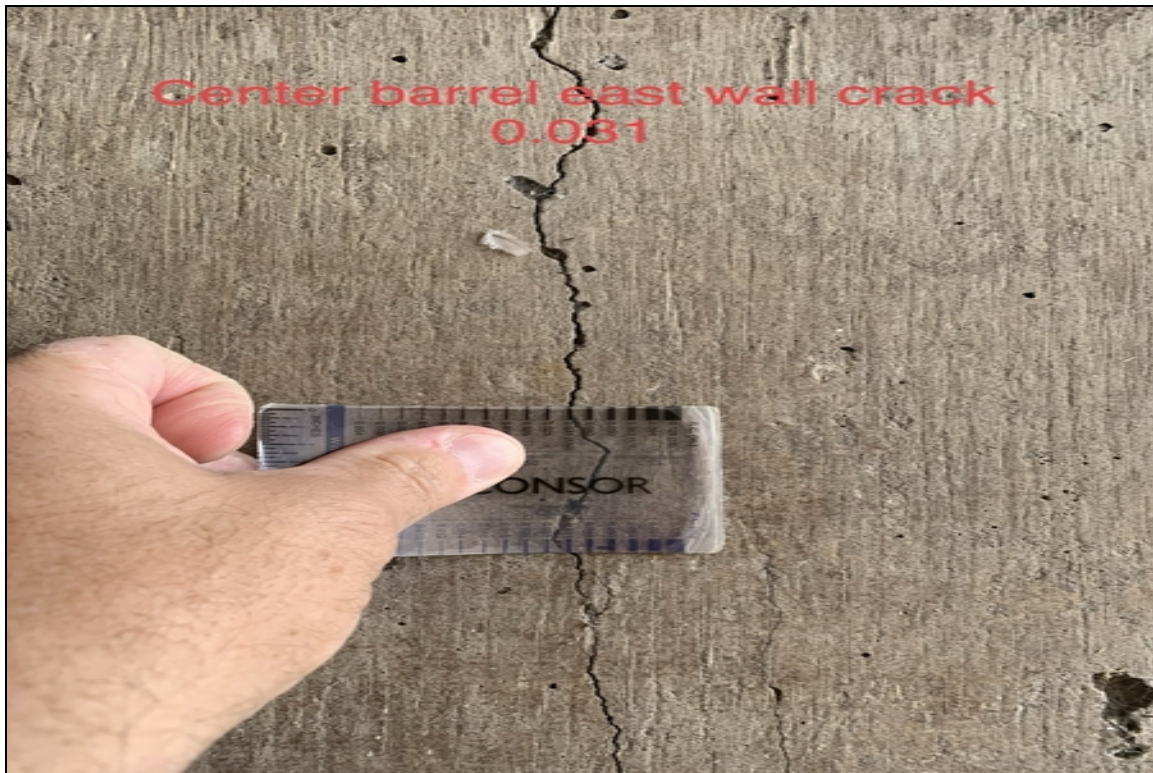
Center barrel east wall crack .031

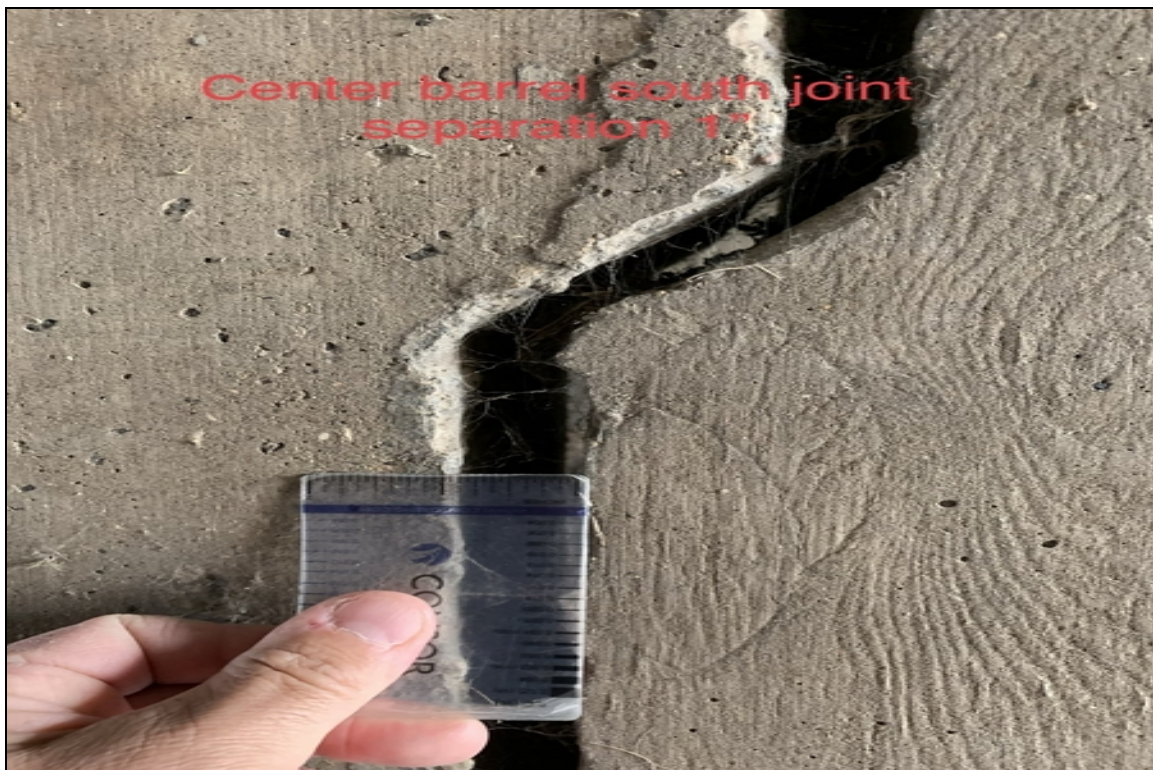
Center barrel south joint open 1"

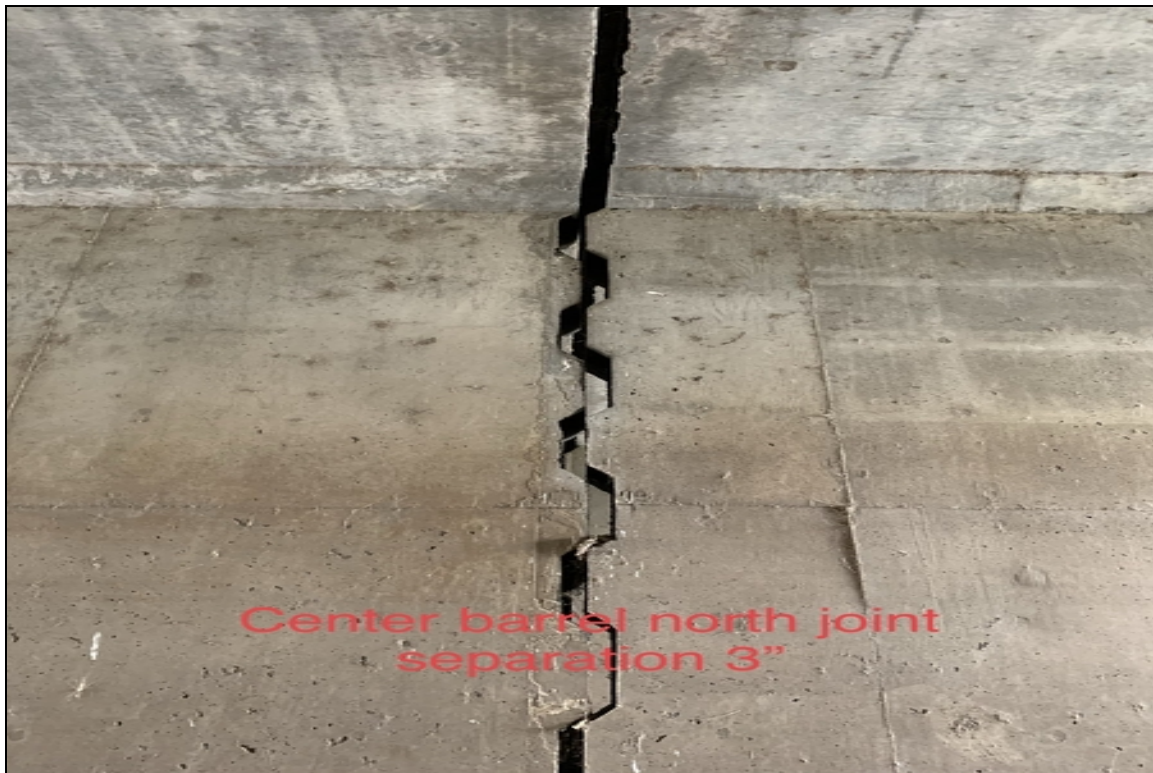
Center barrel north joint separation 3"

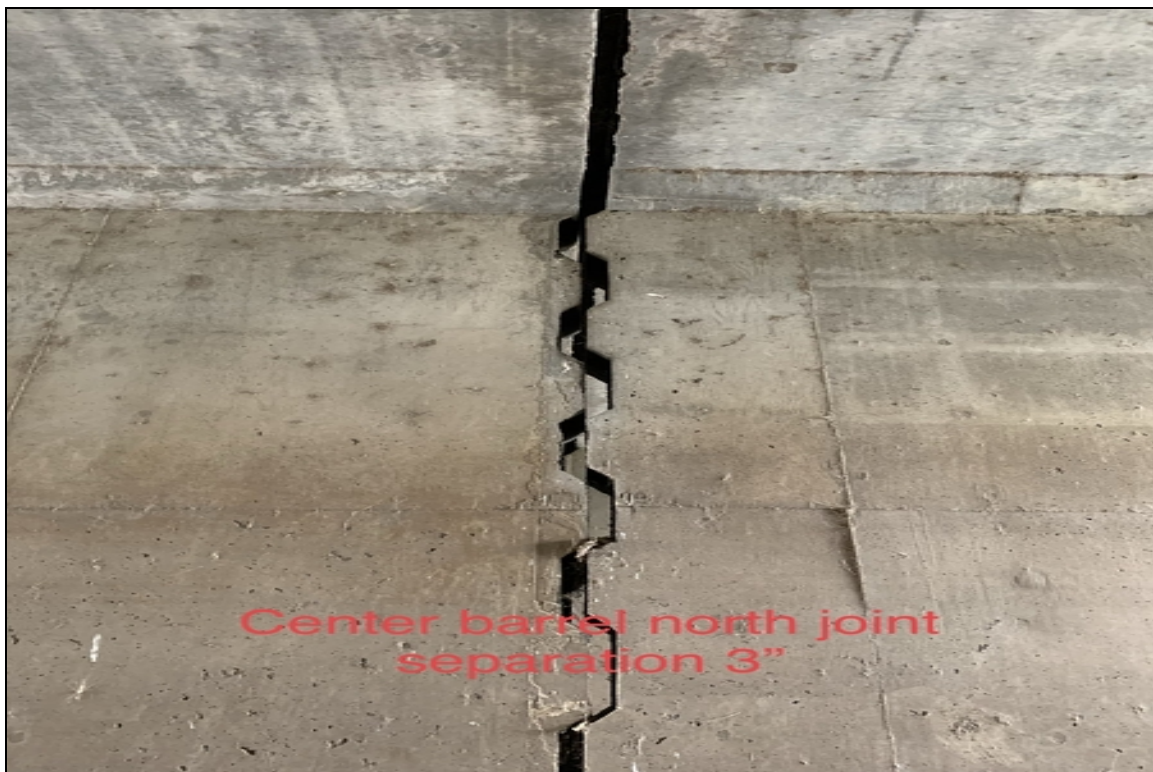
Center barrel north joint separation 3"

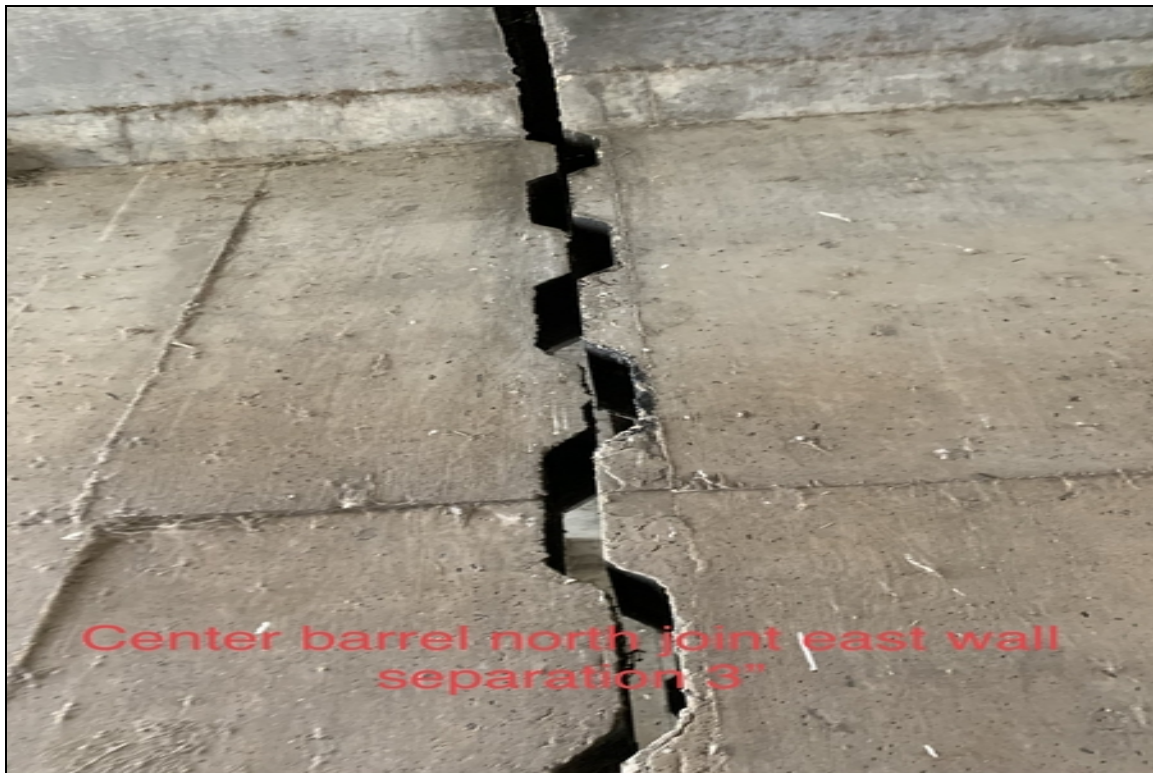
Center barrel north joint east wall separation 3"

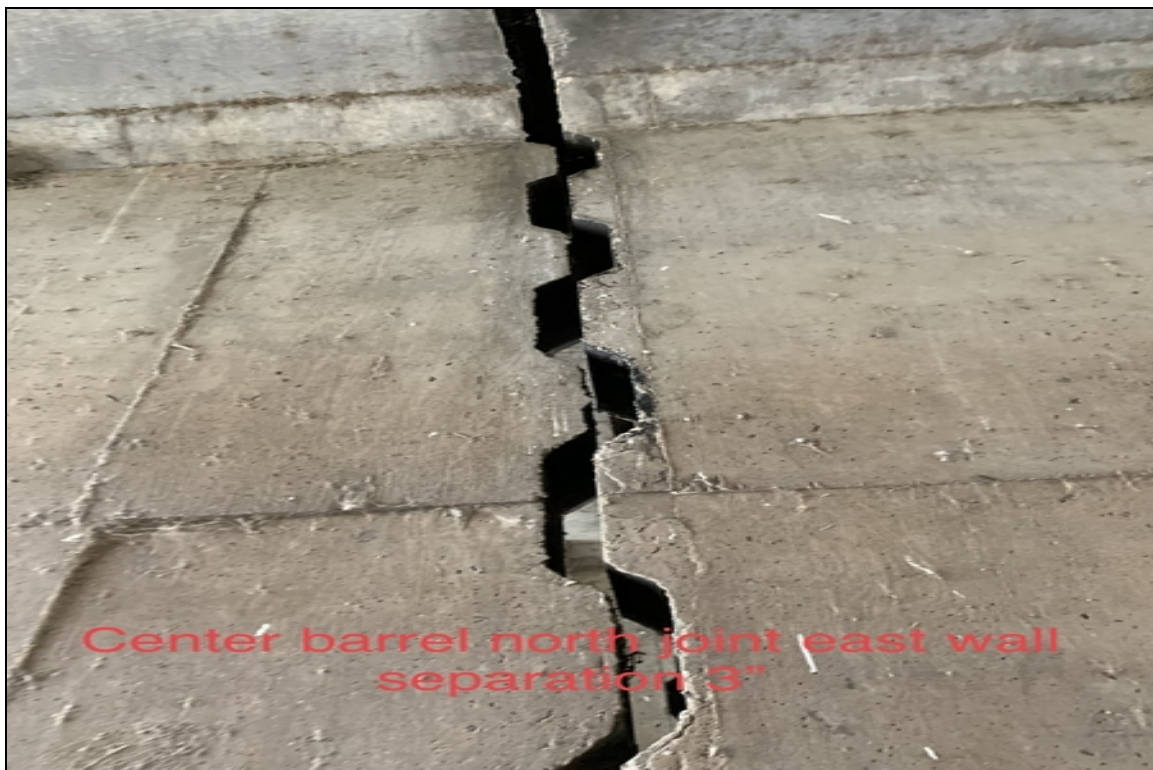
Center barrel north joint east wall separation 3"

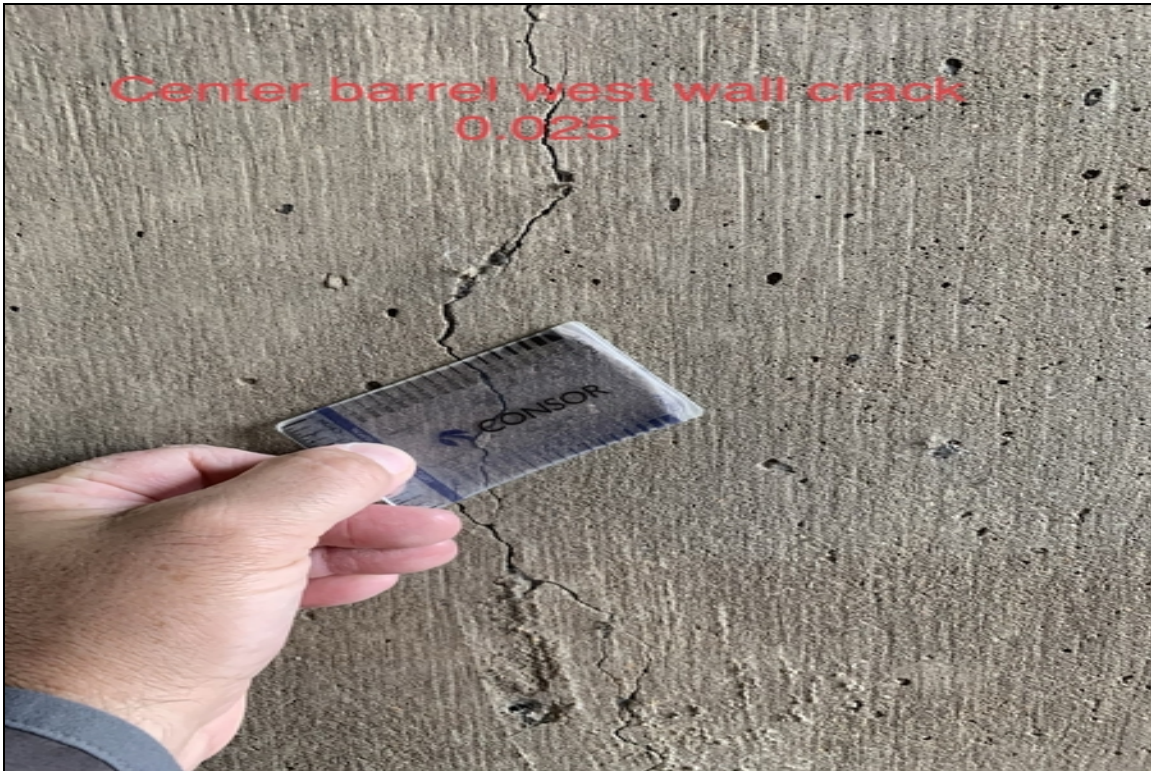
Center barrel west wall crack
0.025

Center barrel west wall crack .025

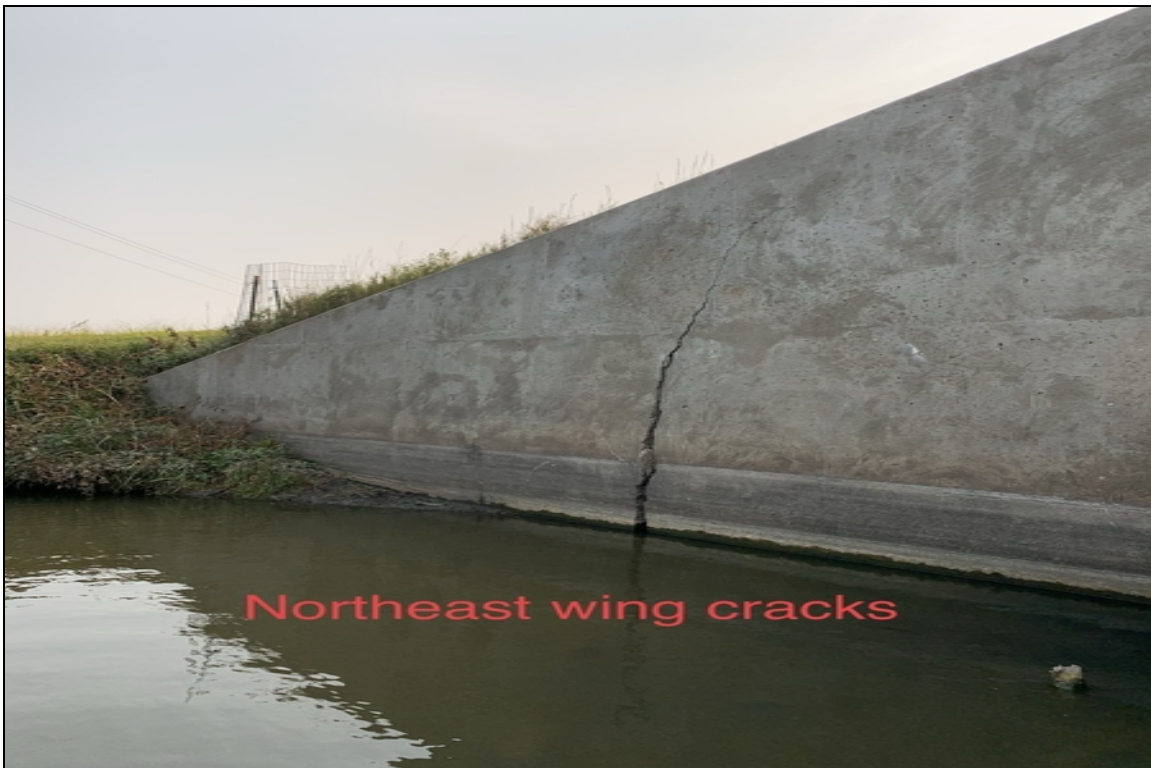
Northeast wing cracks

NE wing crack

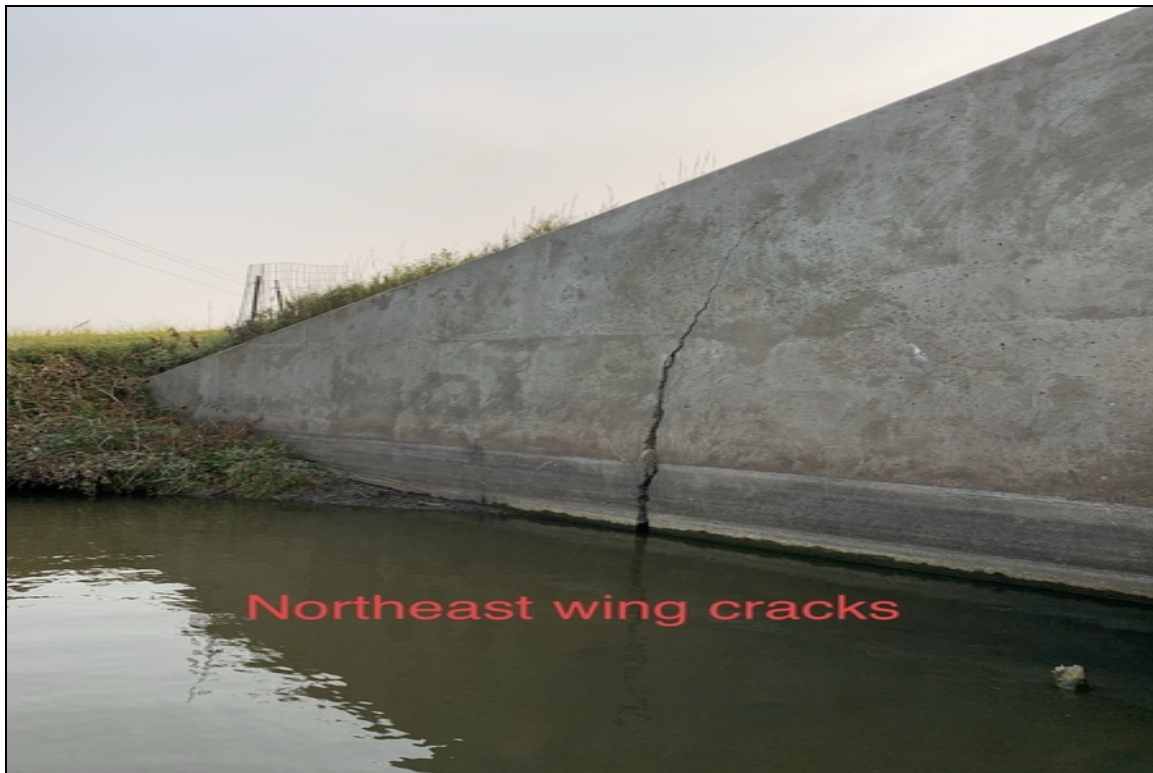
NE wing crack

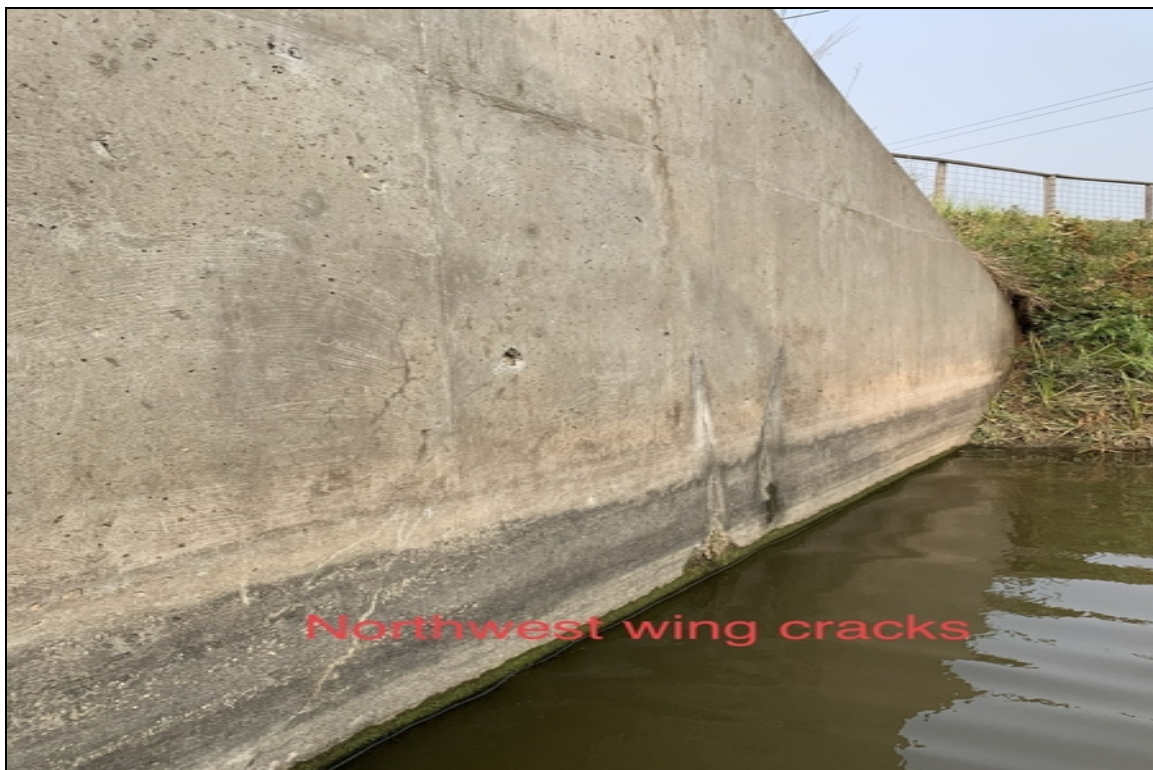
NW wing cracks

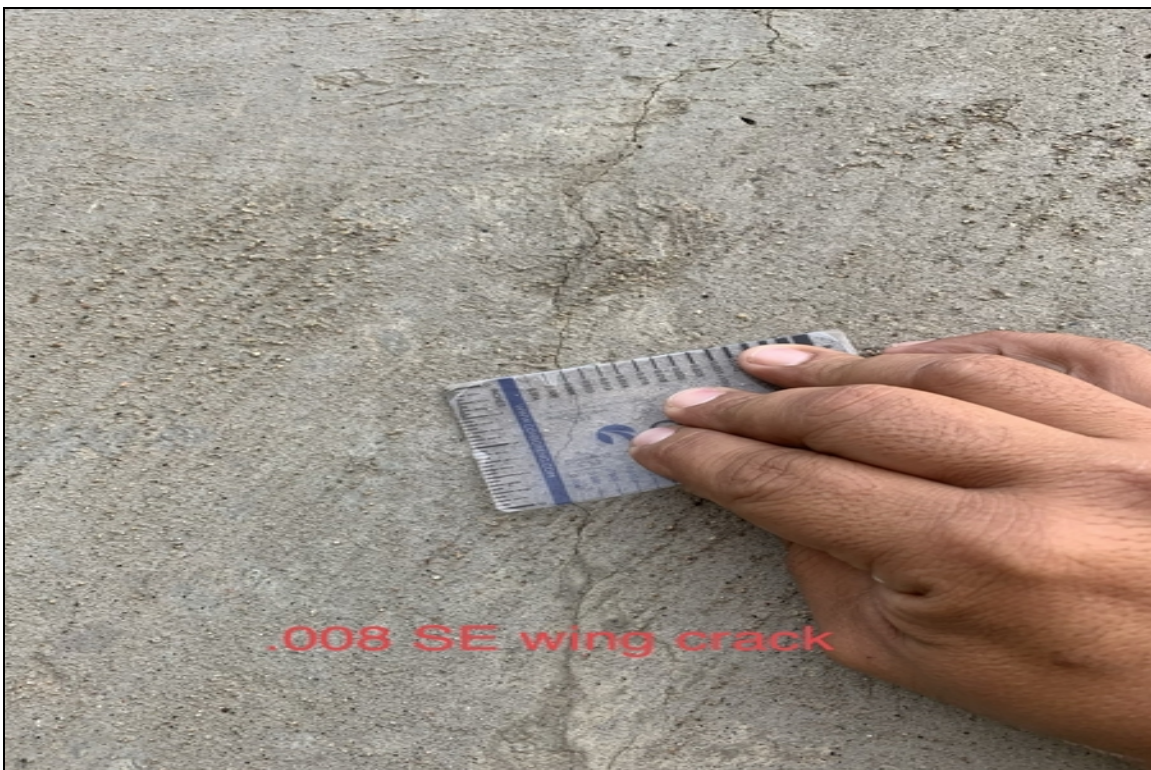
.008 SE wing crack vertical

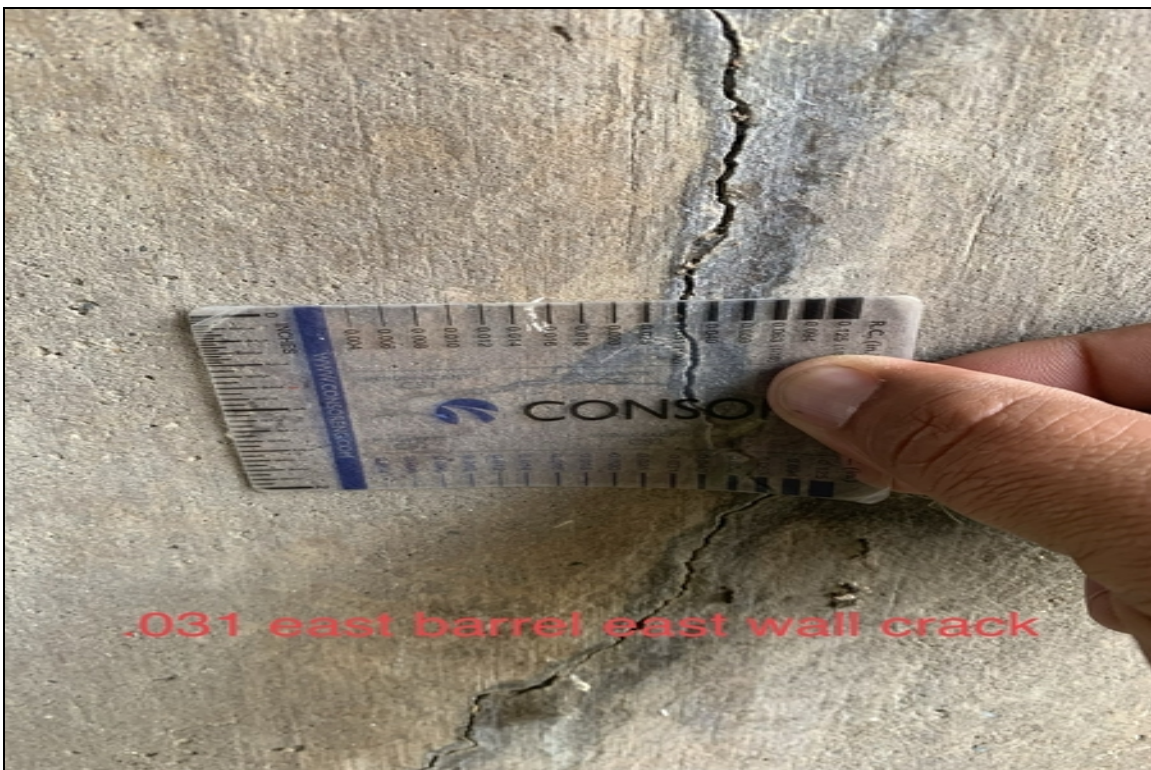
.031 east barrel east wall crack

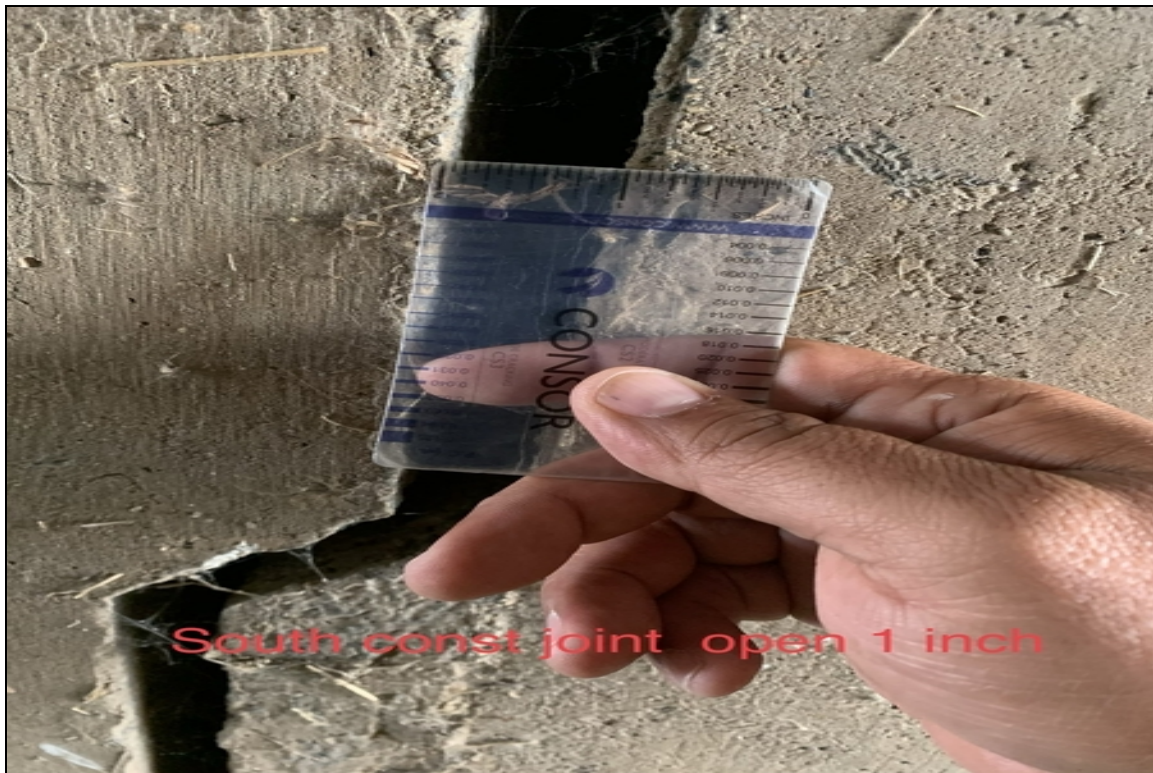
South const joint open 1"

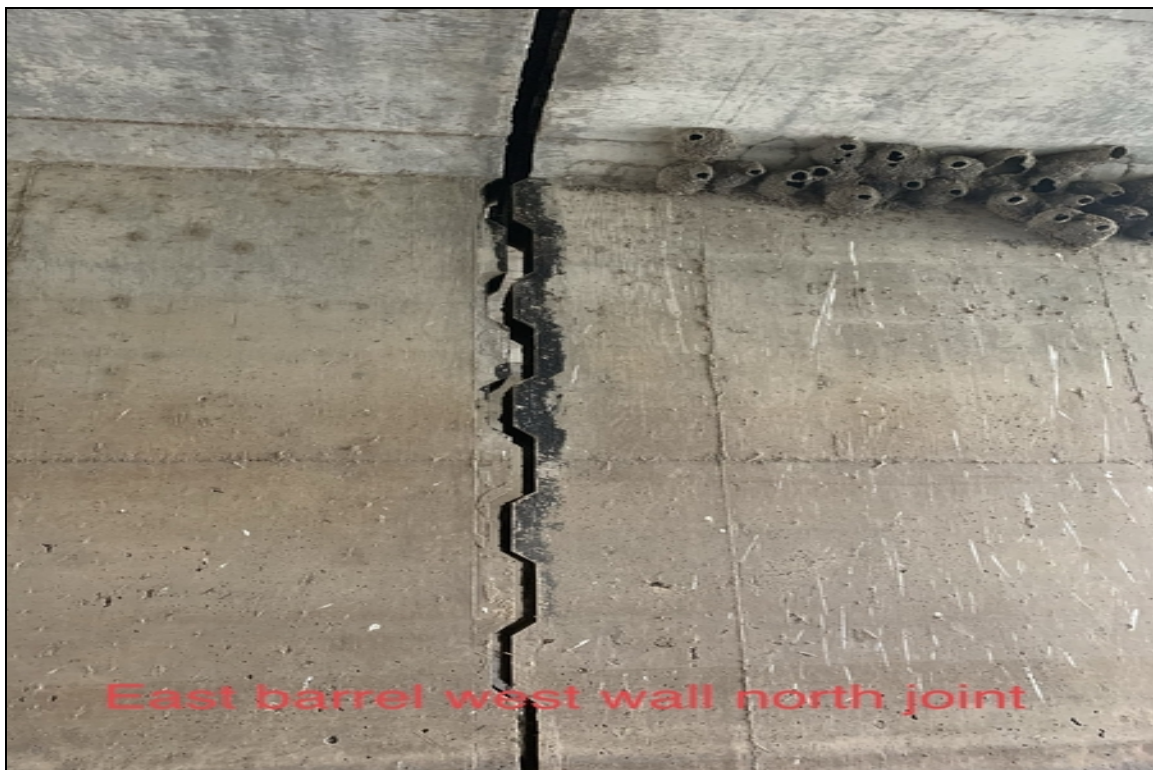
East barrel west wall north const joint open more at top then bottom

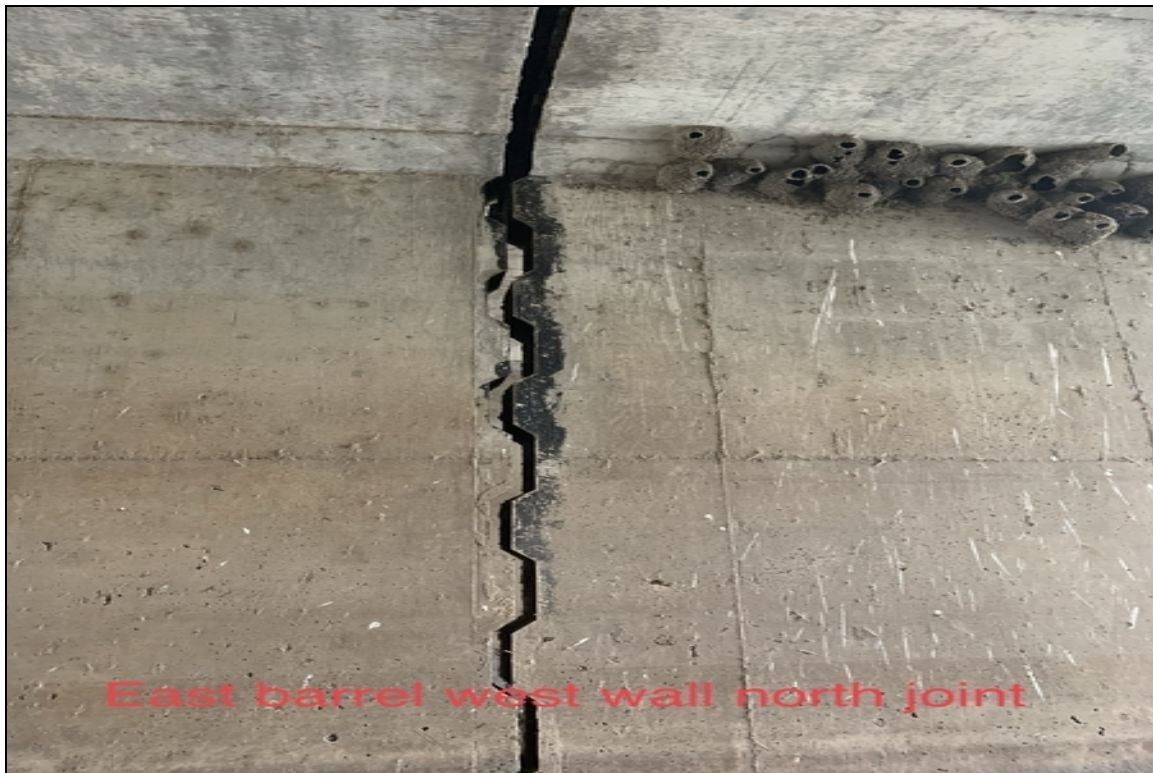
East barrel west wall north const joint open more at top then bottom

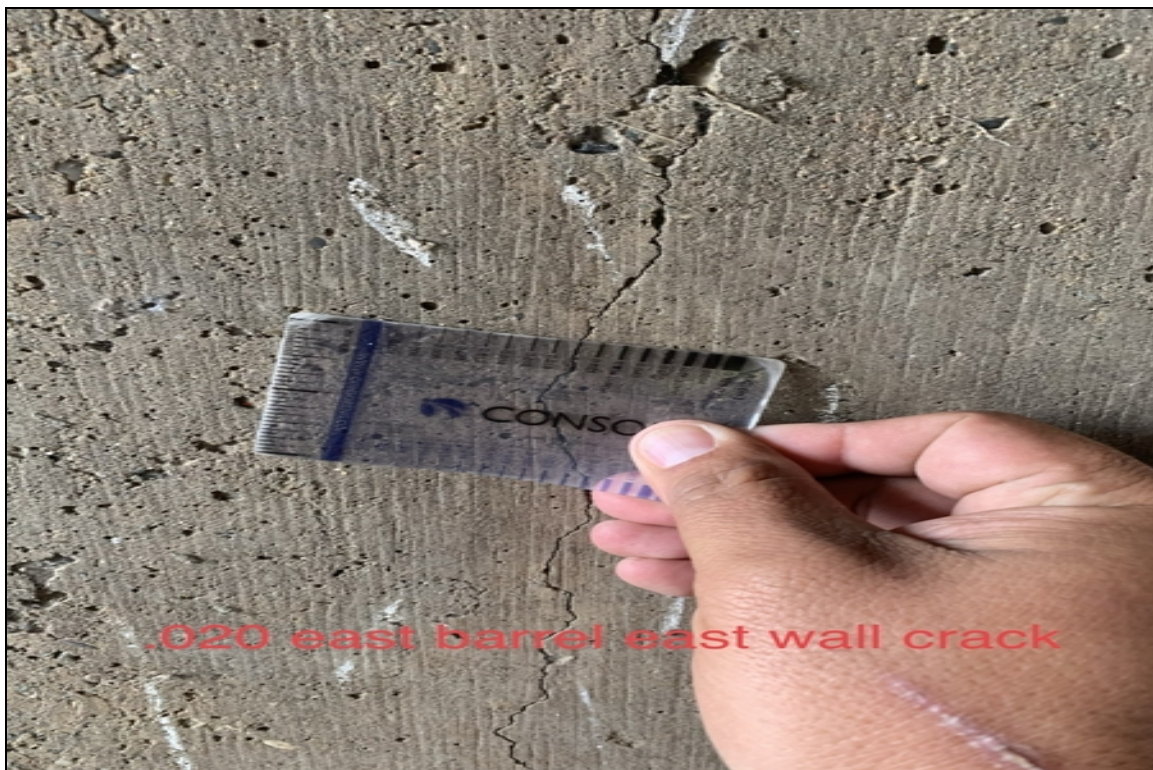
.020 east barrel east wall crack

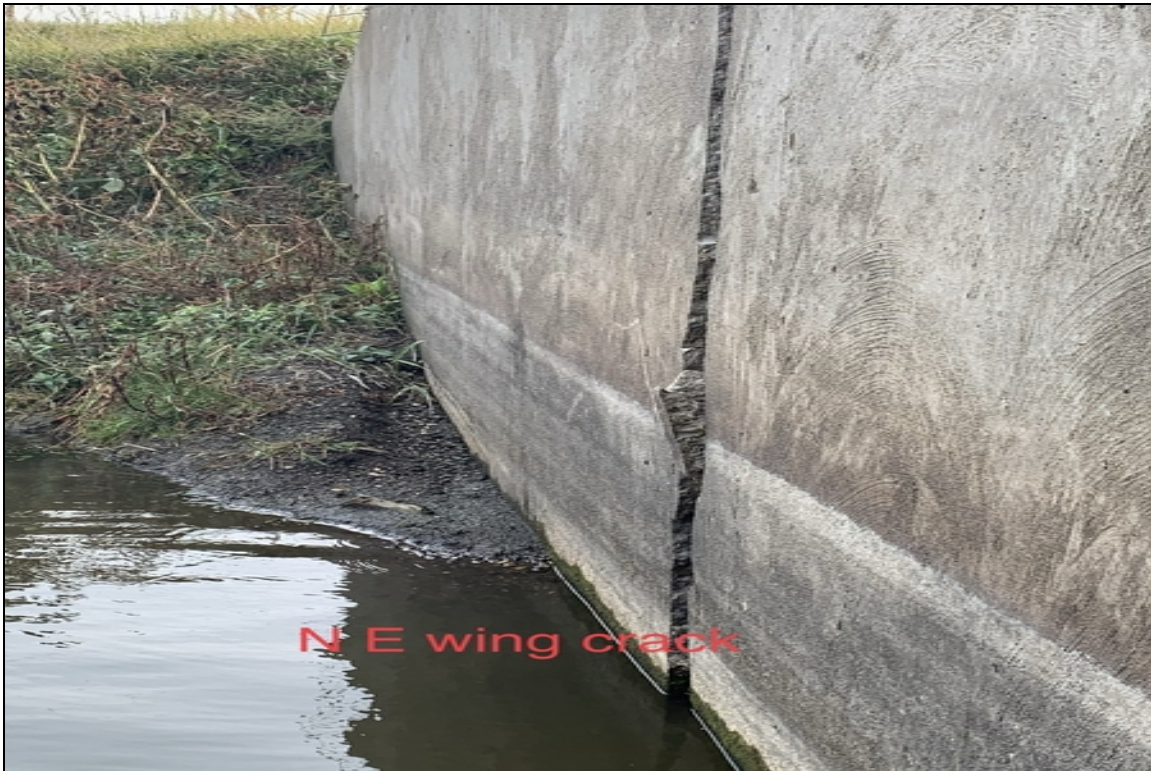
NE wing crack

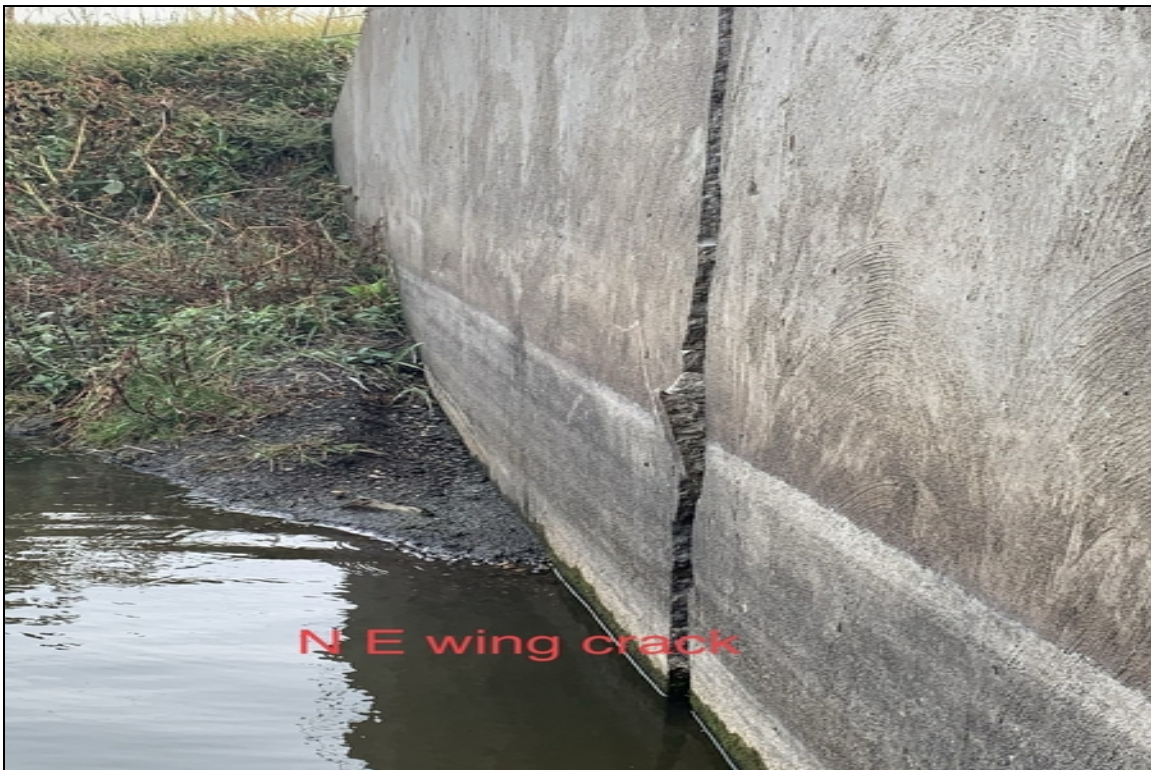
NE wing crack

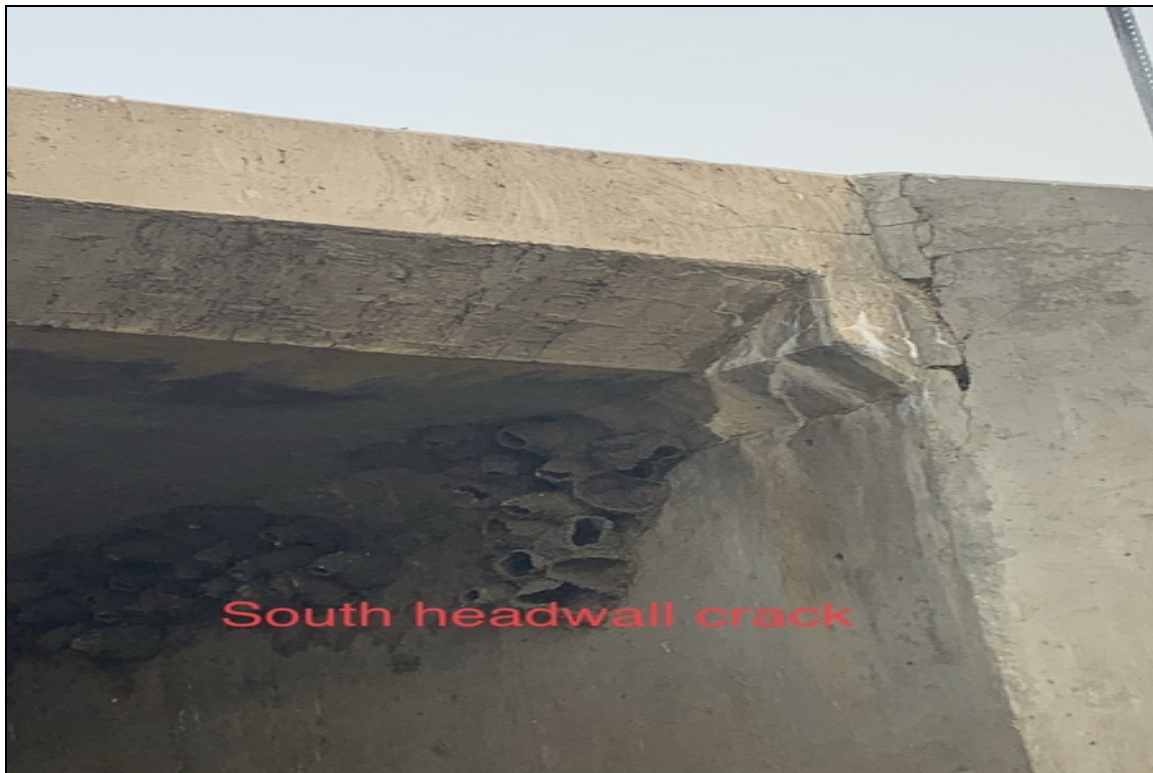
8402	Headwalls	EA	2	0	1	1	0
1080	Delamination/Spall/Patched Area	EA	1	0	0	1	0
1130	Cracking (RC and Other)	EA	1	0	1	0	0
(8402-1080)							
The South headwall has a spall approximately 1 foot by 6 inches in size with 6 inches of exposed rebar. This is located at the West end of the south headwall. 15September2020							
(8402-1130)							
The South headwall has cracks occurring. 15September2020

South headwall east end cracks

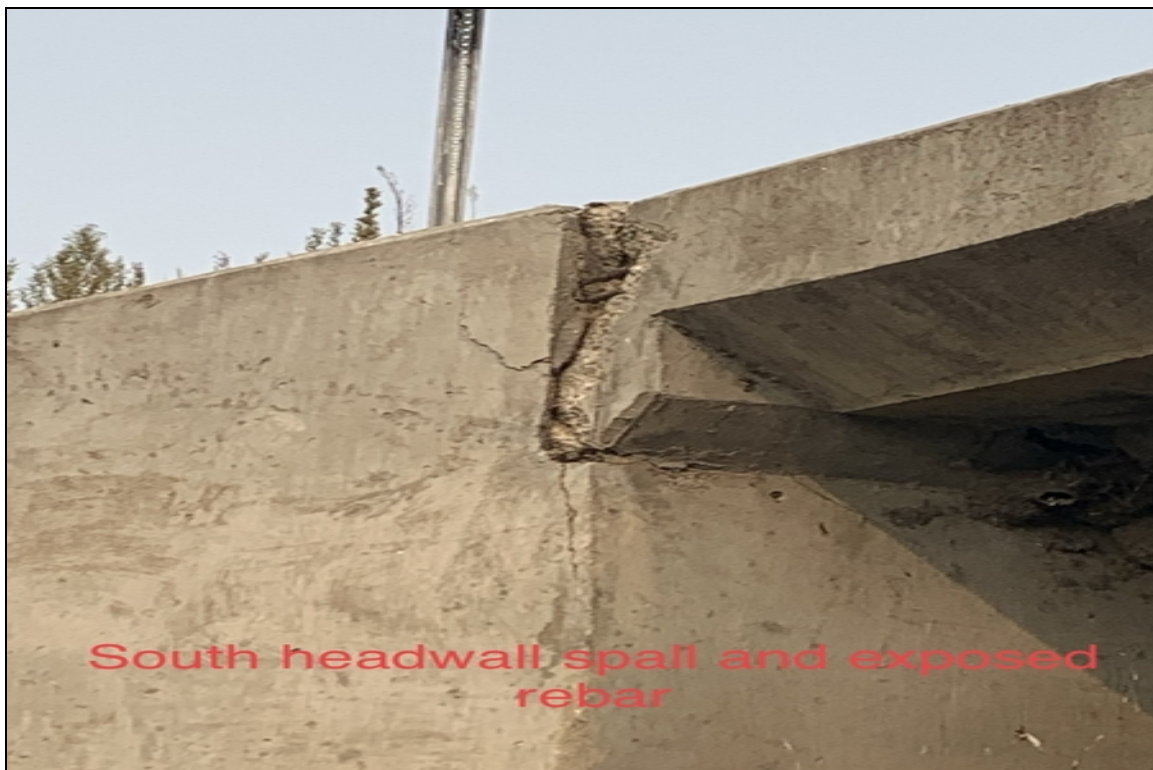
South headwall west end spalled and exposed rebar

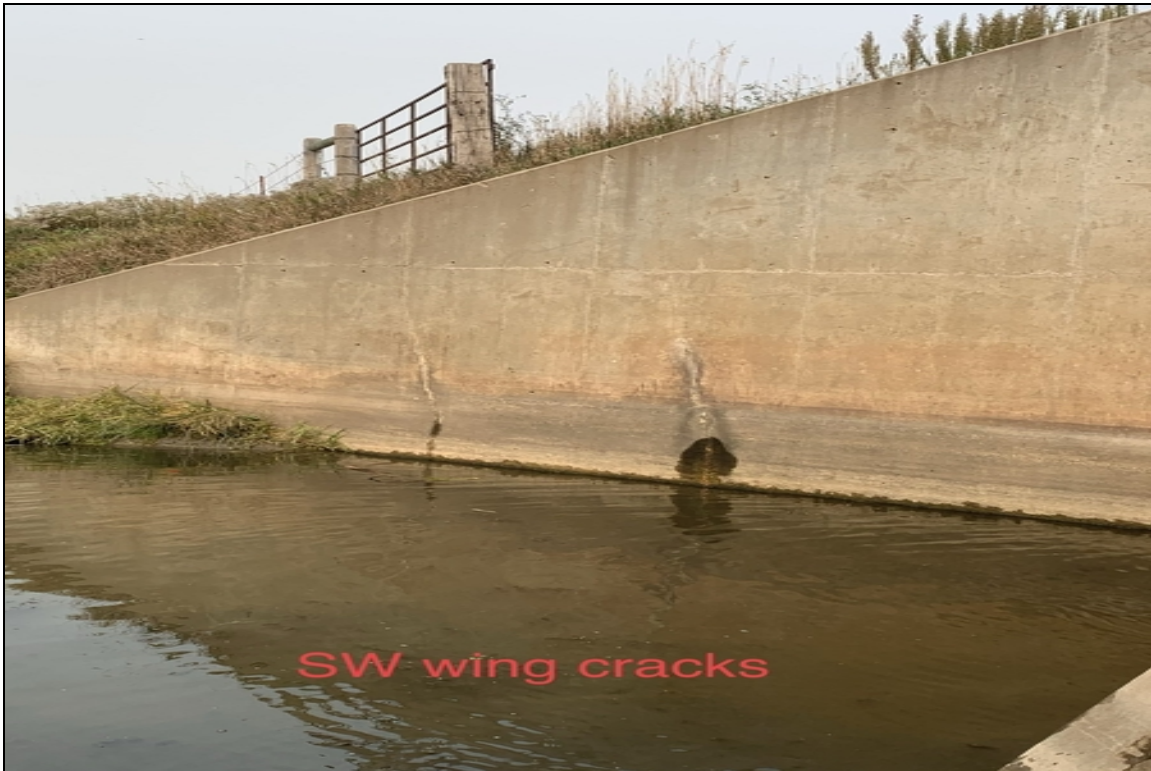
SW wing cracks

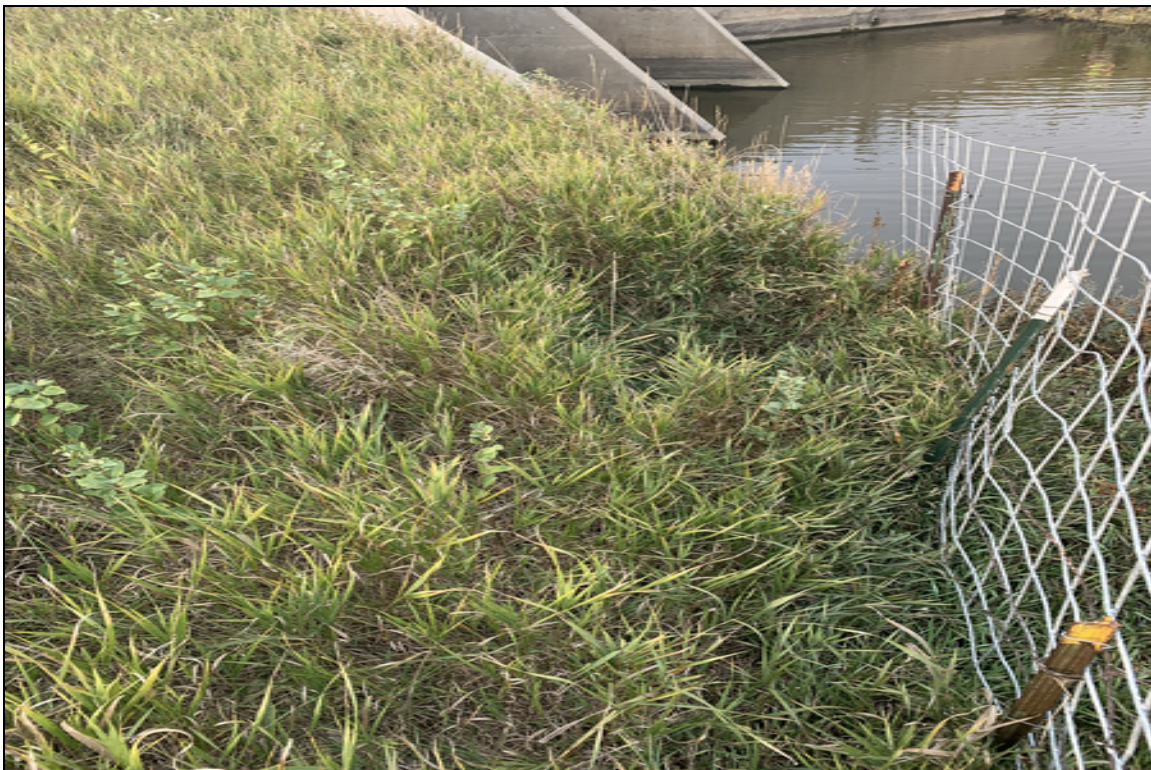
The Northeast wing has some erosion occurring behind the wing. 15september2020

Erosion behind NE wing 5'x3'x1'
