| IDENTIFICATION | |
| (8) Structure Number | 0031-029.214 |
| (6) Features Intersected | DOG TOOTH CREEK |
| (7) Facility Carried | ND HIGHWAY 31 |

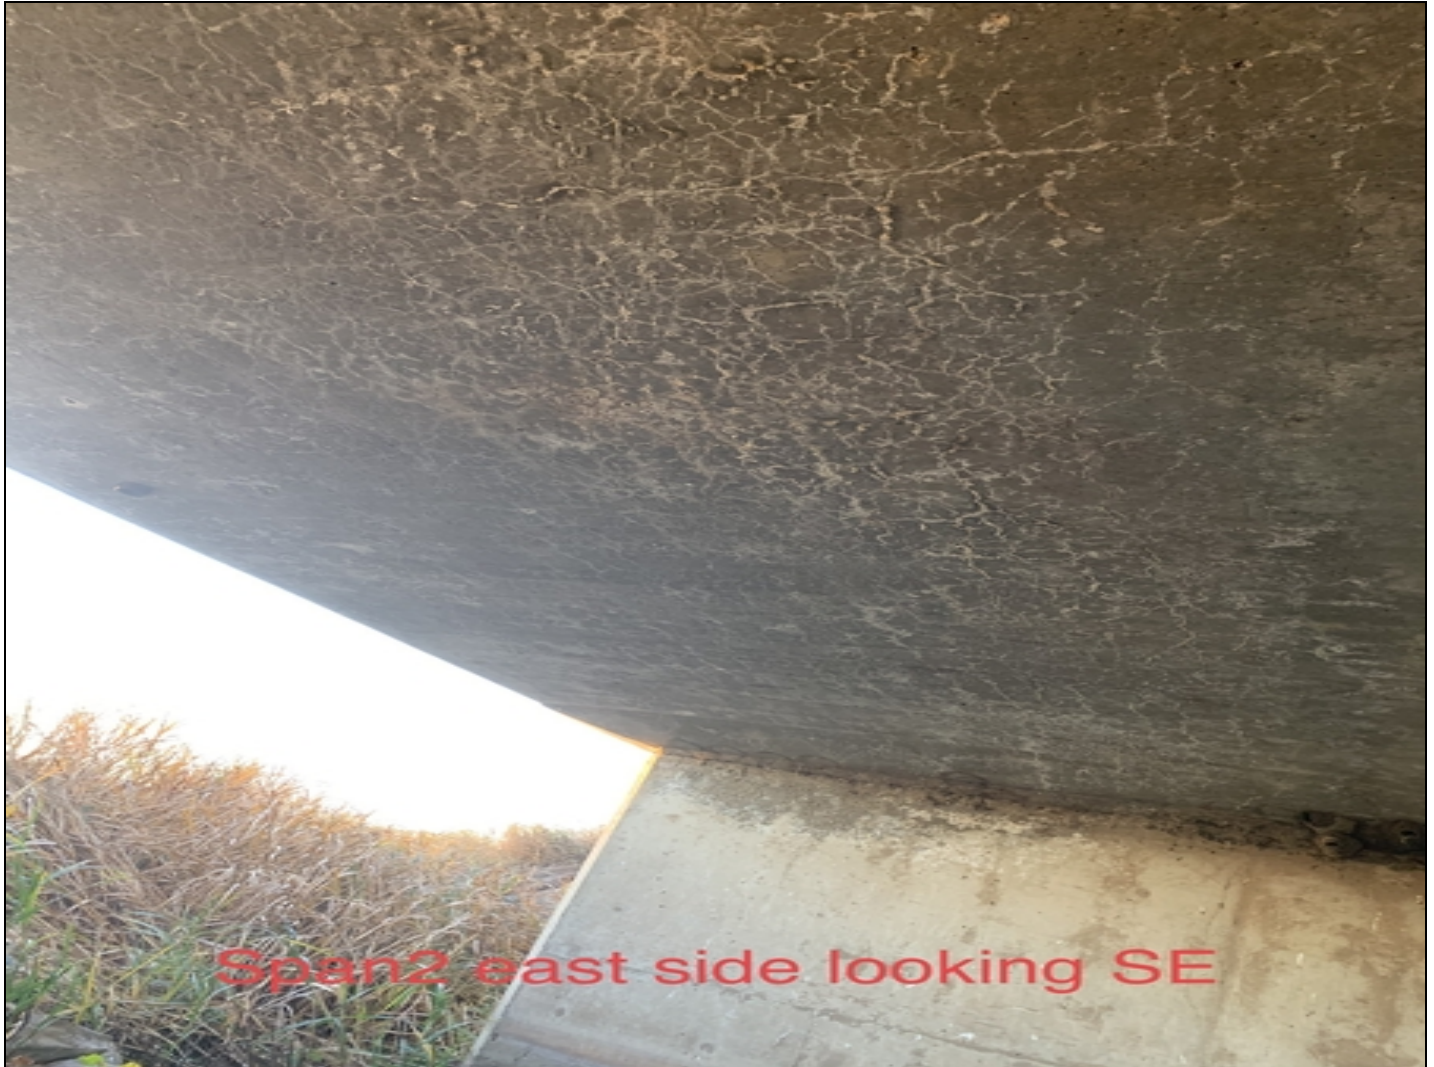
Span2 east side looking SE

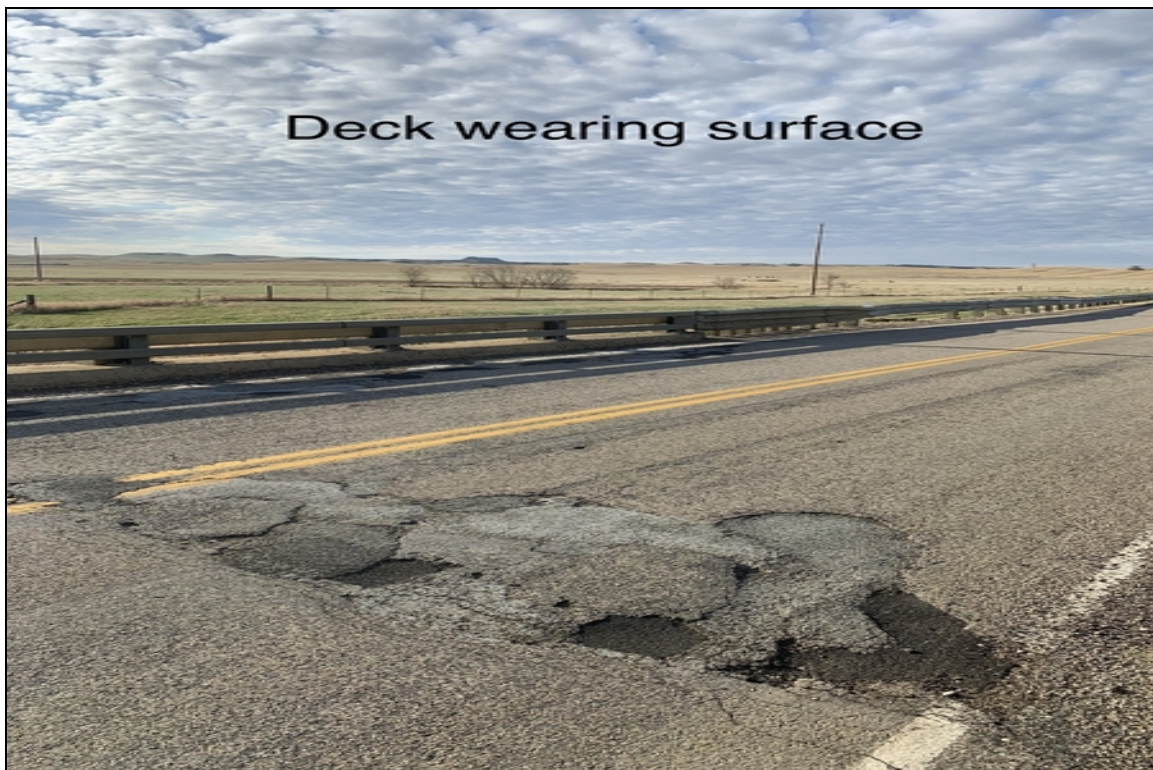
| ELEM | DESCRIPTION | UNITS | TOTAL | CS1 | CS2 | CS3 | CS4 |
|---|---|---|---|---|---|---|---|
| There is cracking of the asphalt wearing surface throughout the deck. 4May2021 | | | | | | | |

Deck wearing surface

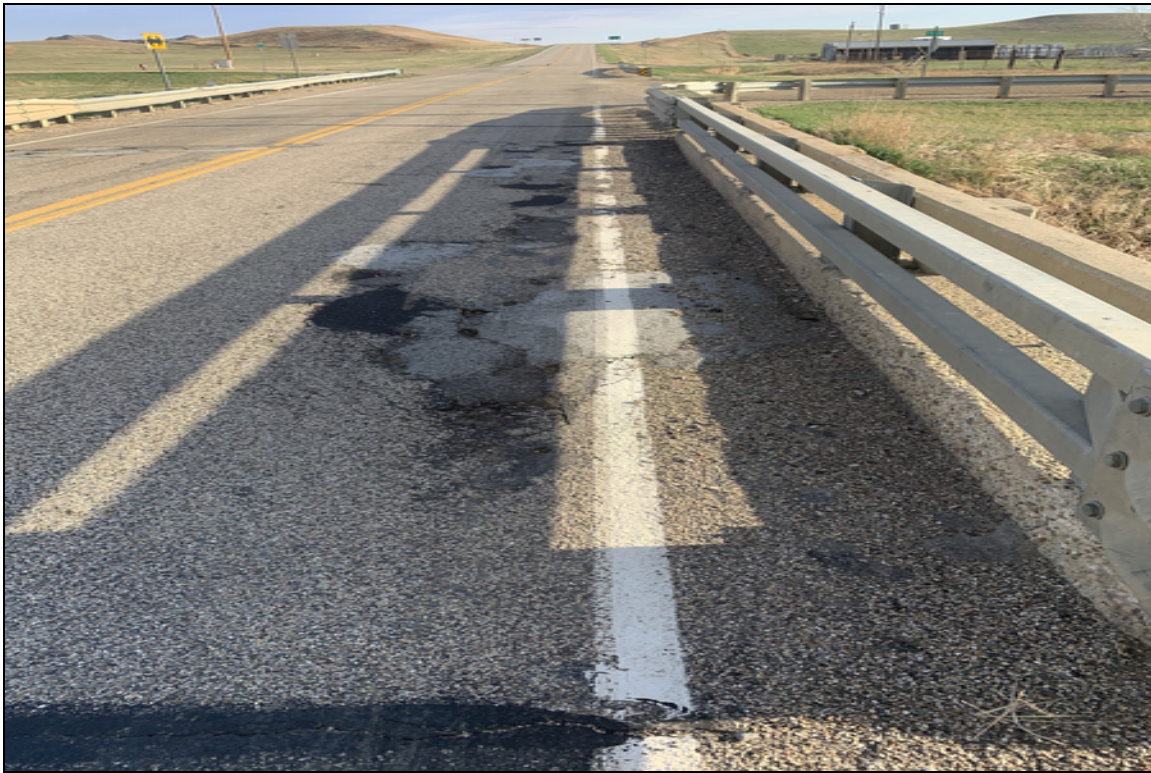
| ELEM | DESCRIPTION | UNITS | TOTAL | CS1 | CS2 | CS3 | CS4 |
|---|---|---|---|---|---|---|---|
| There is a 3 foot by 60 foot area along the east curb and a 11 foot by 3 foot area at the north end in the South bound lane that is spalled. 4May2021 | | | | | | | |

NB lane wearing surface spalls

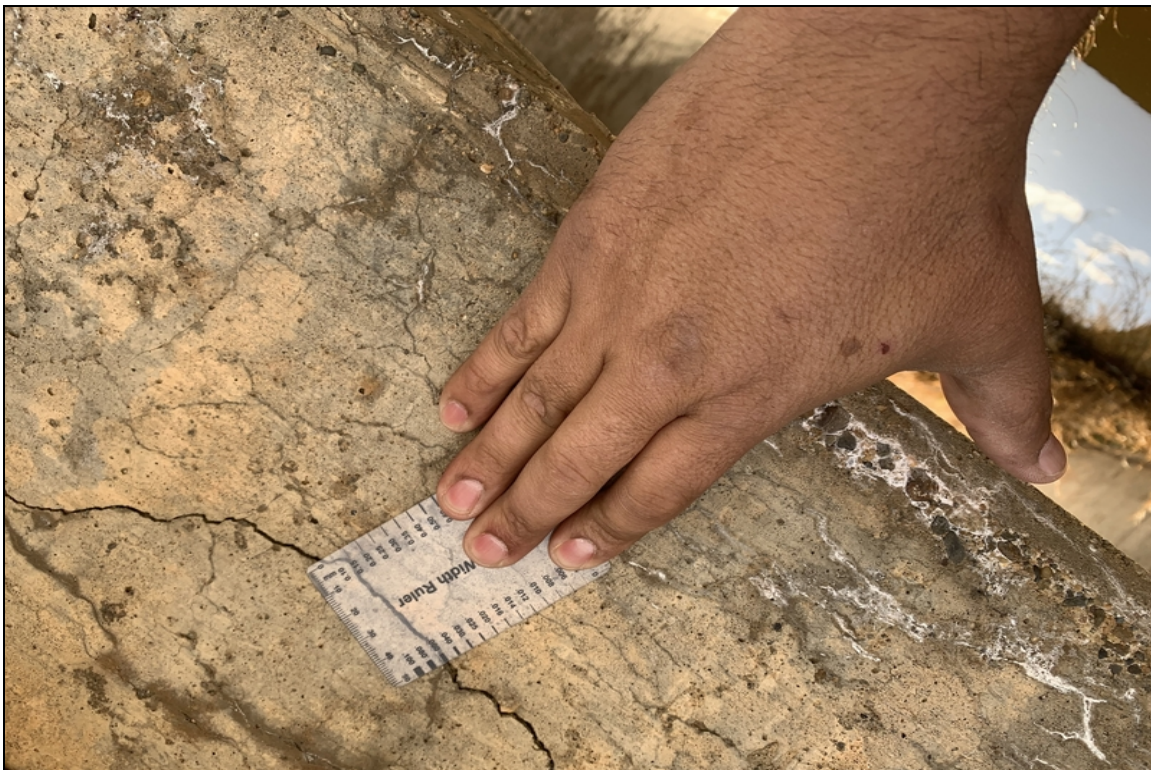
There are large spalls on the slab in the wearing surface and the underside of the deck is map cracked with efflorescence. There are large horizontal cracks on the outside faces of the slab. The largest measuring approximately 0.060 in width.
4May2021

West face slab crack about pier .060

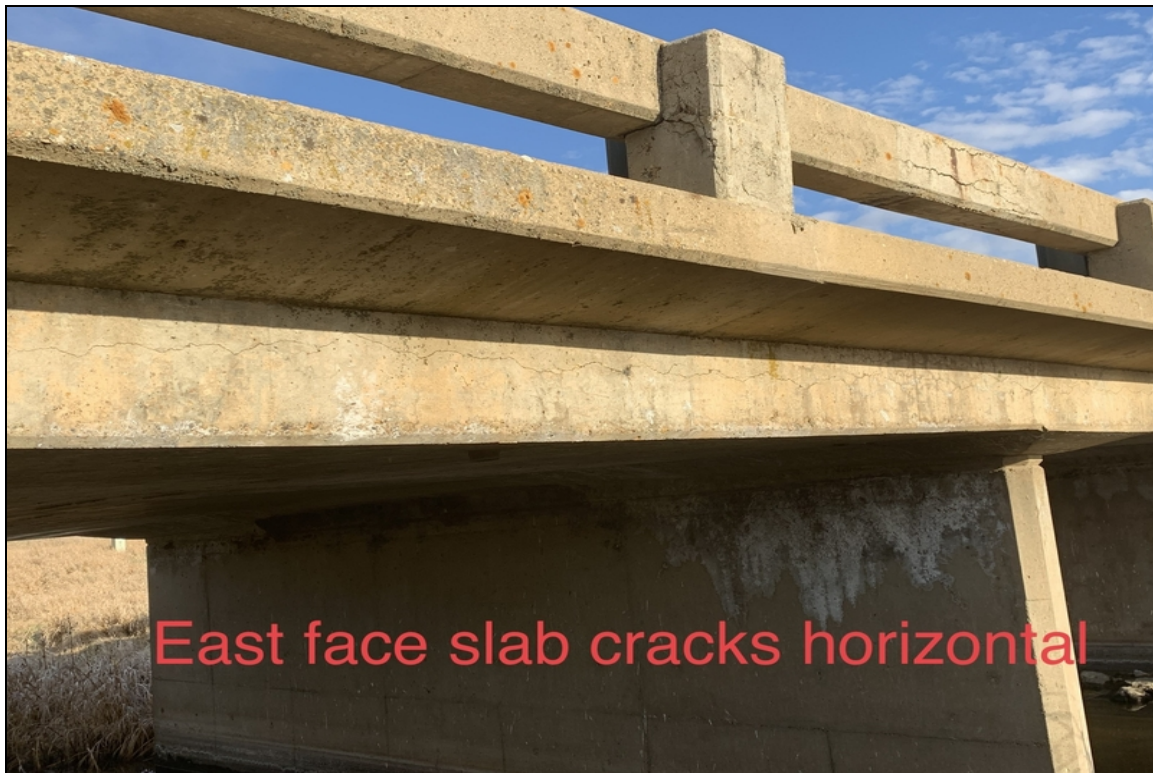
East face slab cracks horizontal

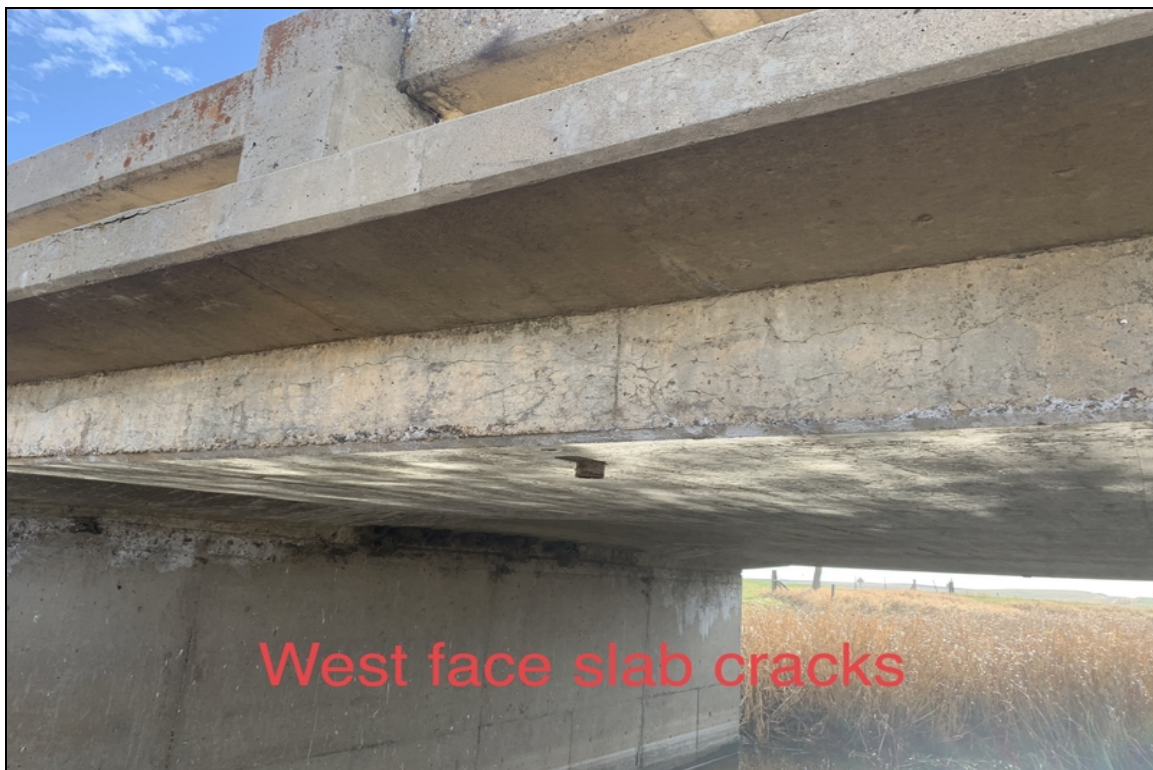
West face slab cracks

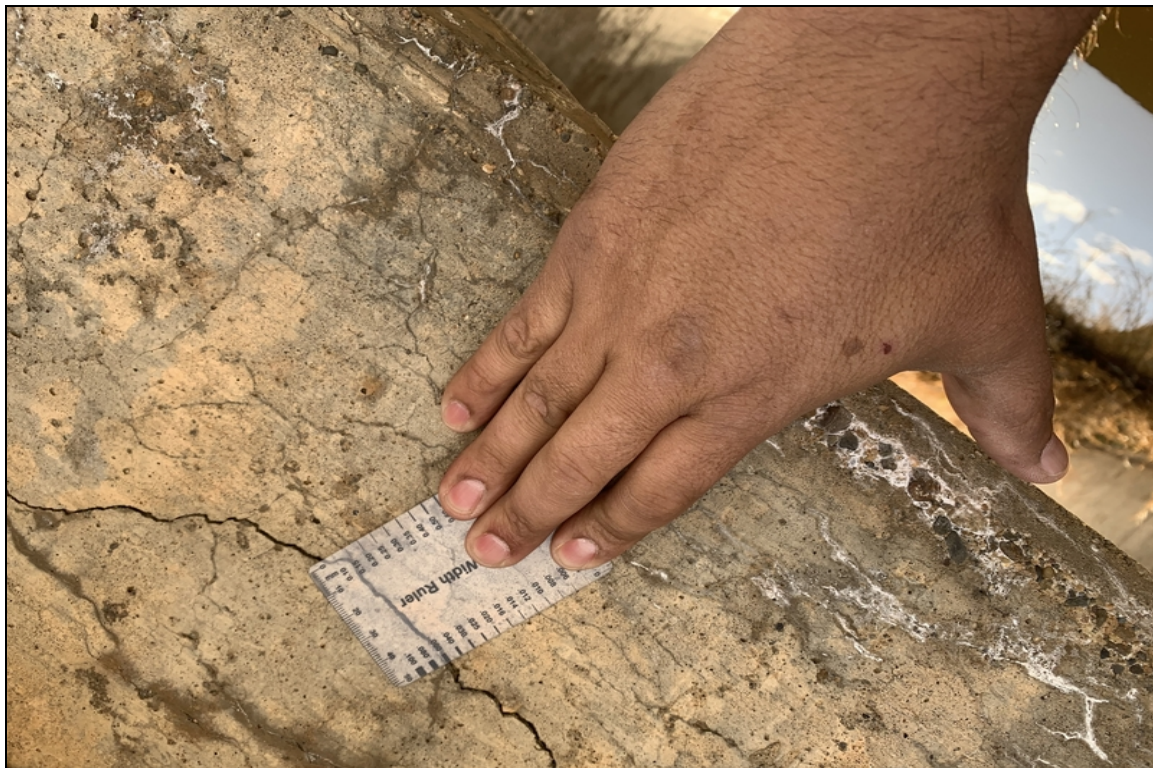
West face slab crack about pier .060

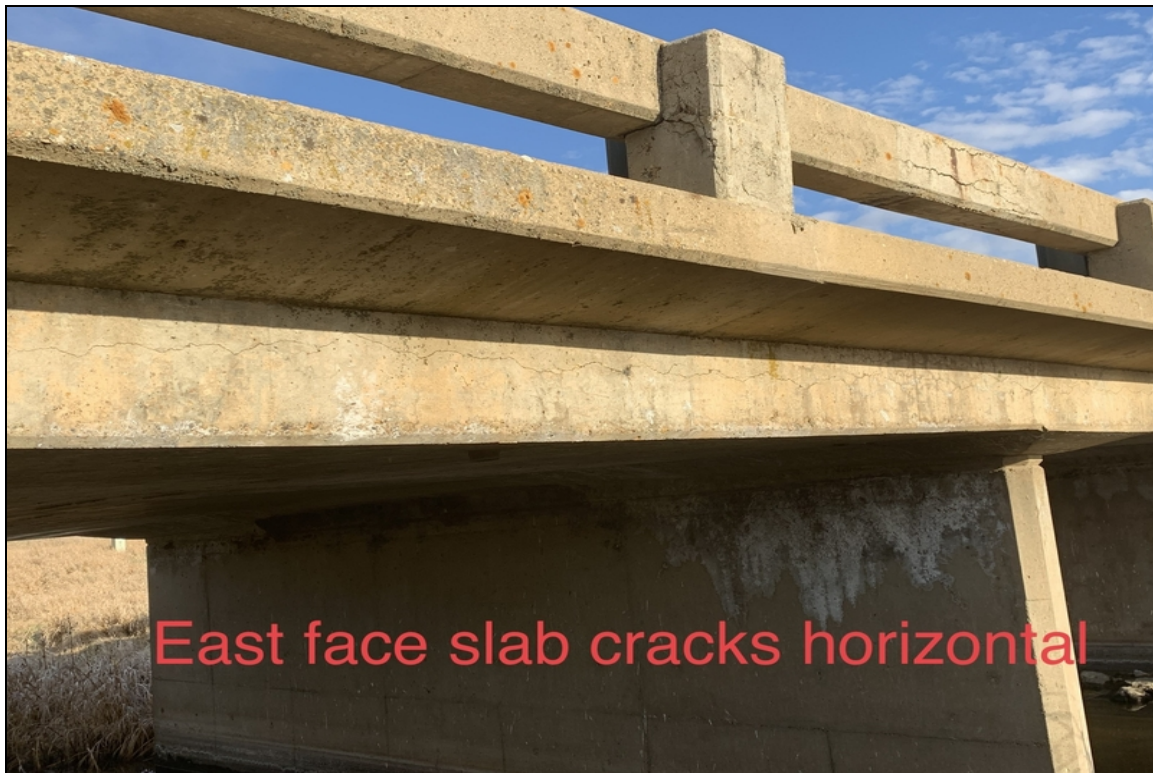
East face slab cracks horizontal

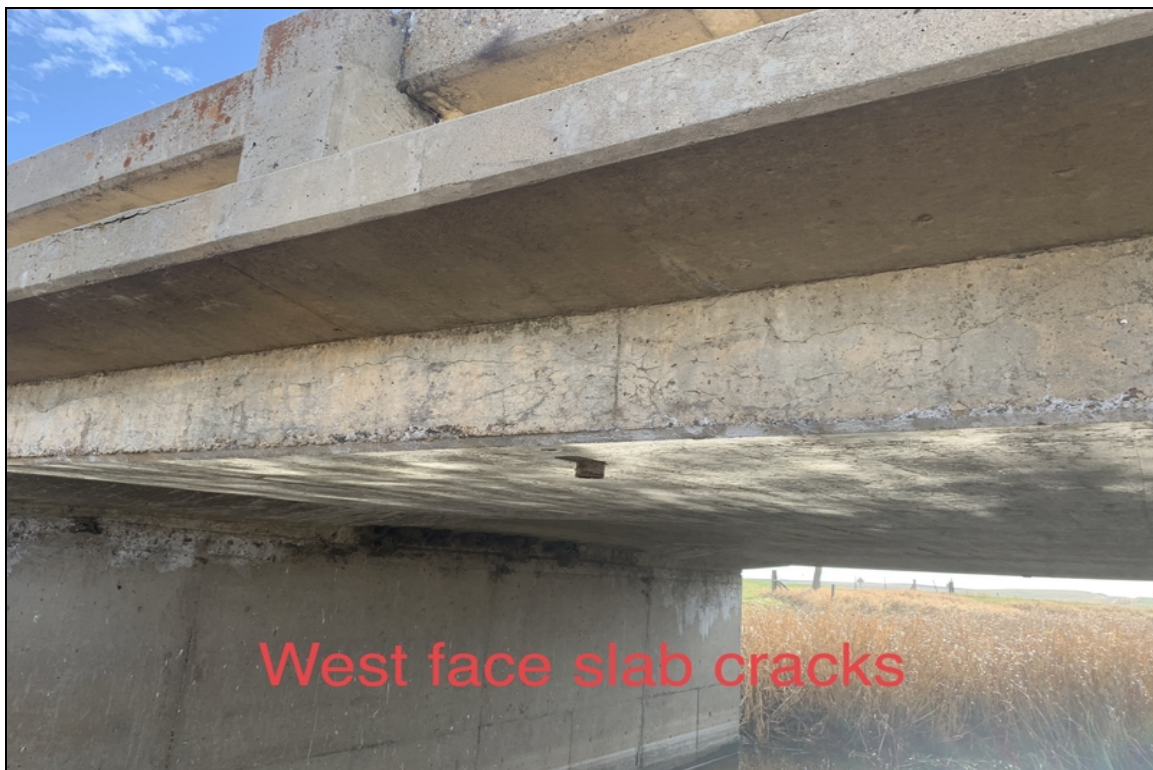
West face slab cracks

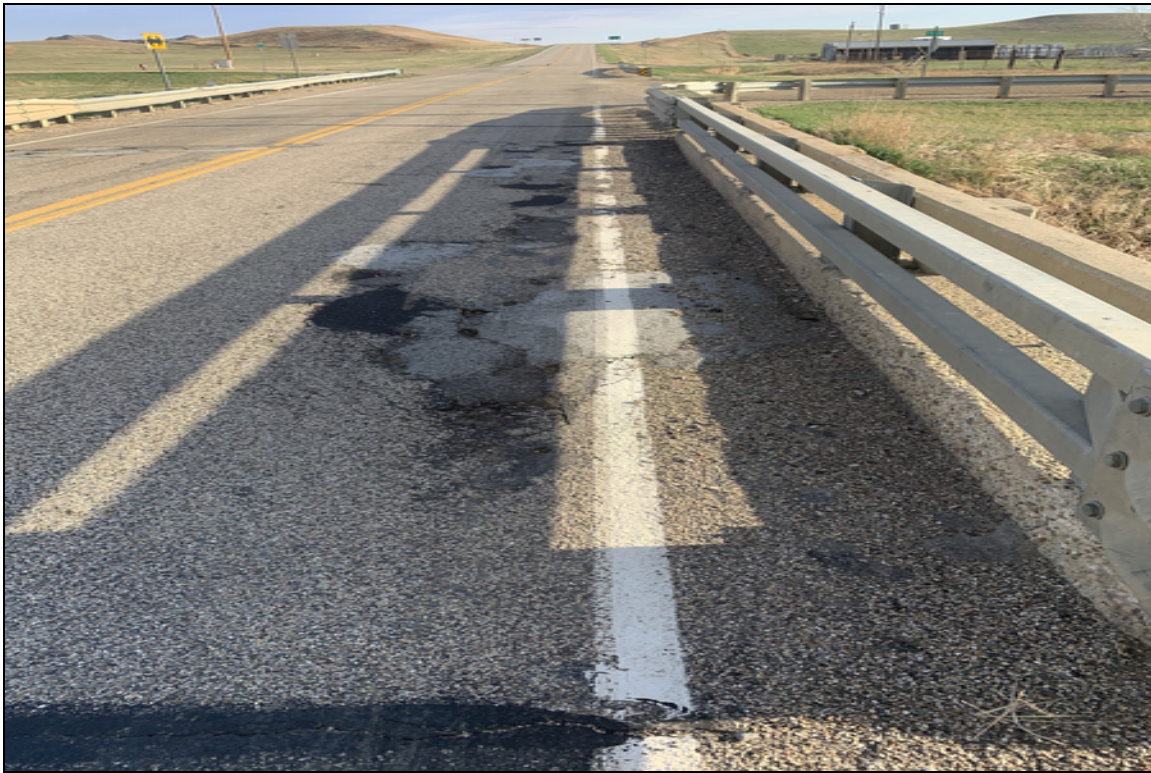
NB lane wearing surface spalls

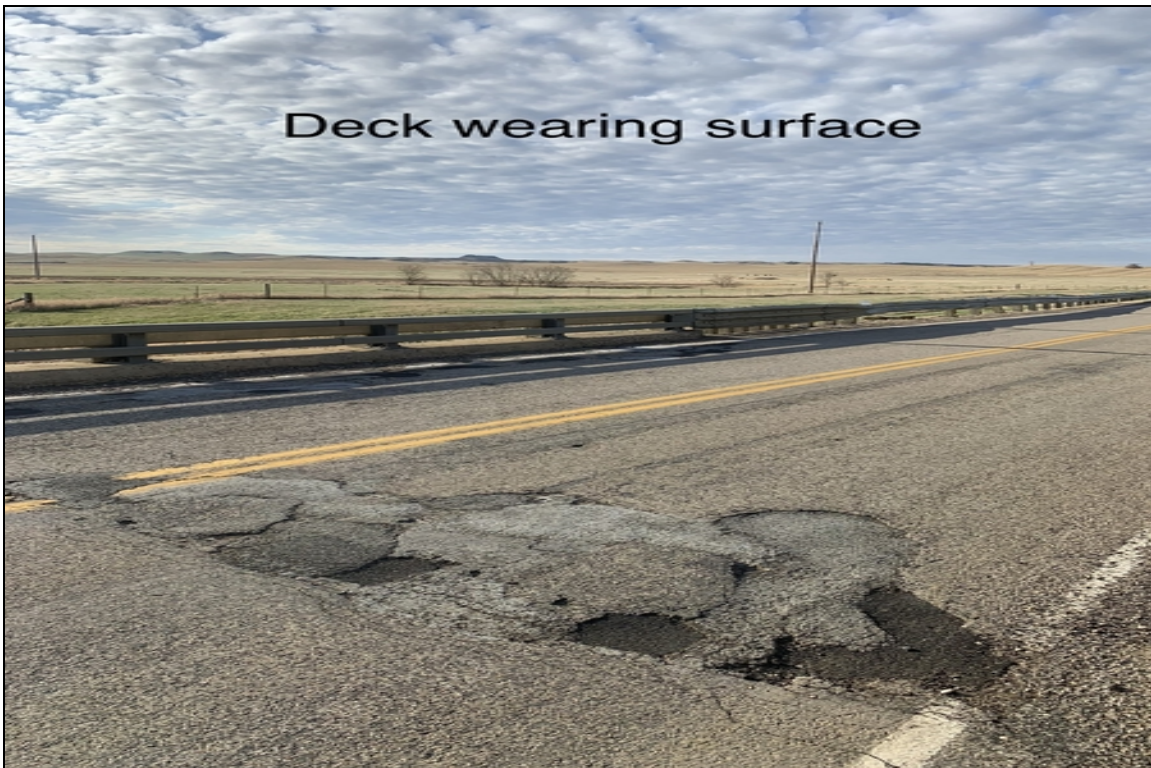
Deck wearing surface

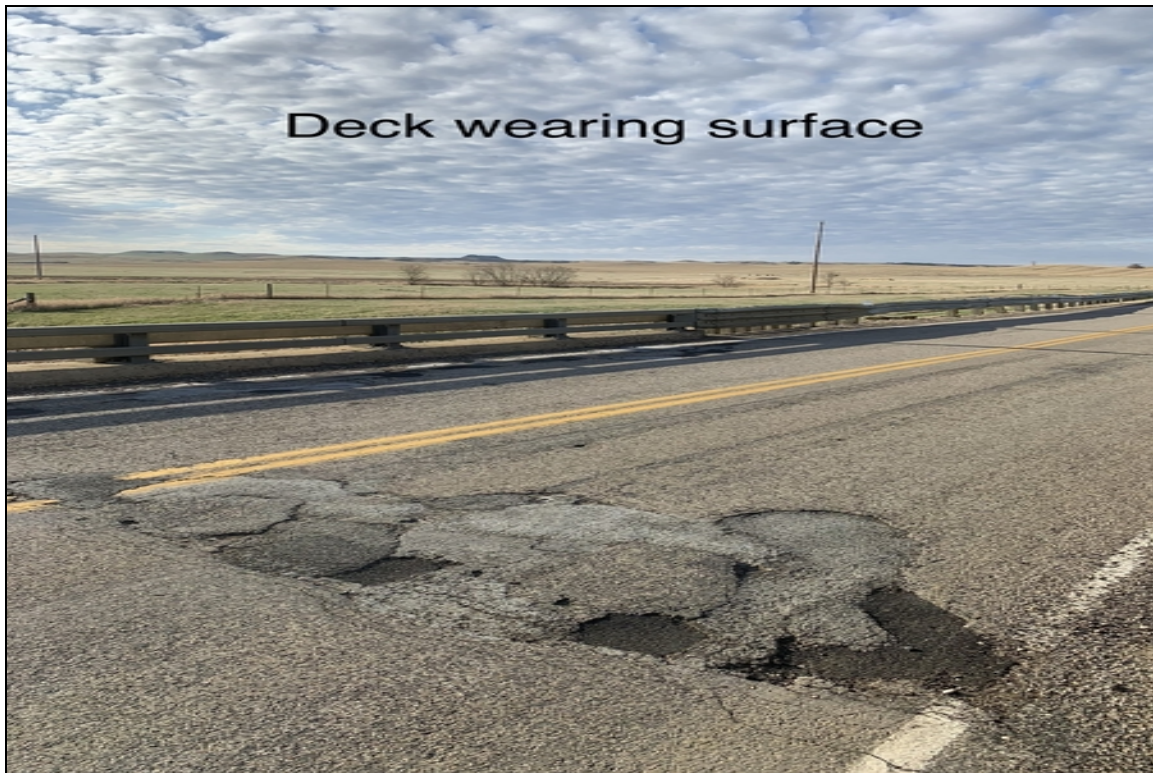
Deck wearing surface

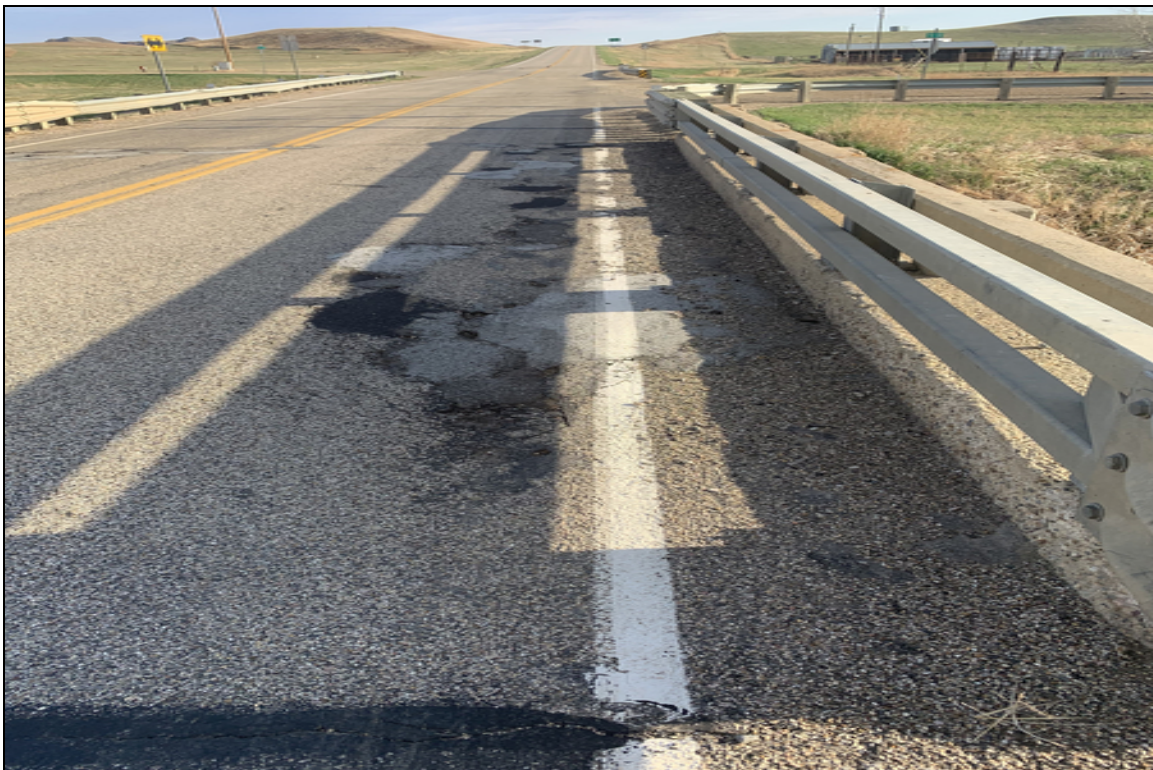
NB lane wearing surface spalls

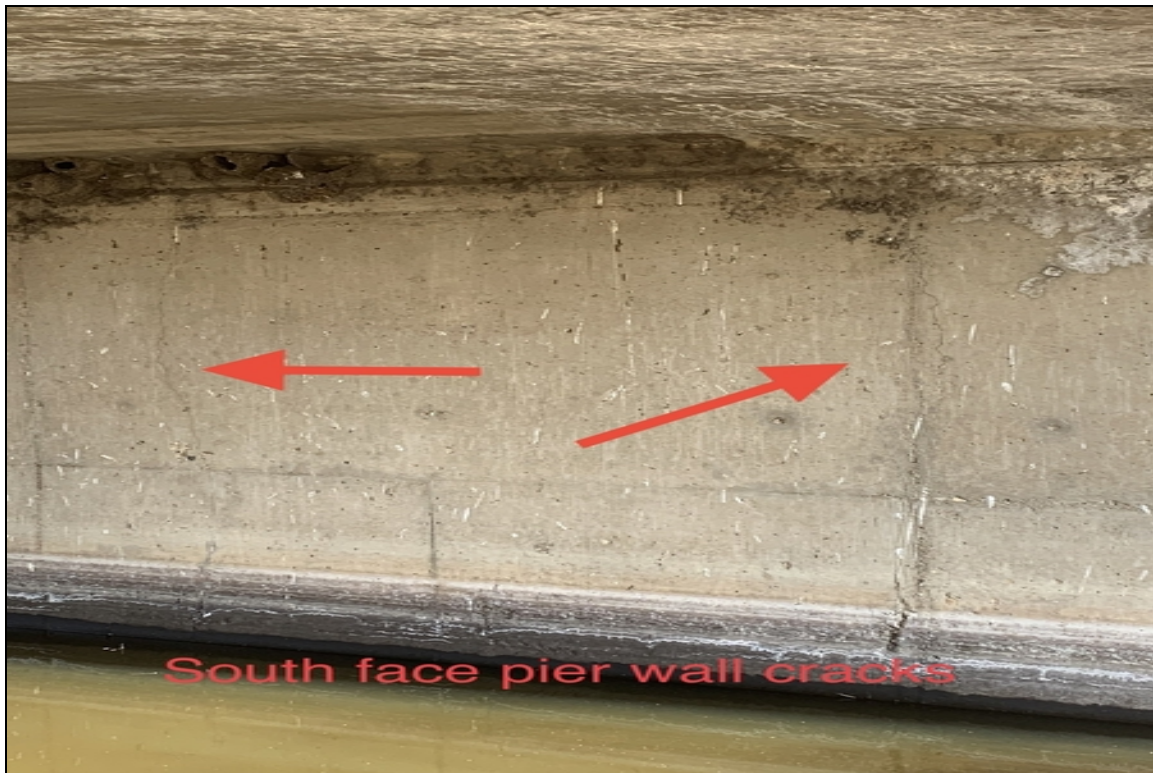
South face pier wall cracks

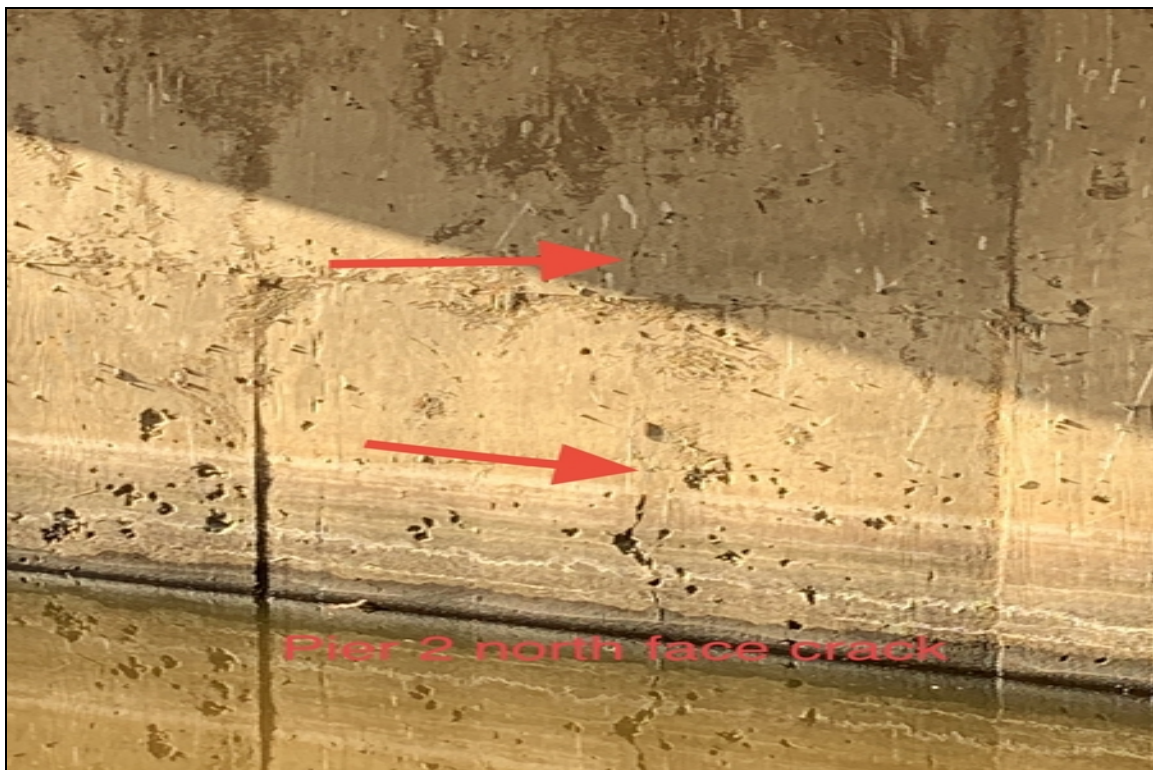
| ELEM | DESCRIPTION | UNITS | TOTAL | CS1 | CS2 | CS3 | CS4 |
|---|---|---|---|---|---|---|---|
| There are 3 cracks in the pier 2 pier wall. 4May2021 | | | | | | | |

Pier 2 north face crack

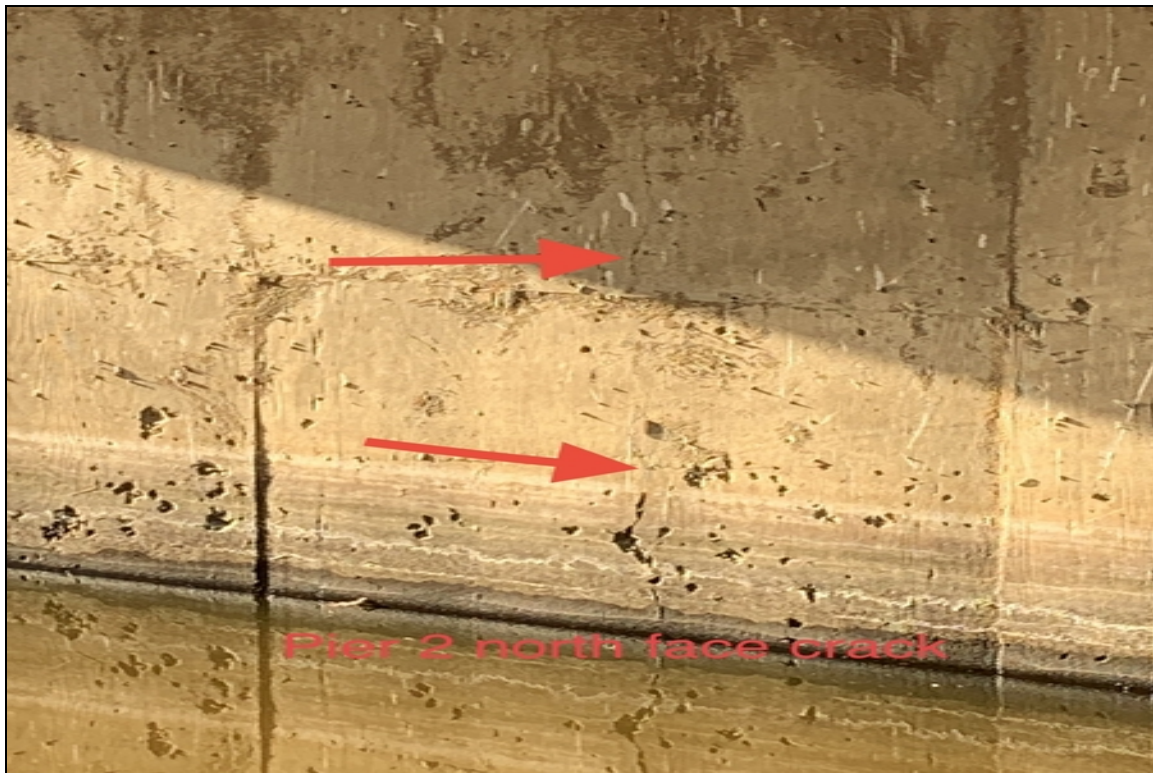
Pier 2 north face crack

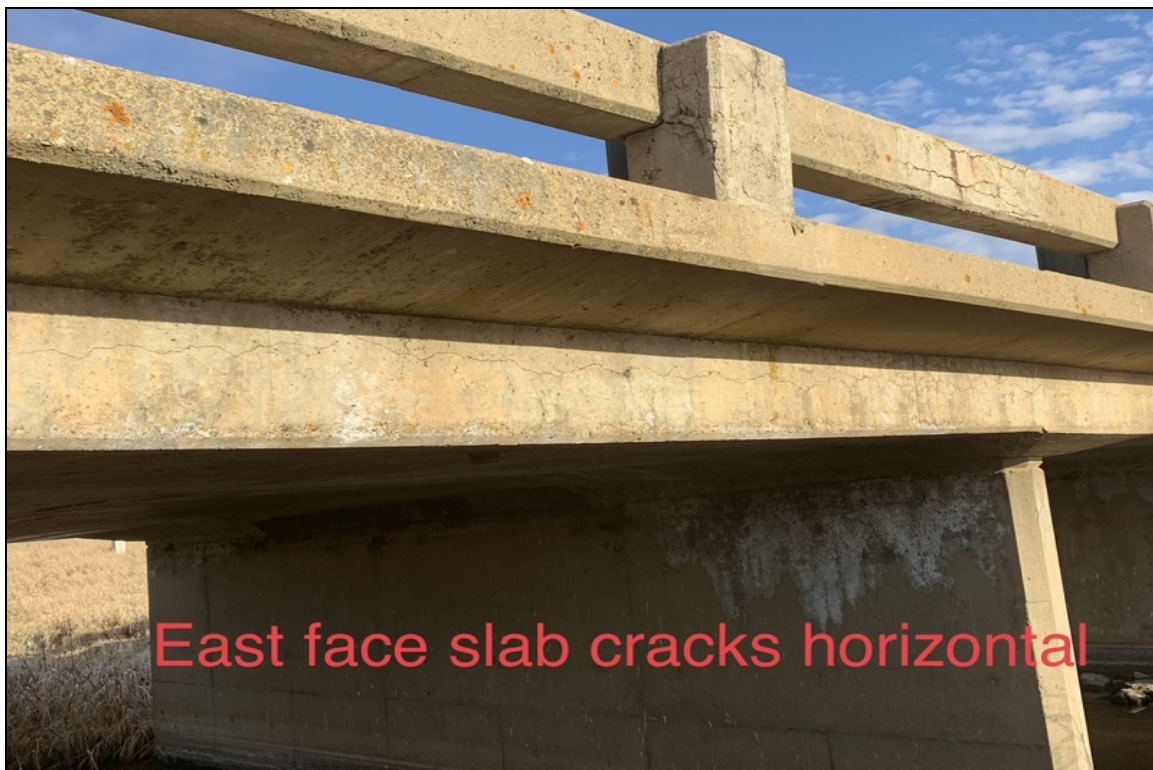
East face slab cracks horizontal

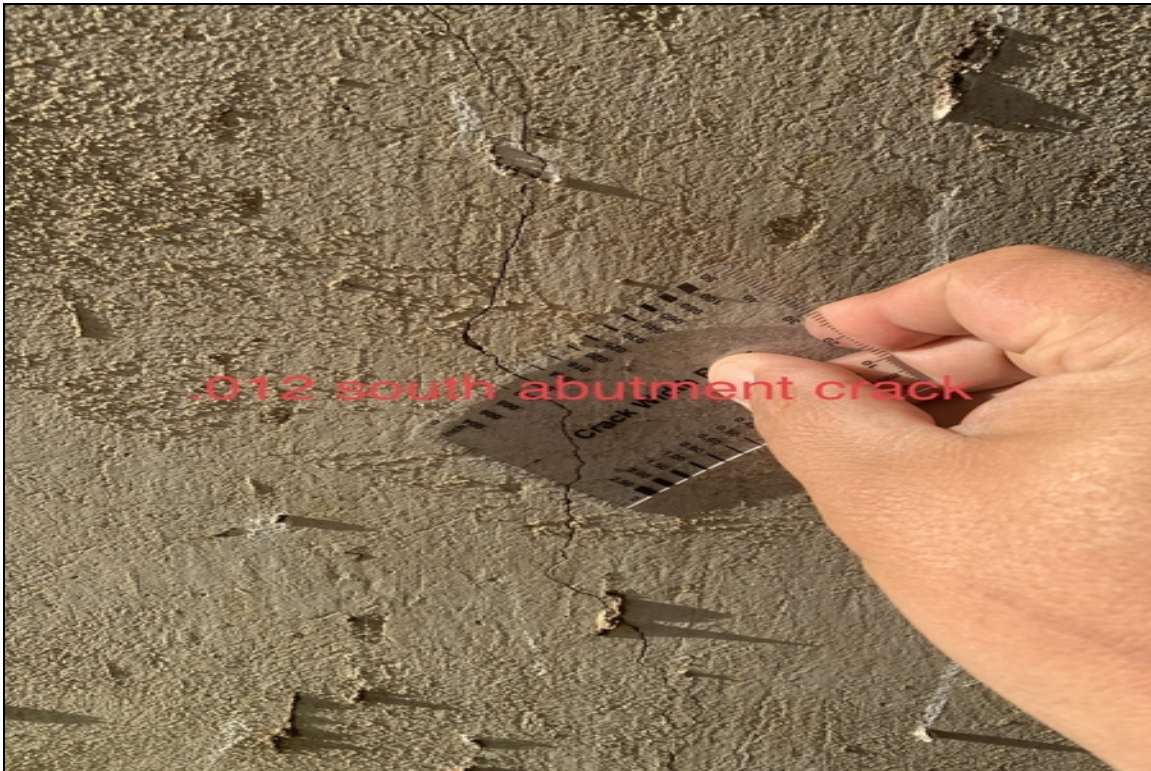
| ELEM | DESCRIPTION | UNITS | TOTAL | CS1 | CS2 | CS3 | CS4 |
|---|---|---|---|---|---|---|---|
| The abutments have a total of 5 cracks that range from approximately 0.010 to 0.012 in width. 4May2021 | | | | | | | |

.012 south abutment crack

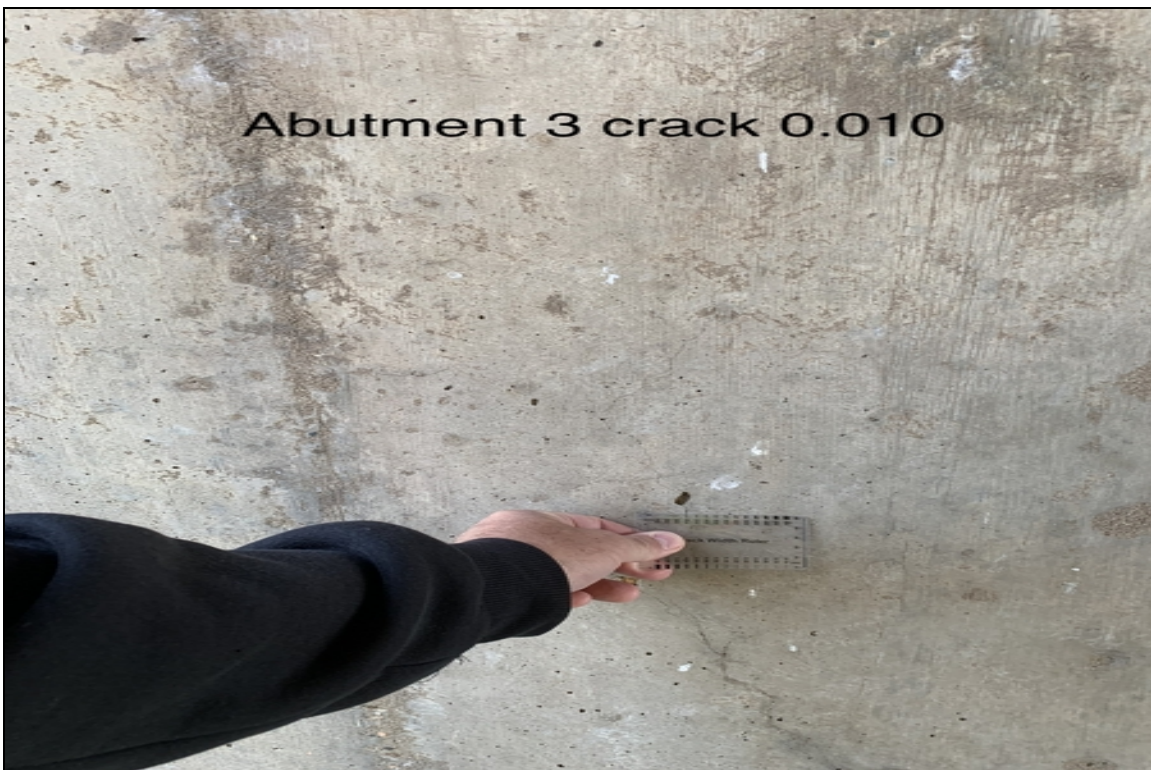
Abutment 3 crack .010

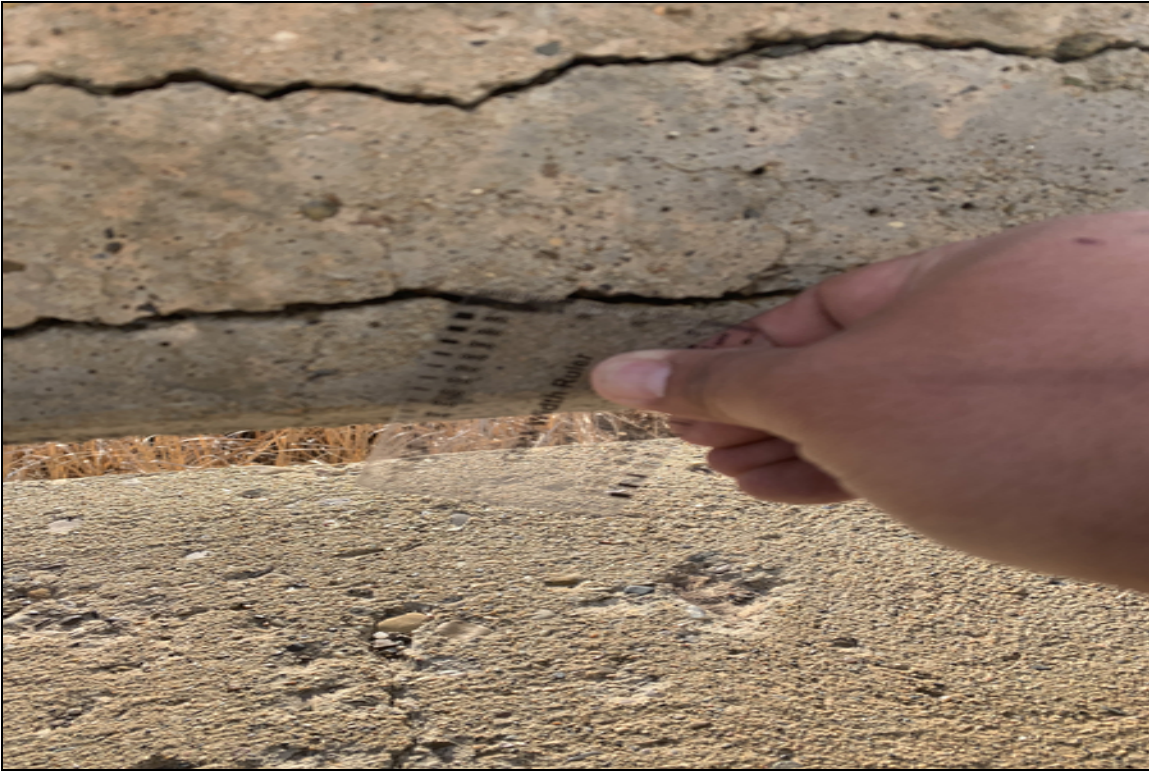
East conc rail crack bigger then .100

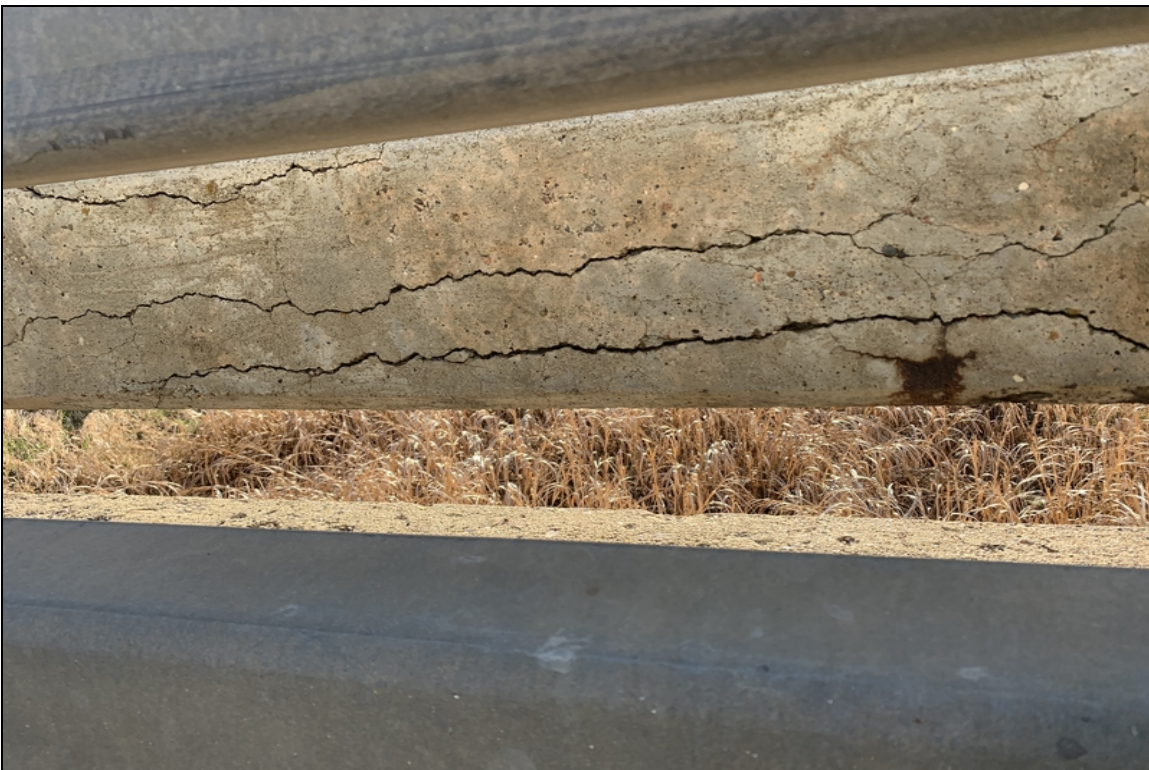
East conc rail cracks

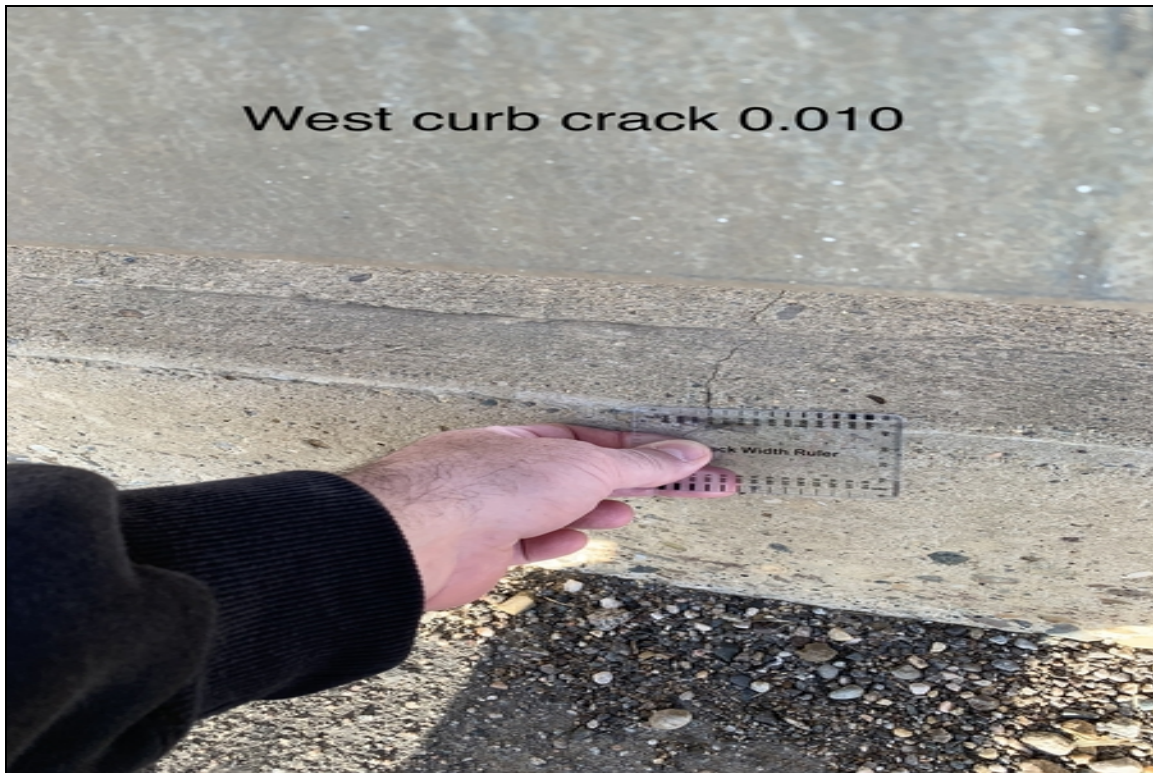
West curb crack .010

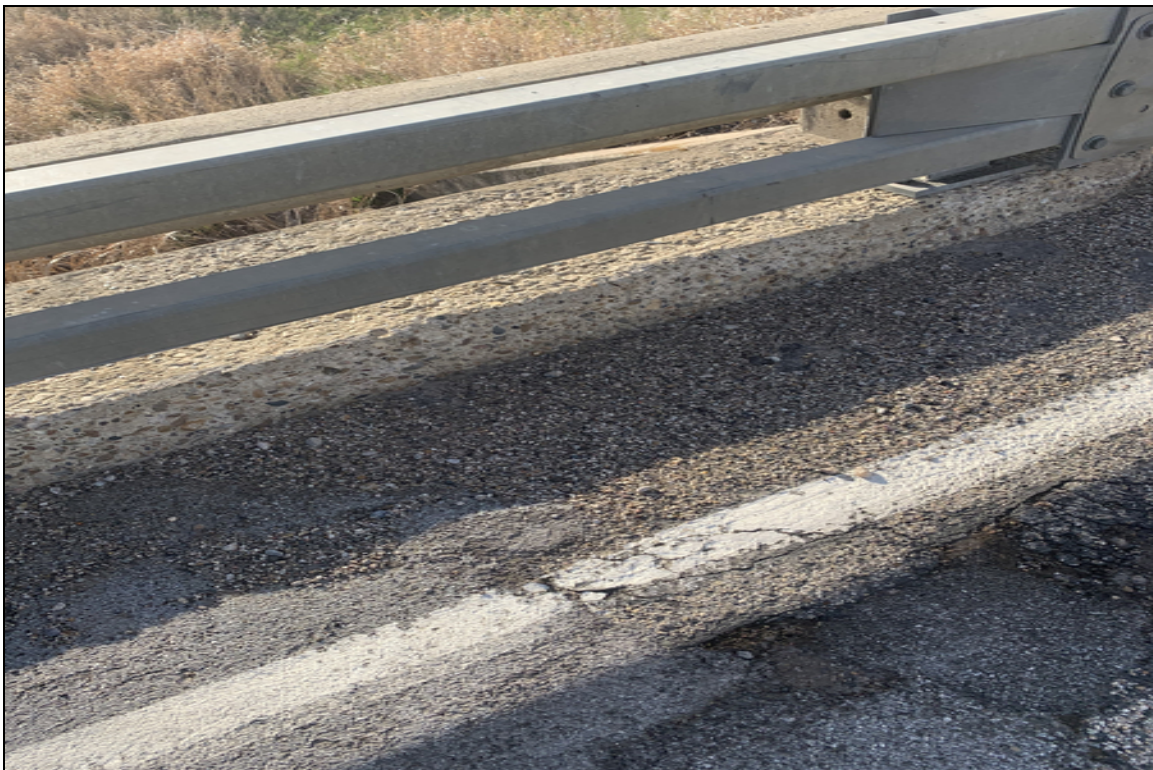
East curb abrasion

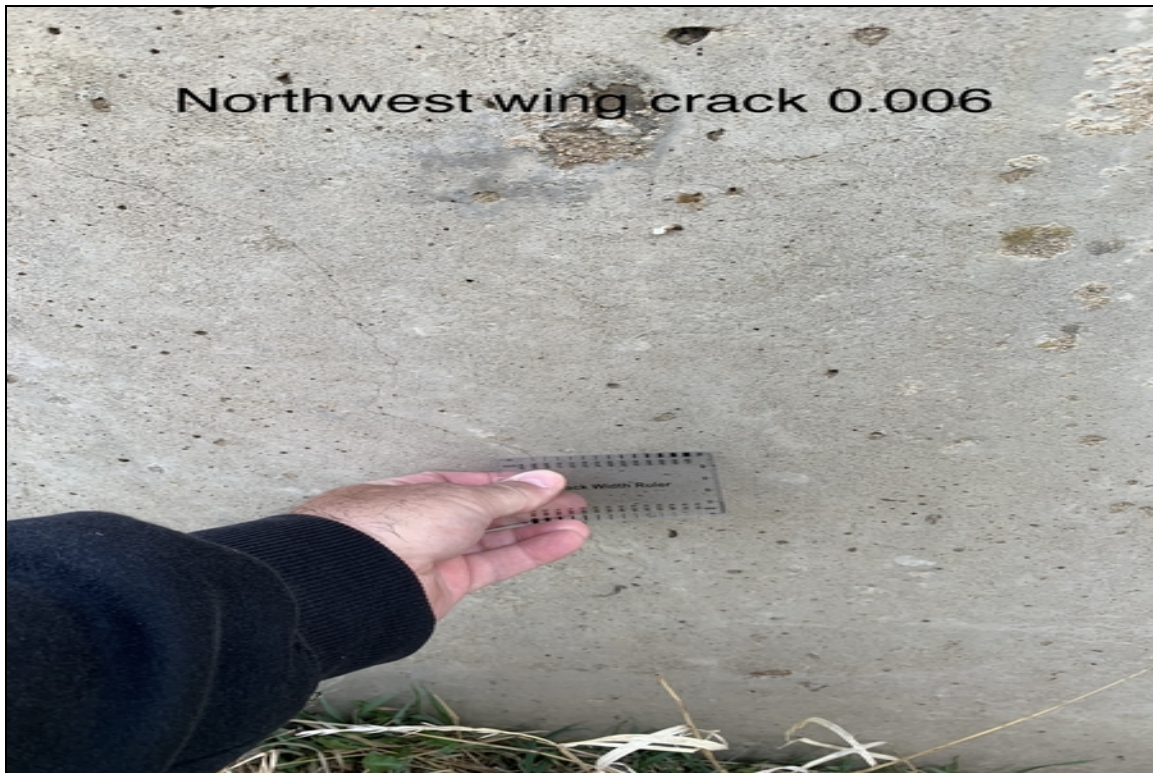
NW wing cracks .006

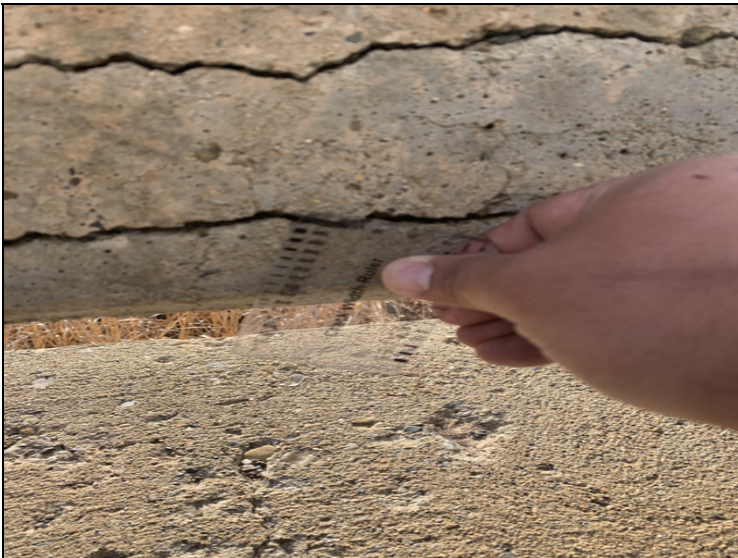
There are cracks on the curb that need to be sealed.

East conc rail crack bigger then .100

Recommend sealing the curb cracks. 4May2021

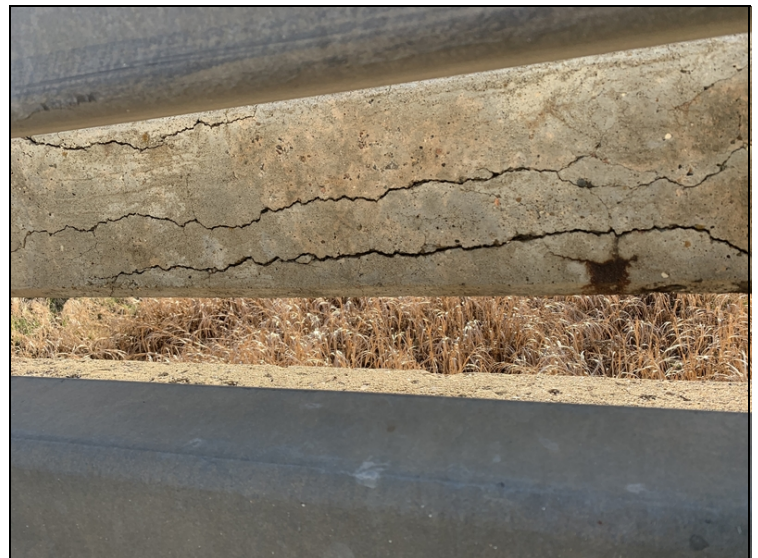
East conc rail cracks
