| IDENTIFICATION | |
| (8) Structure Number | 0031-029.214 |
| (6) Features Intersected | DOG TOOTH CREEK |
| (7) Facility Carried | ND HIGHWAY 31 |

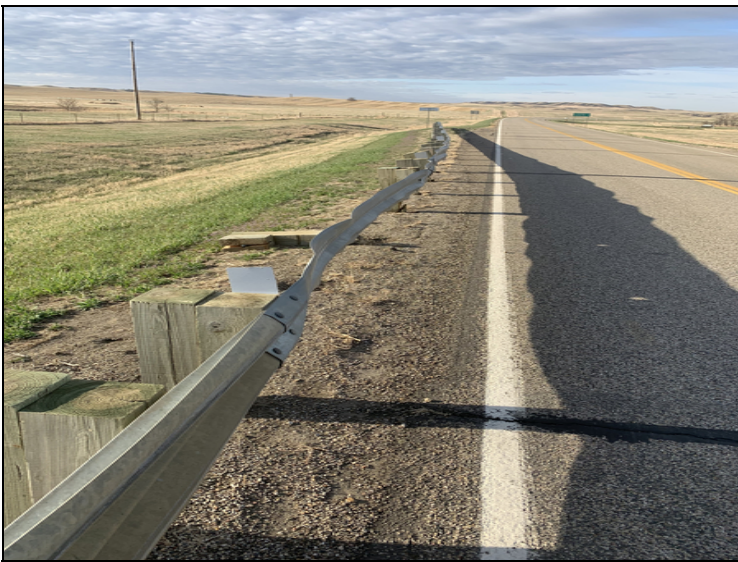
The southeast guardrail has impact damage with broken posts.

SE guardrail damage 3 post broke

Recommend replacing the guardrail and broken posts. 4may2021
