Route:00049 Log:37.669

District 61, Grant County

1 NORTH OF ND 21

IDENTIFICATION	
(1) State Names	North Dakota
(8) Structure Number	0049-037.677
(5) Inventory Route	00049
(2) Highway Agency District	61
(3) County Code	Grant, North Dakota

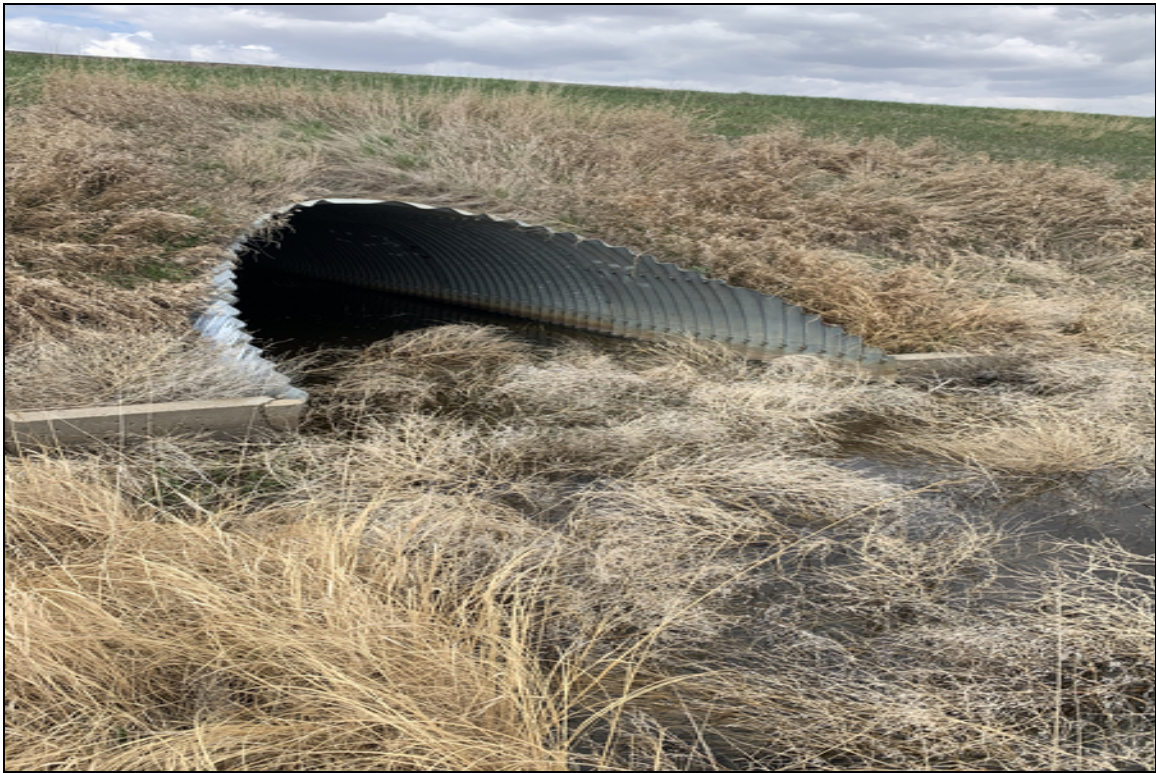
East end looking NW

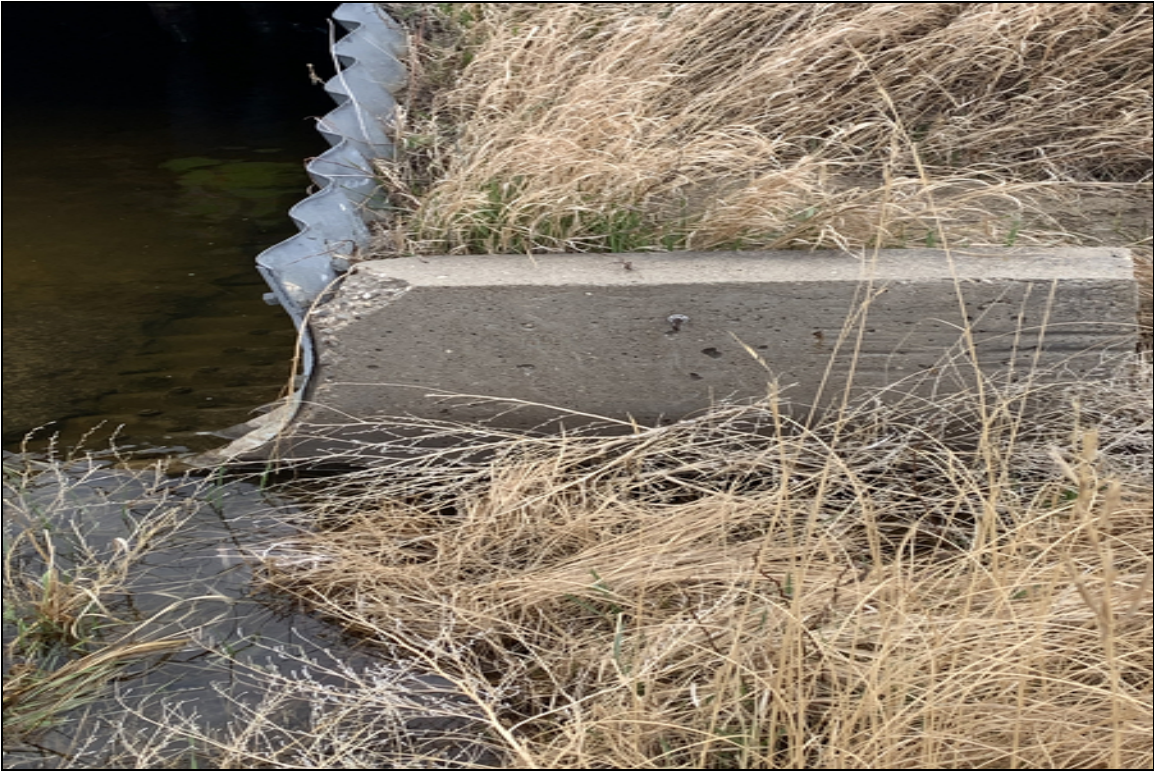
West headwall crack

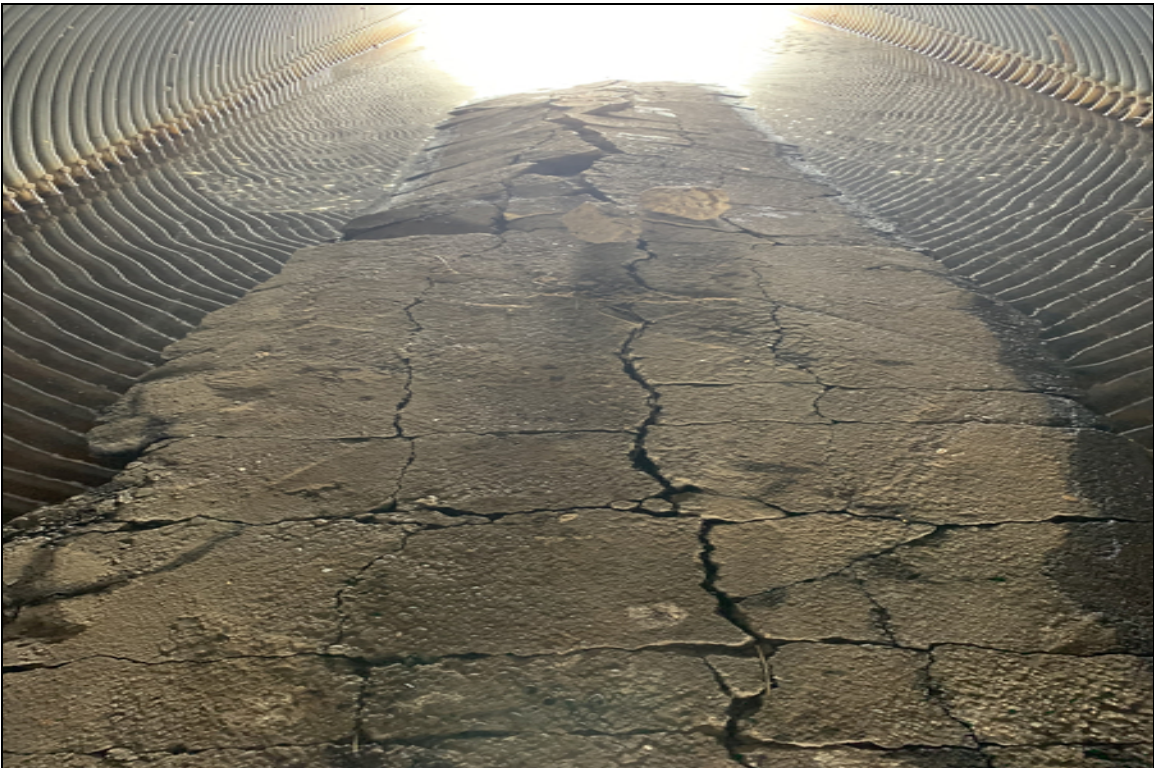
Alert code 1 - Floor of pipe appears to be heaving in center throughout length of pipe. - 4/10/2019

The floor of the pipe has heaved approximately 1-2 feet beginning 20 feet from the West end and ending 20 feet from the East end. There is concrete on the floor this has broken up and the seam for the steel plates is visible. 12May2021

Floor heave

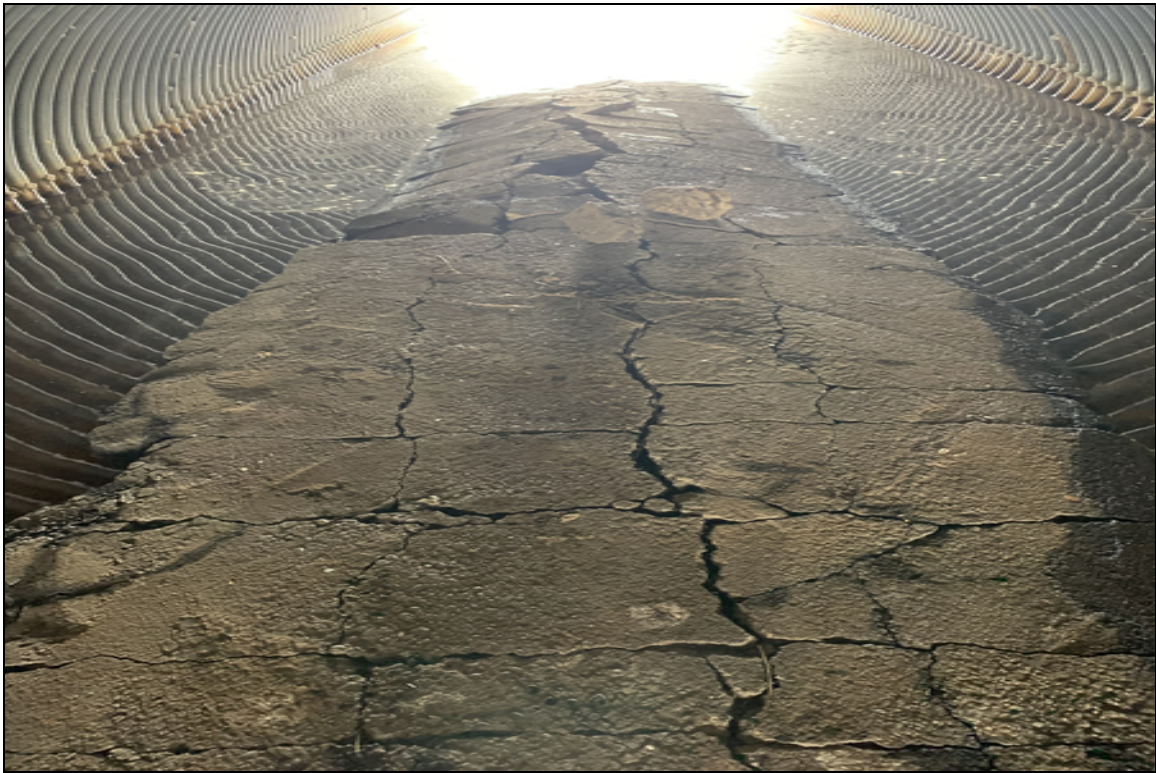
Floor heeve

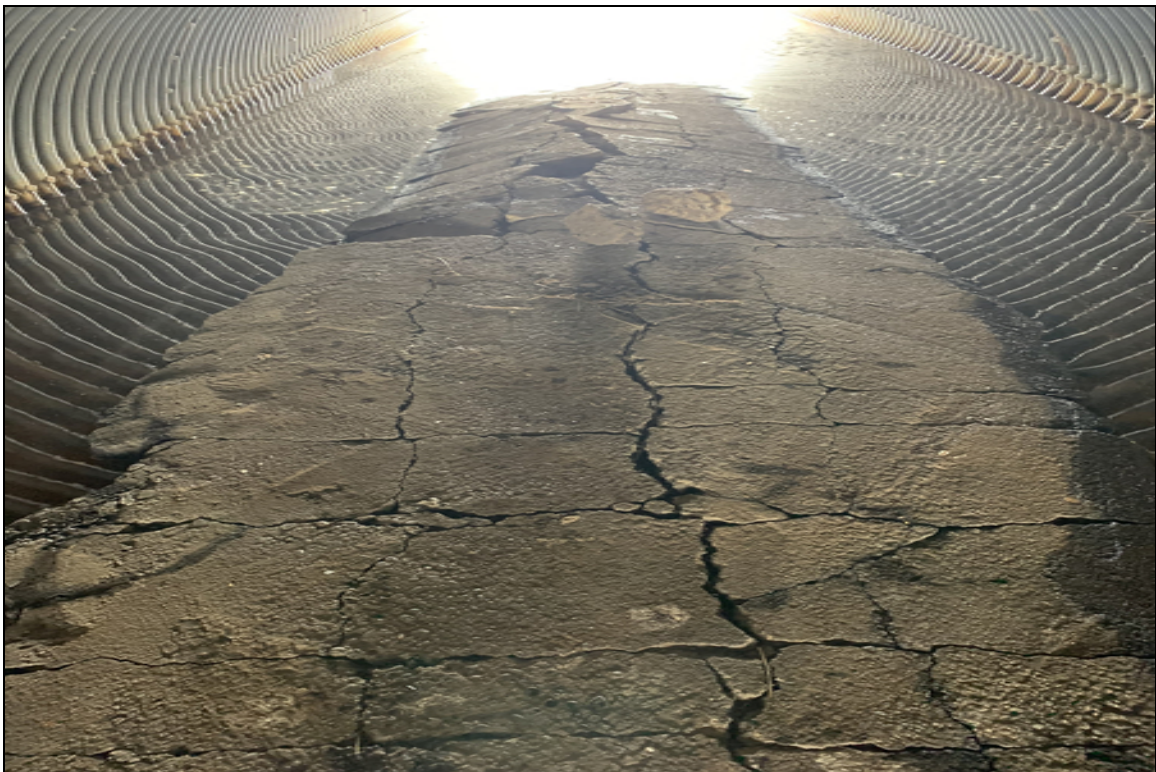
Floor heeve

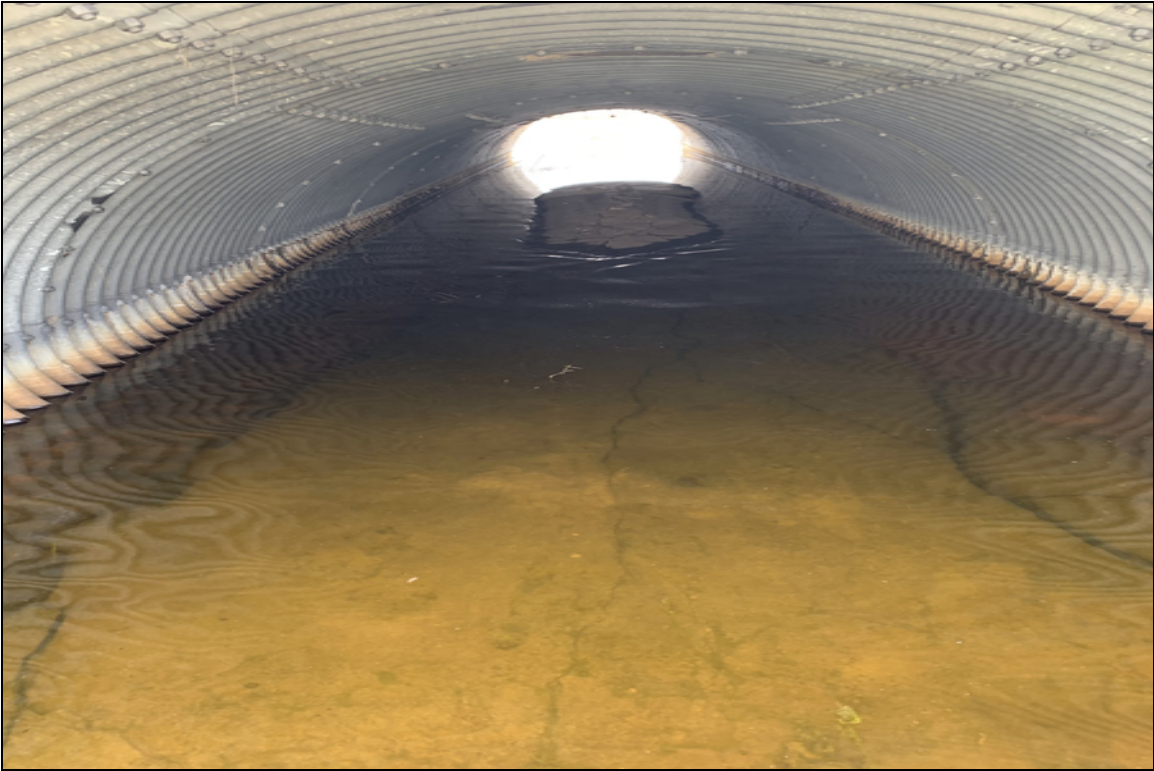
Floor heave

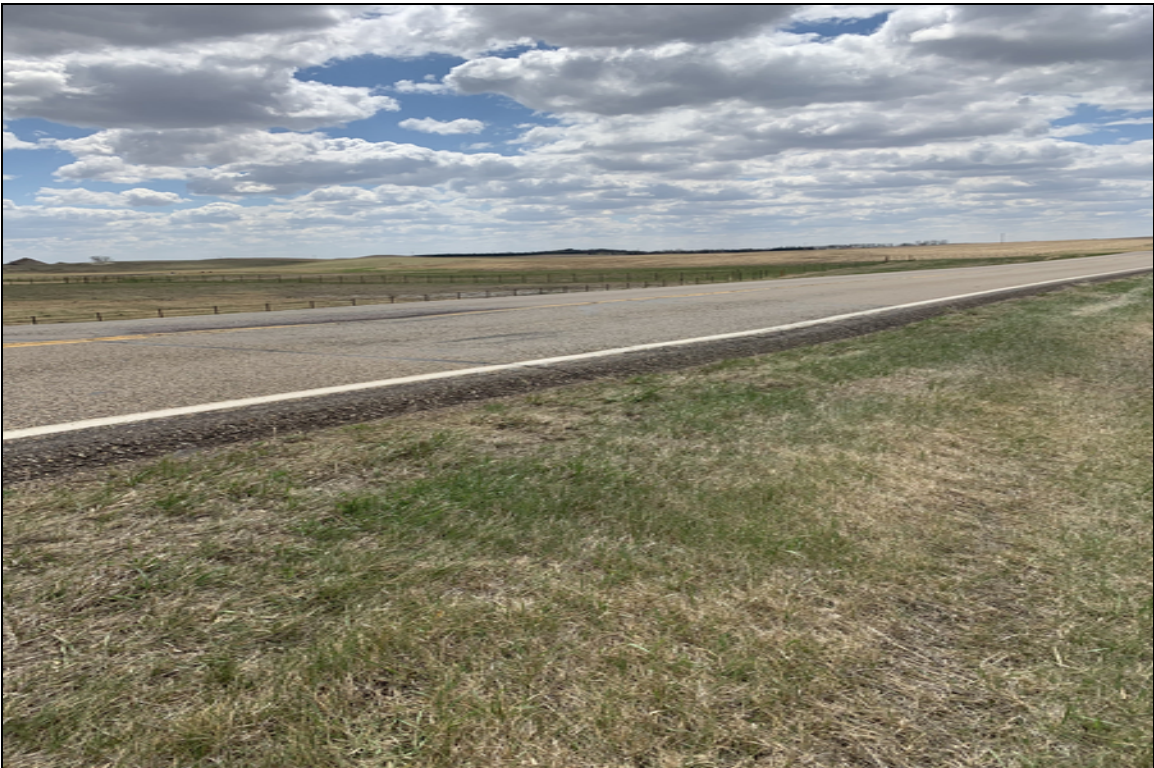
Roadway has a 2 to 3 foot dip over pipe. - 4/10/2019

Top road settlement

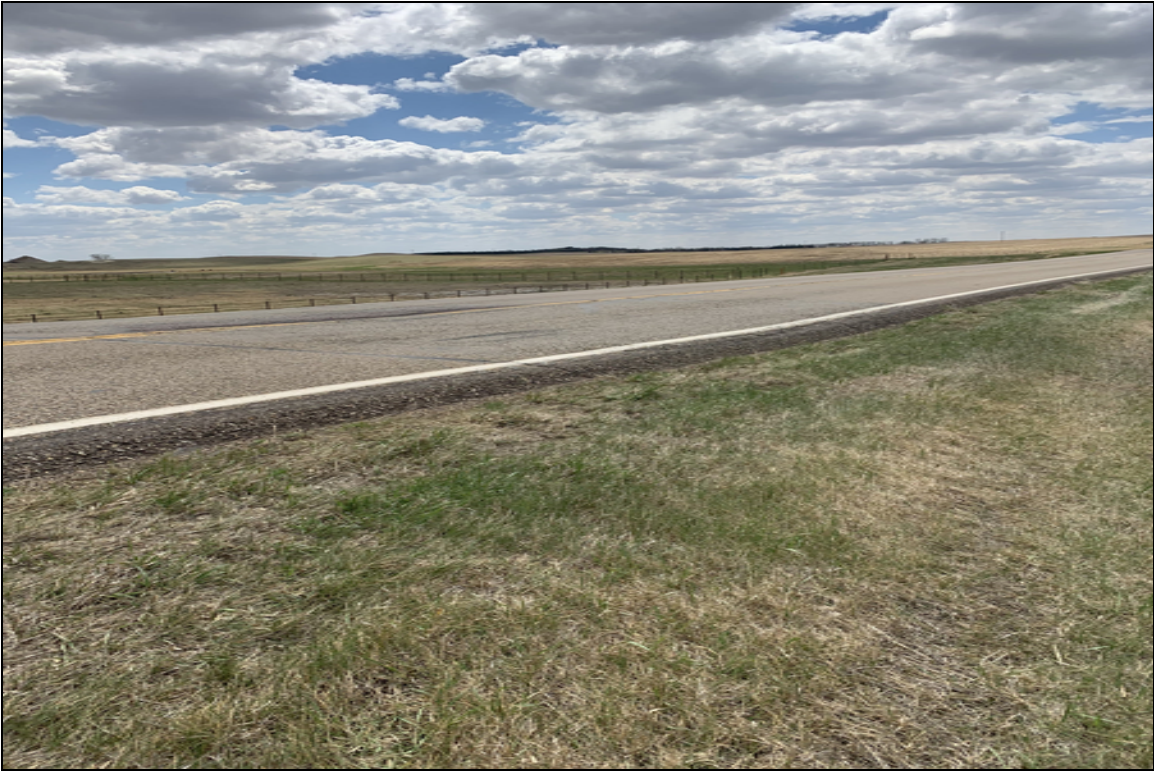
Top road settlement

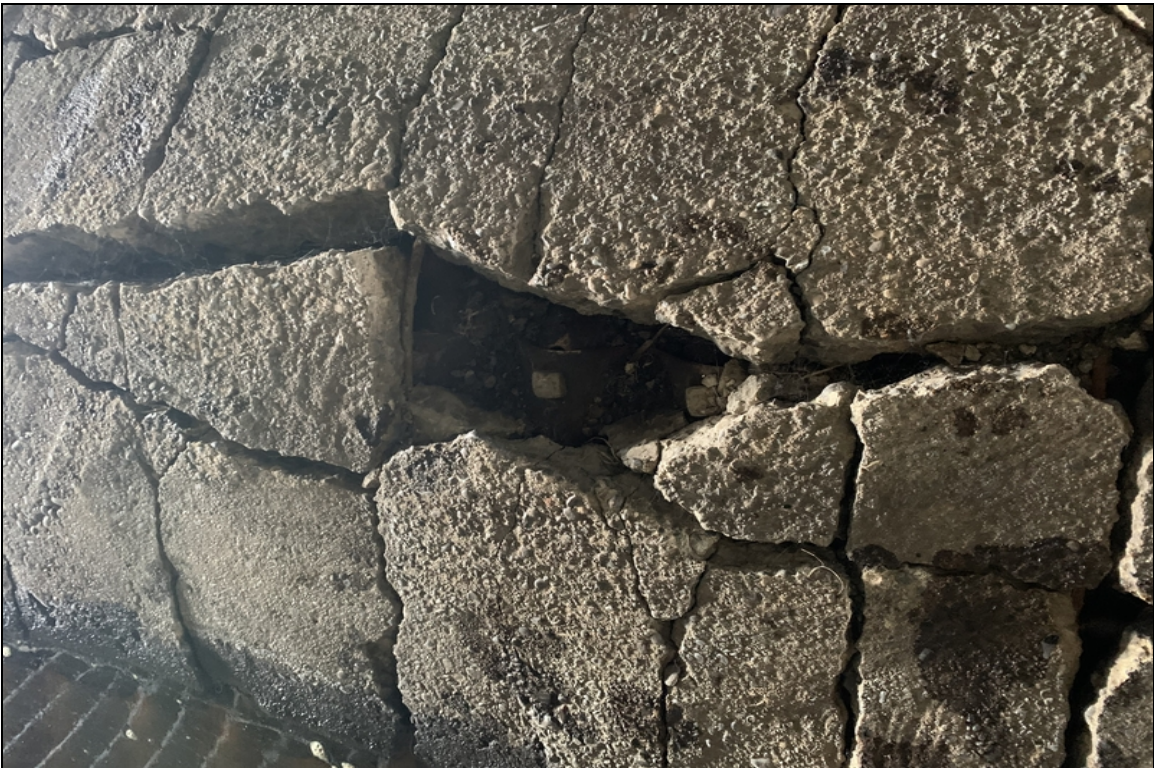
Can see bottom of floor bolts thru conc

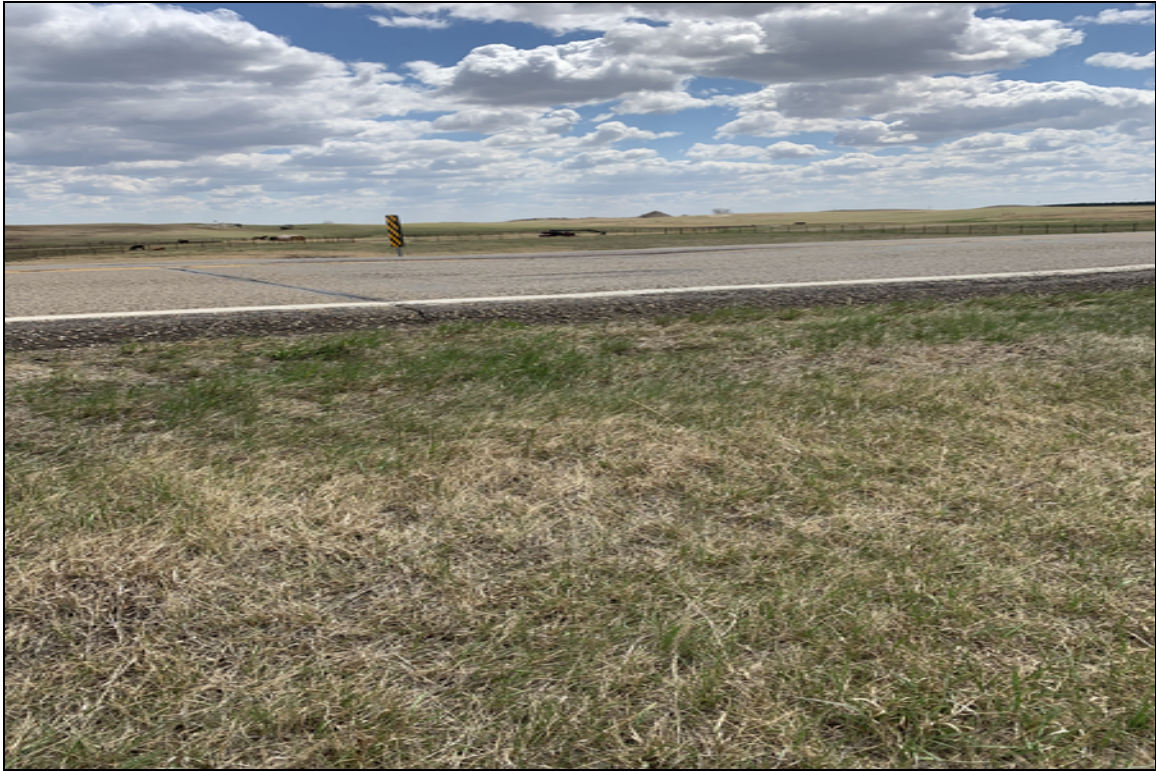
Road settlement
