16 WEST OF JCT. US 85

IDENTIFICATION		
(1) State Names	North Dakota	
(8) Structure Number	0094-026.422 L	
(5) Inventory Route	00094	
(2) Highway Agency District	65	
(3) County Code	Billings, North Dakota

(4) Place Code	0	
(6) Features Intersected	SHEEP CREEK	
(7) Facility Carried	INTERSTATE 94	
(9) Location	16 WEST OF JCT. US 85	
(11) Mile Point	26.416 mi	
(12) Base Highway Network	Yes

Team Lead: Jake Mertz, **Inspection Date:** May 18, 2021

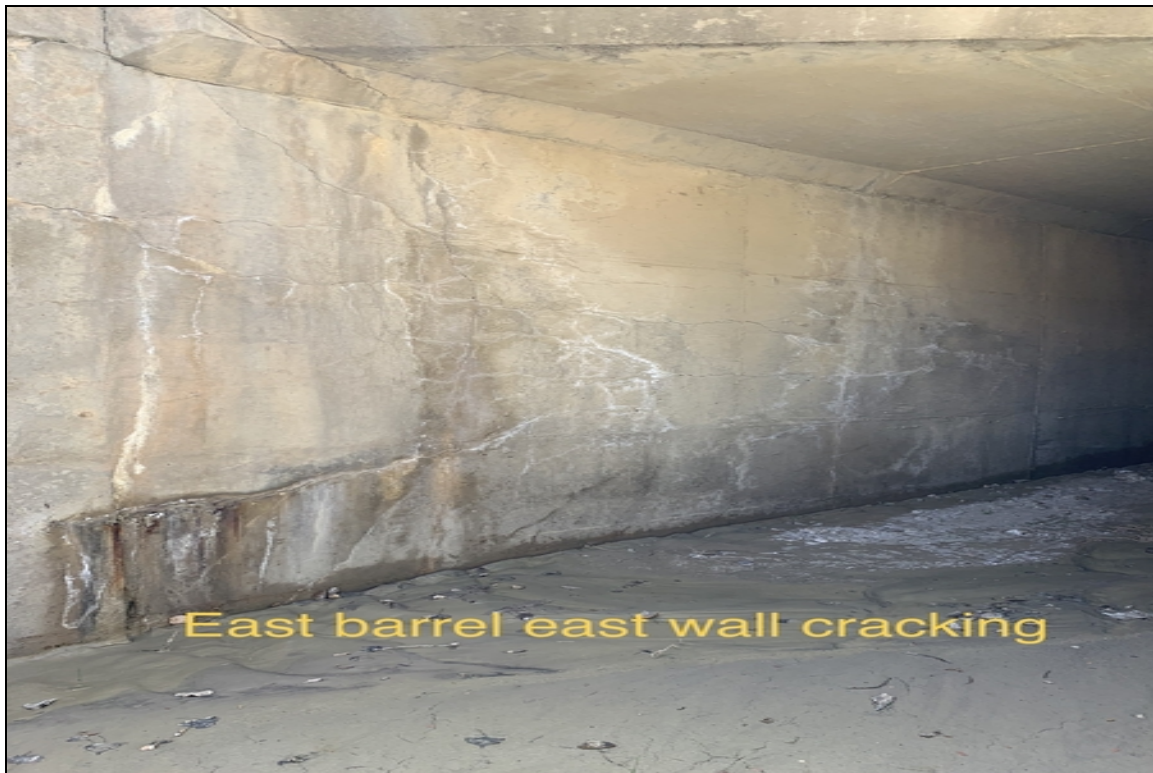
East barrel east wall cracking

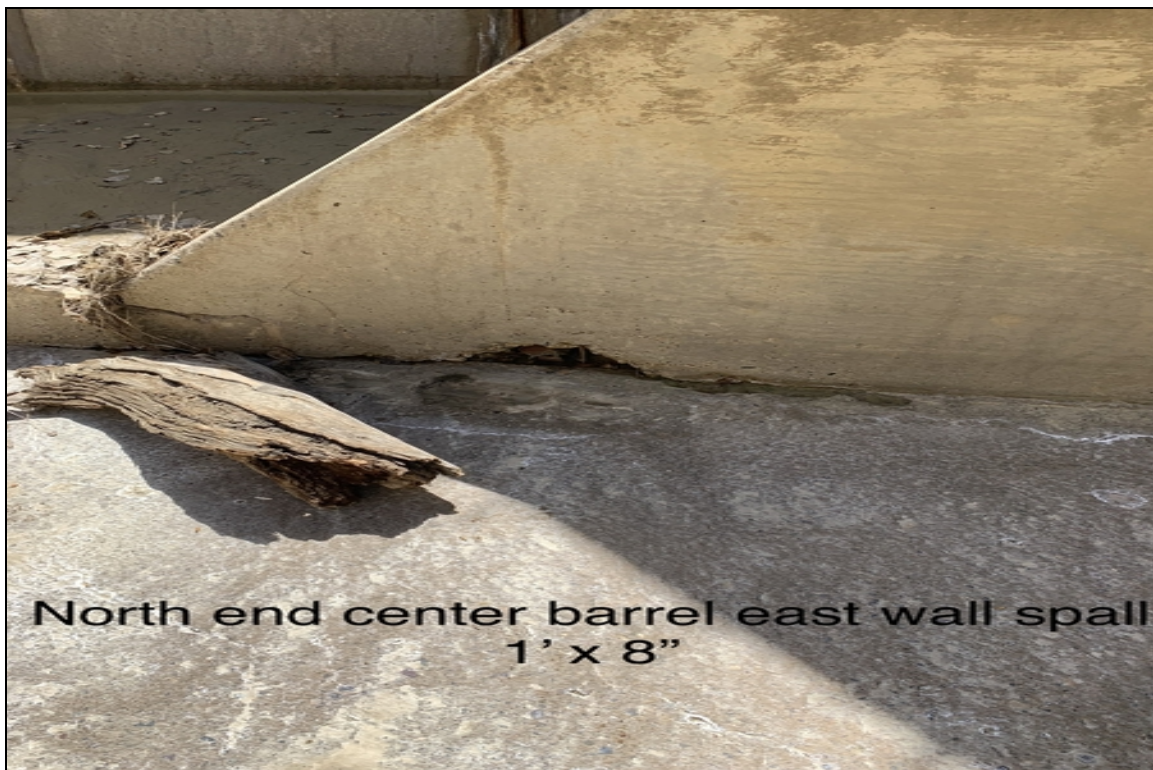
North end center barrel east wall spall
1' x 8"

North end center barrel east wall spall 1'x8"

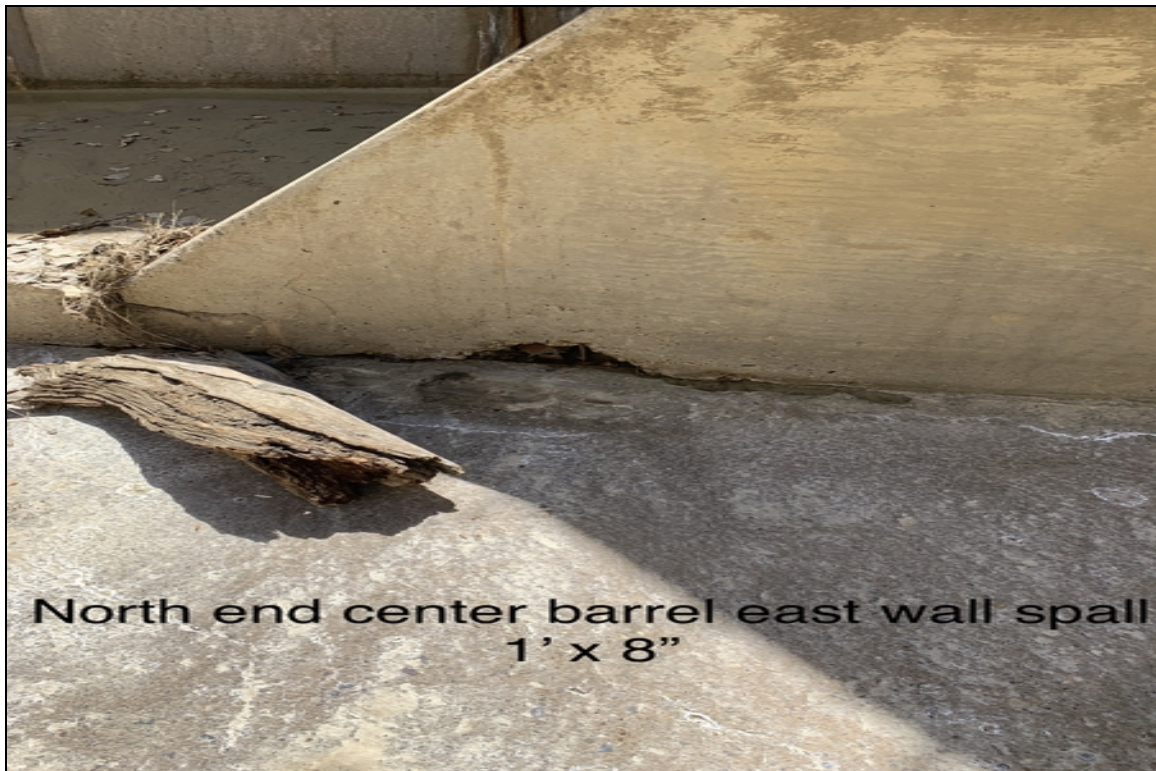
North end center barrel east wall spill 1'x8"

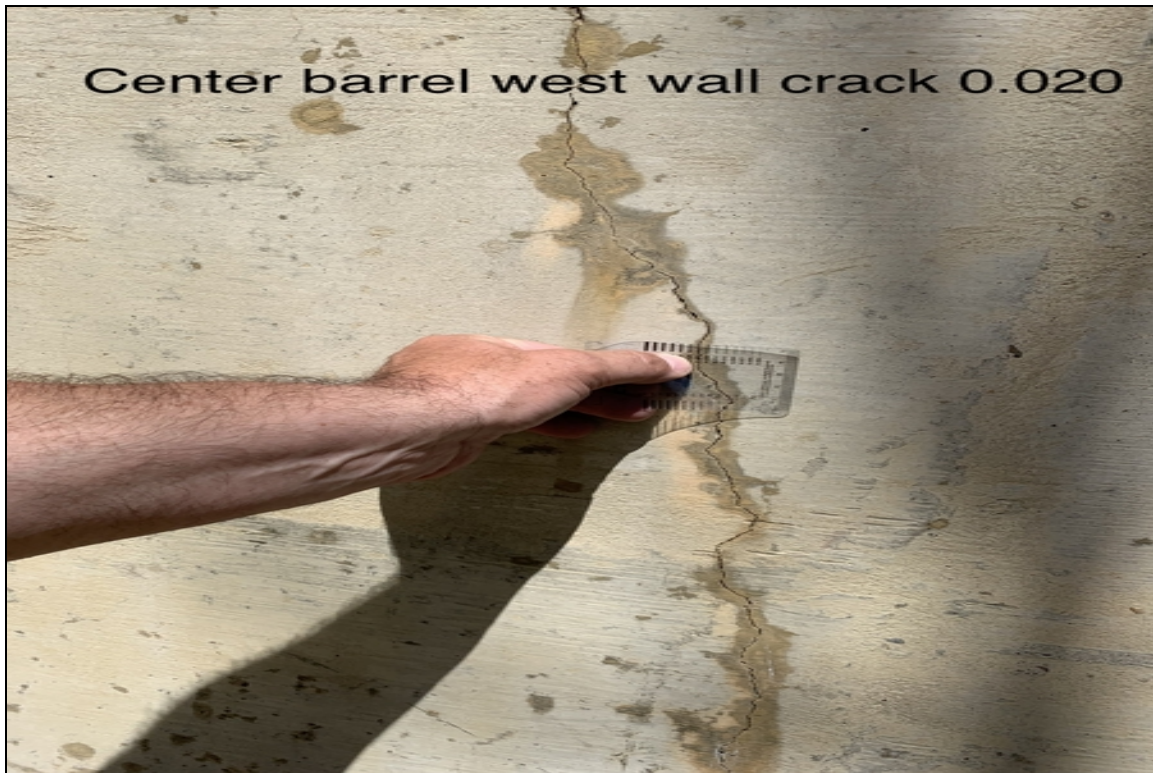
Center barrel west wall crack .020

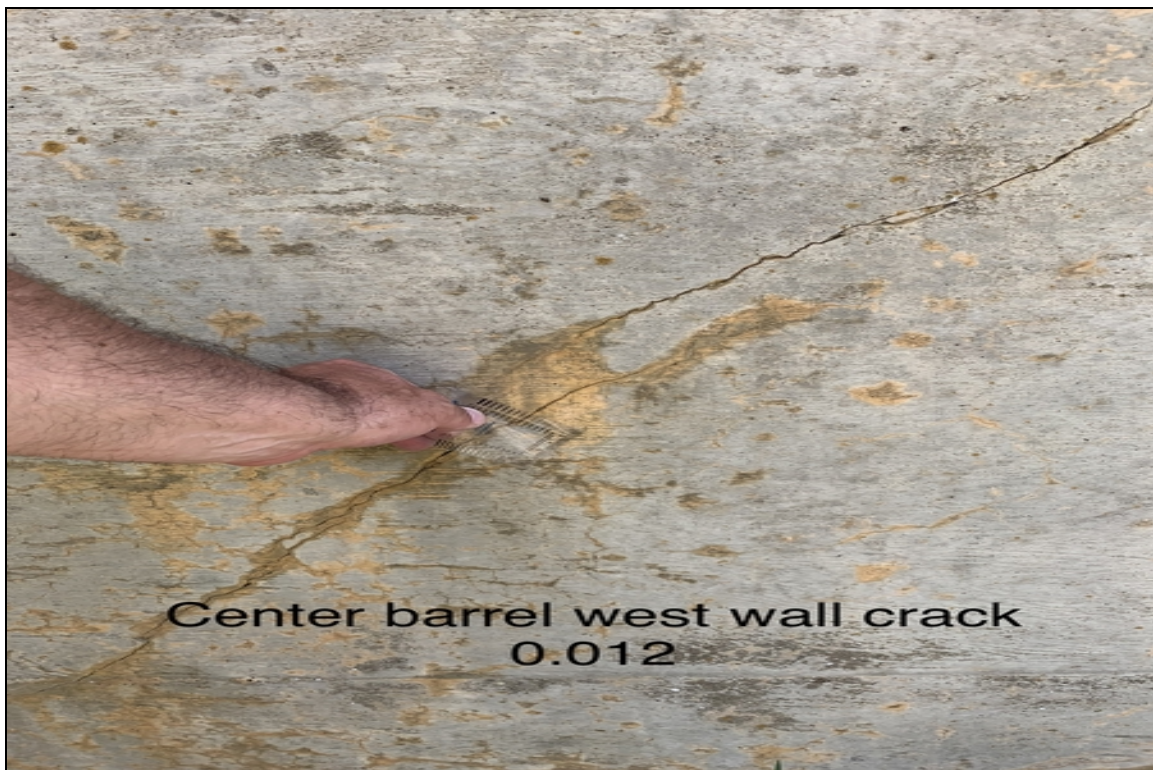
Center barrel west wall crack .012

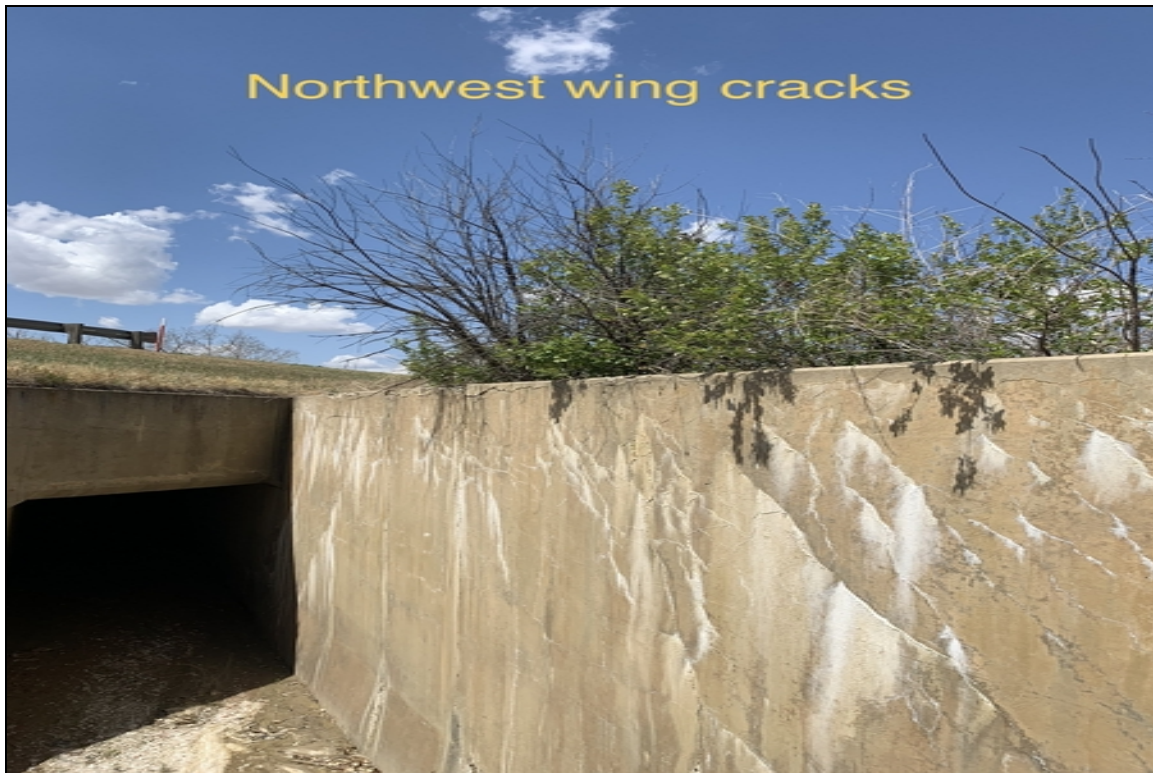
NW wing crack

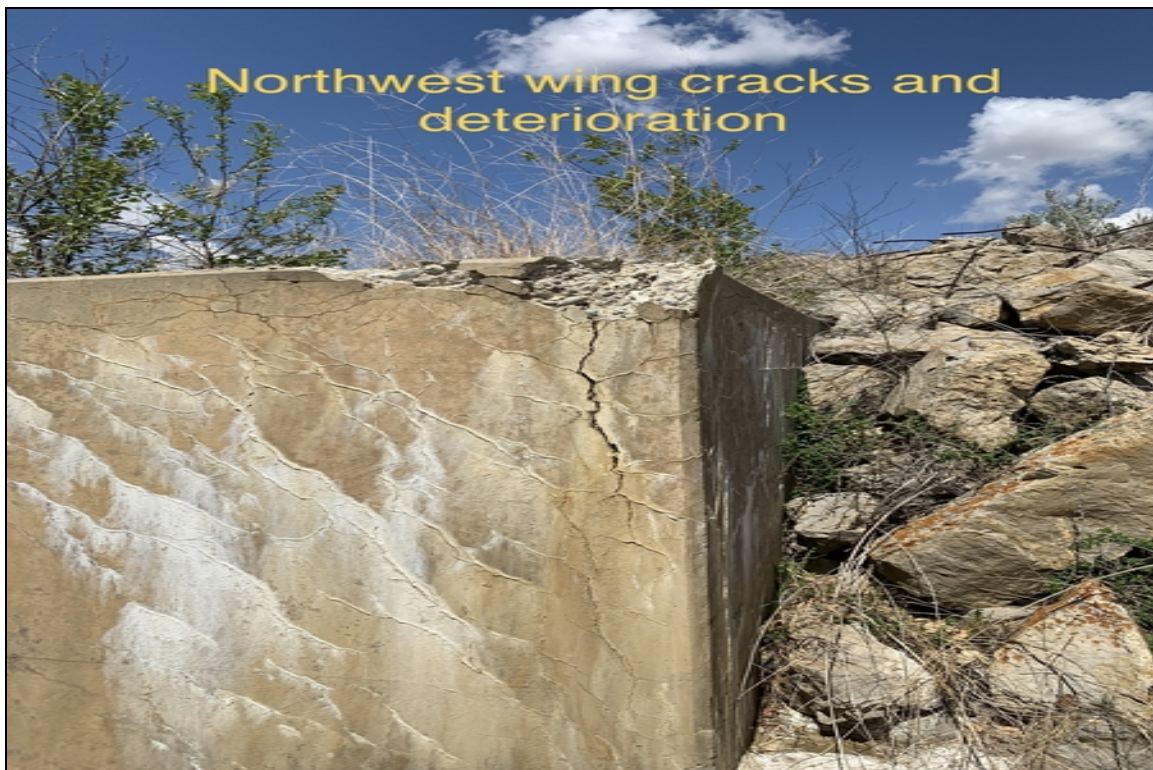
NW wing cracks and deterioration

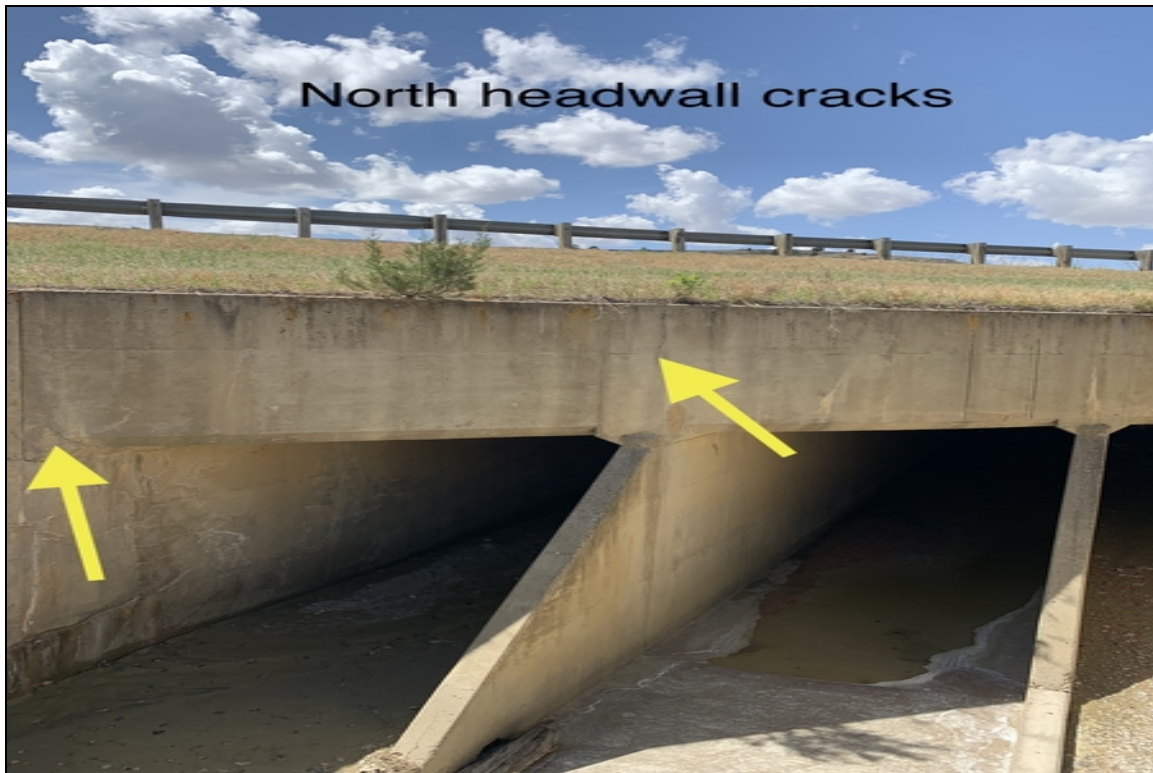
North headwall cracks

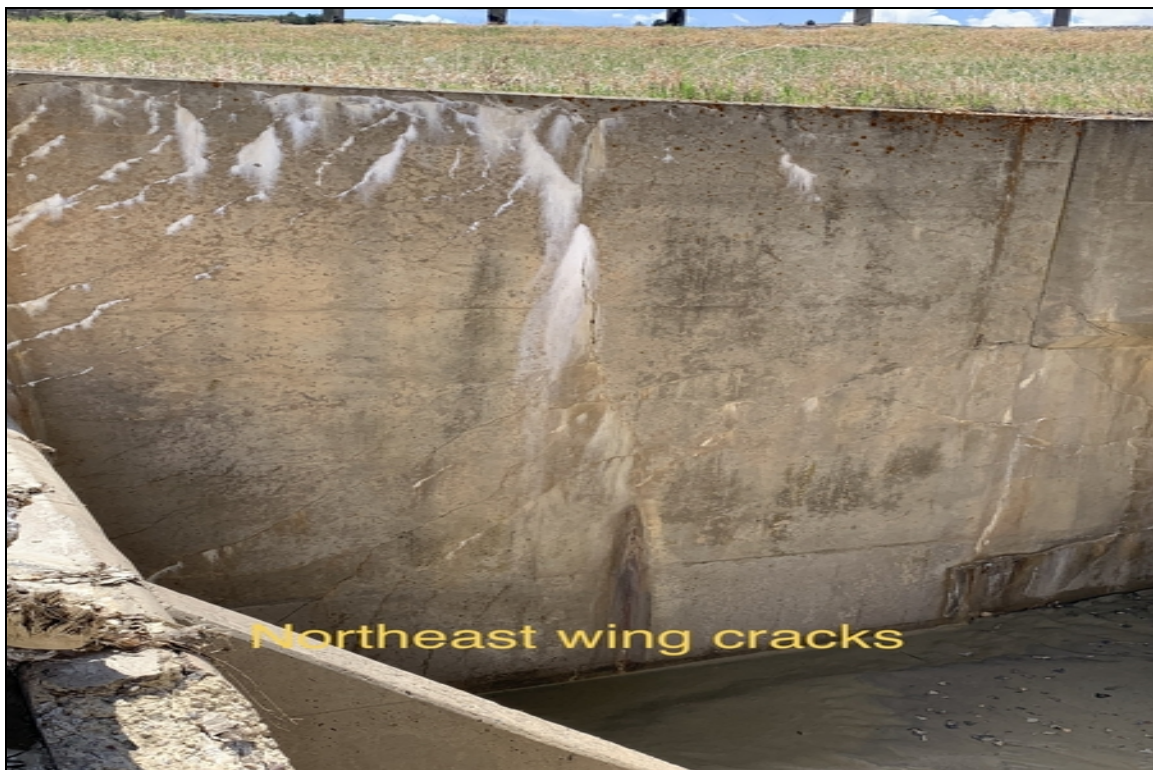
NE wing cracks

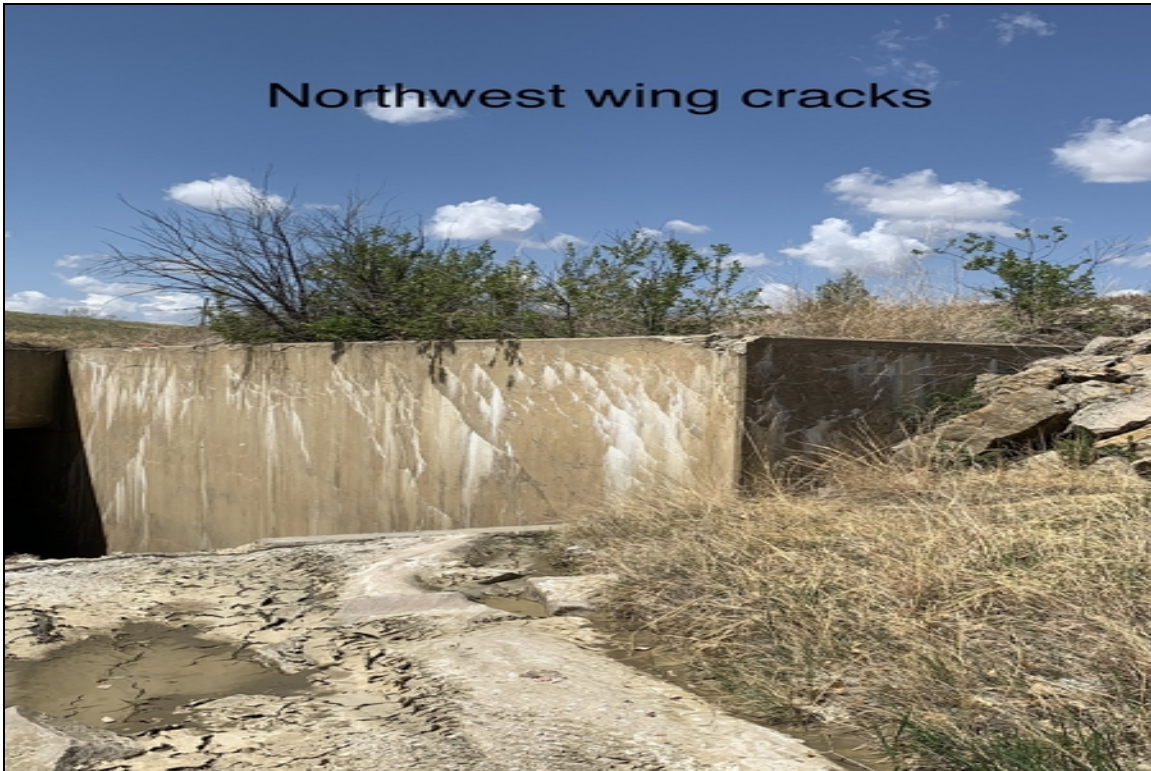
Nw wing cracks

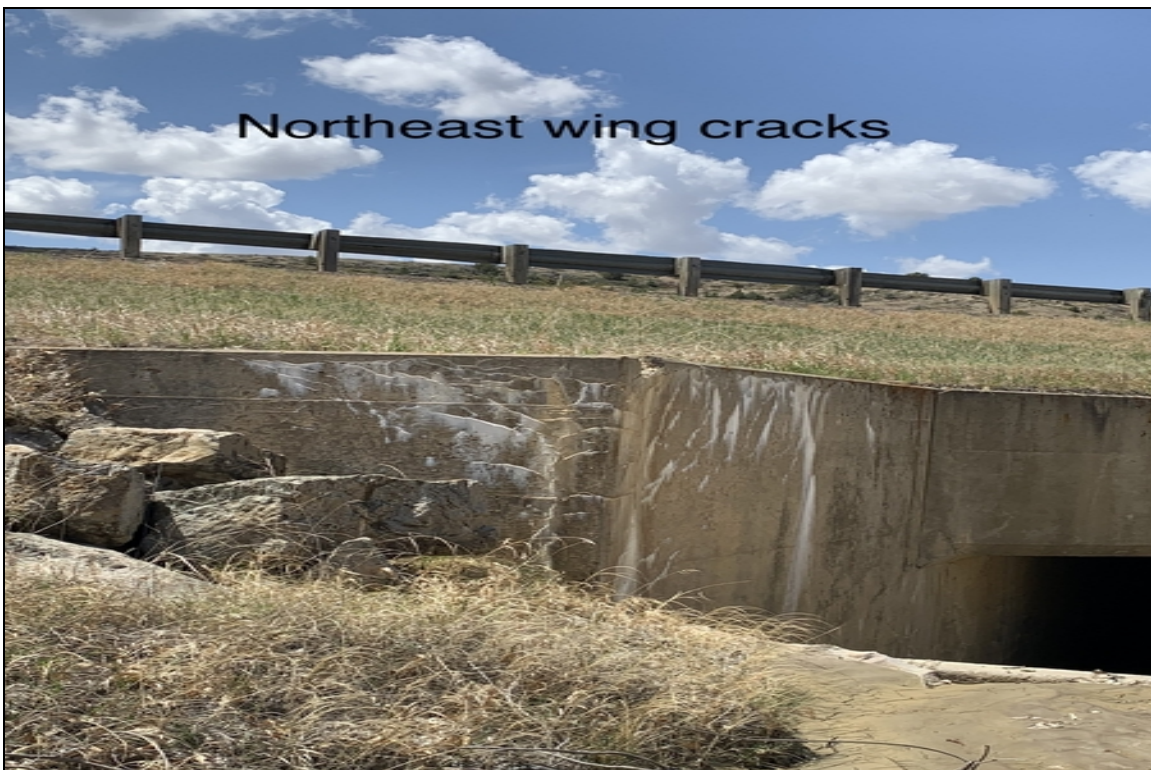
NE wing cracks

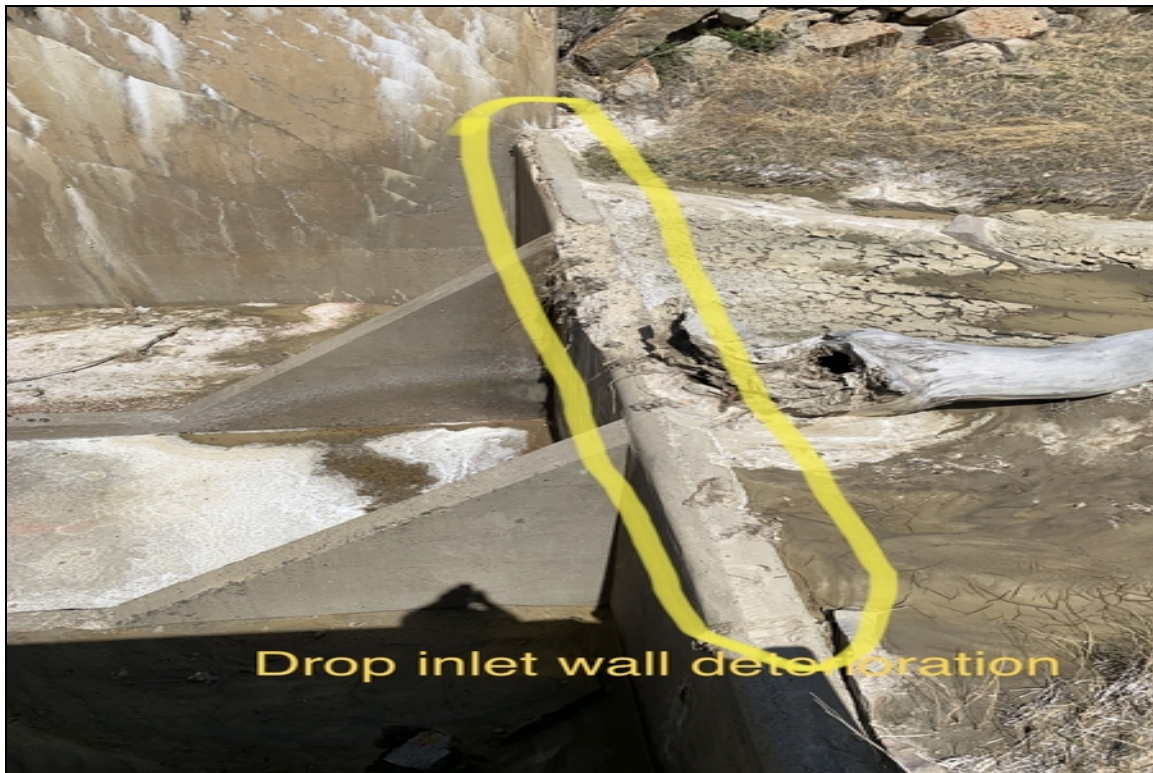
Drop inlet wall deterioration

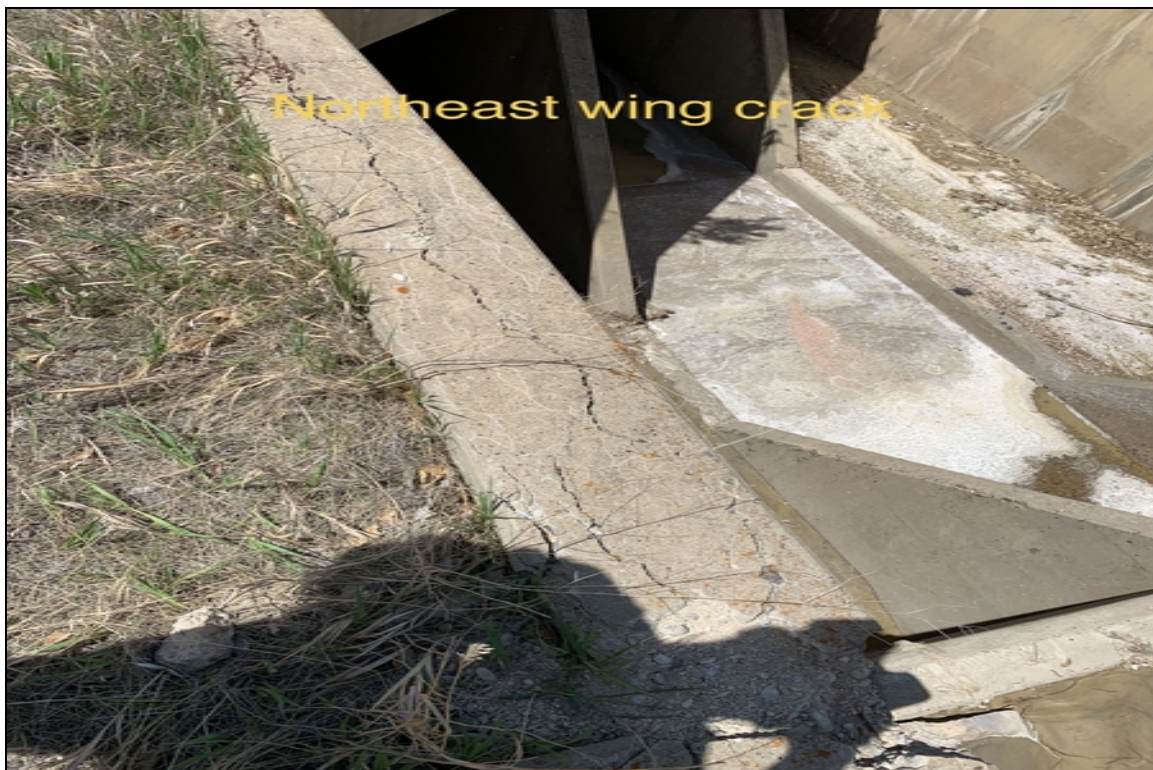
NE wing cracks

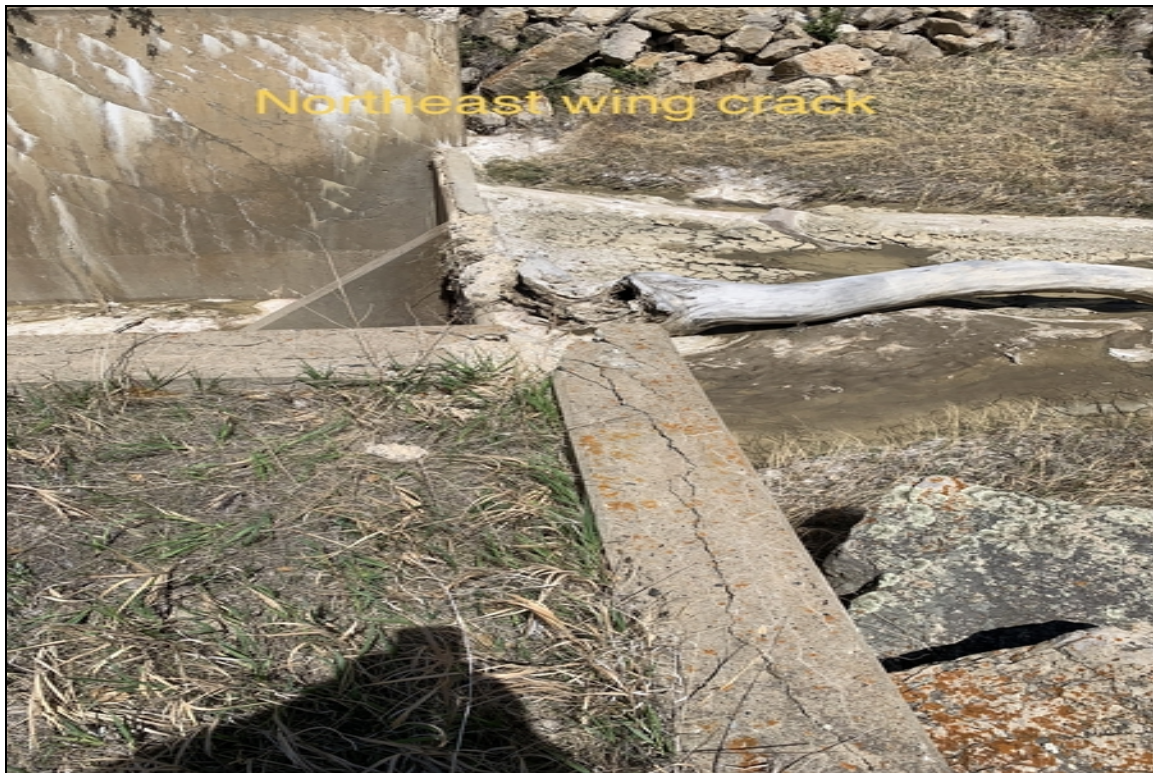
NE wing cracks

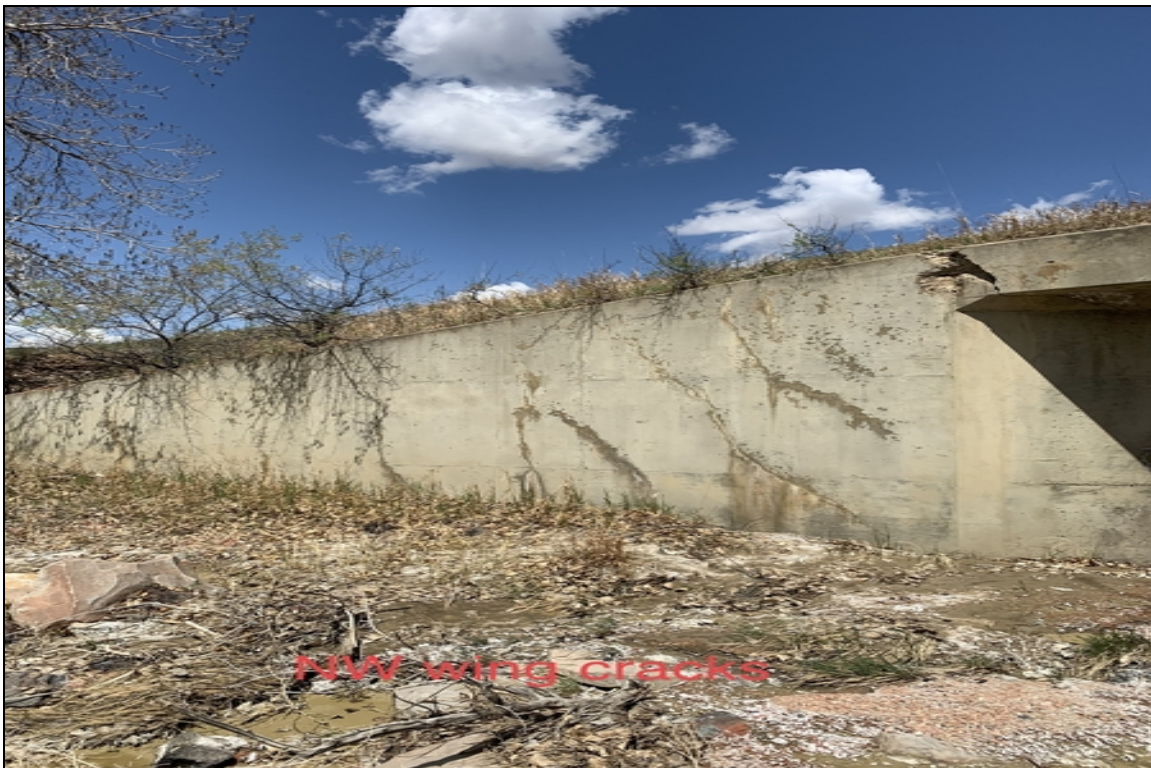
SW wing cracksnot NW

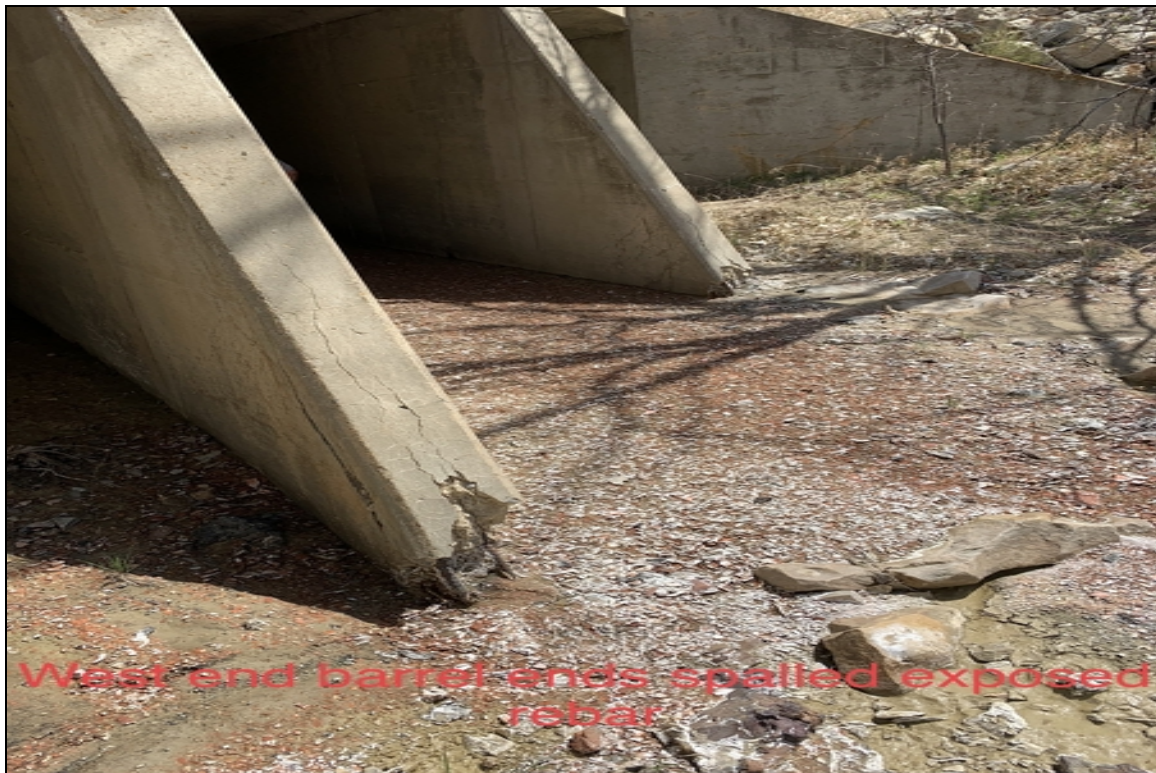
South end barrel ends spalled exposed rebar ..not west

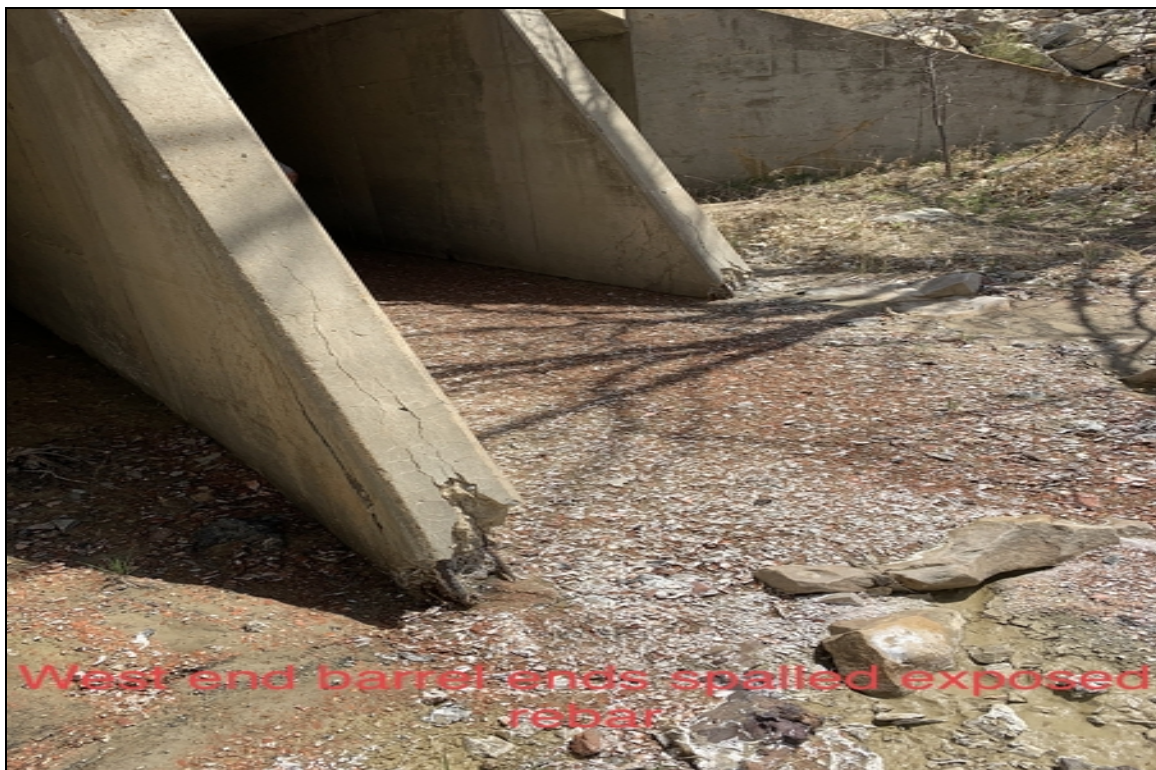
South end barrel ends spalled exposed rebar ...not west

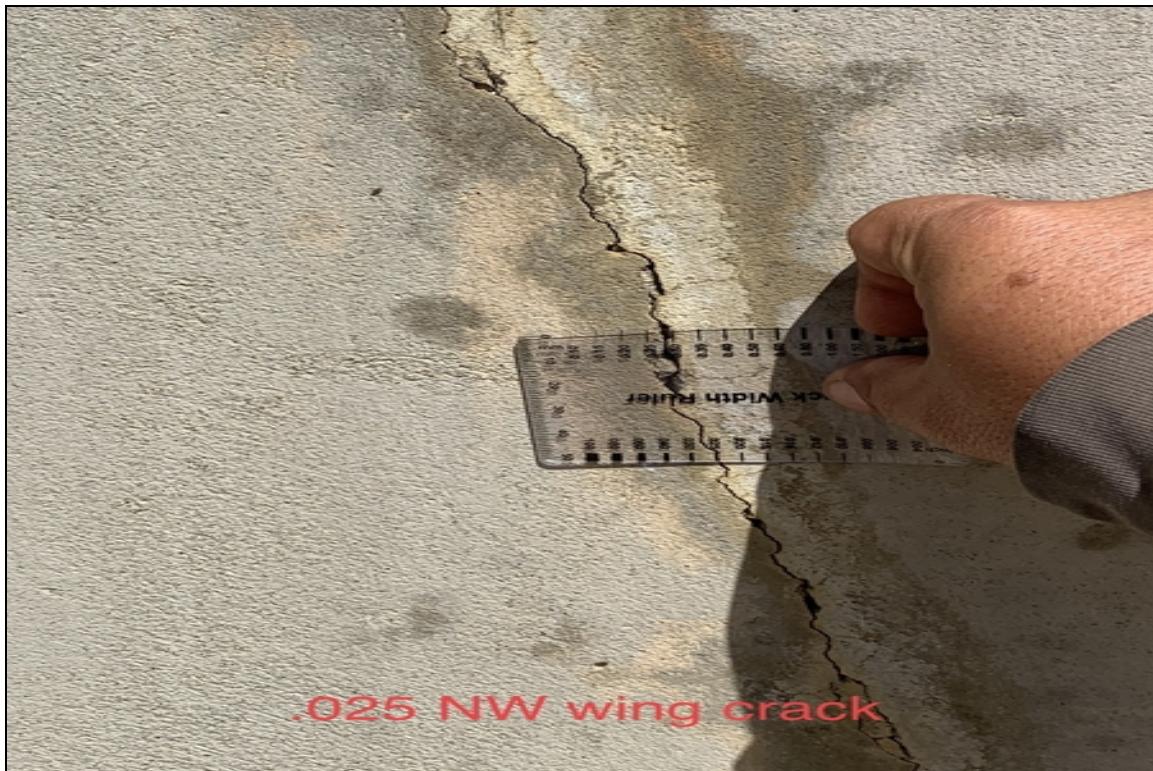
.025 Sw wing crack ..not NW

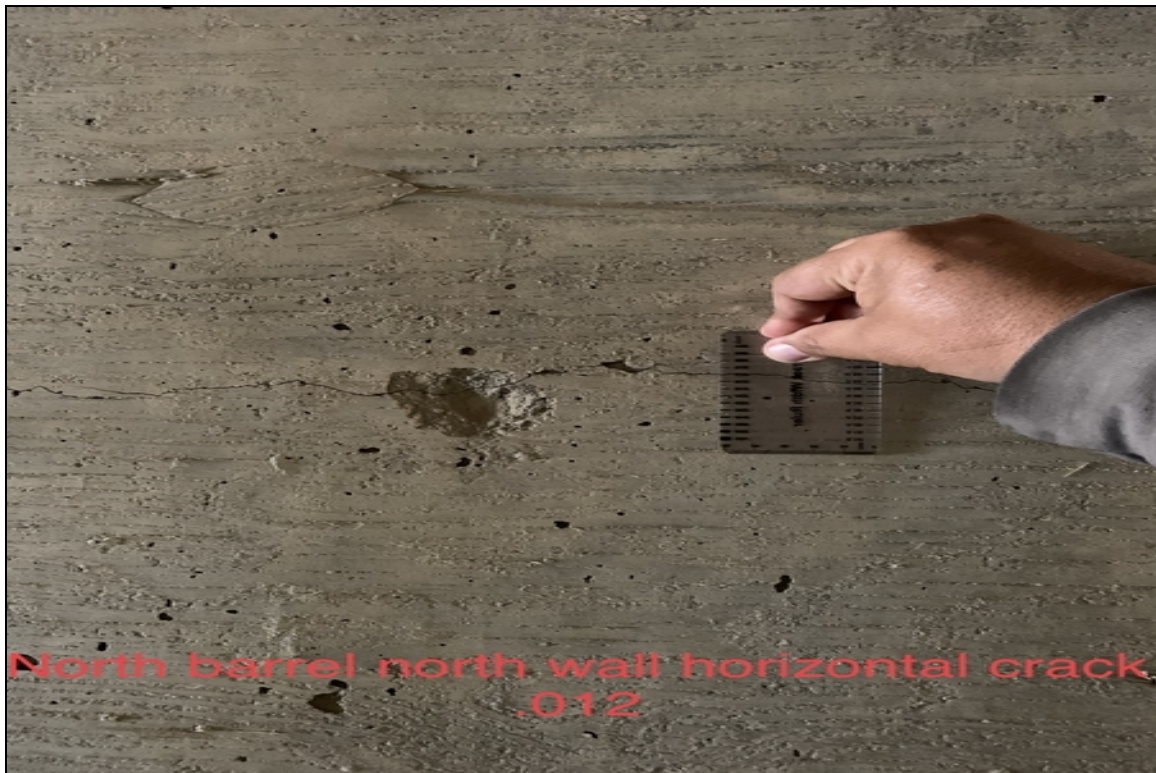
North barrel north wall horizontal crack
.012

West barrel north wall horizontal crack .012
Not north barrel

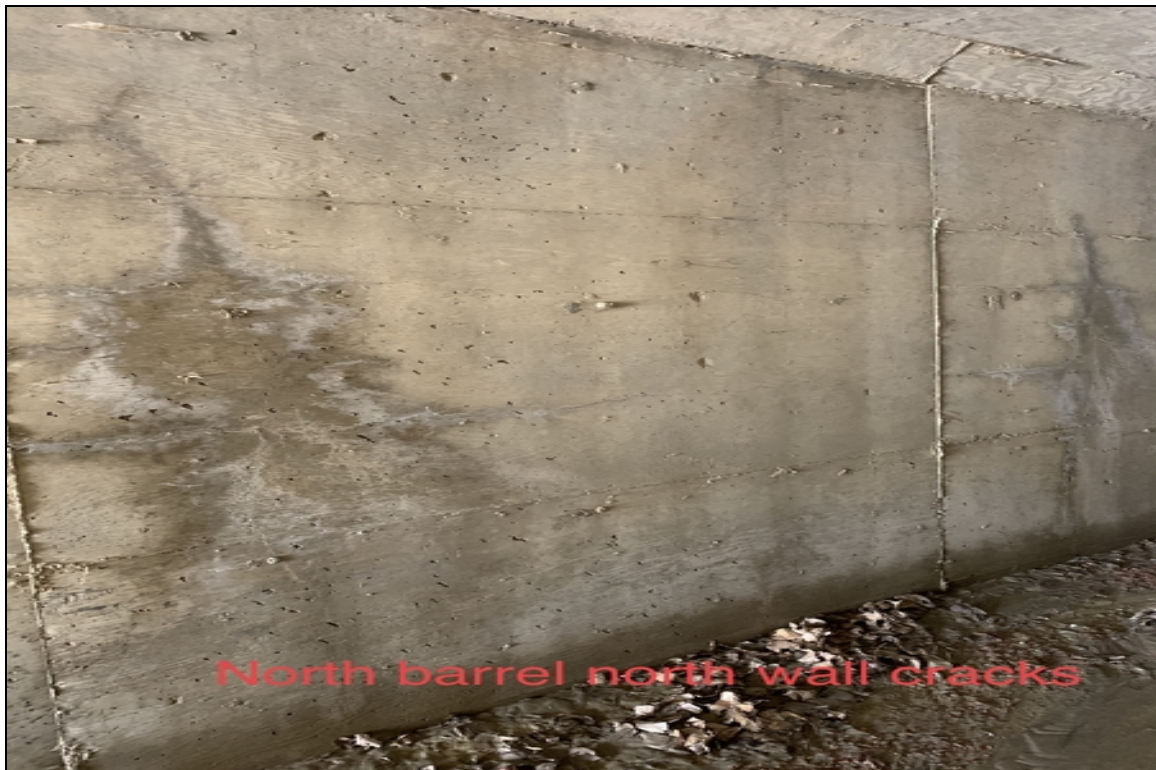
North barrel north wall cracks

West barrel north wall cracks
Not north barrel

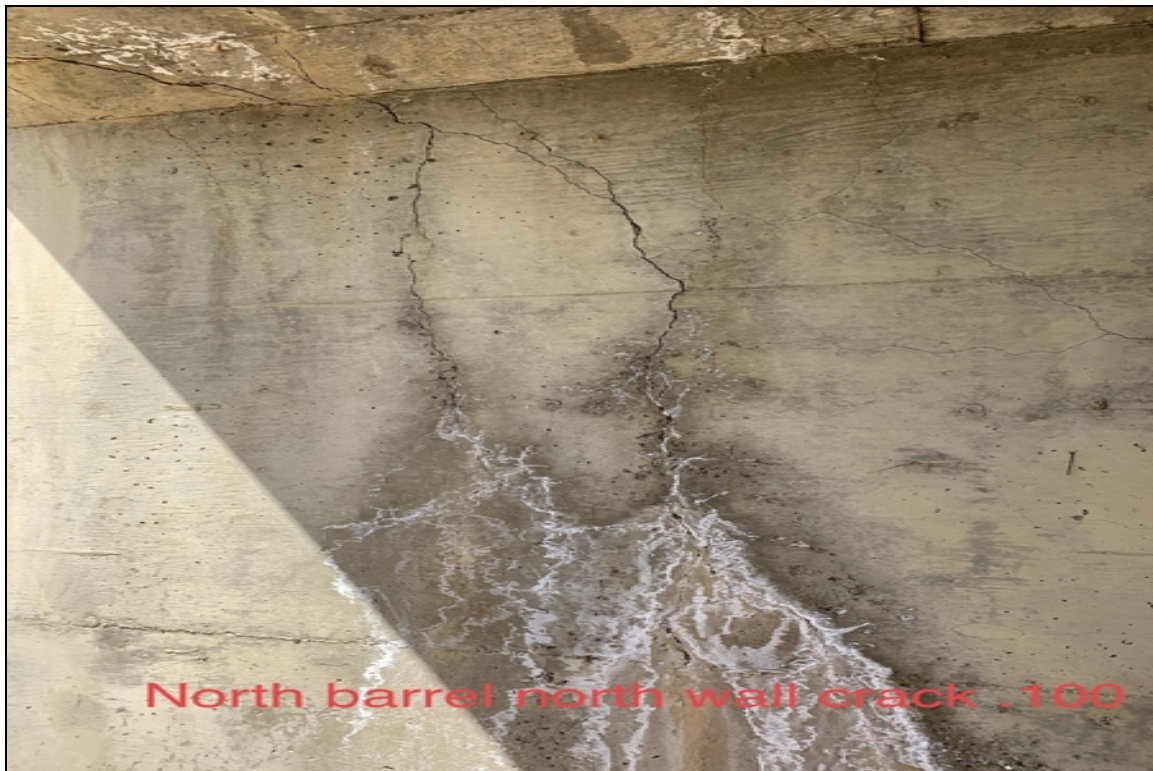
West barrel north wall crack .100
Not north

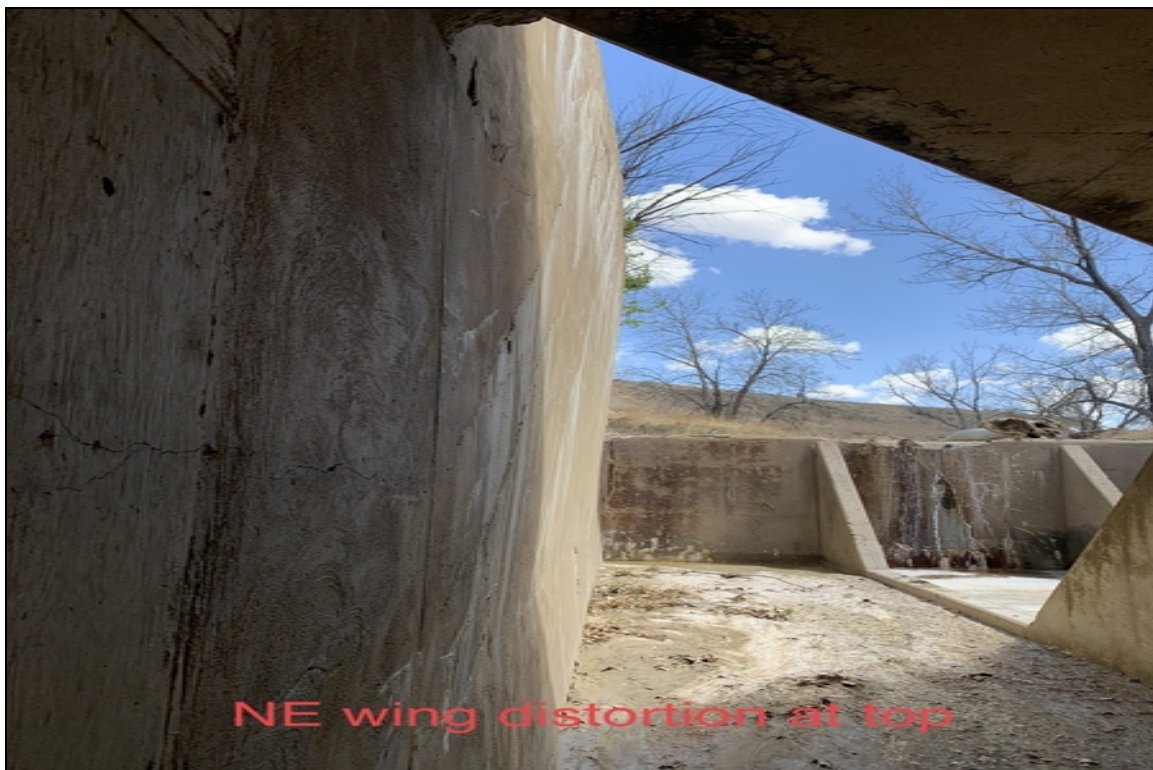
NW wing distortion at top
Not NE

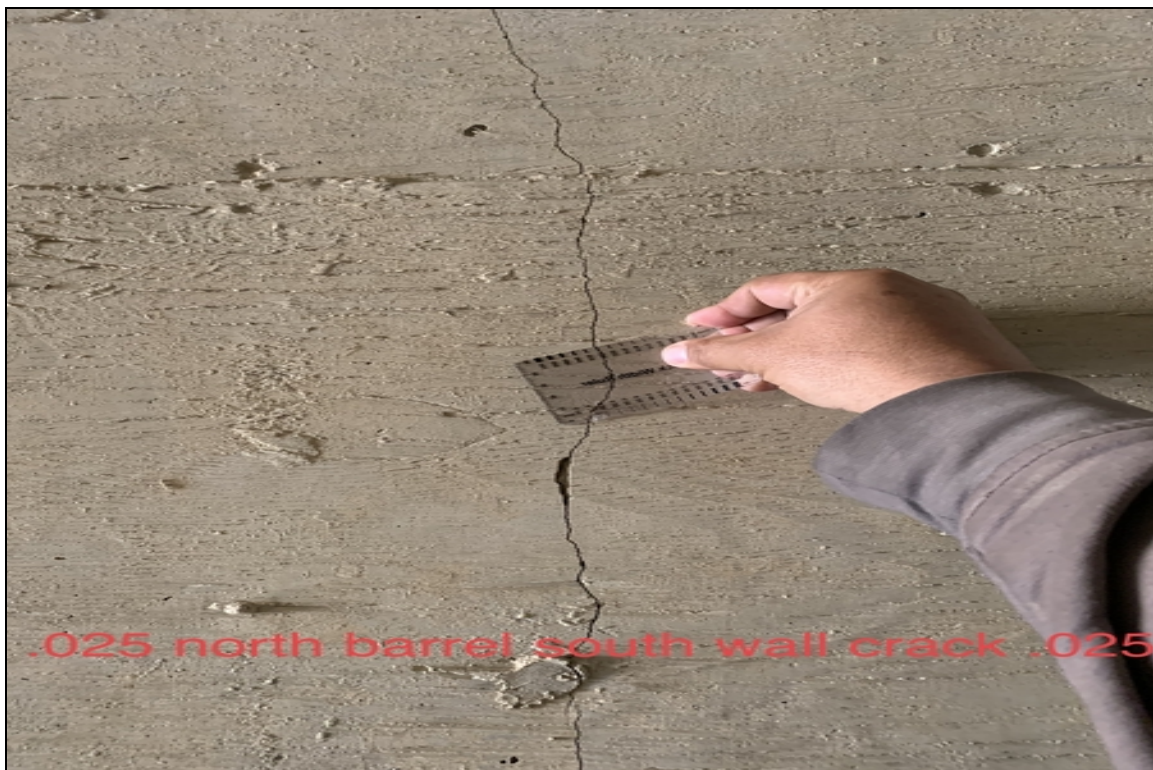
.025 west barrel south wall crack
Not north

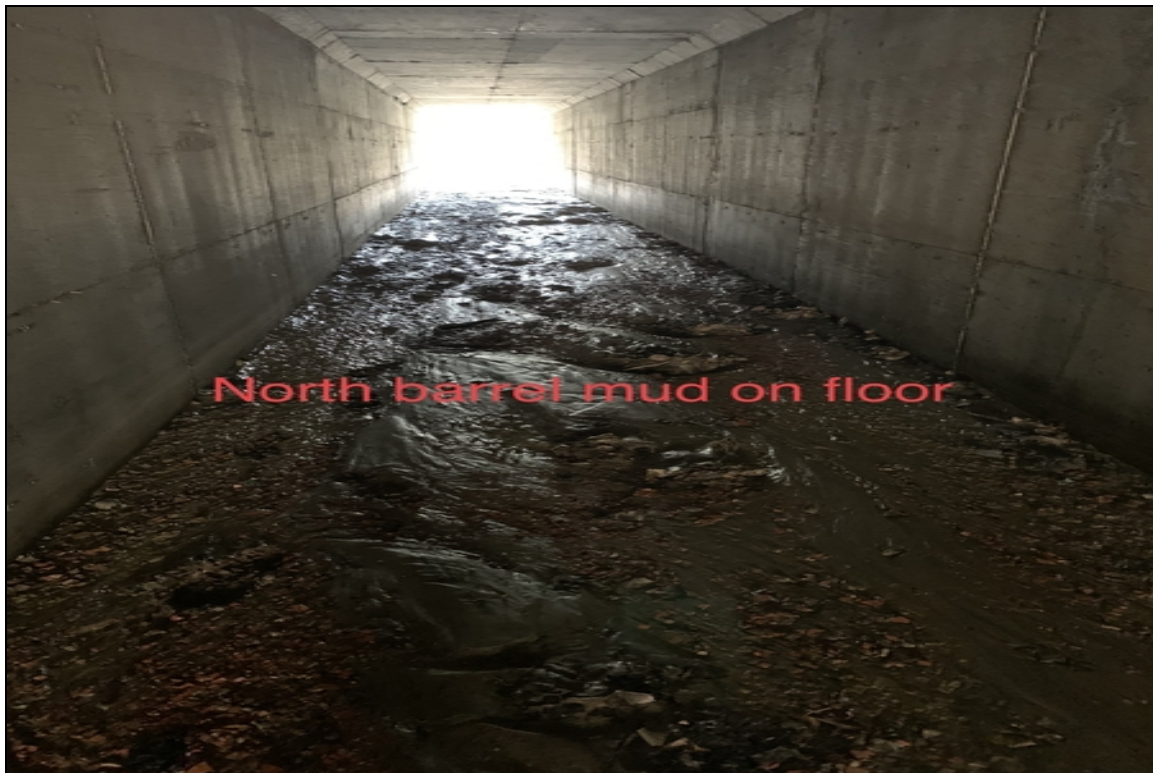
North barrel mud on floor

West barrel mud on floor
Not west

Recommend removing the sediment from the barrels with a skid steer. 18May2021

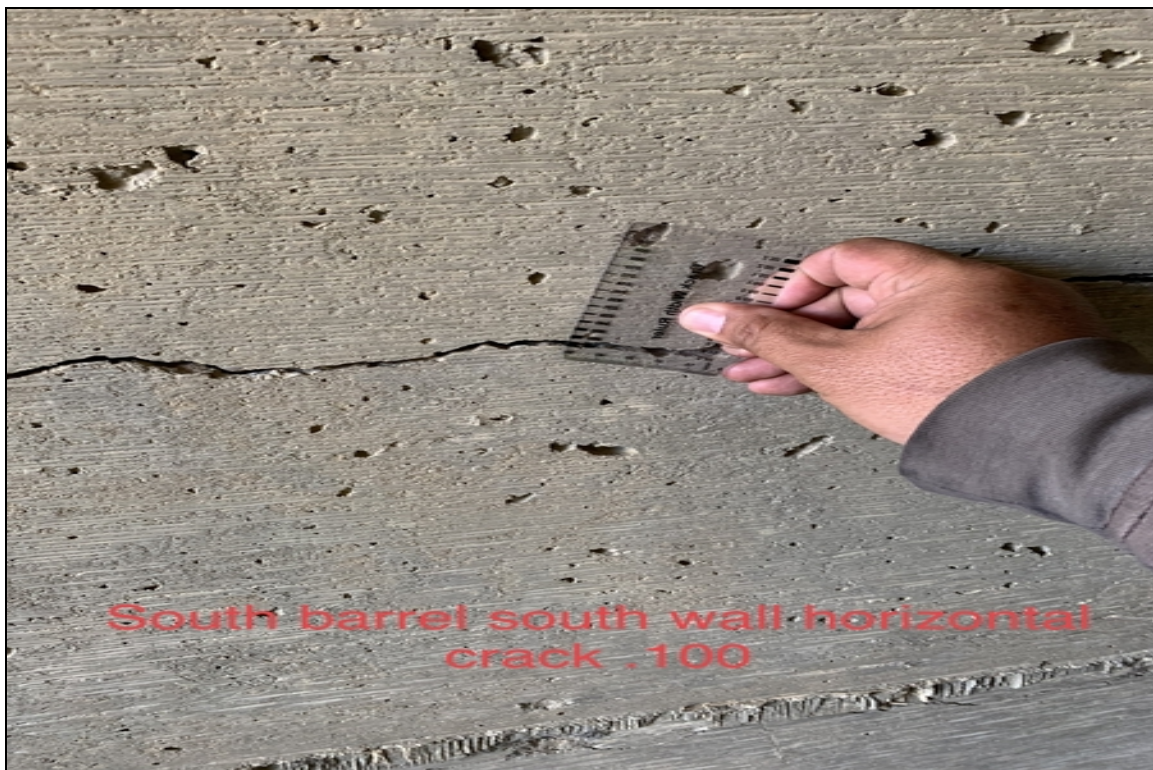
South barrel south wall horizontal
crack .100

East barrel south wall crack horizontal.100
Not south
