16 WEST OF JCT. US 85

IDENTIFICATION		
(1) State Names	North Dakota	
(8) Structure Number	0094-026.422 L	
(5) Inventory Route	00094	
(2) Highway Agency District	65	
(3) County Code	Billings, North Dakota

(4) Place Code	0	
(6) Features Intersected	SHEEP CREEK	
(7) Facility Carried	INTERSTATE 94	
(9) Location	16 WEST OF JCT. US 85	
(11) Mile Point	26.416 mi	
(12) Base Highway Network	Yes

Team Lead: Jake Mertz, **Inspection Date:** May 18, 2021

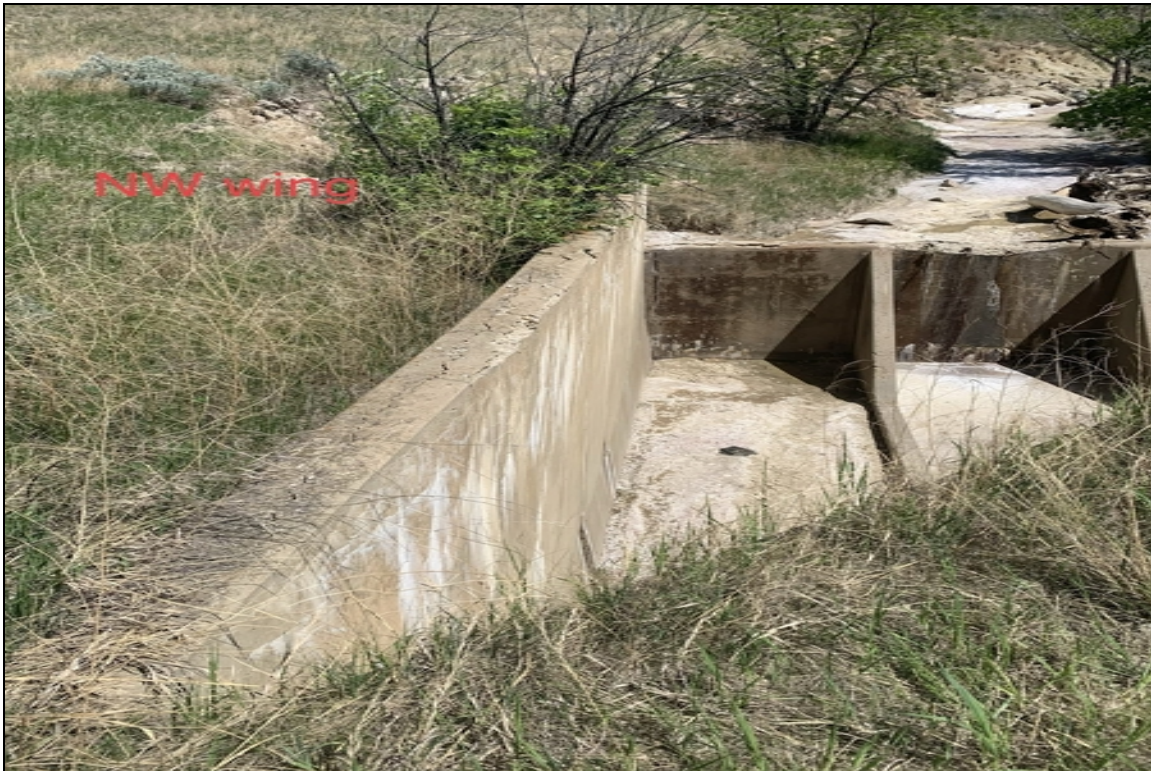
NW wing bow

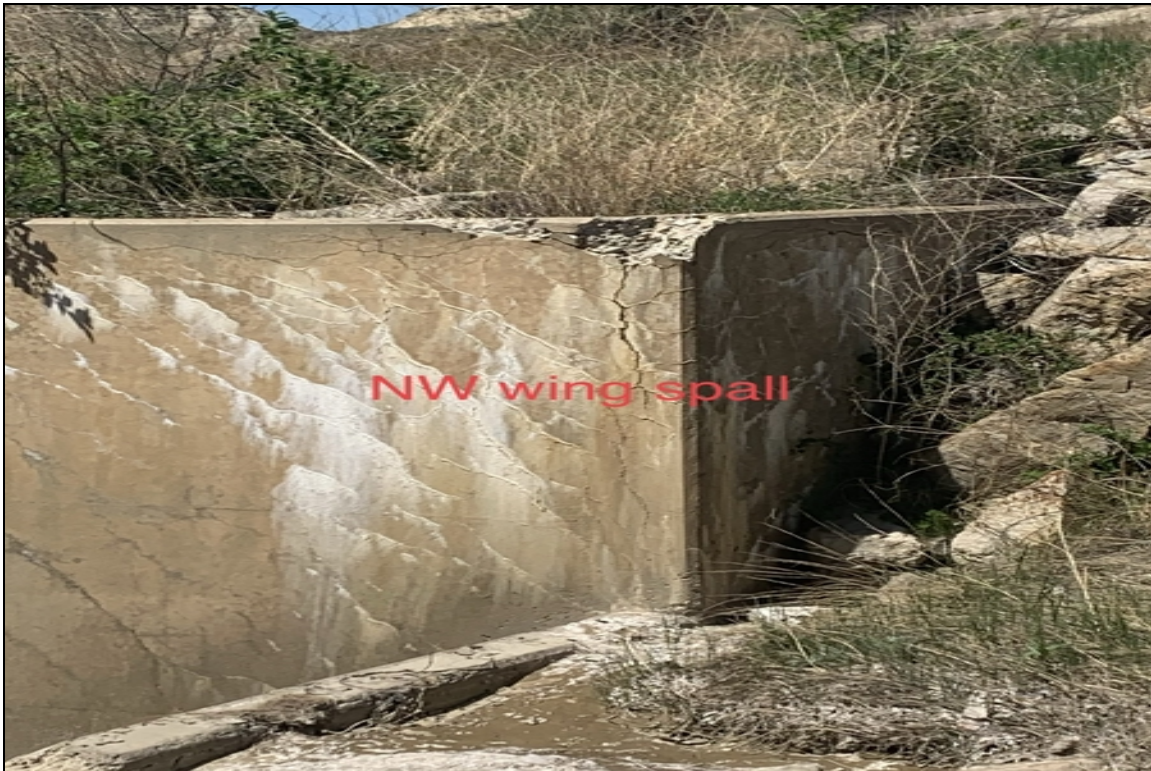
NW wing spall

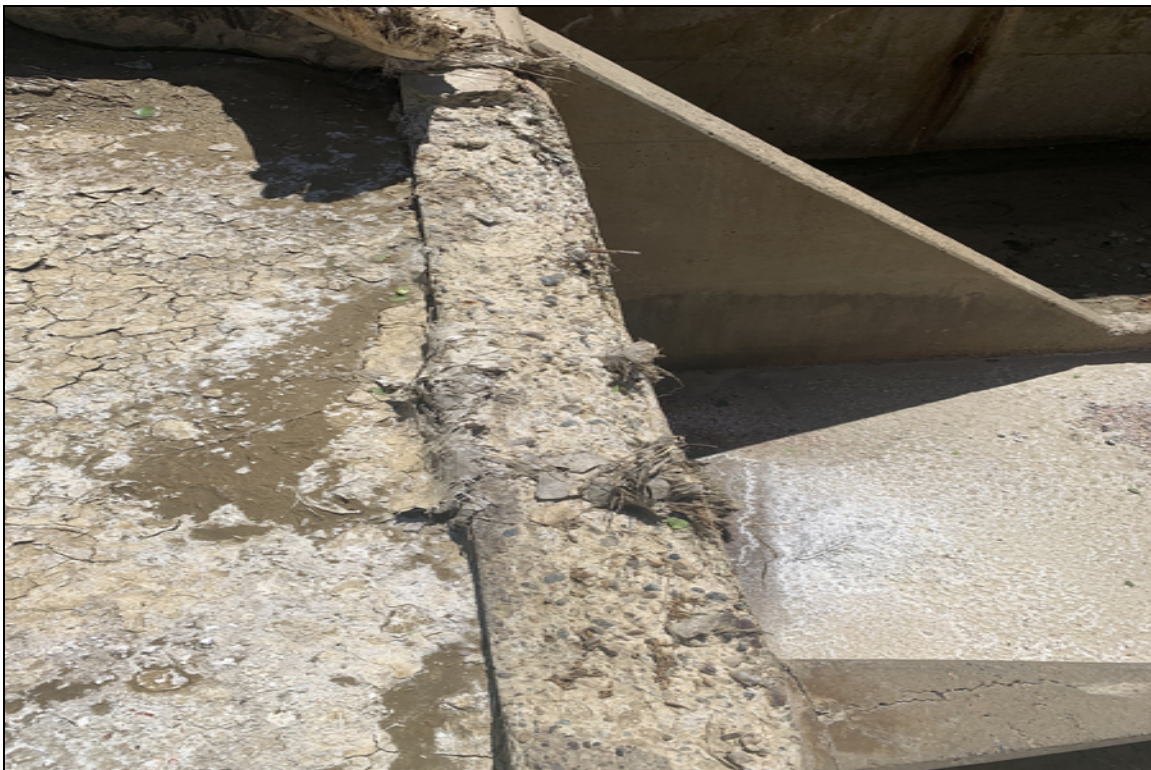
Drop inlet lip spalling

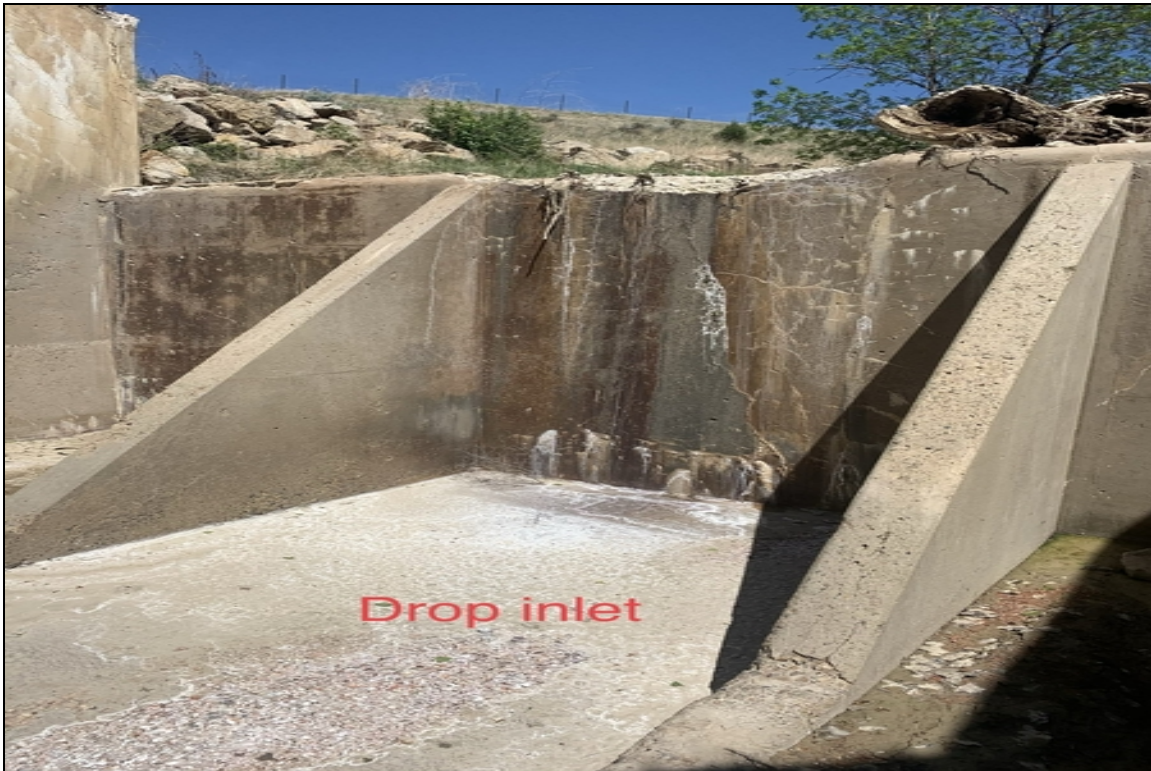
Drop inlet cracking

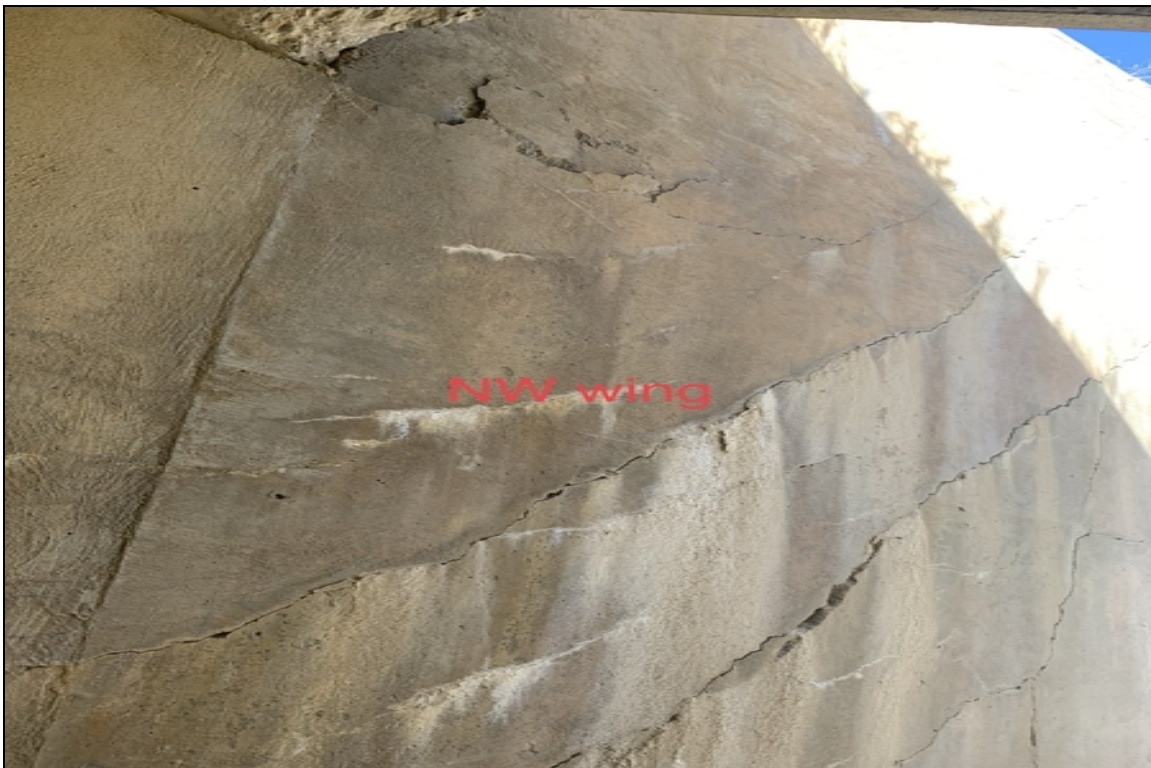
NW wing cracks

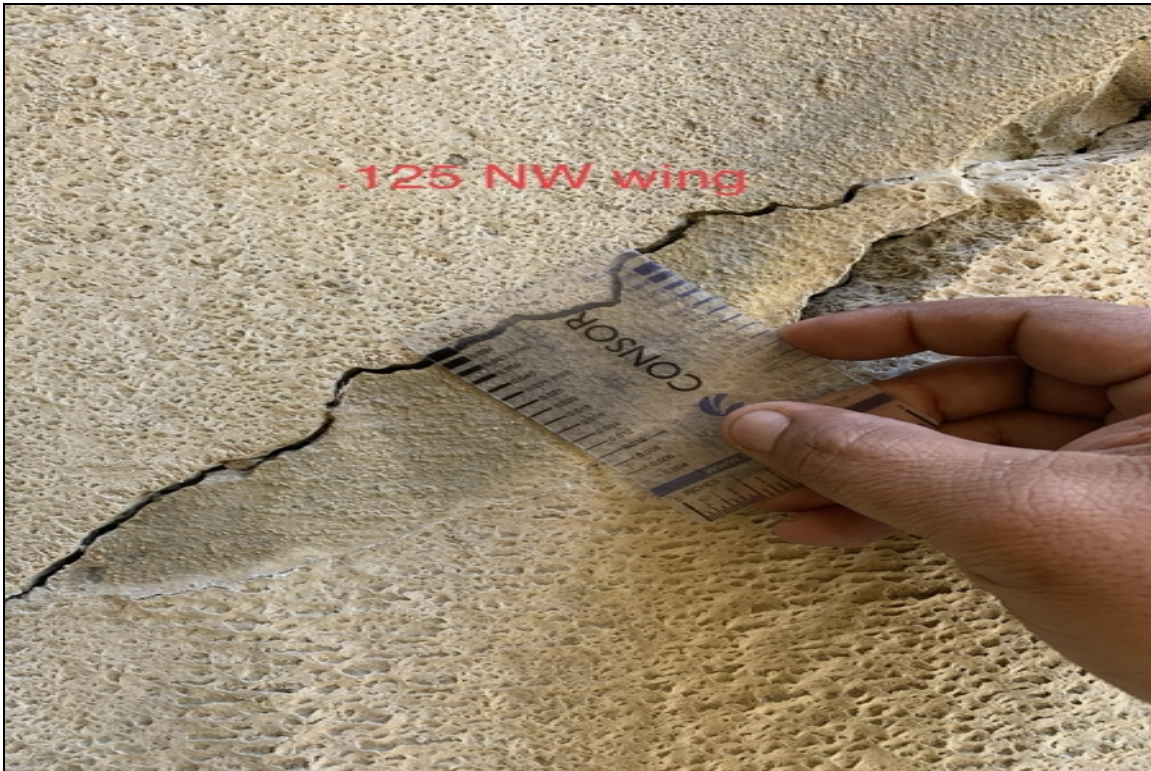
.125 NW wing crack

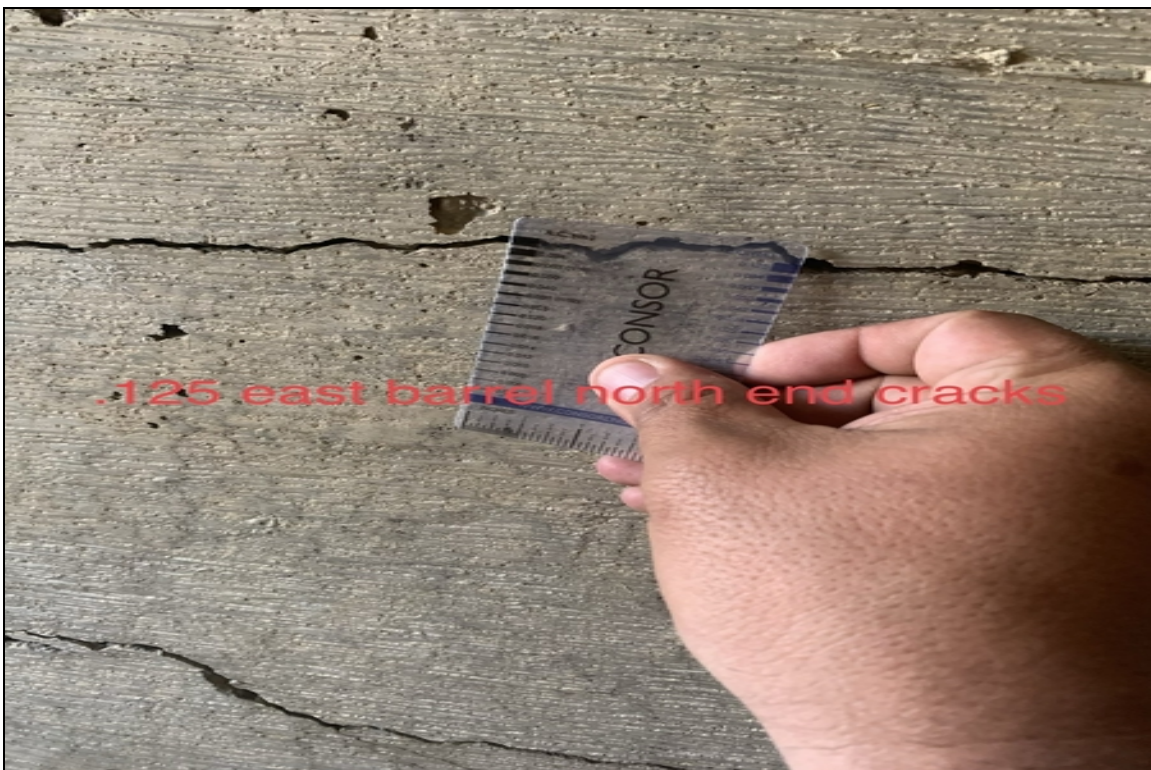
.125 east barrel outside wall crack north end

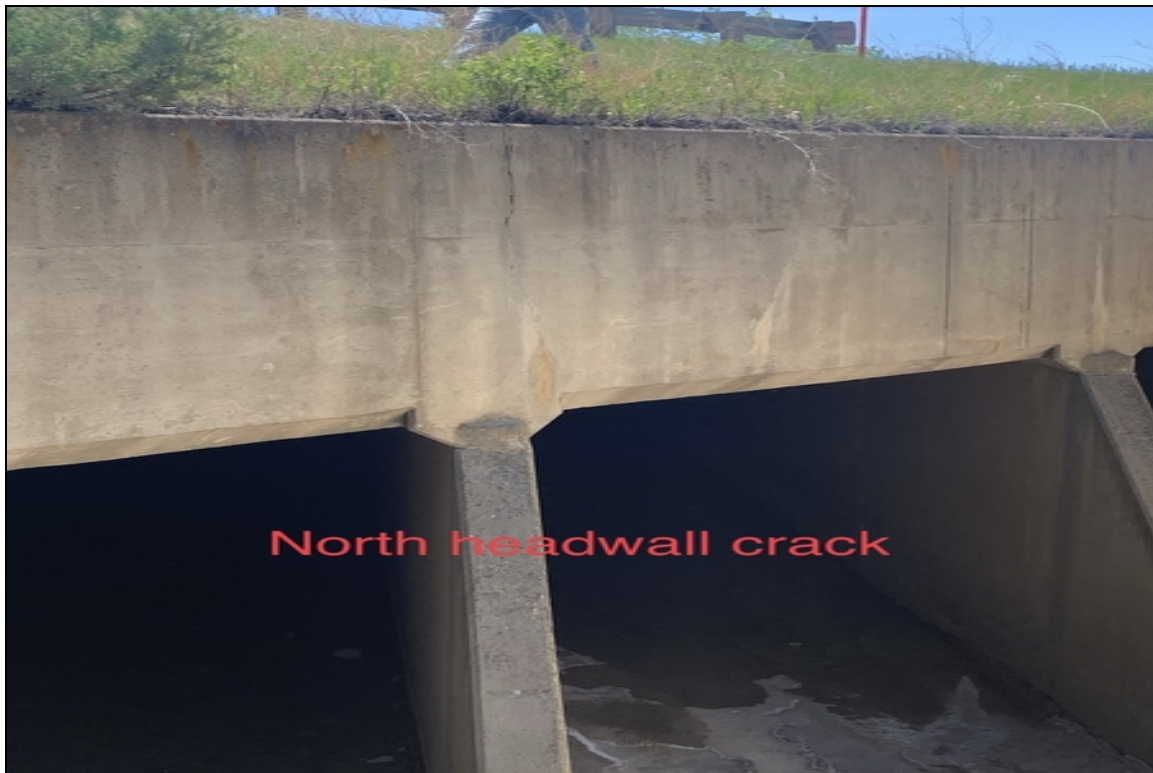
North headwall crack

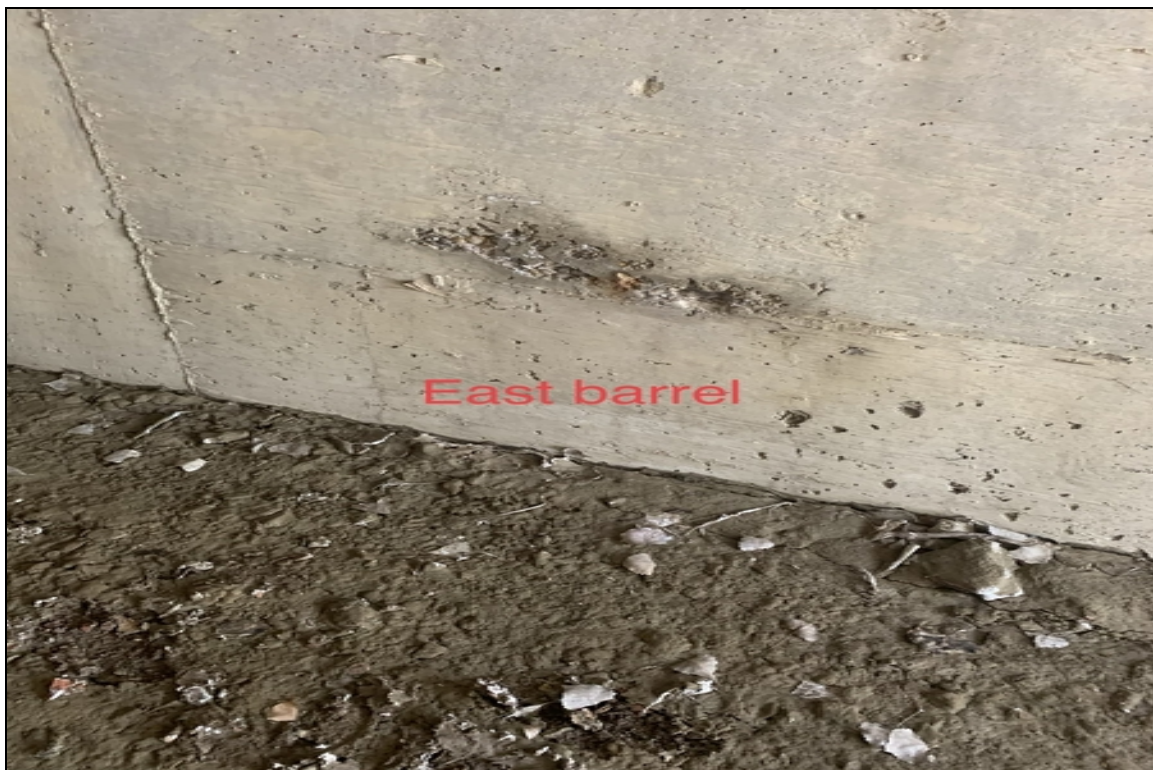
East barrel inner wall honeycomb

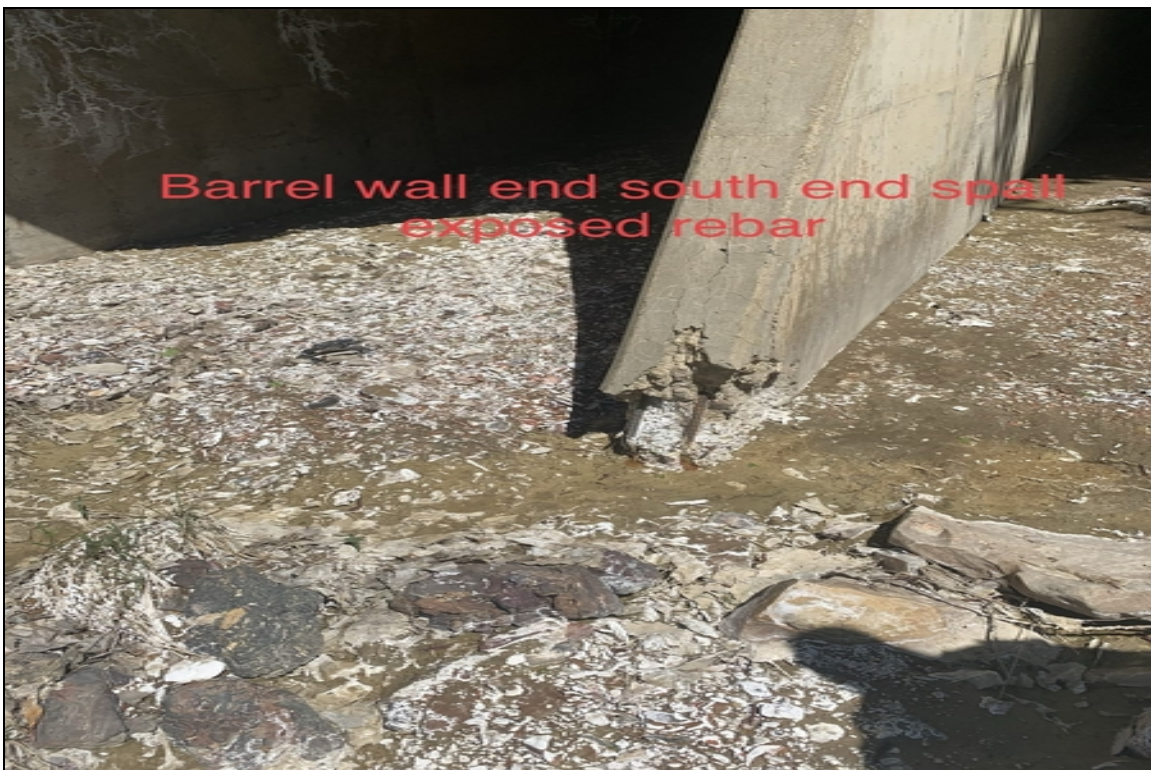
Barrel wall end south spall exposed rebar

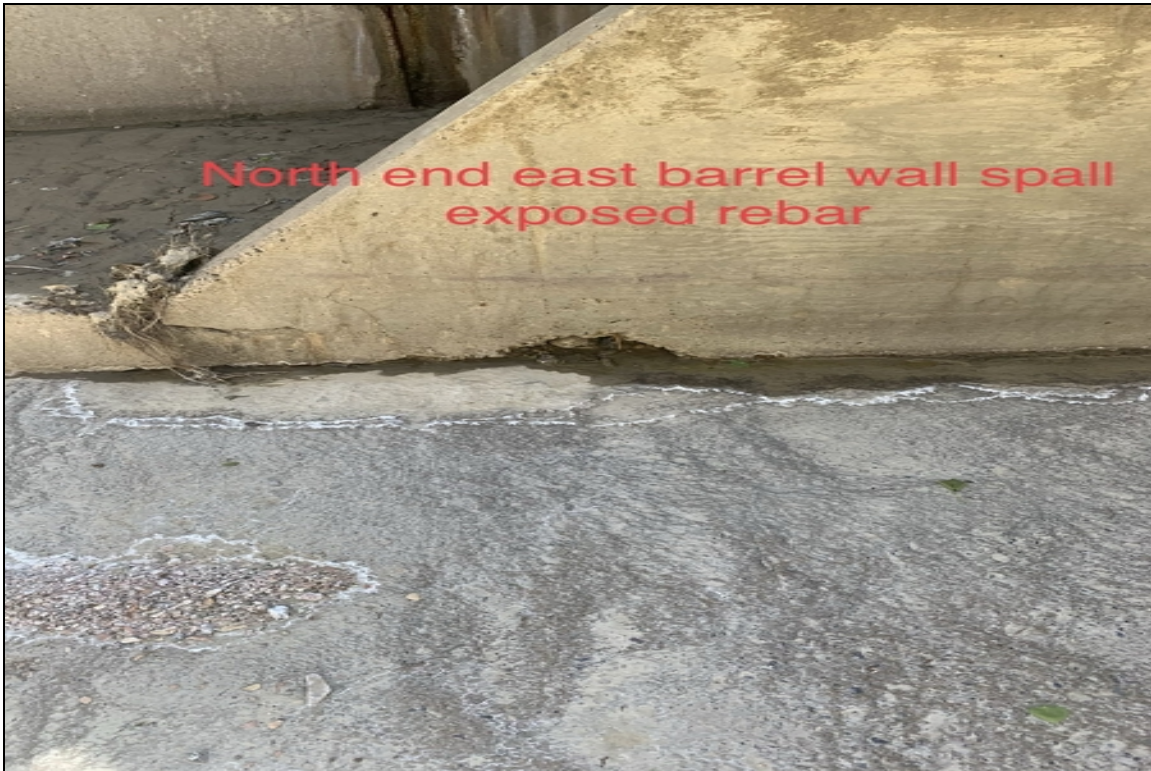
North end east barrel inner wall spall and exposed rebar

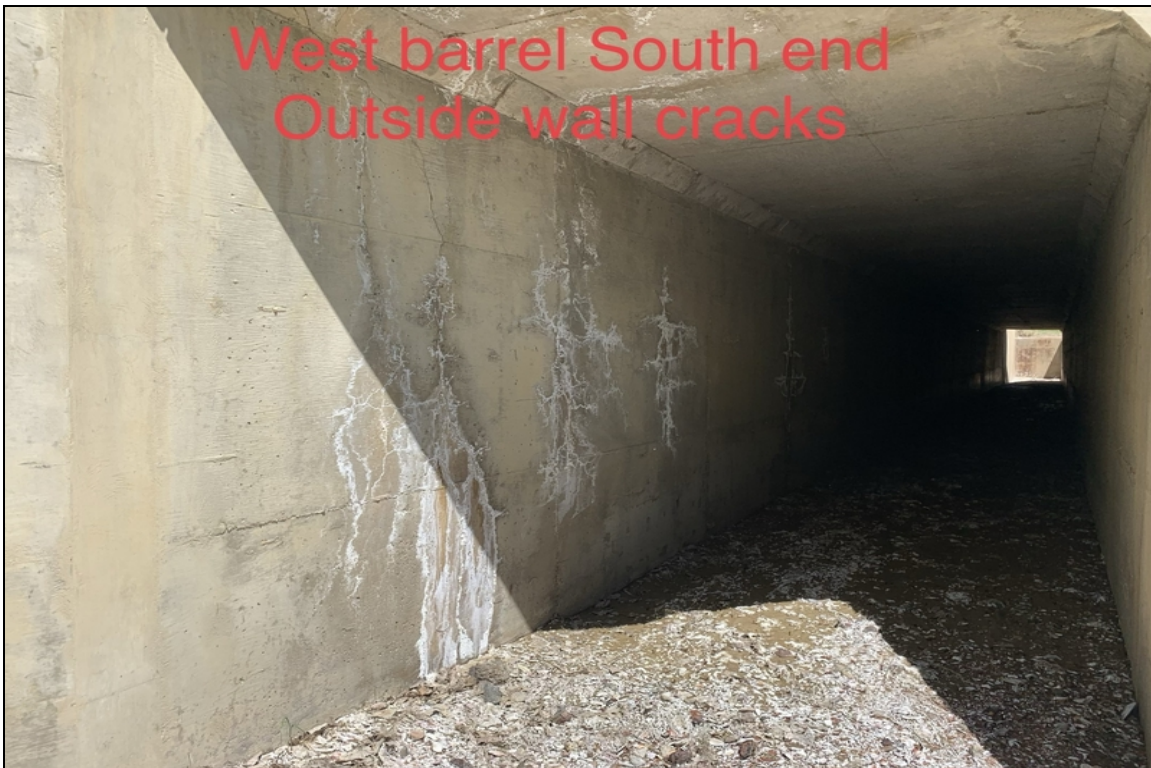
West barrel south end outside wall cracks

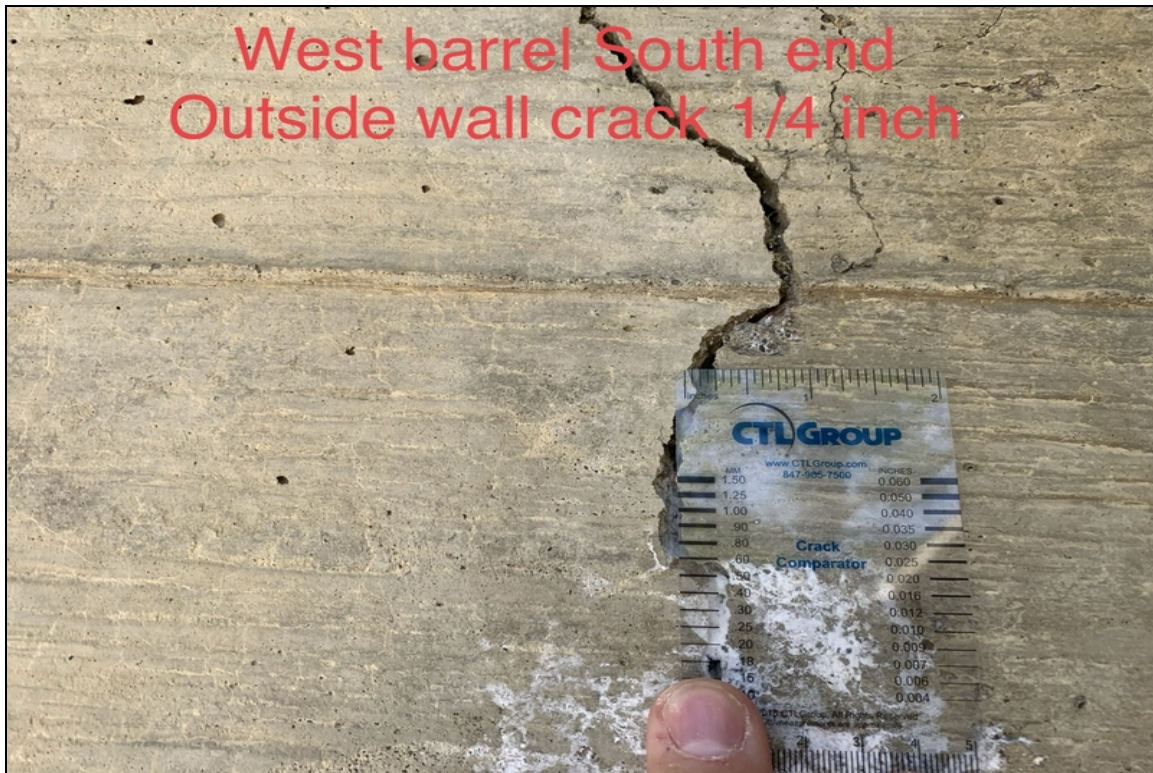
West barrel south end outside wall cracks 1/4"

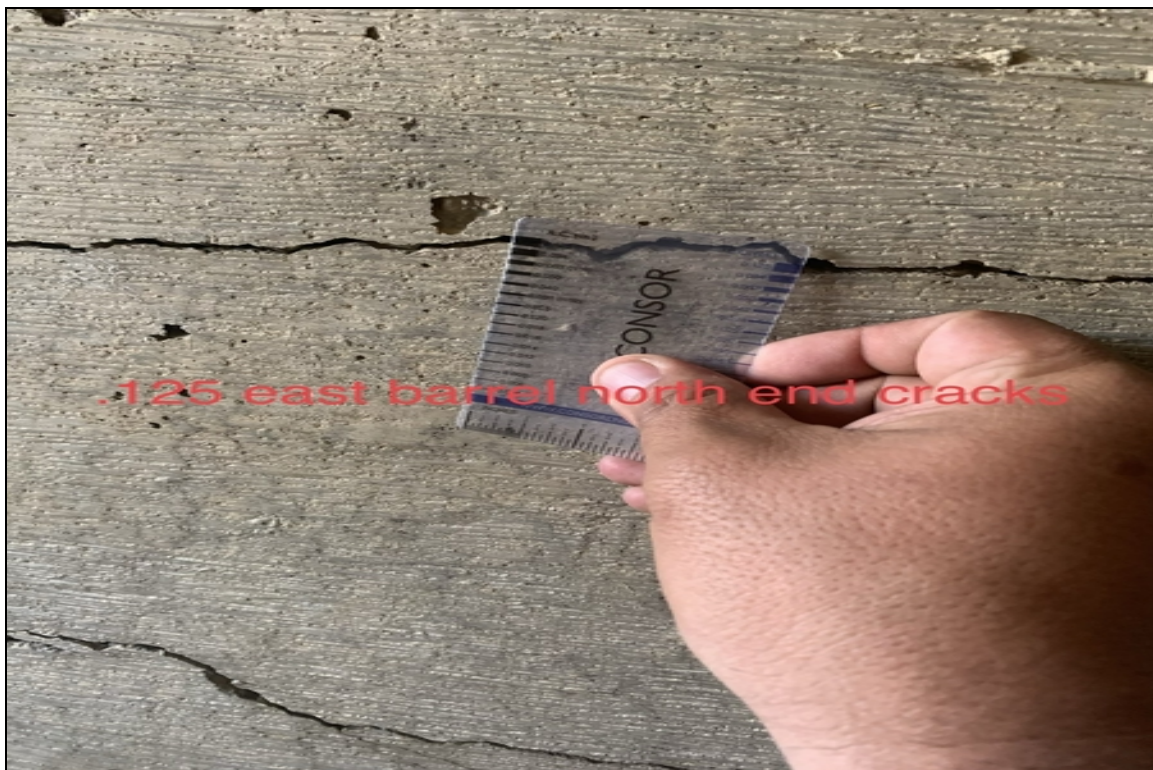
.125 east barrel outside wall crack north end

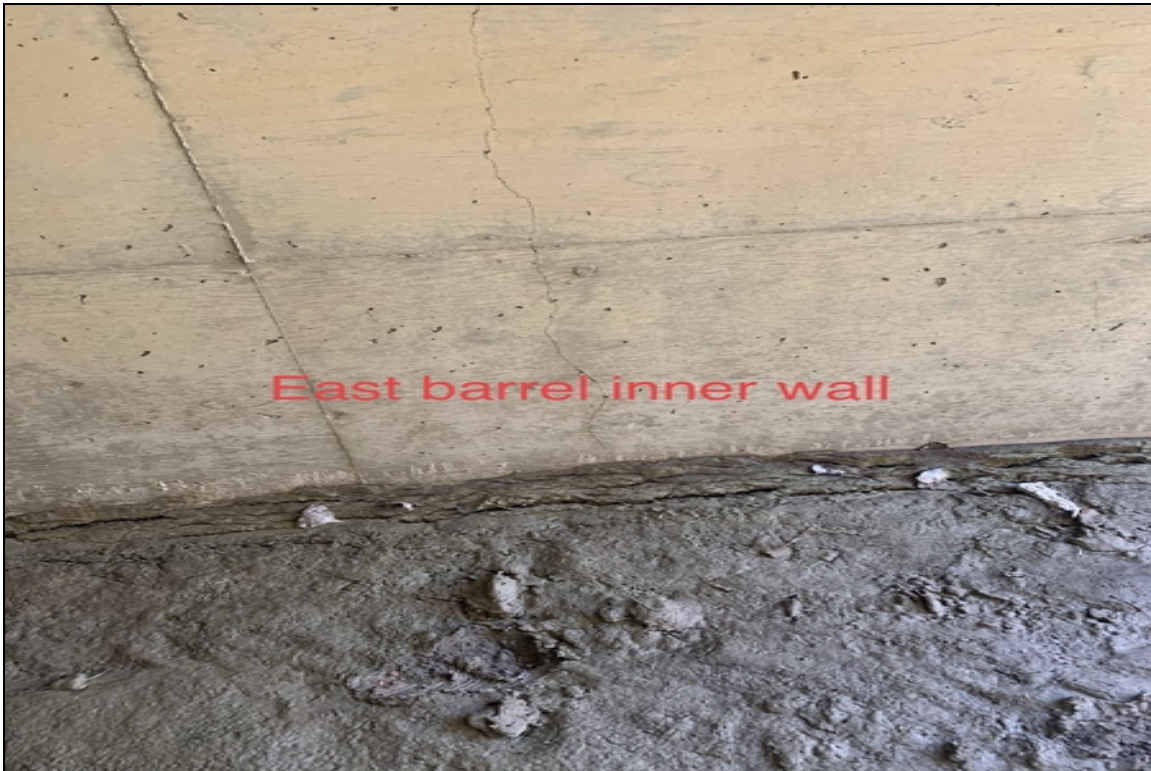
East barrel inner wall crack

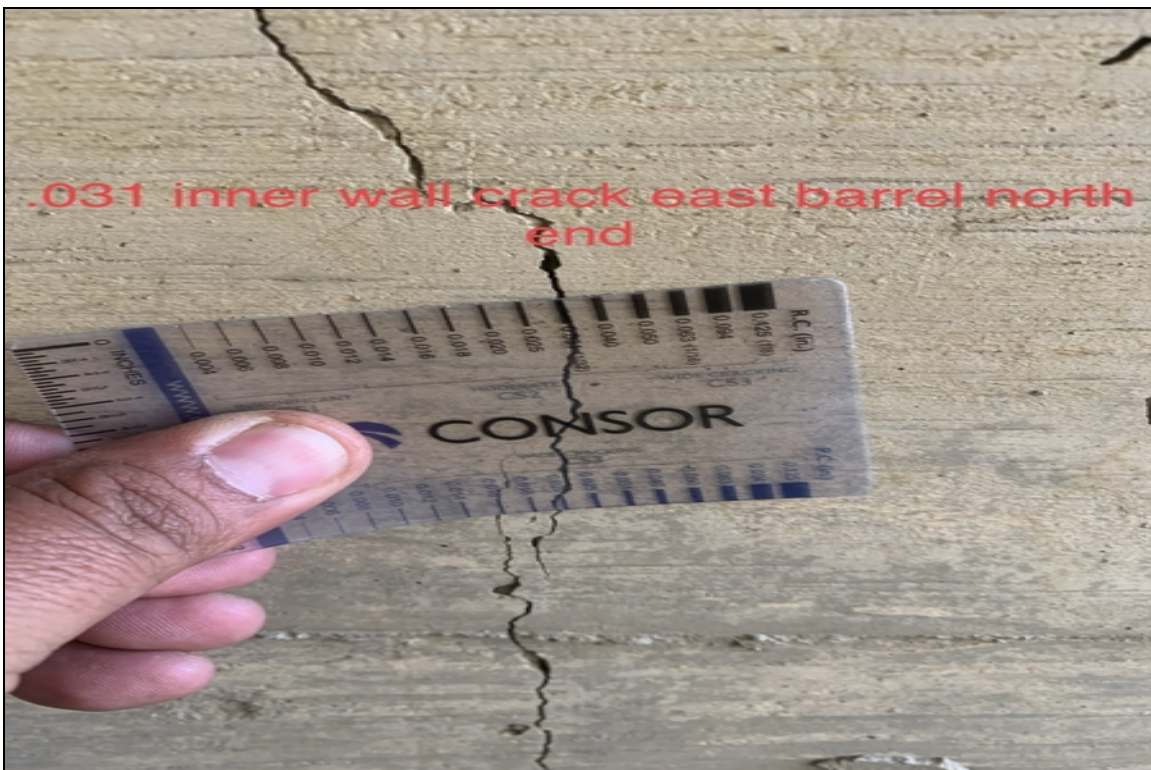
.031 inner wall crack east barrel north end

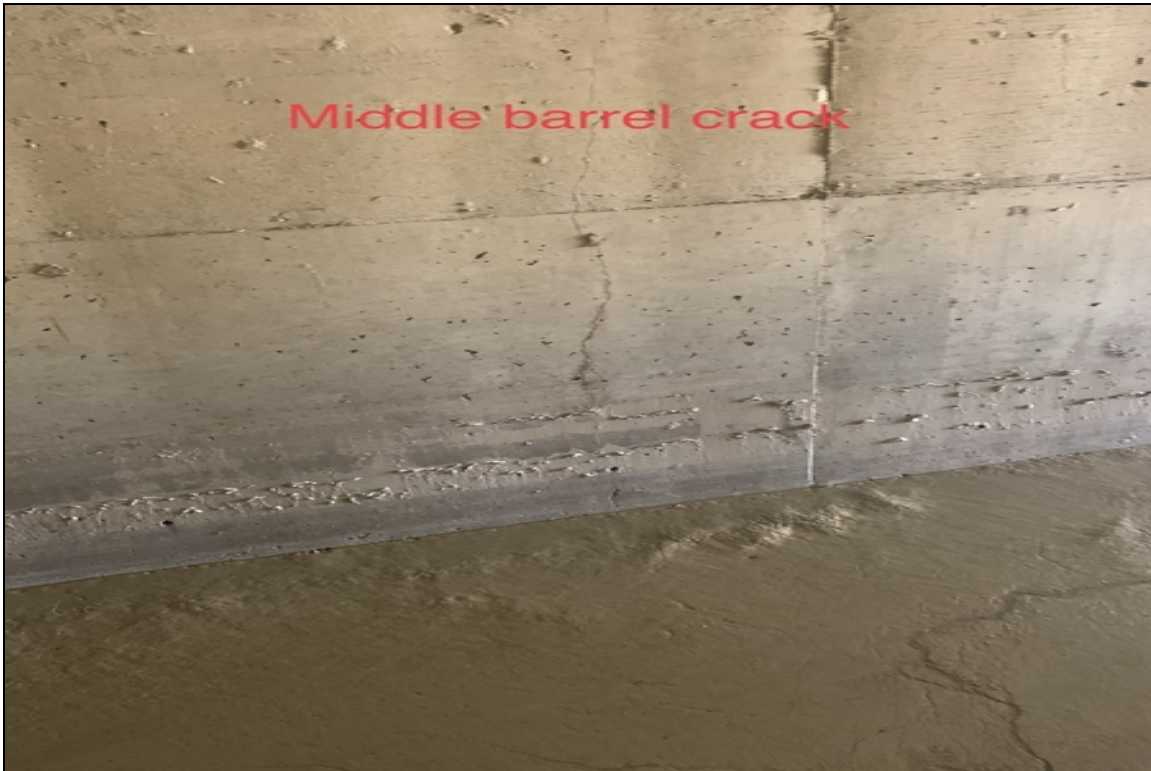
Middle barrel crack

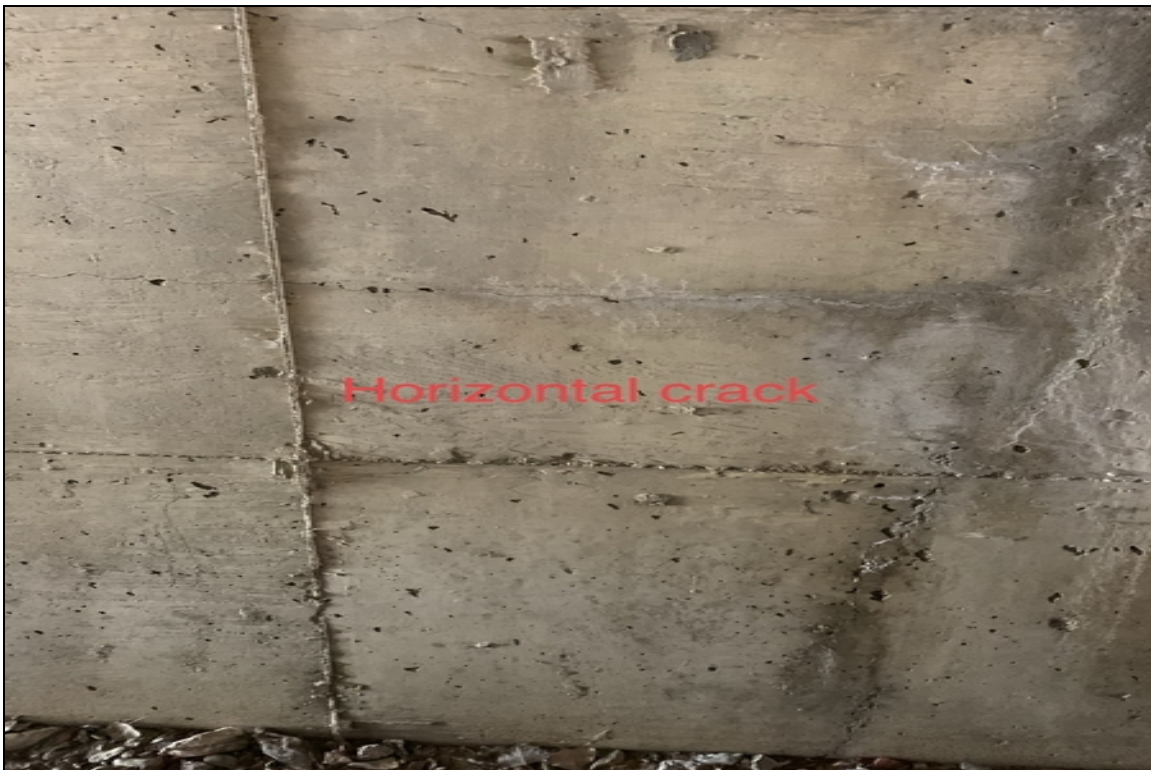
Horizontal cracks west outside wall south end

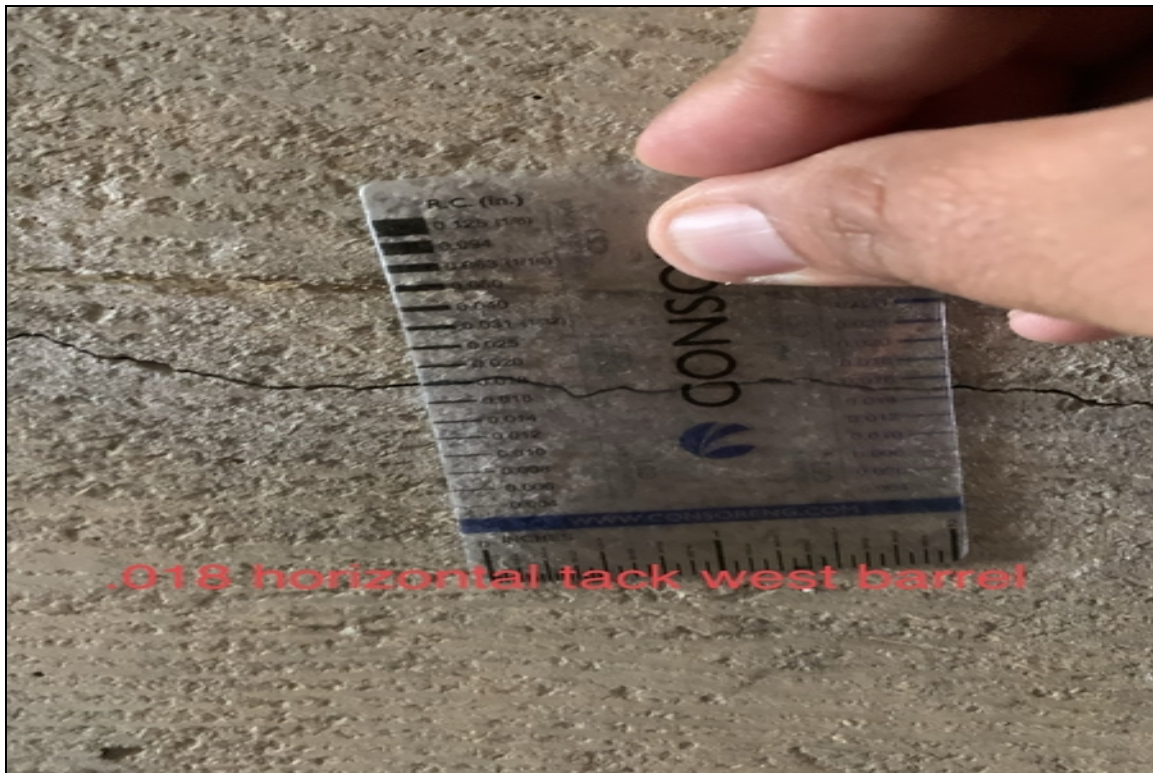
.018 horizontal crack west barrel outside wall

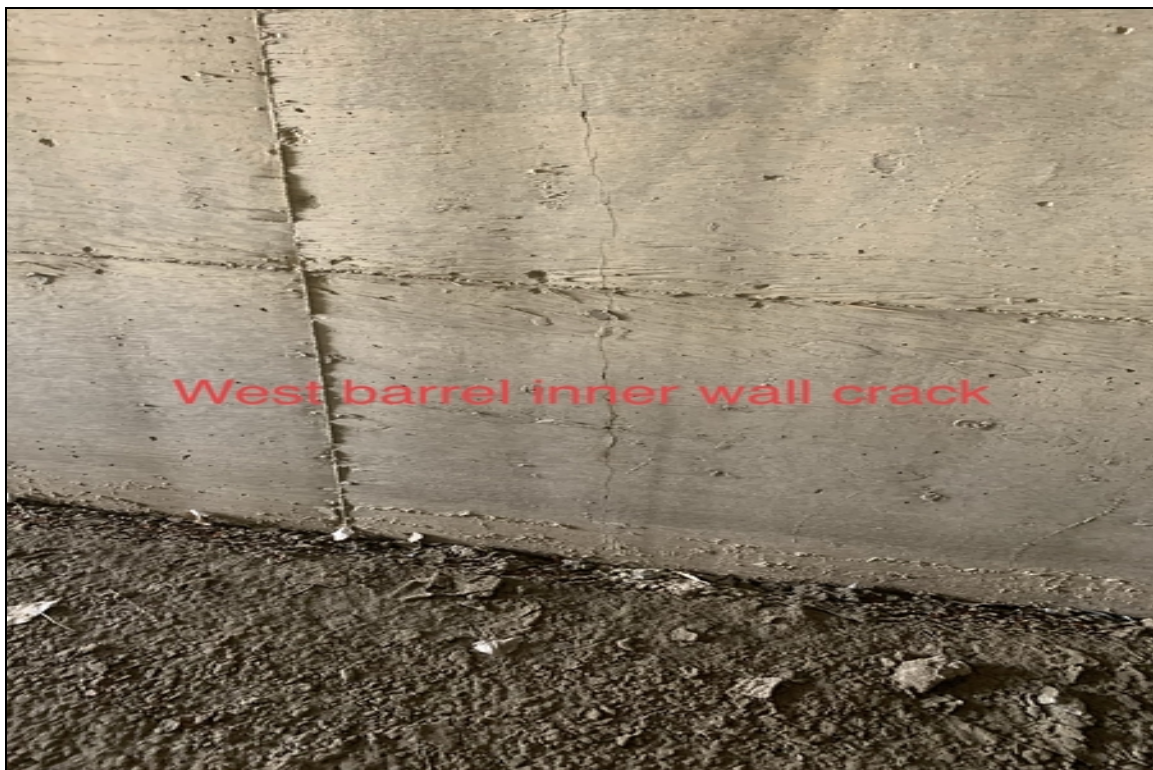
West barrel inner wall crack

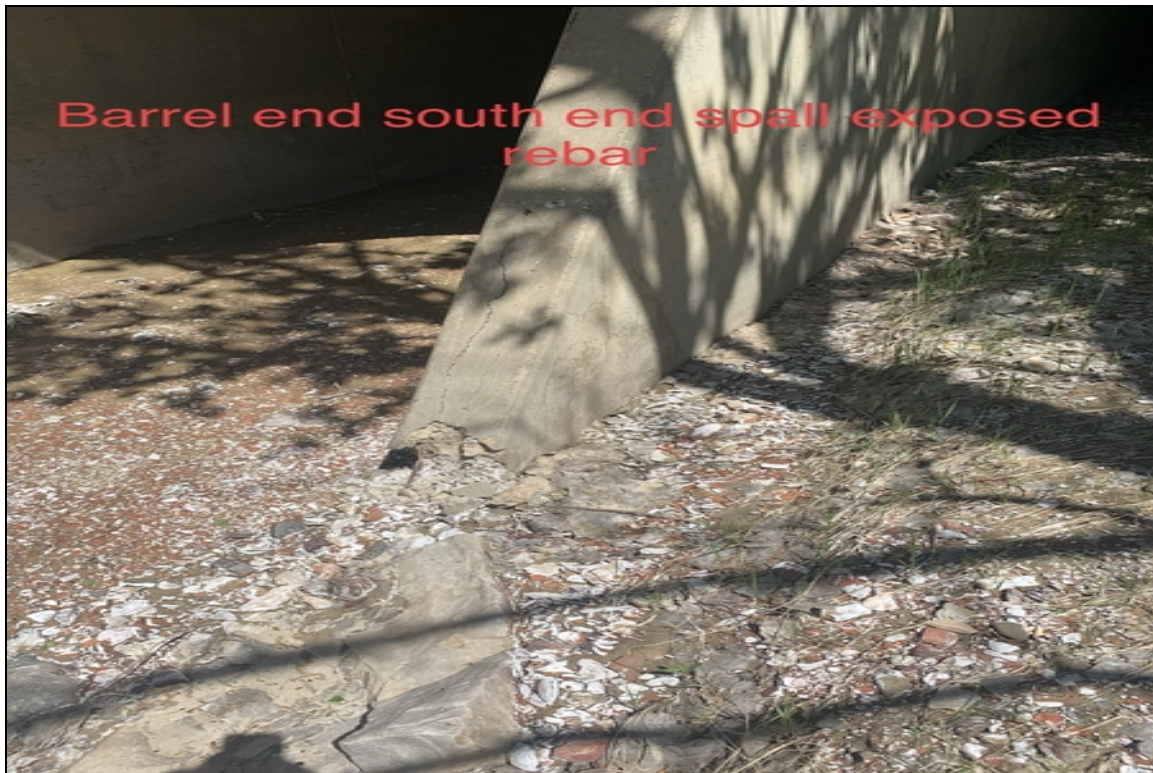
Barrel end south end spall exposed rebar

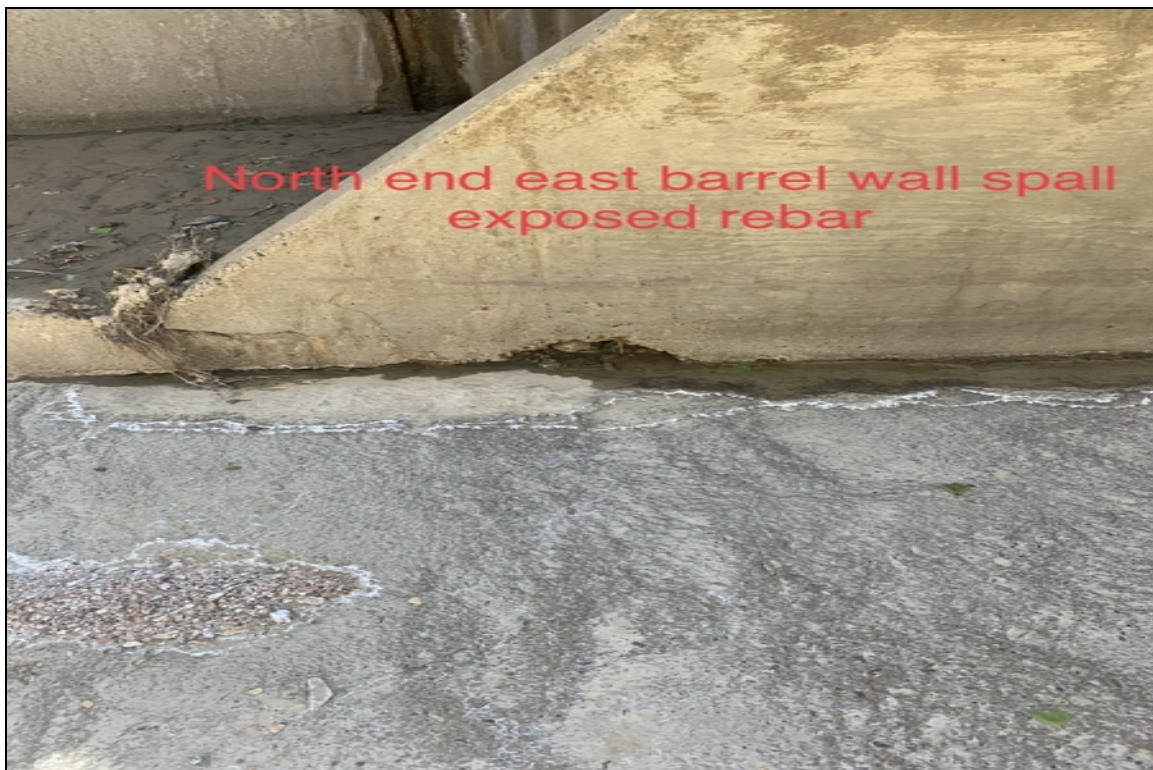
North end east barrel inner wall spall and exposed rebar

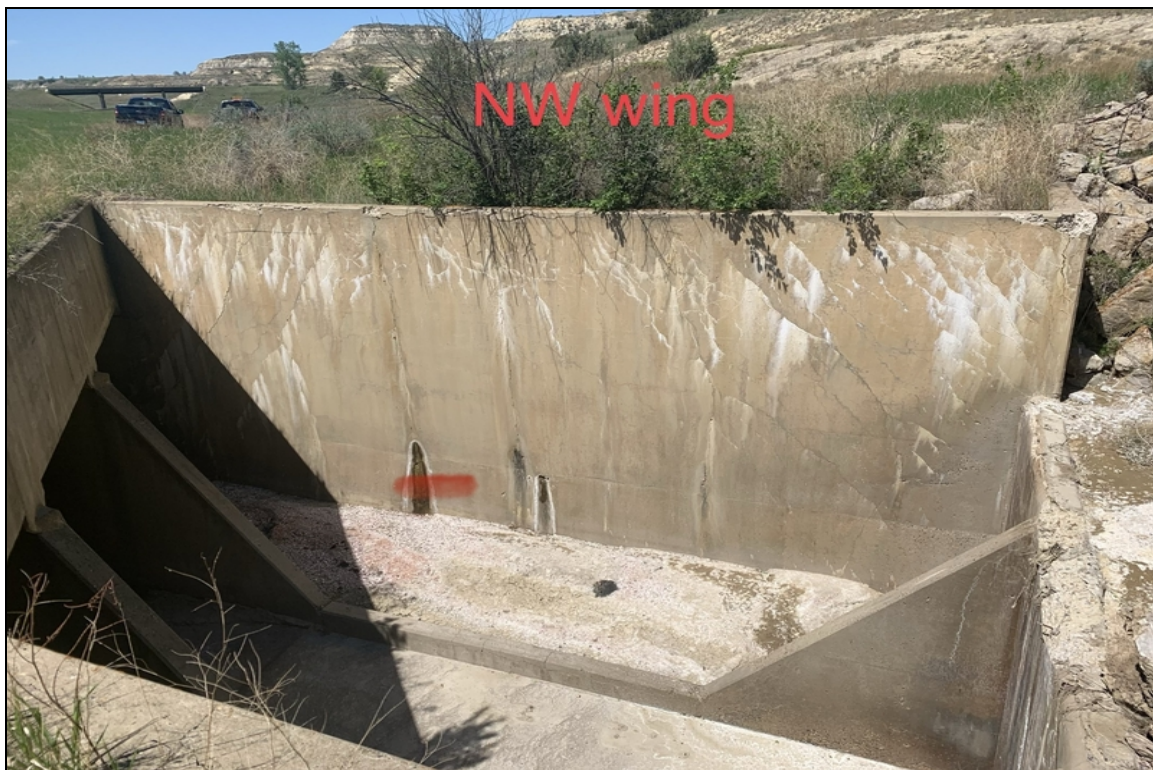
NW wing cracks

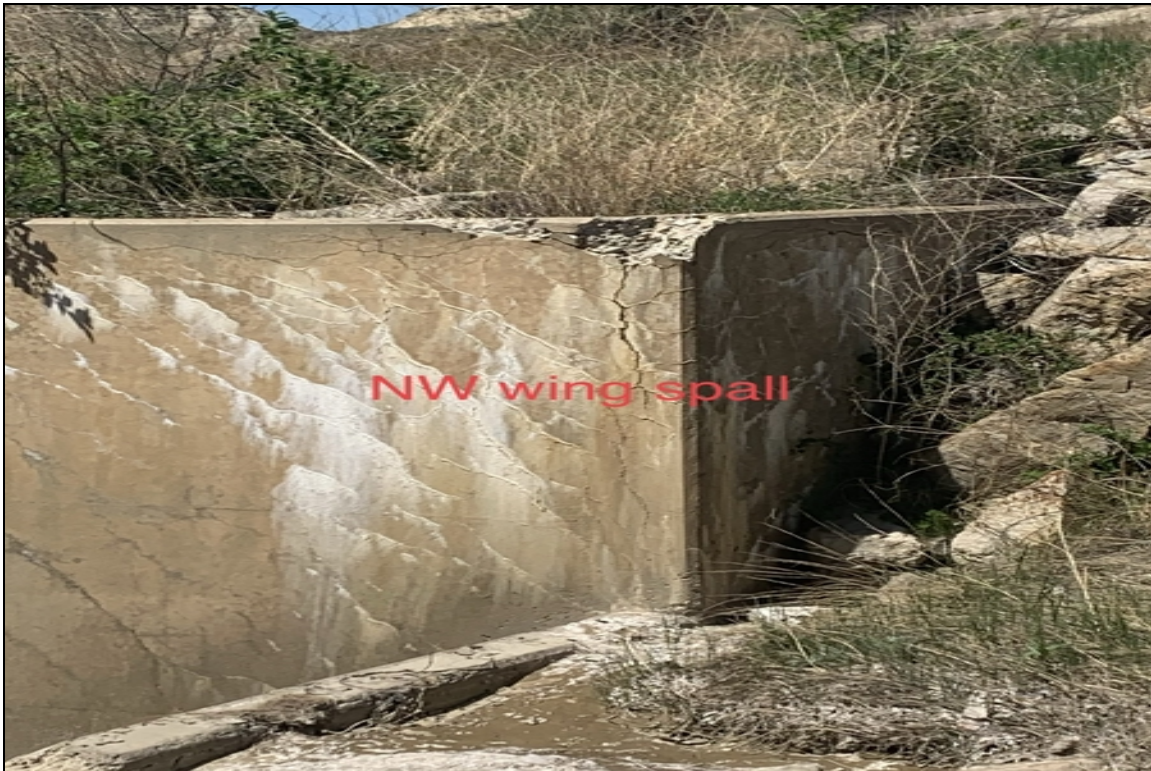
NW wing spall

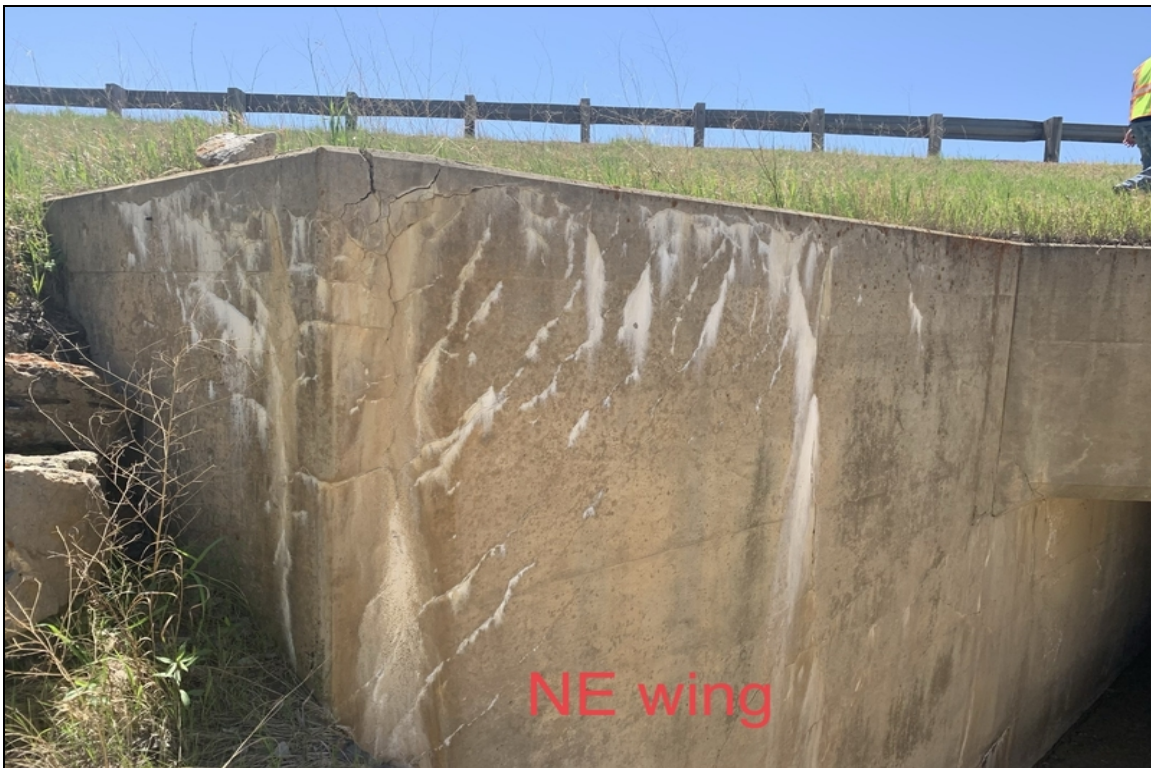
NE wing cracks

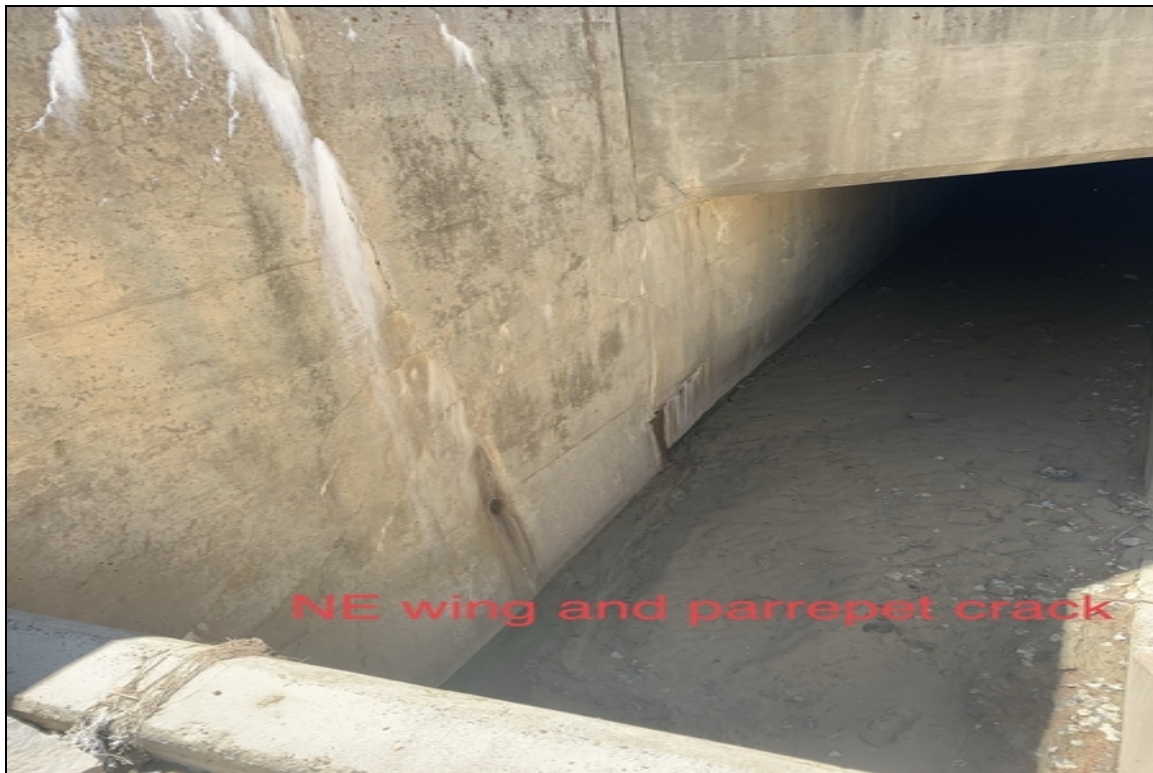
NE wing and parapet cracks
