16 WEST OF JCT. US 85

IDENTIFICATION		
(1) State Names	North Dakota	
(8) Structure Number	0094-026.422 L	
(5) Inventory Route	00094	
(2) Highway Agency District	65	
(3) County Code	Billings, North Dakota

(4) Place Code	0	
(6) Features Intersected	SHEEP CREEK	
(7) Facility Carried	INTERSTATE 94	
(9) Location	16 WEST OF JCT. US 85	
(11) Mile Point	26.416 mi	
(12) Base Highway Network	Yes

Team Lead: Jake Mertz, **Inspection Date:** May 18, 2021

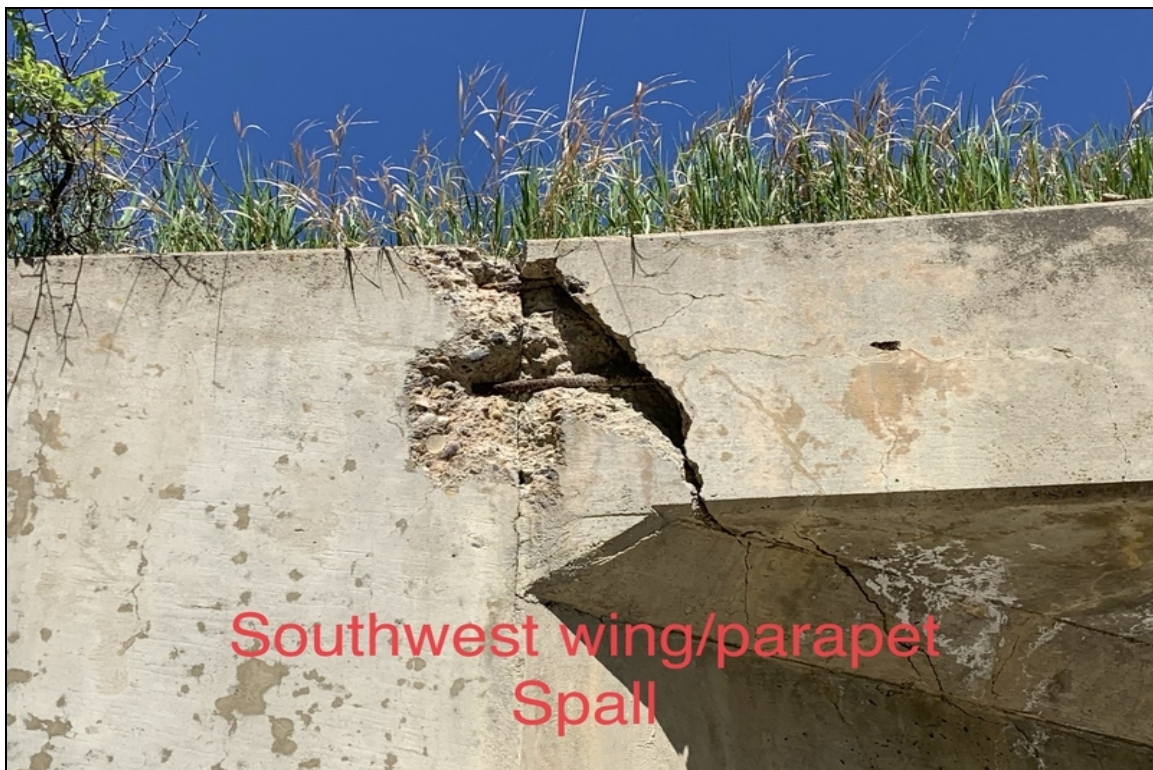
SW wing and parapet spall exposed rebar

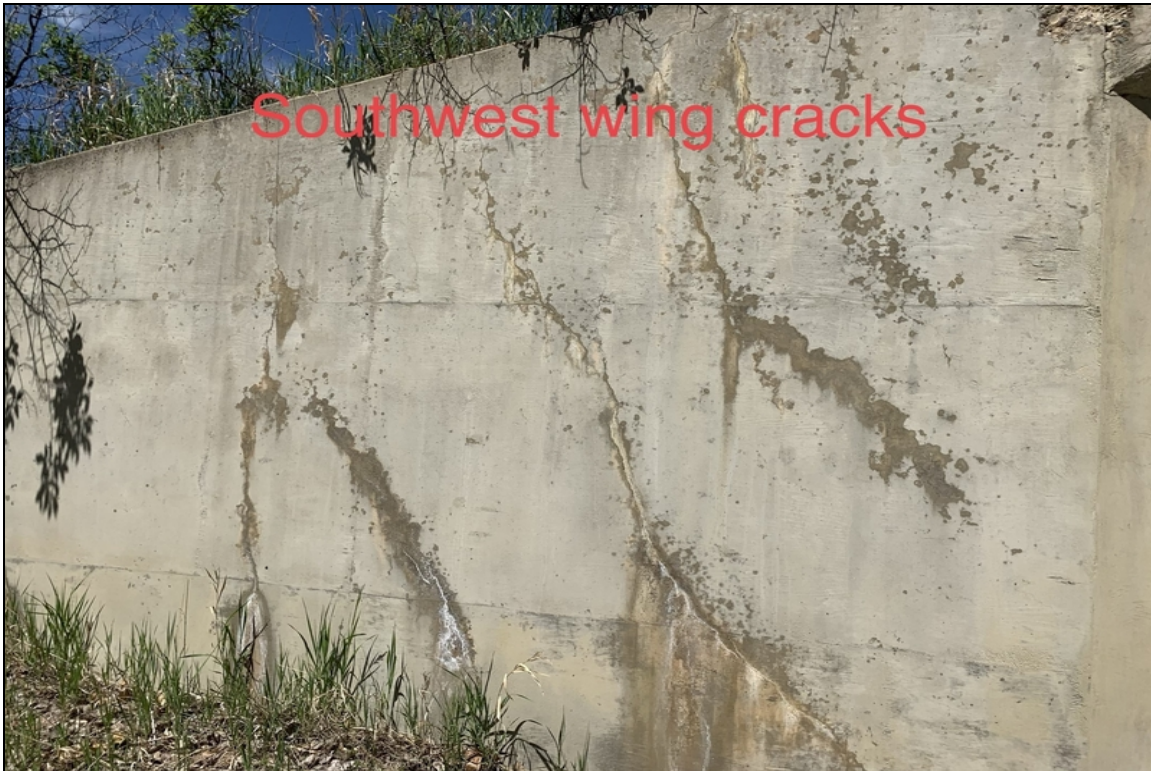
SW wing cracks

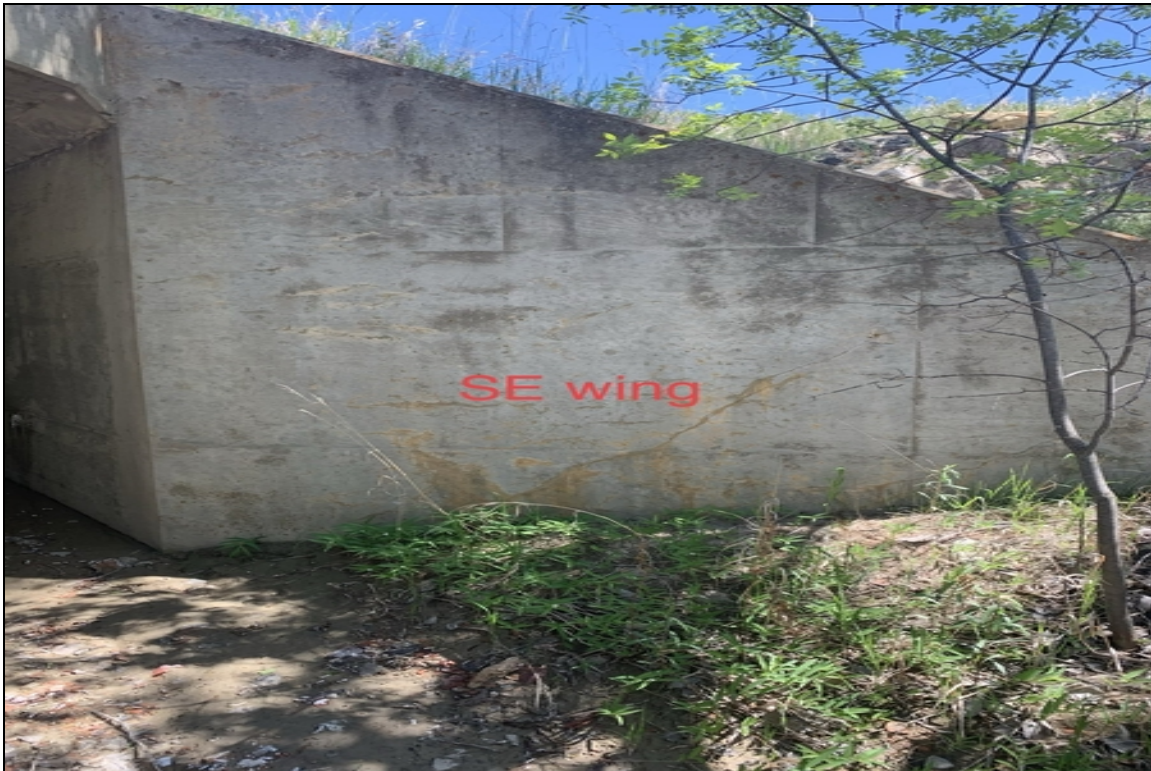
SE wing cracks

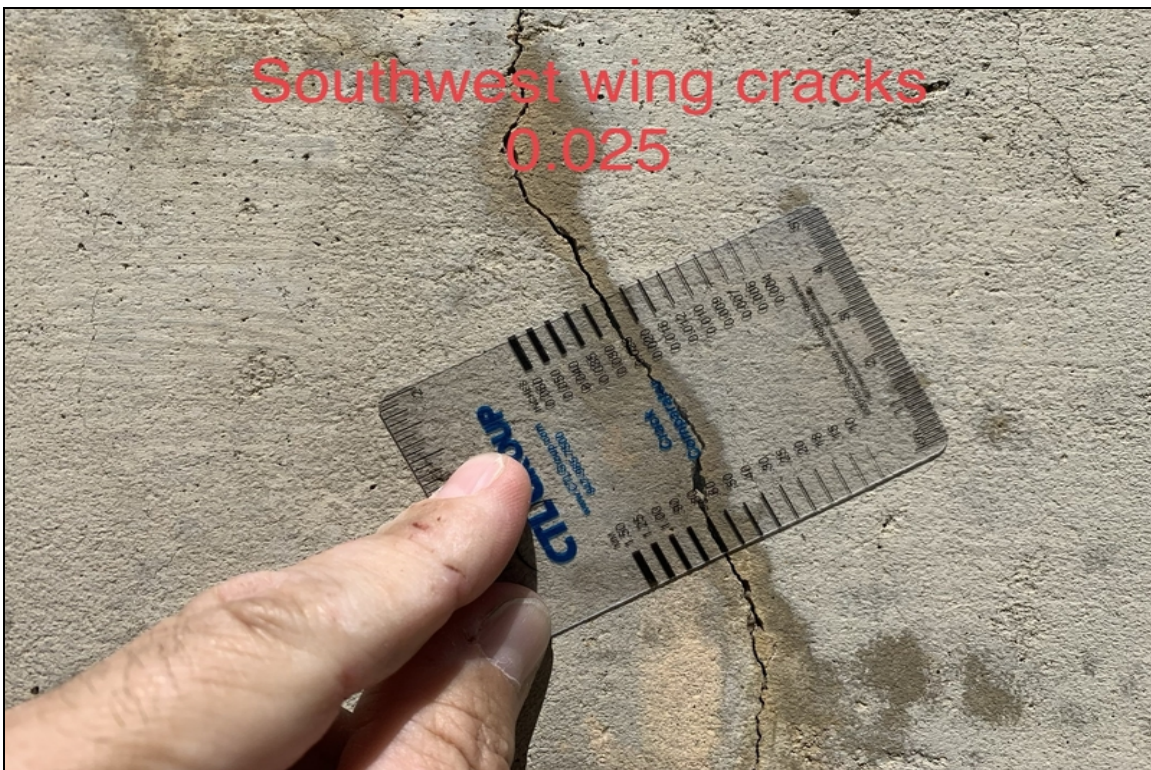
SW wing crack .025

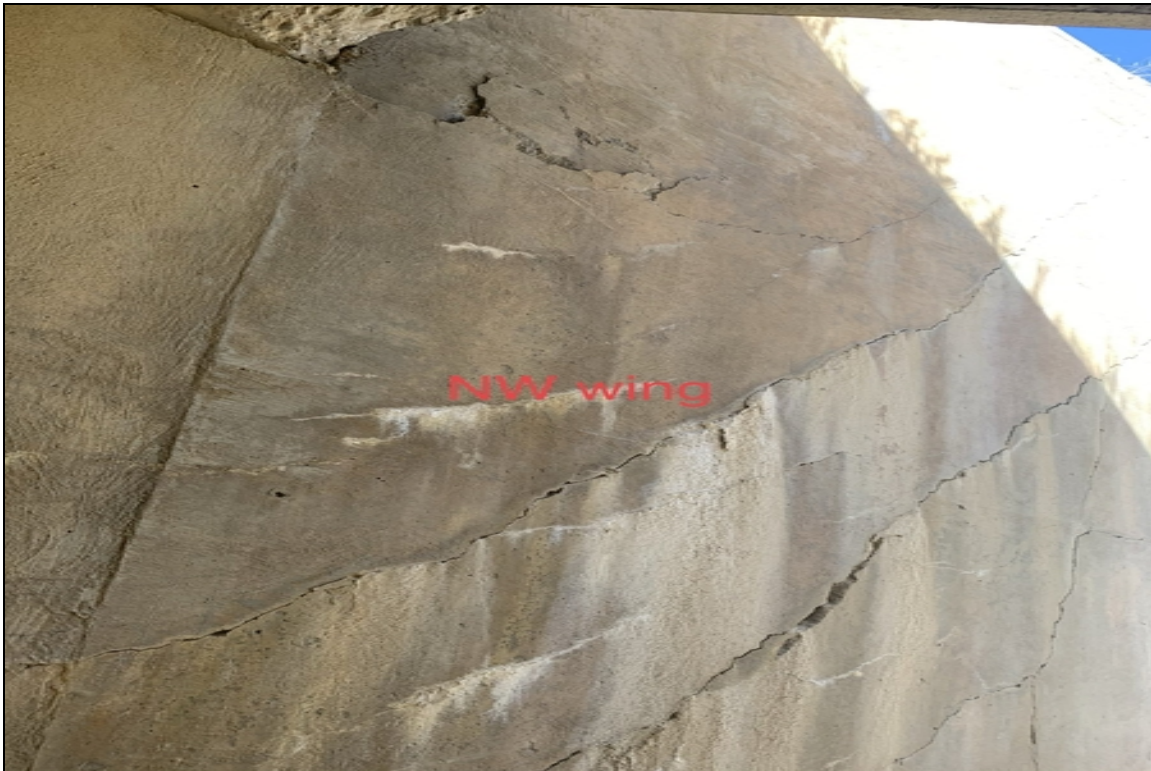
NW wing cracks

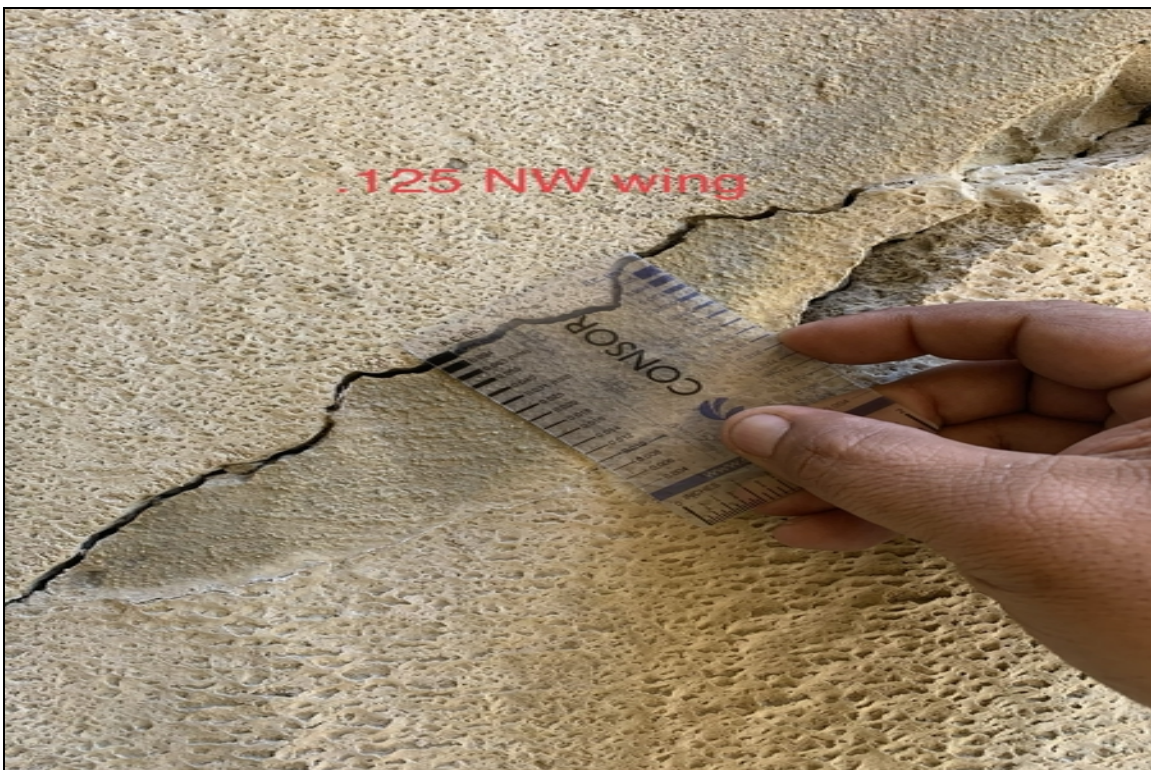
.125 NW wing crack

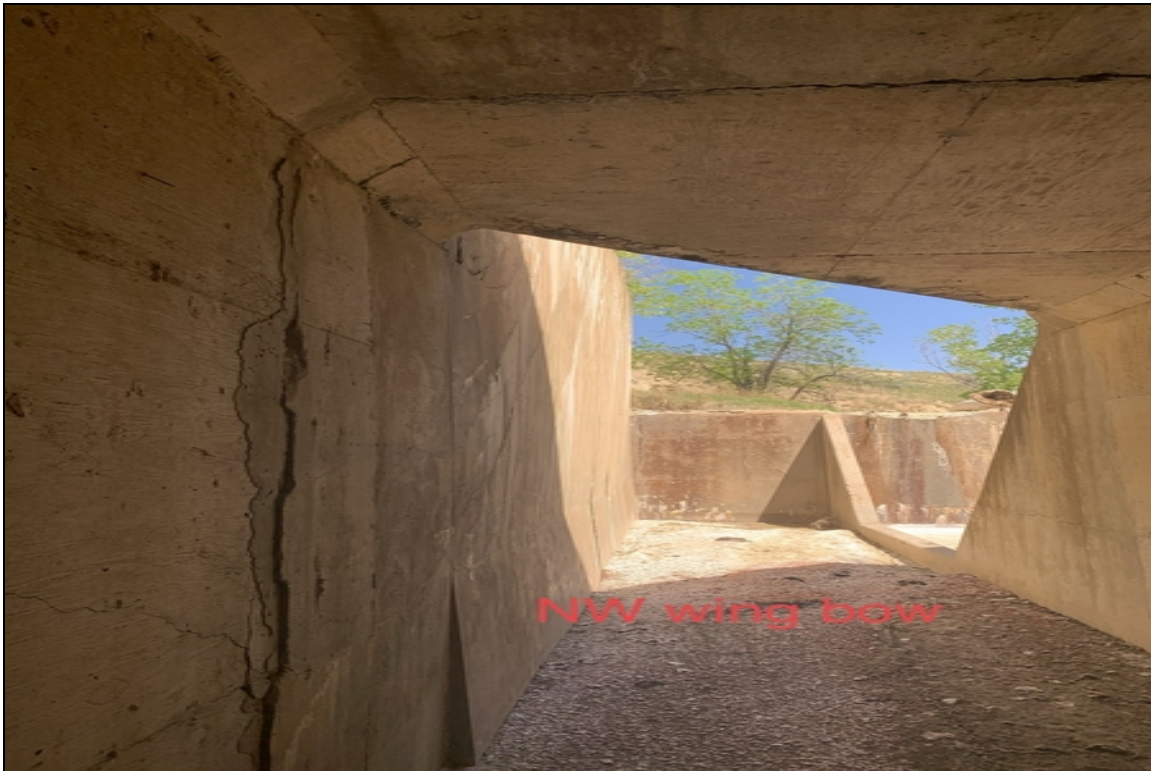
NW wing bowing inward

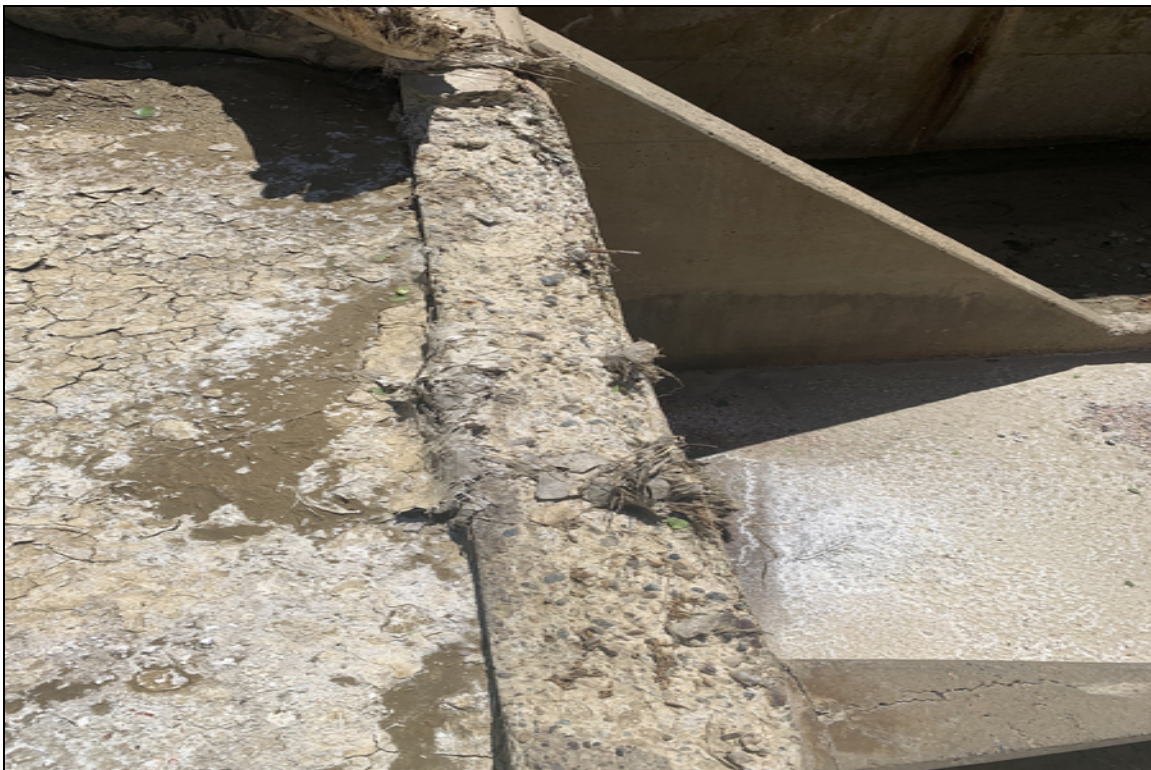
Drop inlet lip spalling

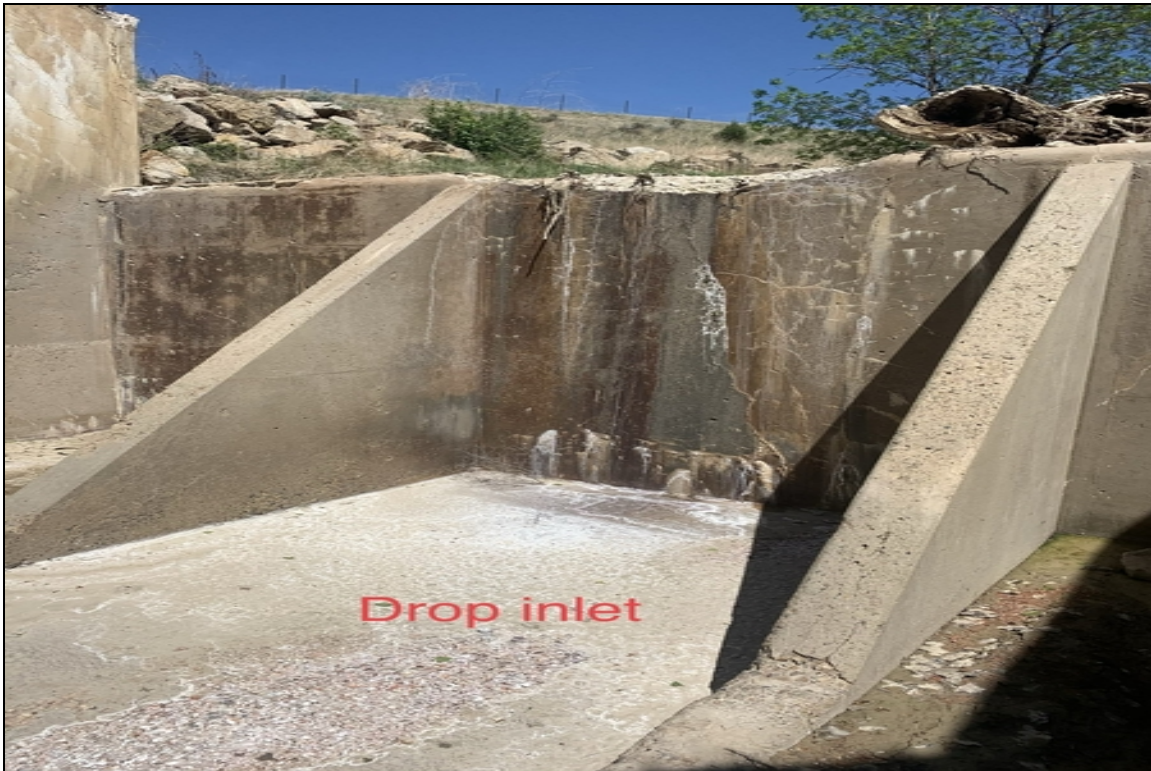
Drop inlet cracking

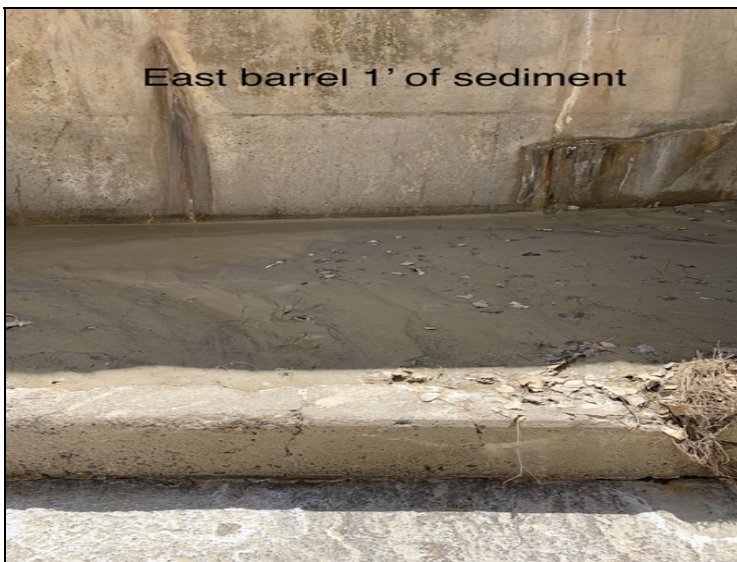
All 3 barrels have between 6 inches to 1.5 feet of sediment.

East barrel 1' sediment

Recommend removing the sediment from the barrels with a skid steer. 18May2021
