Route:00200 Log:163.127

6 NORTH OF 200A

| IDENTIFICATION | |
|---|--|
| (8) Structure Number | 0200-163.162 |
| Culvert | TRIPLE, 10X12X113' RCB |

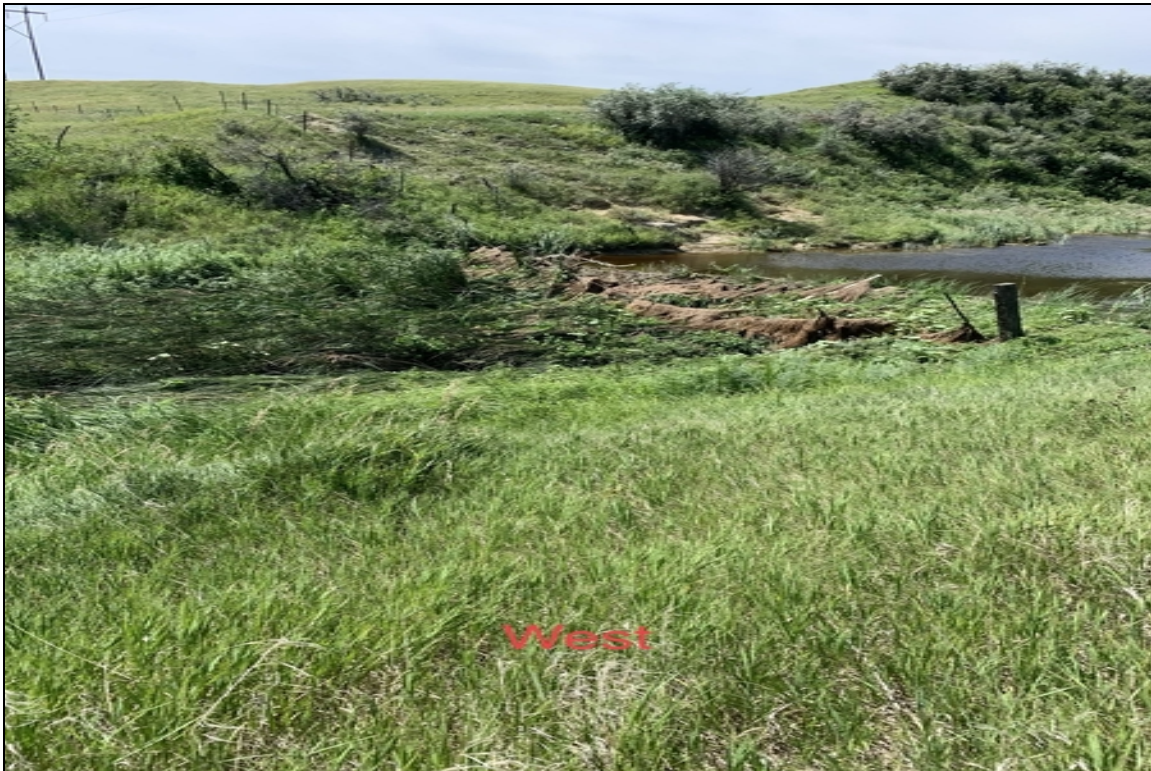
4/12/2017: SETTLEMENT IN MIDDLE. Joints open 1 1/2" wider on bottom than top typical all joints. Fence on the west end is collecting debris and restricting flow. Efflorescence on outside of the box on both east and west ends, headwalls, wings, and inner walls.

West side earthen dam build up

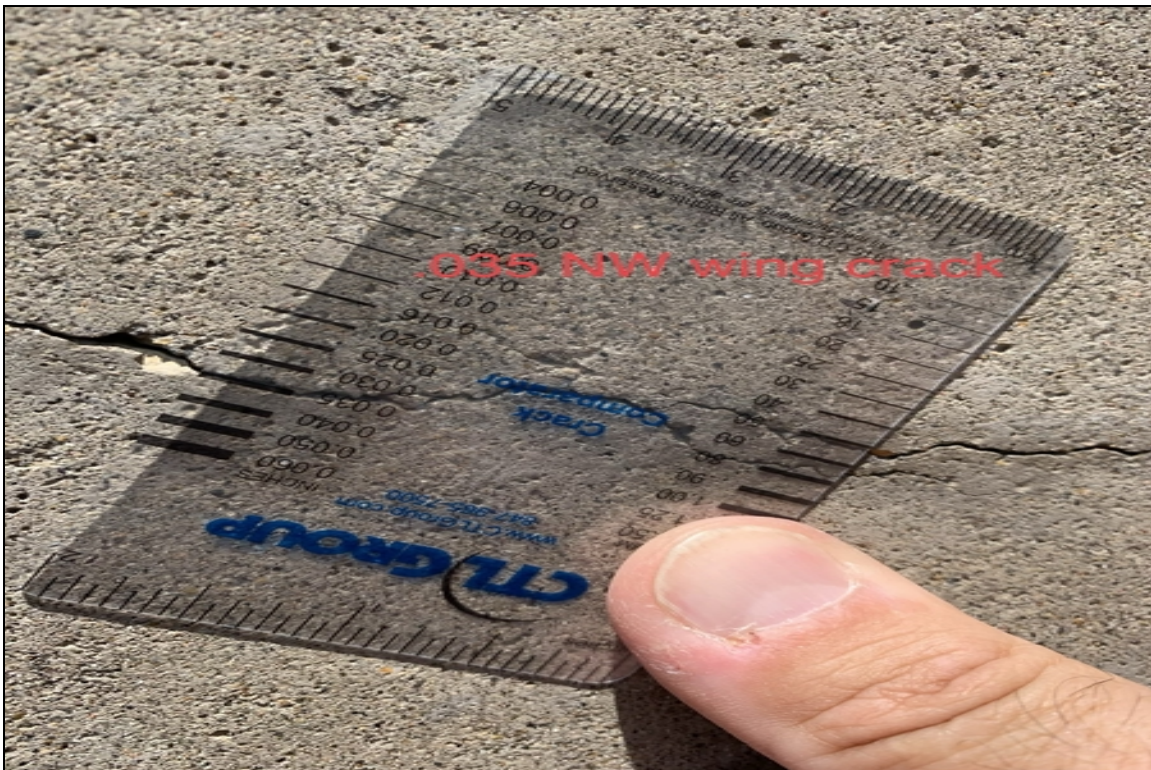
| ELEM | DESCRIPTION | UNITS | TOTAL | CS1 | CS2 | CS3 | CS4 |
|---|--|---|---|---|---|---|---|
| (8401-1130) | All four wings have some light cracking - 4/8/2019 The cracks in the wings range from 0.010 to 0.030 in width and are diagonal in nature. 23July2020 | | | | | | |

.035 NW wing crack

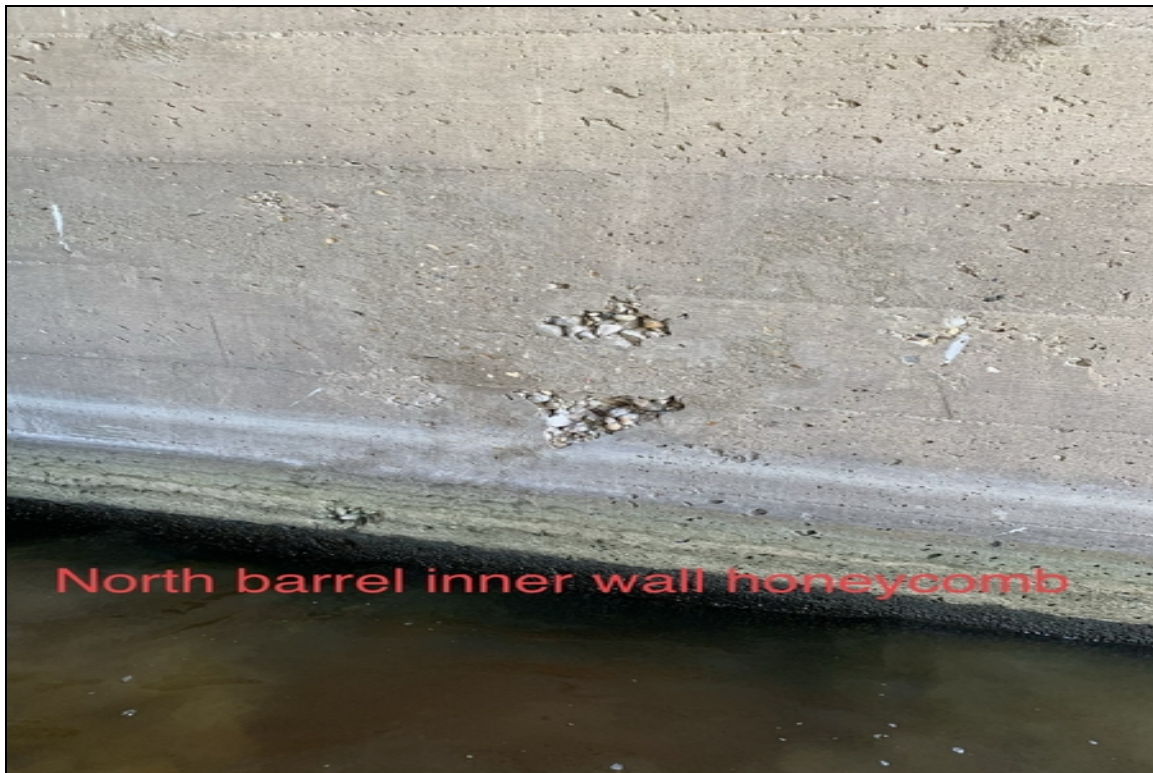
North barrel inner wall honeycomb

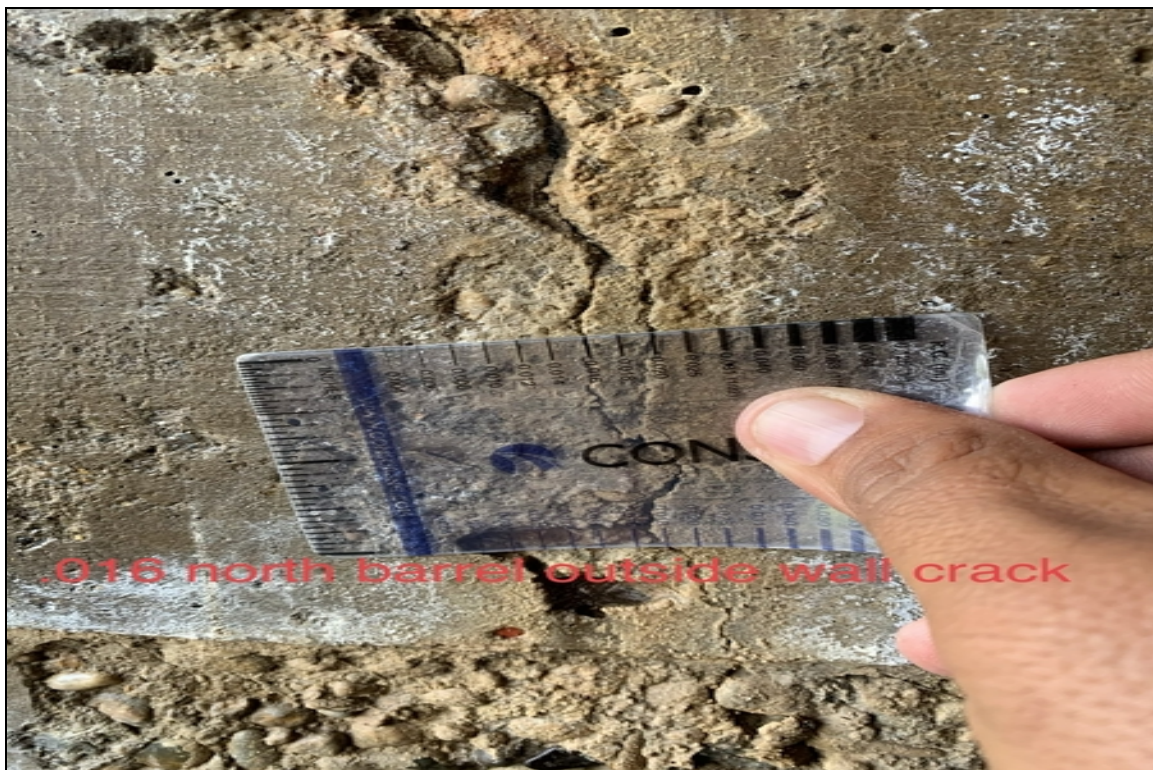
| ELEM | DESCRIPTION | UNITS | TOTAL | CS1 | CS2 | CS3 | CS4 |
|---|--|---|---|---|---|---|---|
| (241) | The West joint is open approximately 2 inches in all three barrels with efflorescence and fill material entering in through the joint. 23July2020 (241-1130) Walls have vertical cracking and the roof at he ends has some cracking with efflorescence - 4/8/2019 Each barrel has approximately 10 cracks in each. These cracks range fro approximately 0.012 to 0.040 in width. 23July2020 | | | | | | |

.016 north barrel outside wall crack

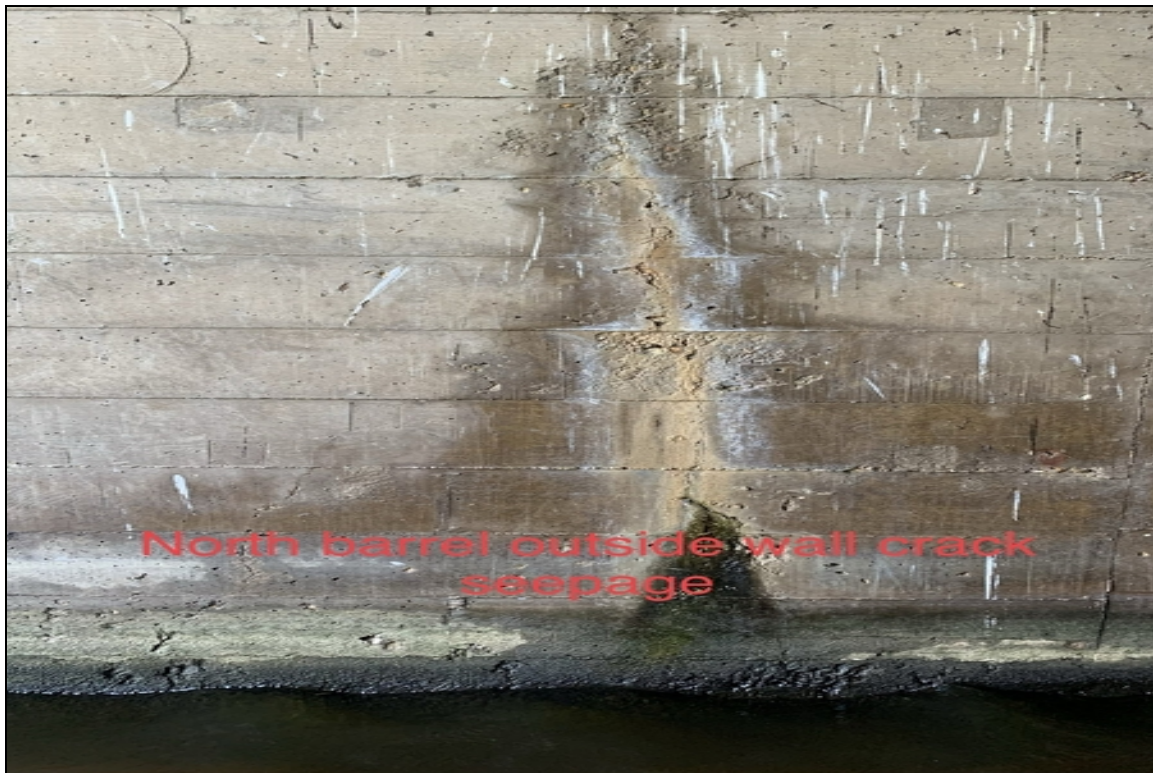
North barrel outside wall crack and seepage

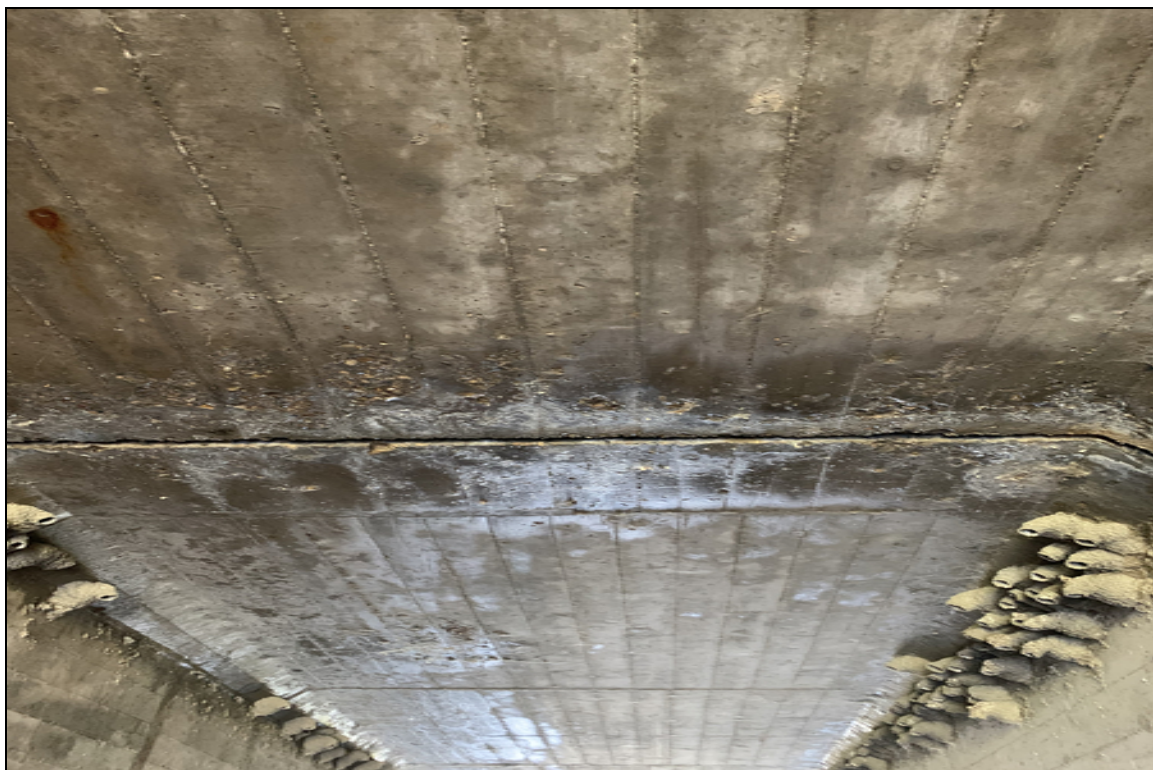
Roof joint

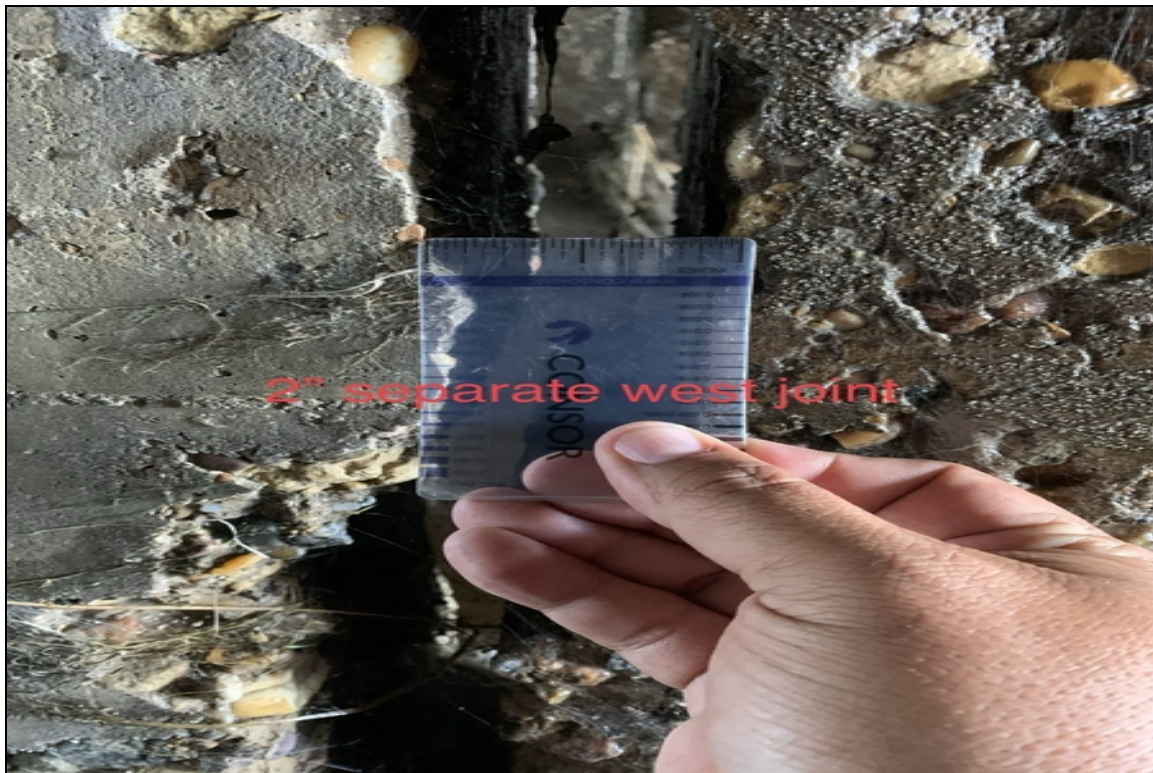
The West joint is open approximately 2 inches in all three barrels with efflorescence and fill material entering in through the joint. The East joint is open approximately 1.5 inches in all three barrels with efflorescence and fill material entering through the joint. 23July2020

2" separation west joint

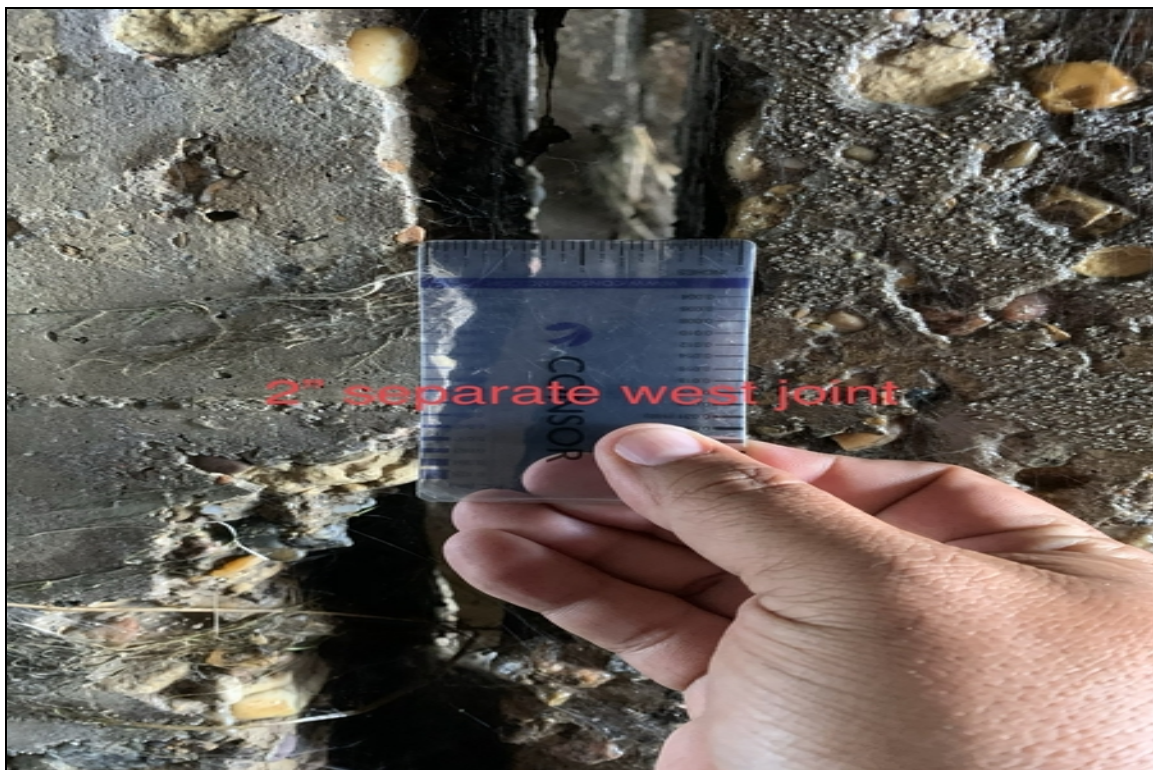
2" separation west joint

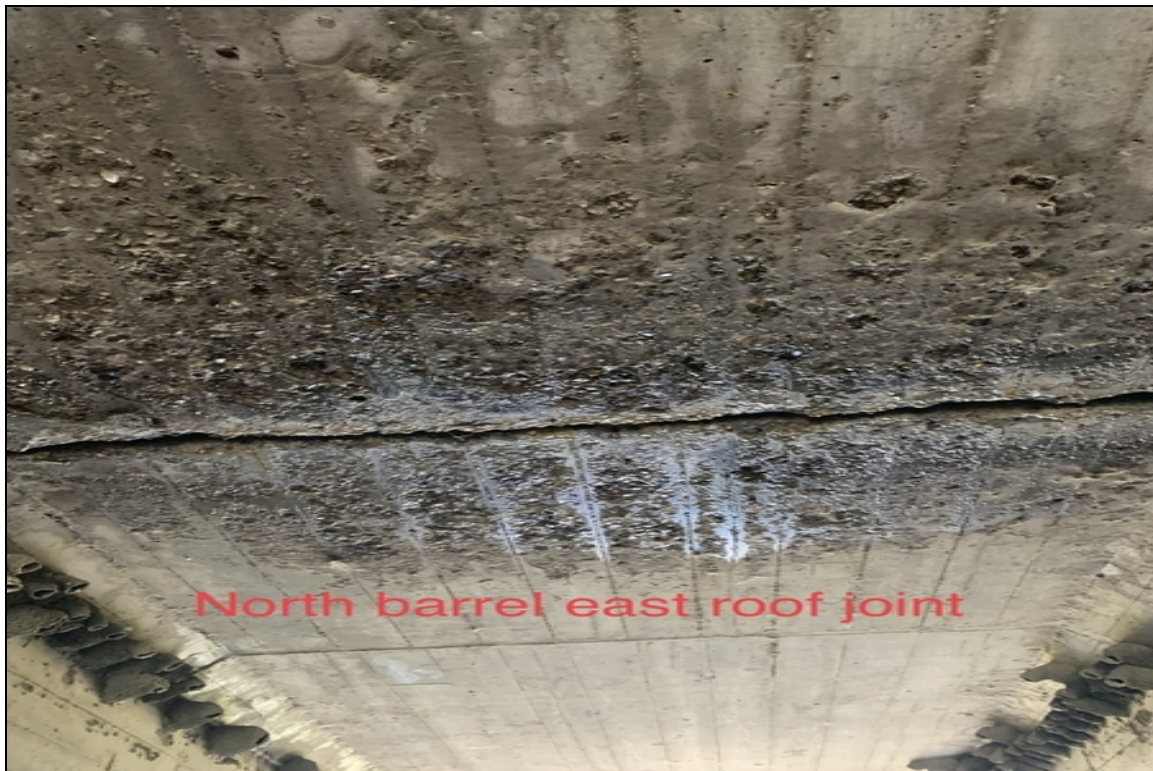
North barrel east roof joint

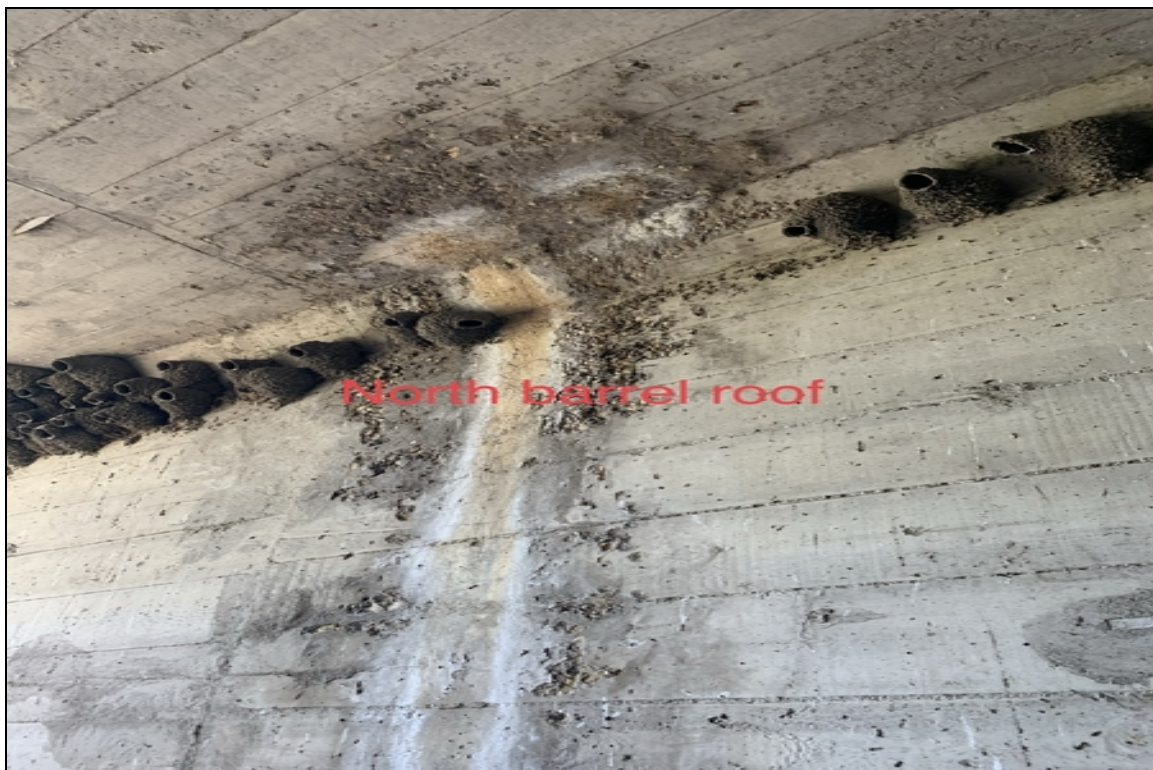
North barrel roof

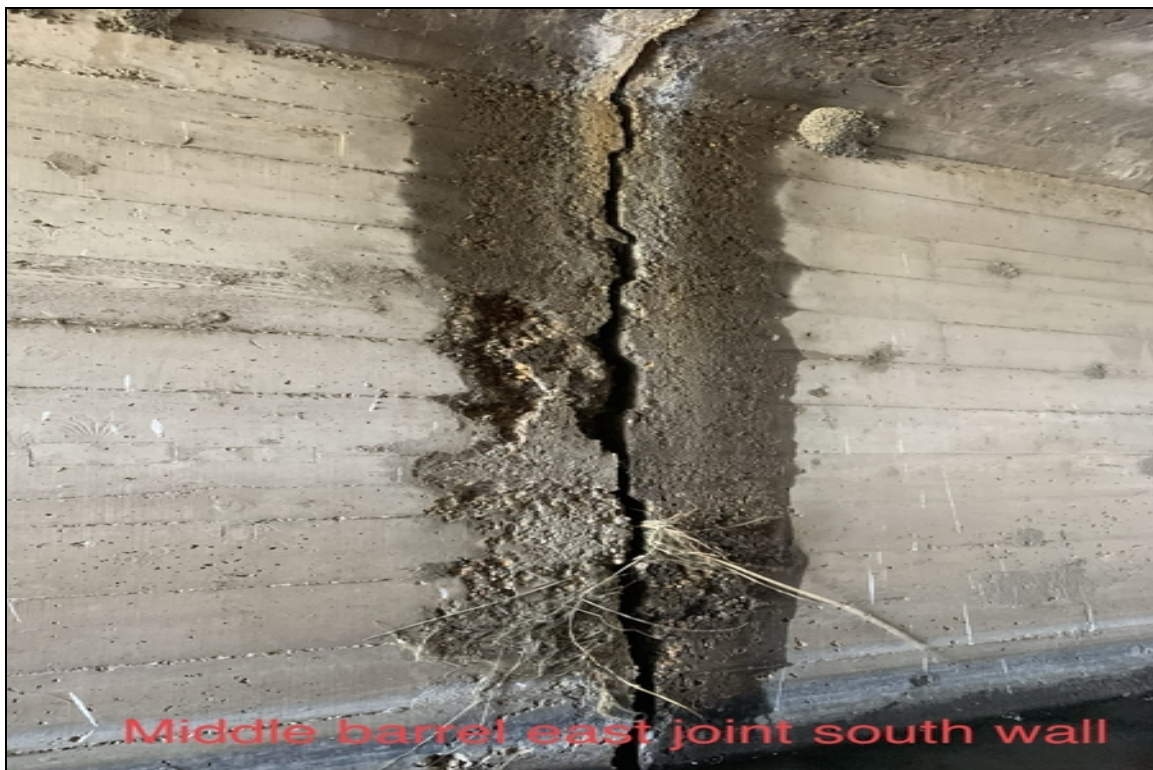
Middle barrel east joint south wall

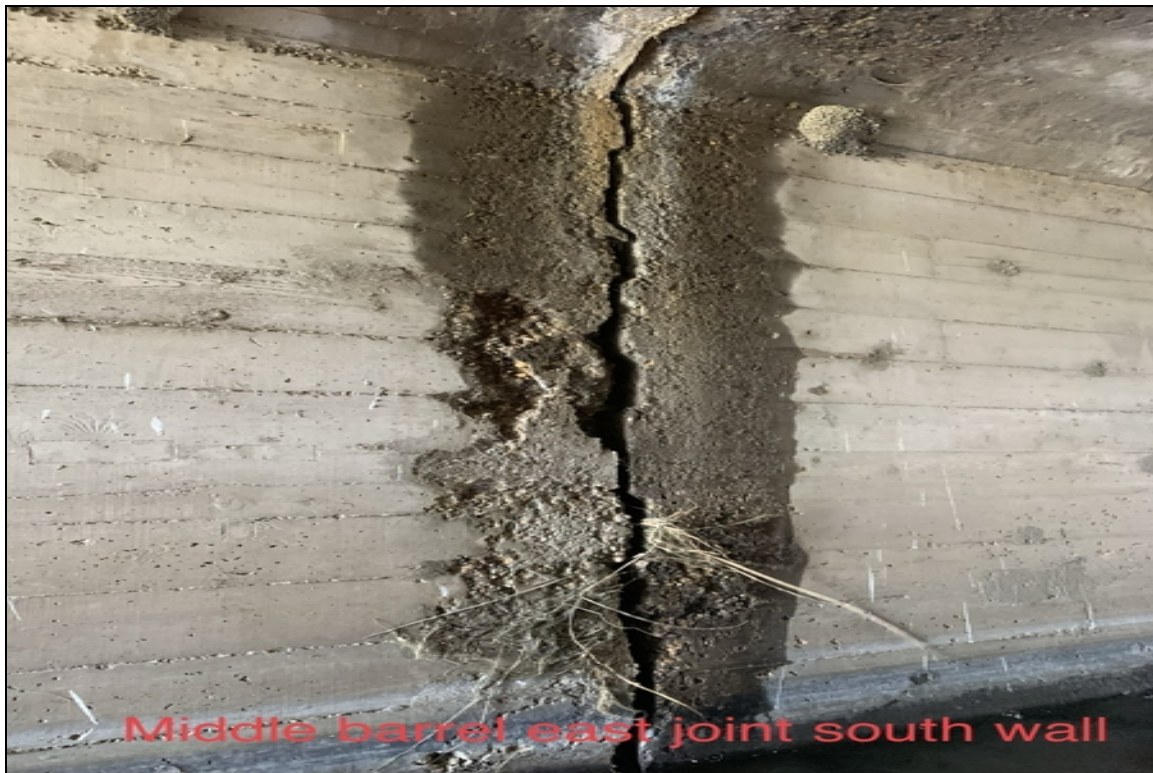
Middle barrel east joint south wall

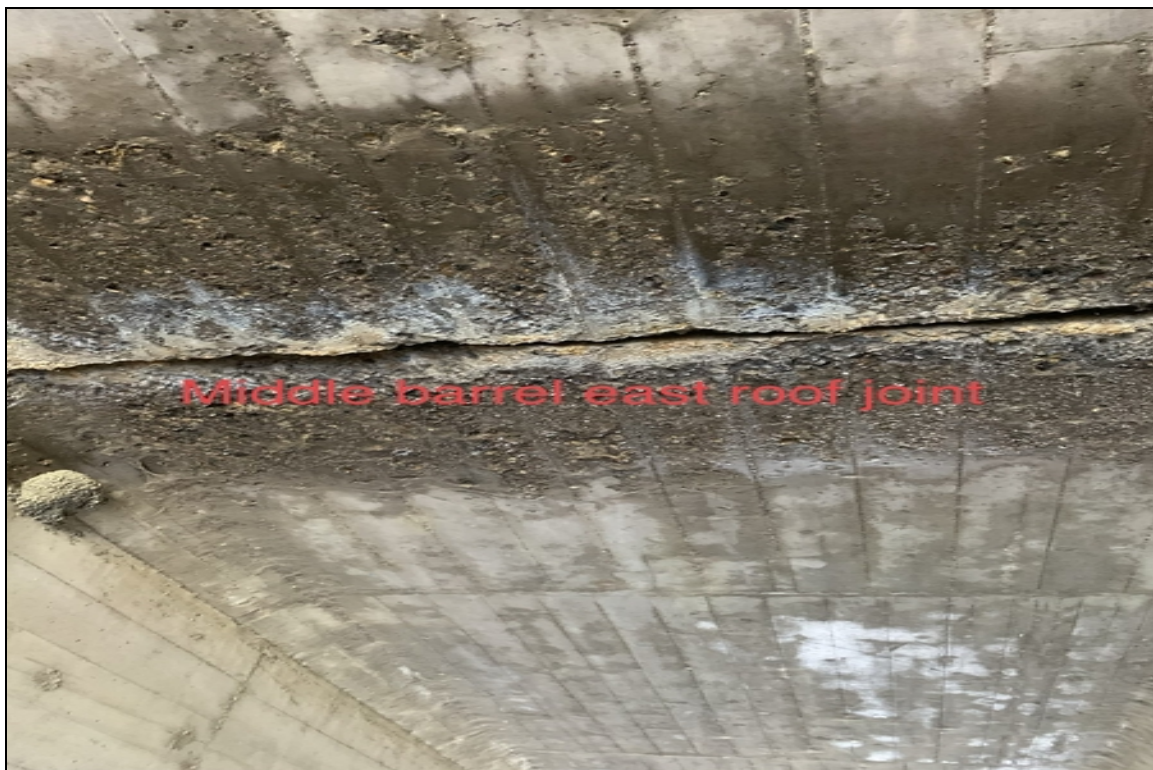
Middle barrel east roof joint

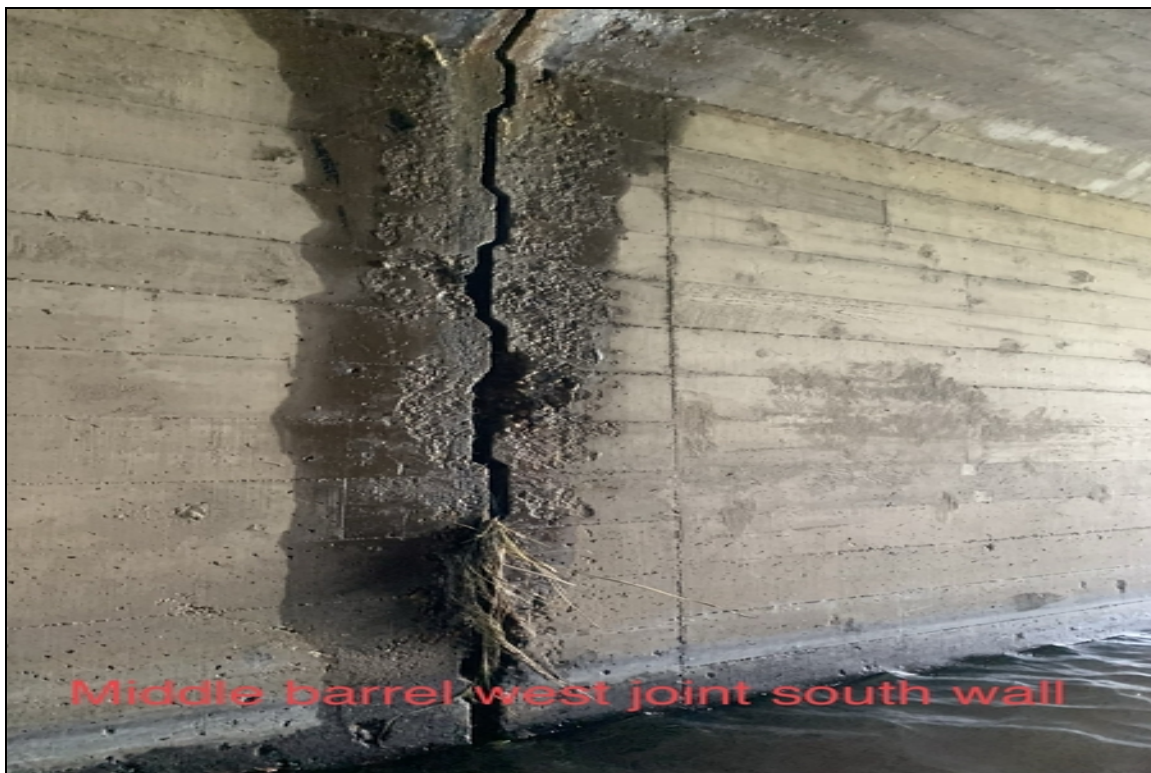
Middle barrel west joint south wall

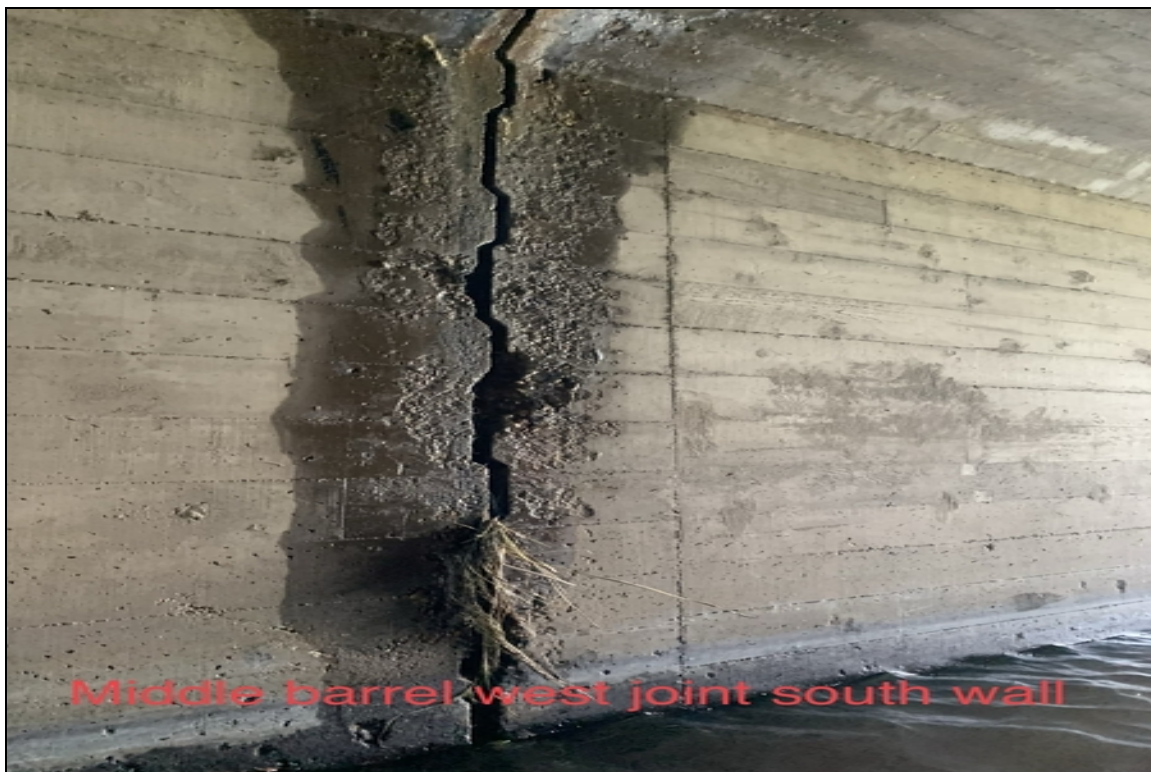
Middle barrel west joint south wall

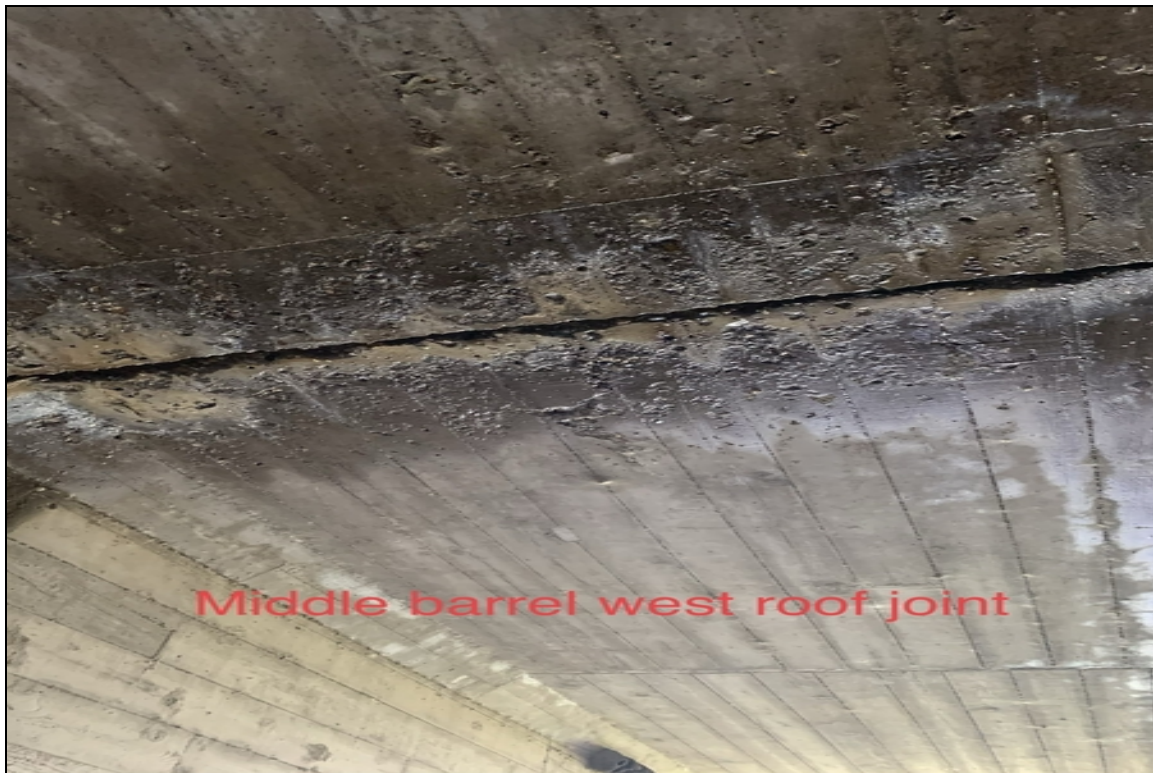
Middle barrel west roof joint

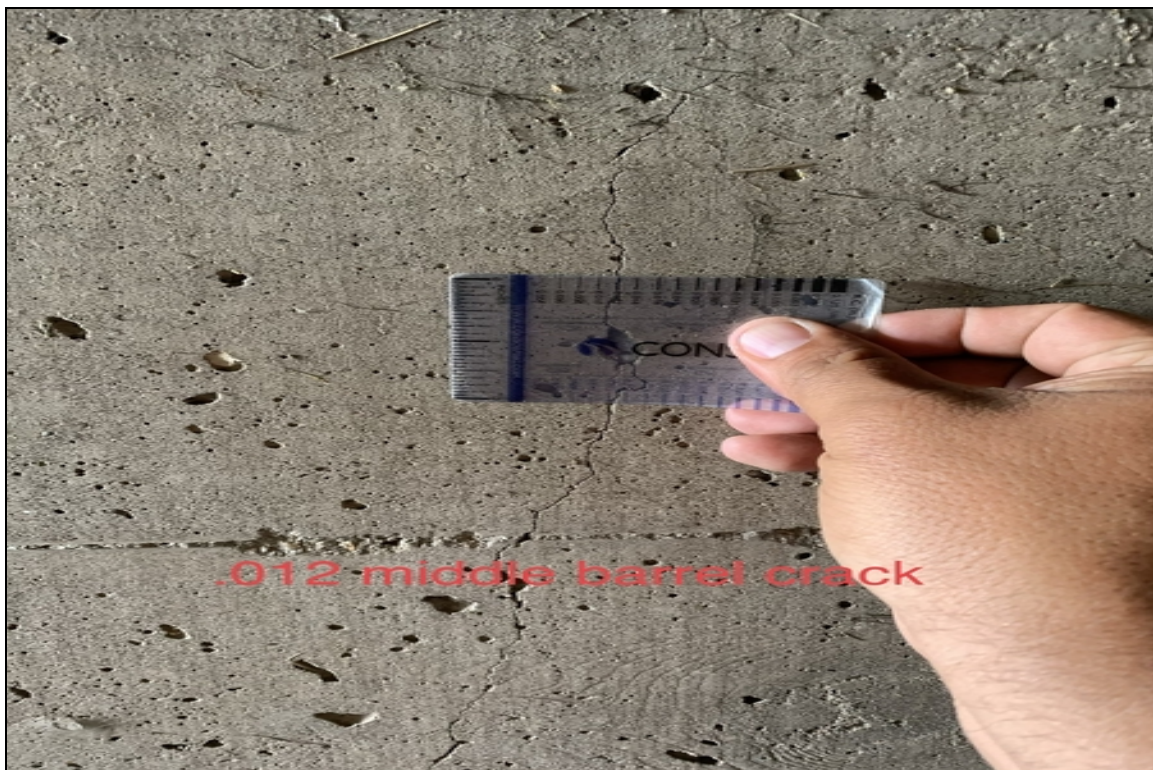
.012 middle barrel crack

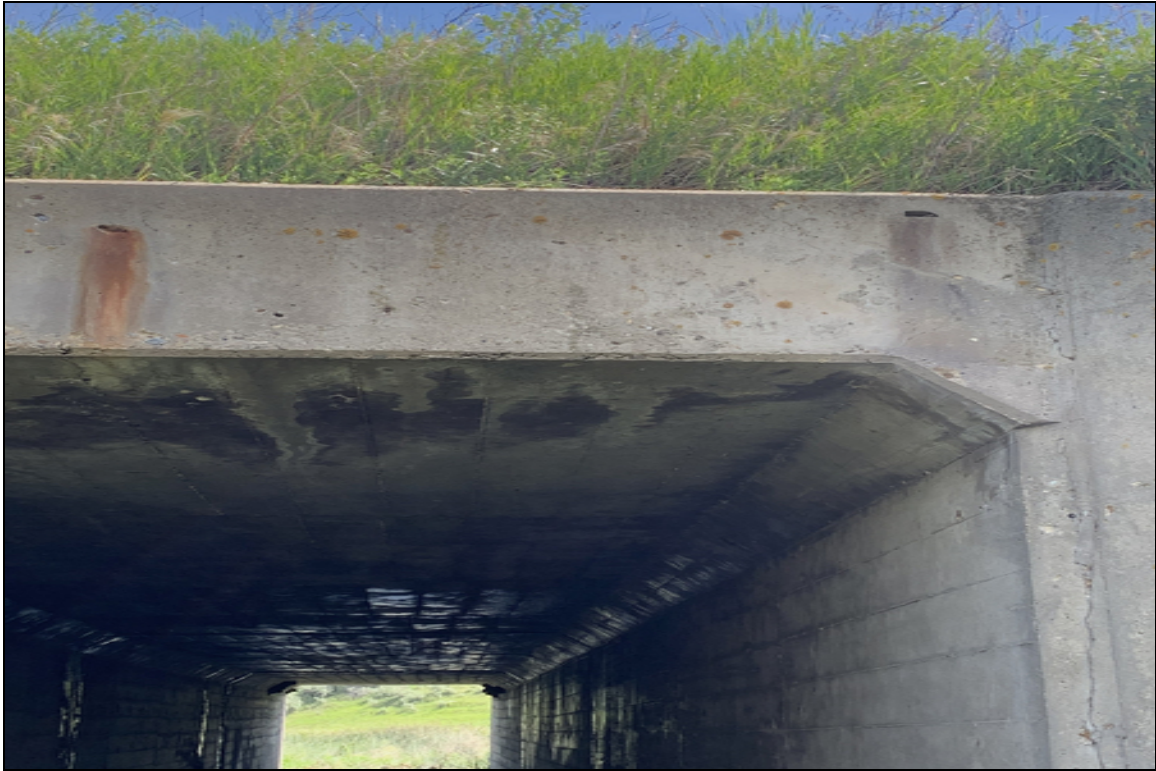
| ELEM | DESCRIPTION | UNITS | TOTAL | CS1 | CS2 | CS3 | CS4 |
|---|--|---|---|---|---|---|---|
| (8402-1130) | Both headwall are cracking where they meet the wings - 4/8/2019 No change to previous entry. 23JULY2020 | | | | | | |

South headwall crack

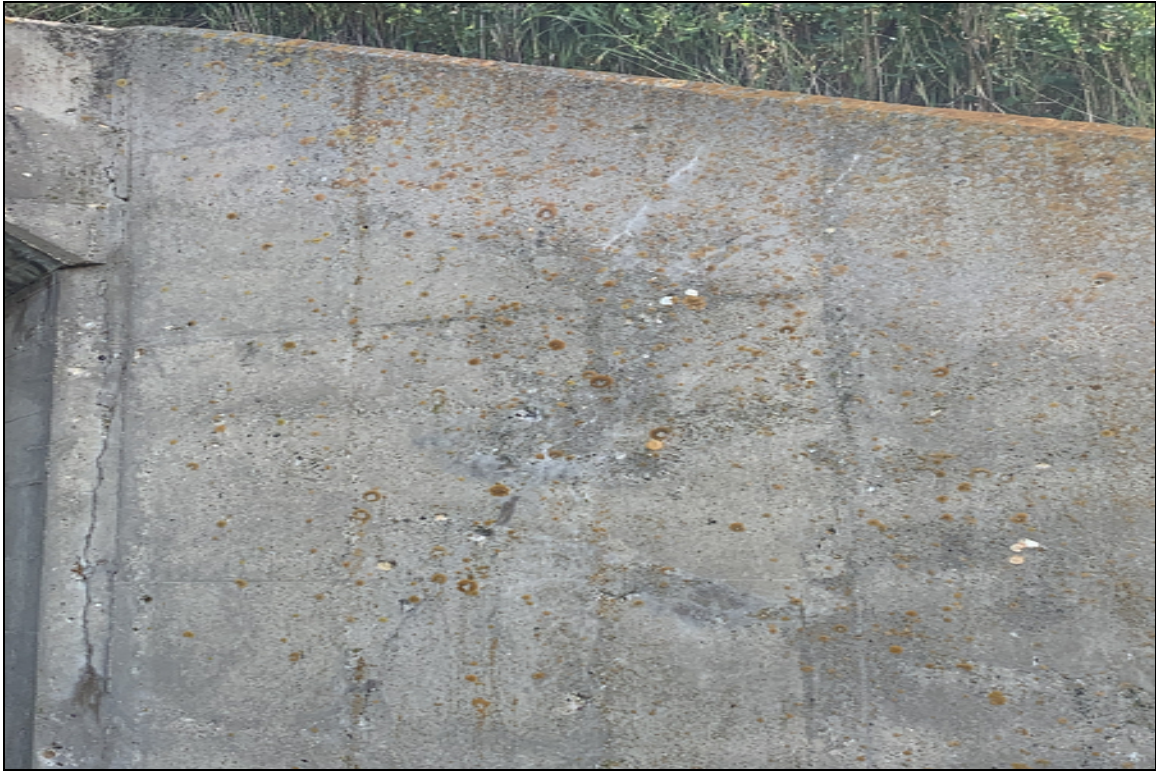
SW wing crack

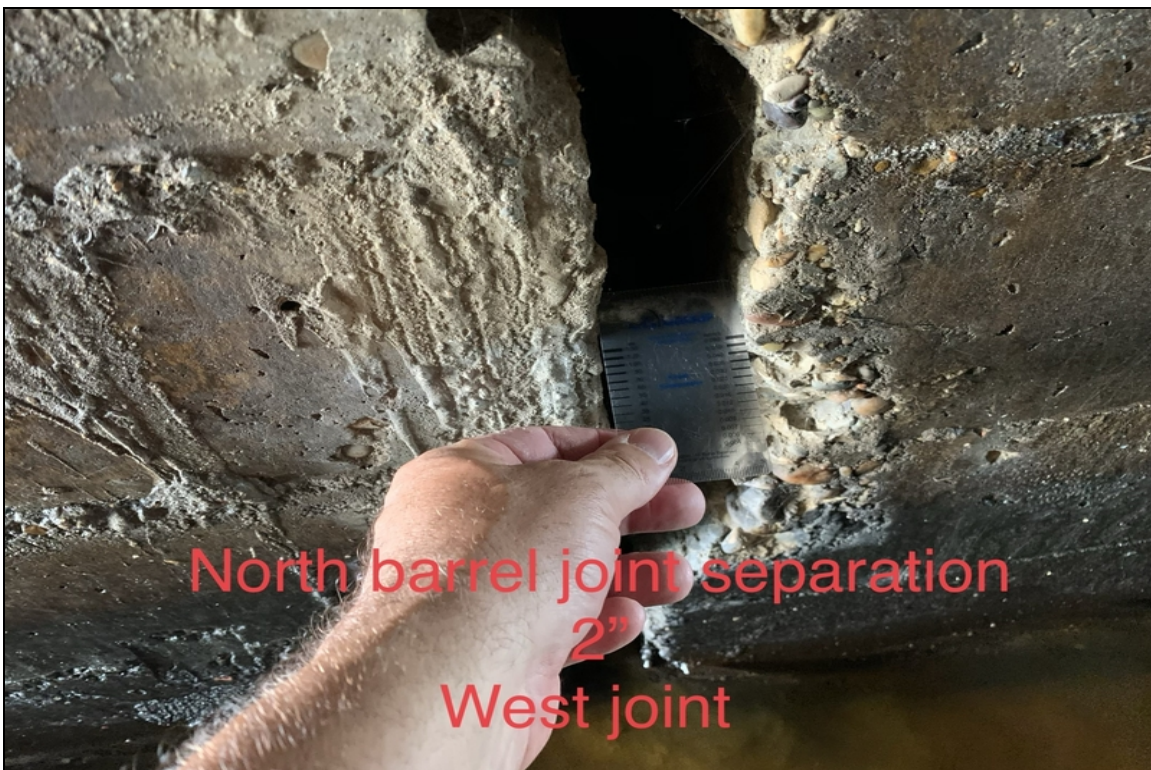
North barrel joint separation 2" west joint

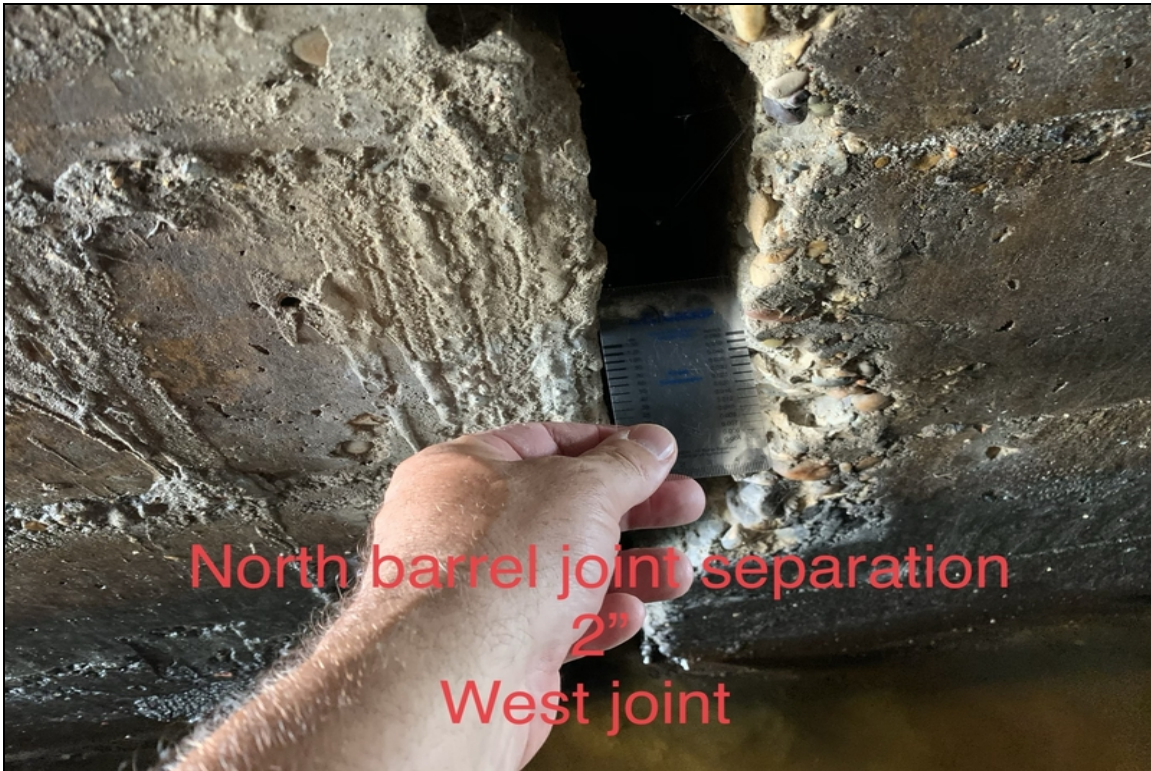
North barrel joint separation 2" west joint

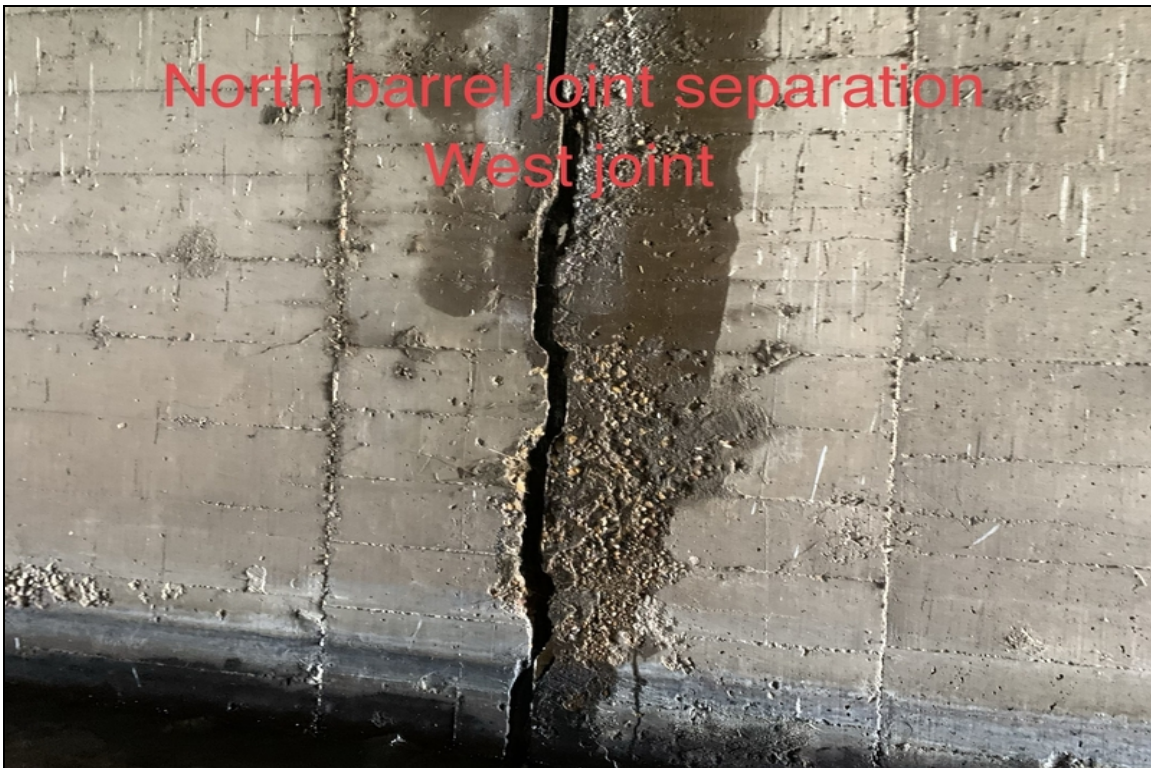
North barrel joint separation west joint

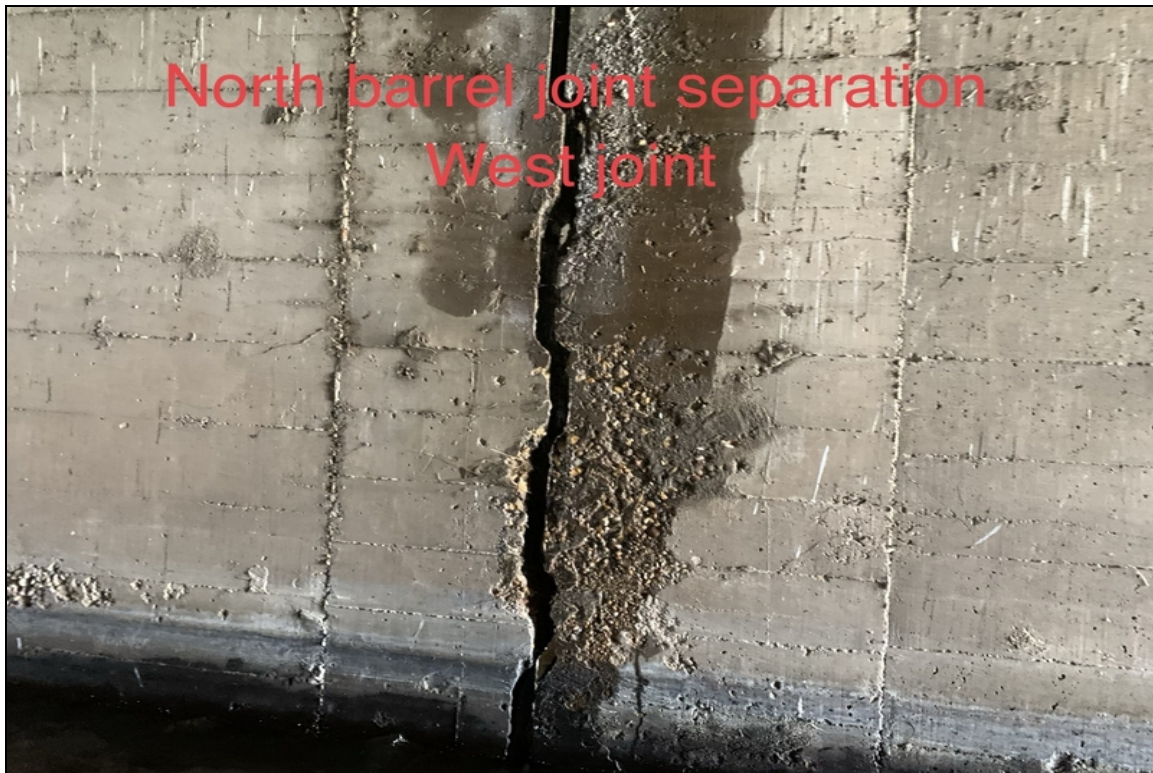
North barrel joint separation
West joint

North barrel joint separation west joint

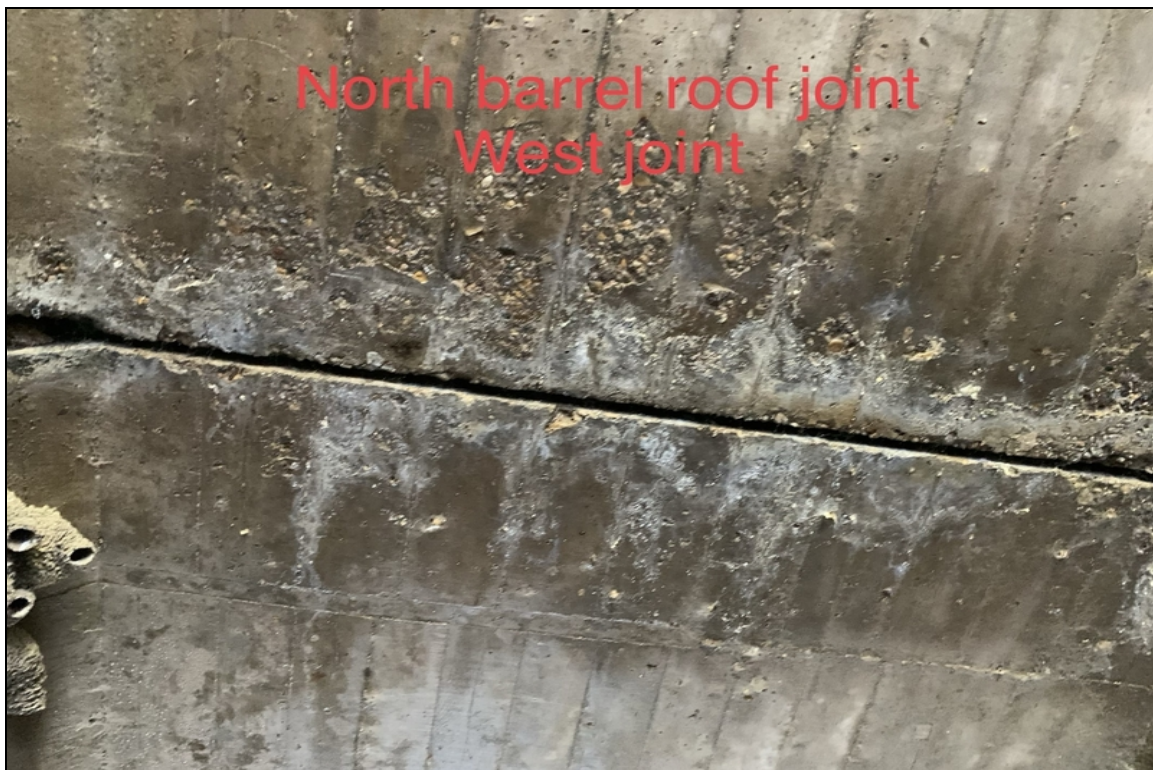
North barrel roof joint
West joint

North barrel roof joint west joint

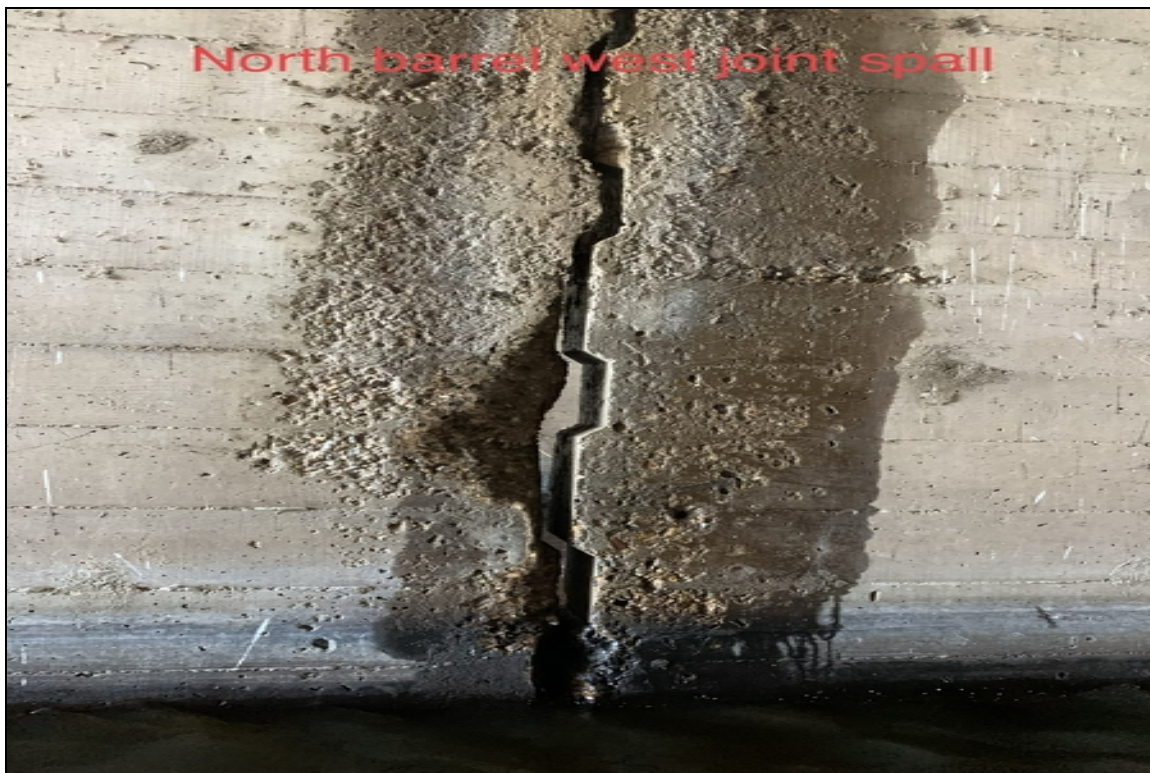
North barrel west joint spall
