Route:00200 Log:163.127

6 NORTH OF 200A

| IDENTIFICATION | |
|---|--|
| (8) Structure Number | 0200-163.162 |
| Culvert | TRIPLE, 10X12X113' RCB |

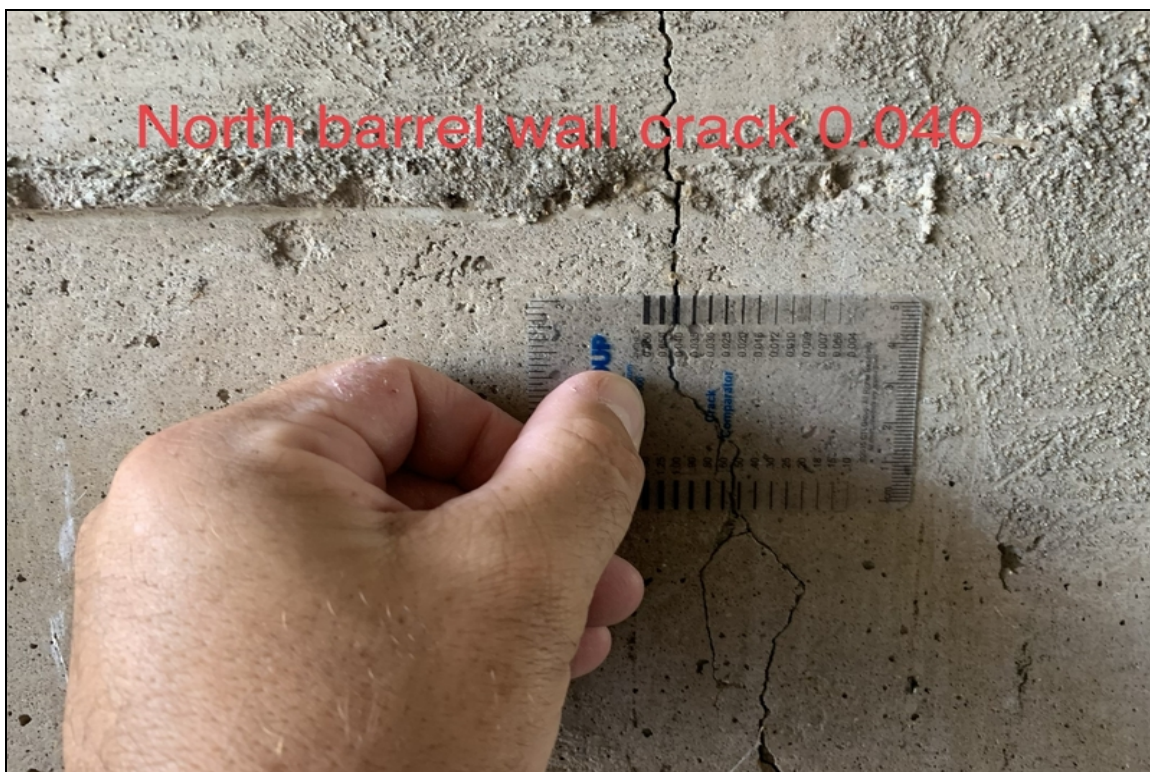
| ELEM | DESCRIPTION | UNITS | TOTAL | CS1 | CS2 | CS3 | CS4 |
|---|--|---|---|---|---|---|---|
| (241) | The West joint is open approximately 2 inches in all three barrels with efflorescence and fill material entering in through the joint. 23July2020 (241-1130) Walls have vertical cracking and the roof at he ends has some cracking with efflorescence - 4/8/2019 Each barrel has approximately 10 cracks in each. These cracks range fro approximately 0.012 to 0.040 in width. 23July2020 | | | | | | |

.040 north barrel crack

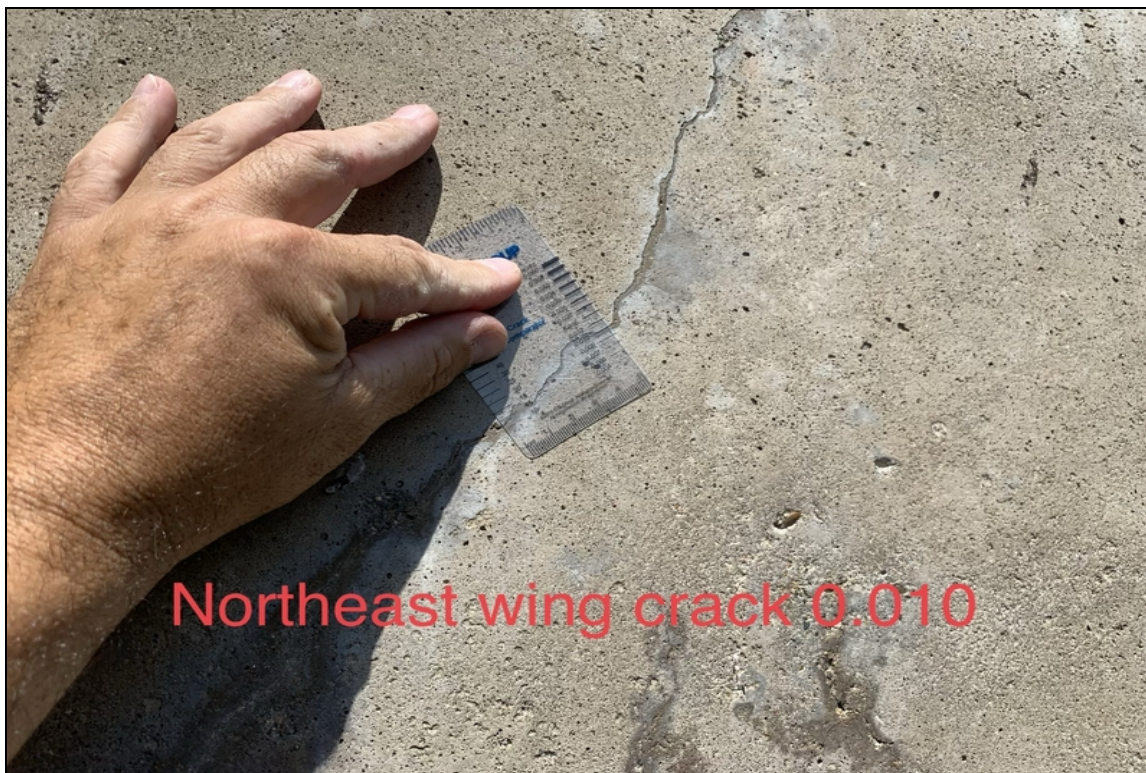
| ELEM | DESCRIPTION | UNITS | TOTAL | CS1 | CS2 | CS3 | CS4 |
|---|--|---|---|---|---|---|---|
| (8401-1130) | All four wings have some light cracking - 4/8/2019 The cracks in the wings range from 0.010 to 0.030 in width and are diagonal in nature. 23July2020 | | | | | | |

NE wing crack .010

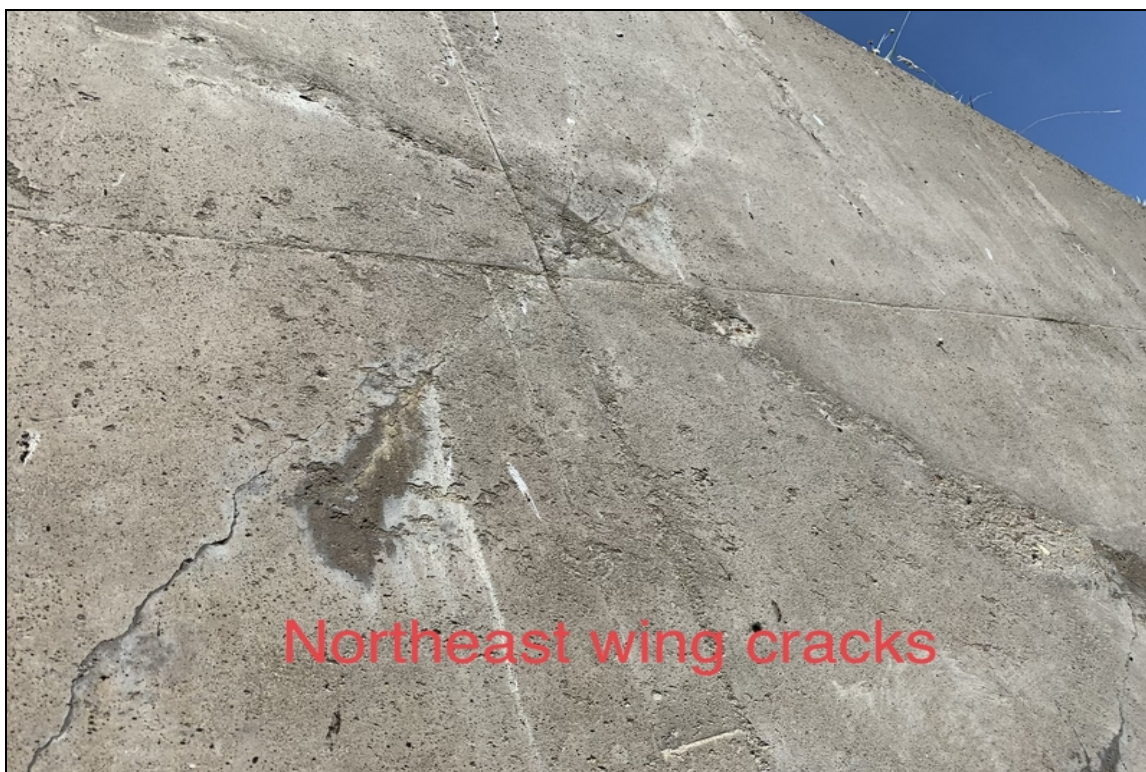
NE wing cracks

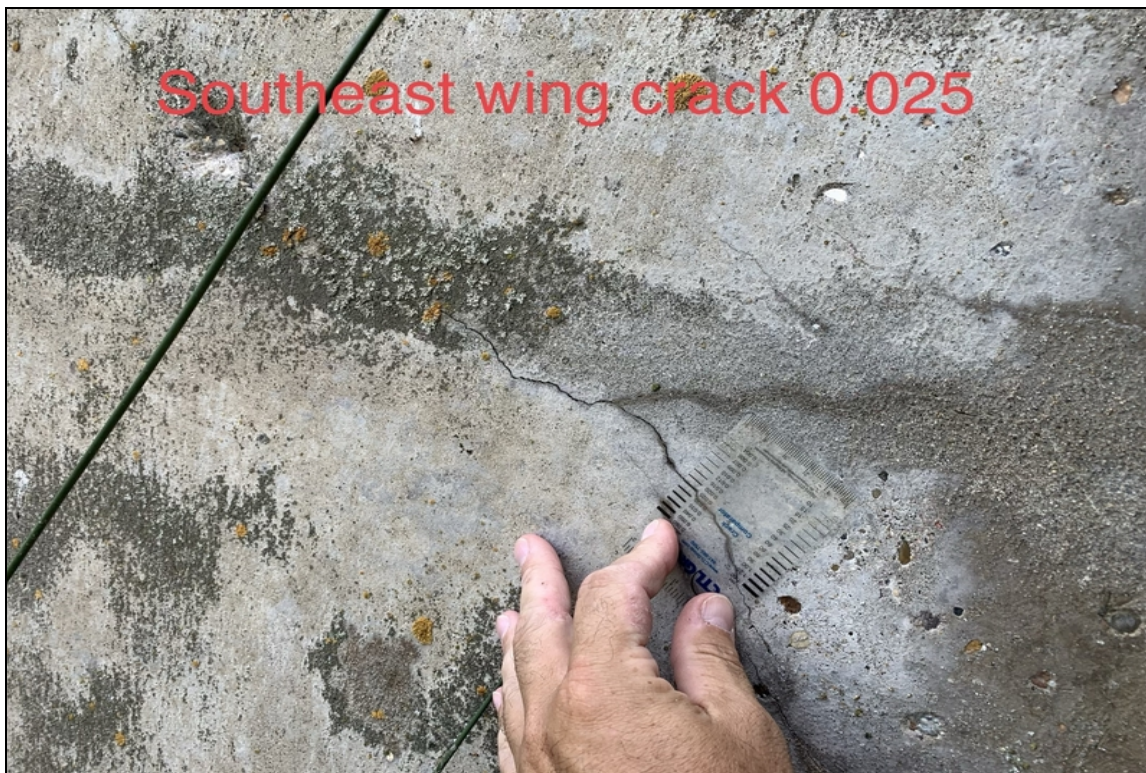
SE wing crack .025

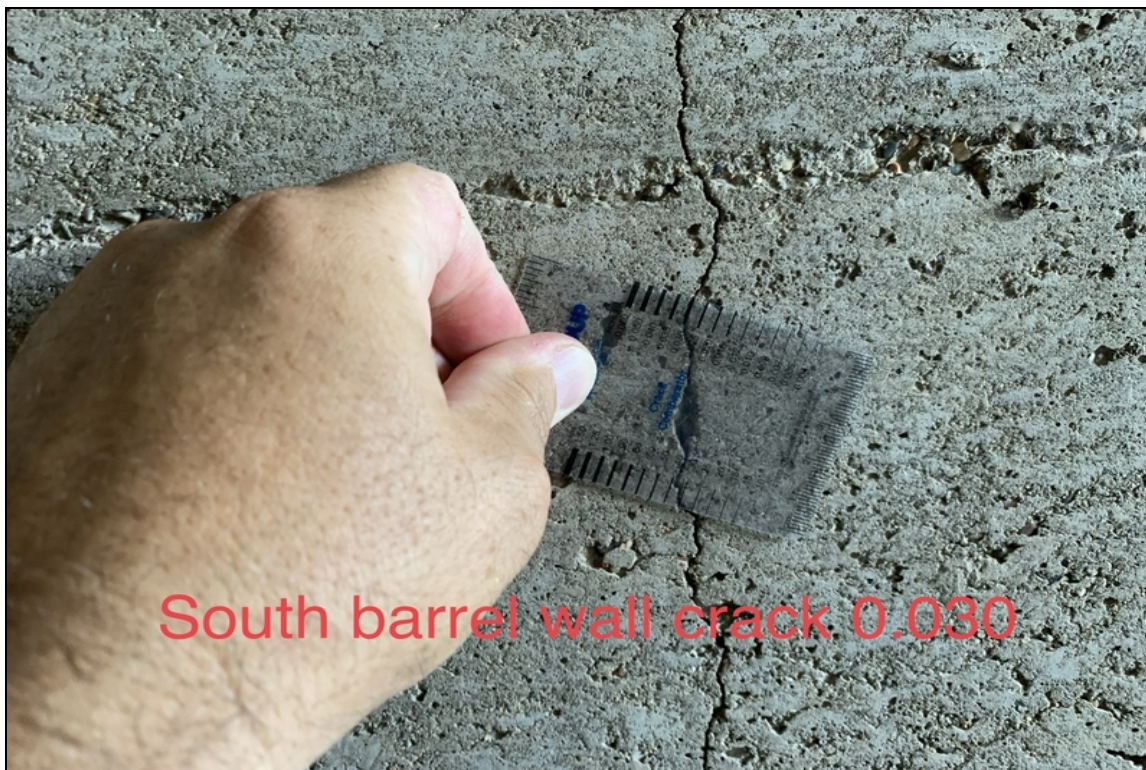
South barrel crack .030

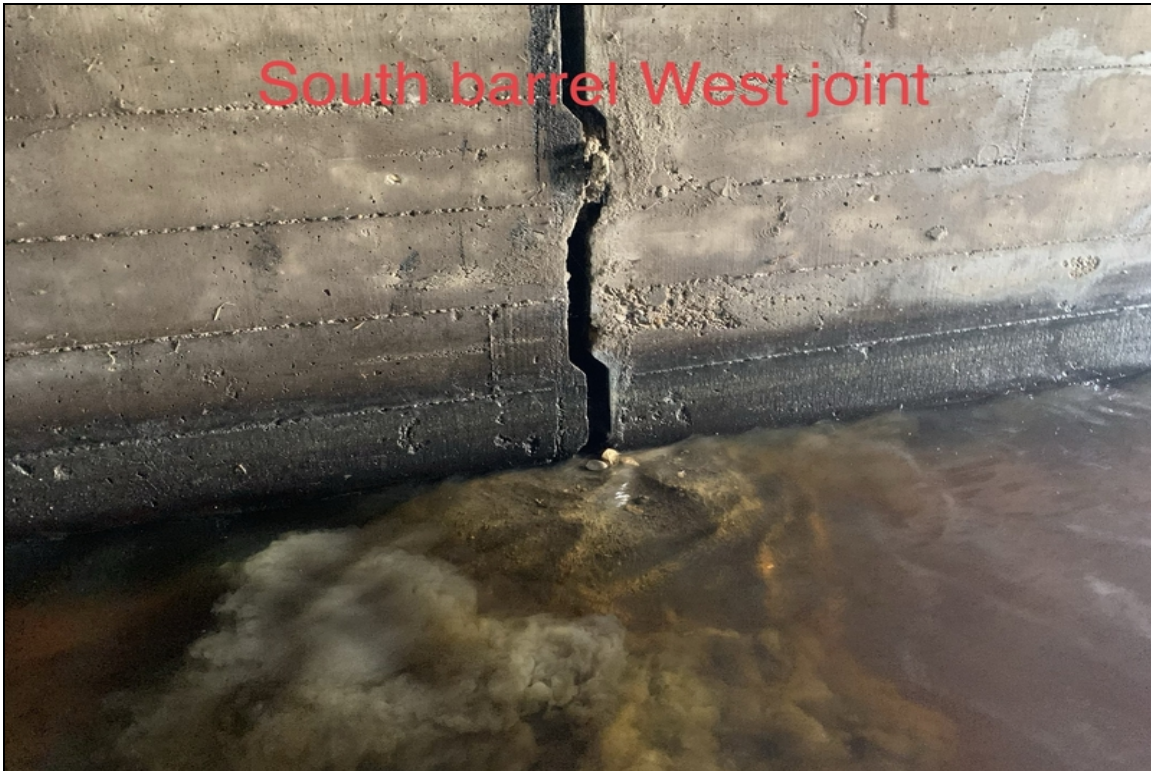
The West joint is open approximately 2 inches in all three barrels with efflorescence and fill material entering in through the joint. The East joint is open approximately 1.5 inches in all three barrels with efflorescence and fill material entering through the joint. 23July2020

South barrel west joint fill loss

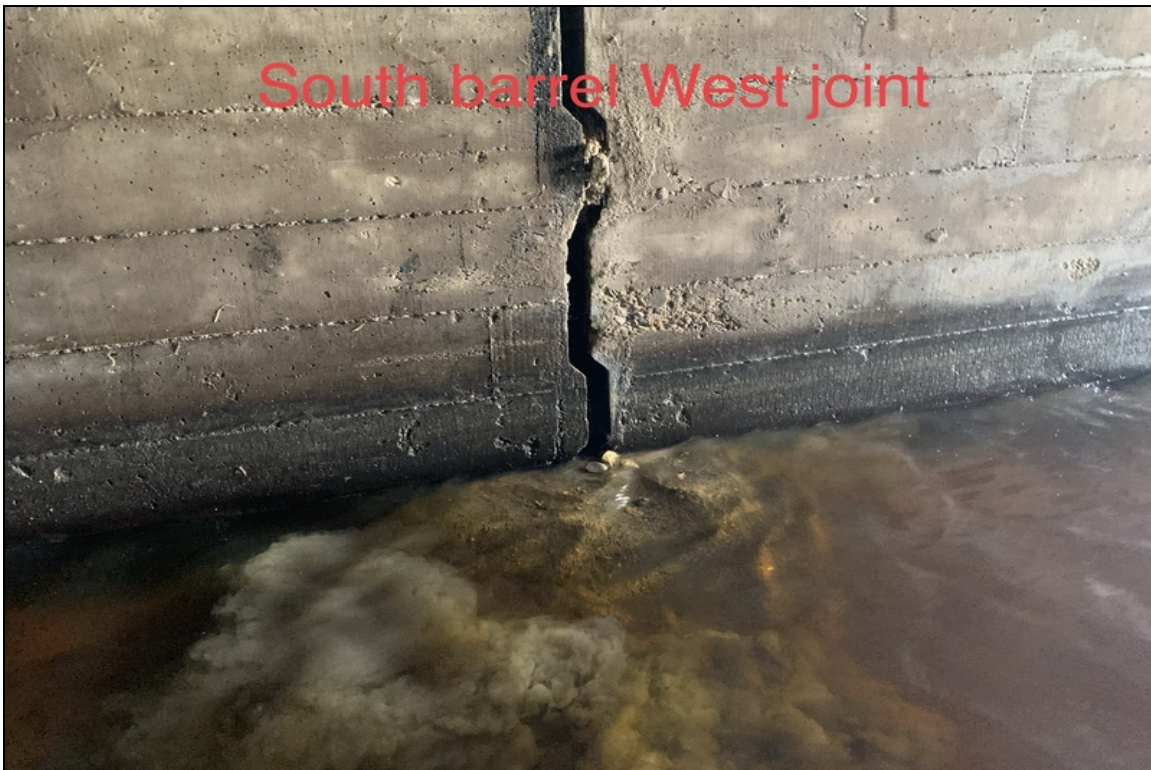
South barrel west joint fill loss
