2 SOUTHEAST OF I-94

IDENTIFICATION	
(1) State Names	North Dakota
(8) Structure Number	0094-901.376
(5) Inventory Route	00094
(2) Highway Agency District	65
(3) County Code	Billings, North Dakota

(4) Place Code	51900
(6) Features Intersected	LITTLE MISSOURI RIVER
(7) Facility Carried	I-94 BUSINESS LOOP
(9) Location	2 SOUTHEAST OF I-94
(11) Mile Point	900.807 mi

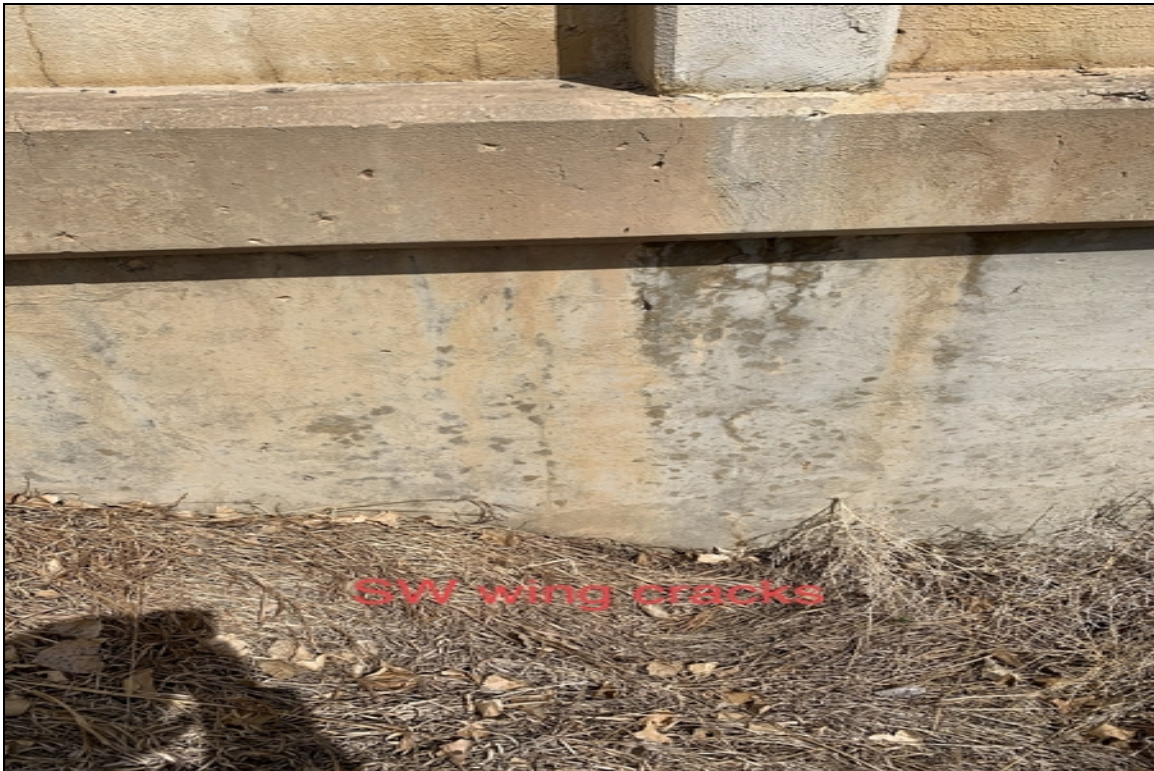
(331)							
There is hairline cracking on both barriers. 19April2021							
815	Re Conc Backwall	LF	112	112	0	0	0
8398	Slope Protection	EA	2	2	0	0	0
8401	Wings	EA	4	1	2	1	0
1080	Delamination/Spall/Patched Area	EA	1	0	0	1	0
1130	Cracking (RC and Other)	EA	2	0	2	0	0
(8401-1080)							
The Southeast wing has a 6 inch by 6 inch spall with approximately 6 inches of exposed rebar. 19April2021							
(8401-1130)							
The Southwest wing and the Southeast wing have cracks. The Southeast wing crack measured approximately 0.006 in width. The Southwest wing crack measured approximately 0.008. In width. 19April2021

SW wing cracks

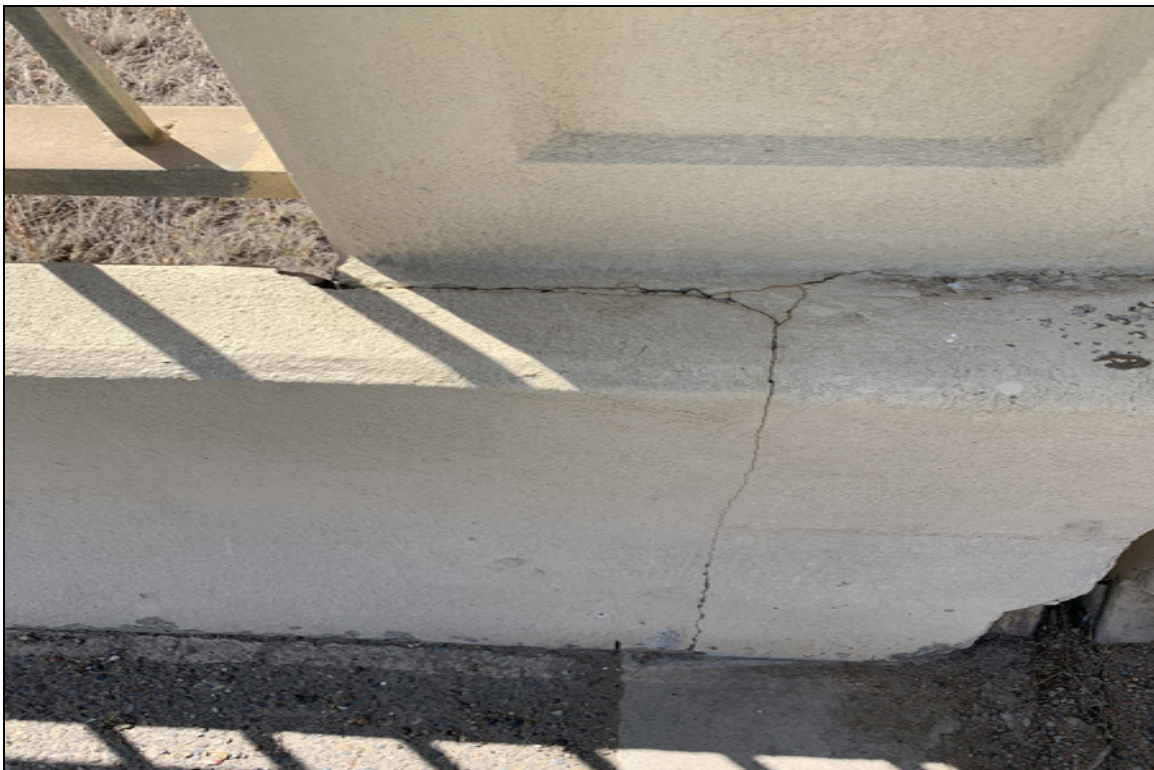
South barrier crack

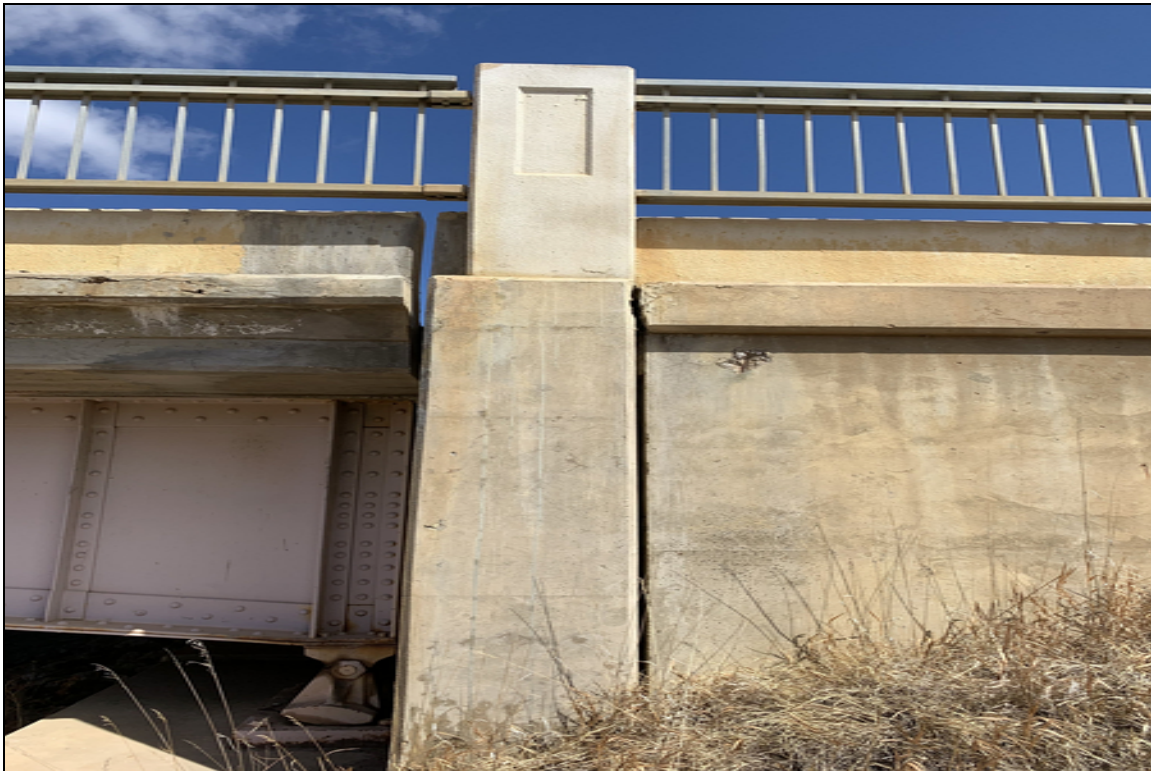
SE wing

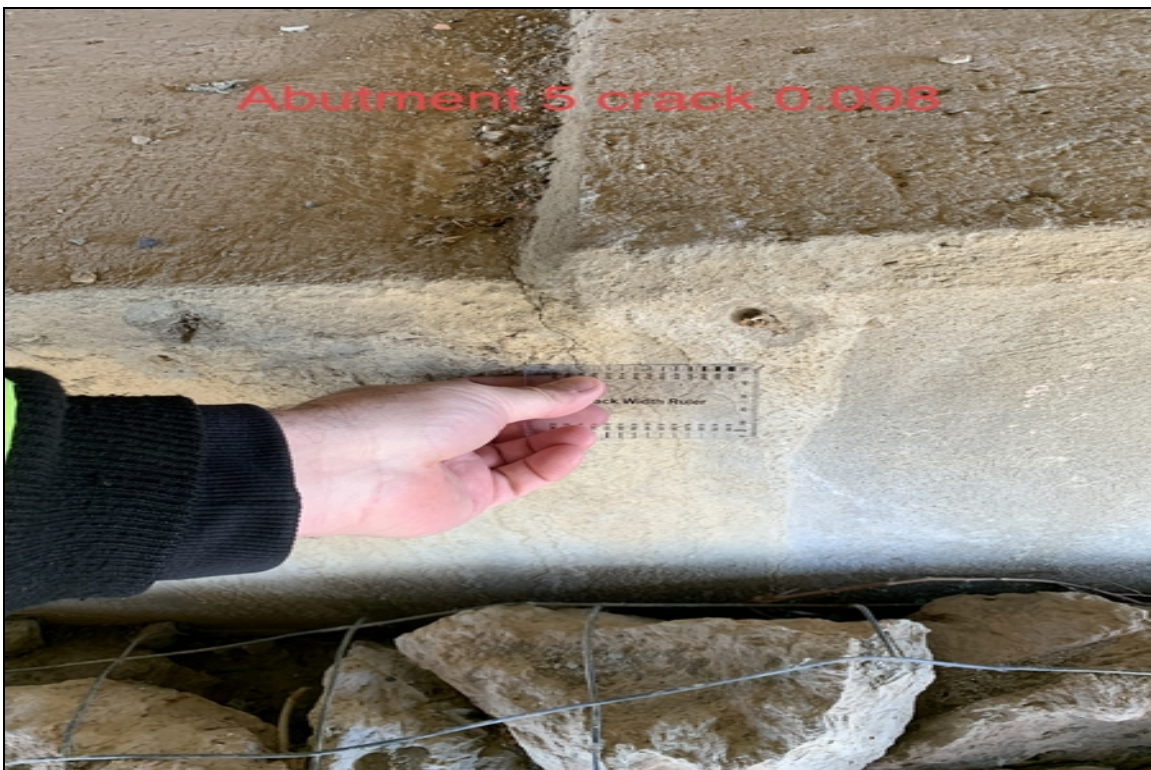
Abutment 5 cracks .008

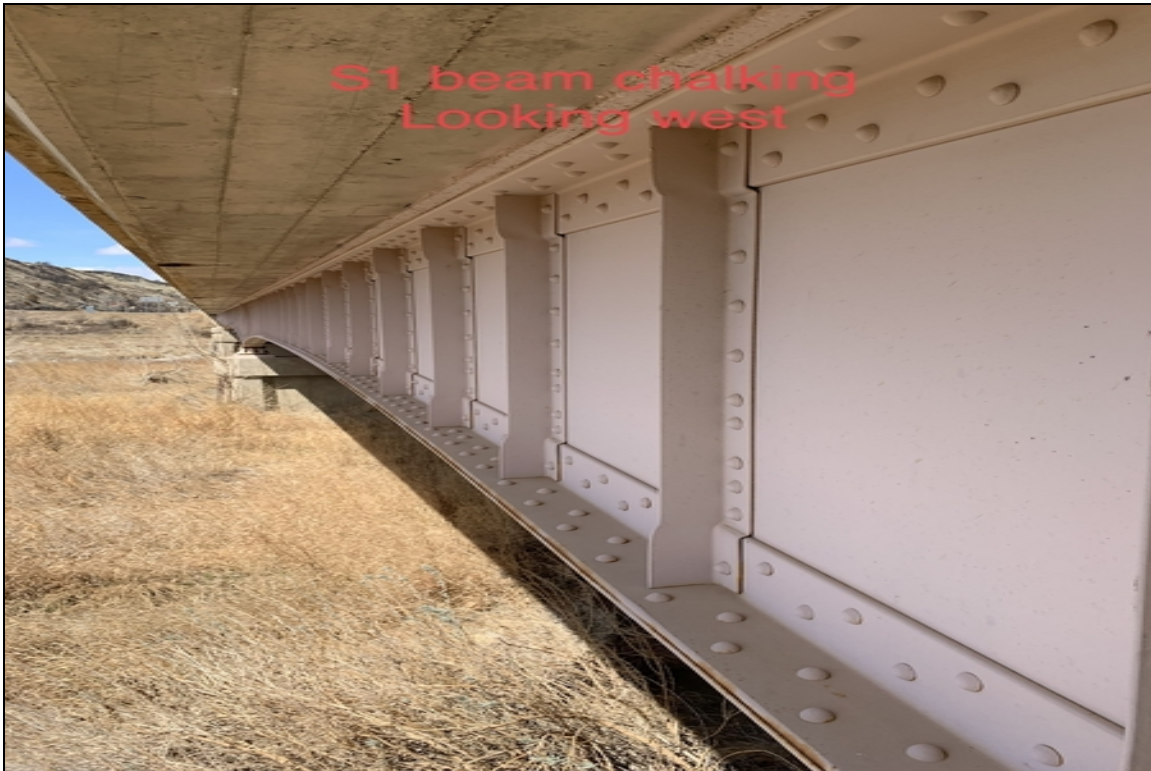
(107-515-3410)	All the steel beams have chalked with loss of pigment. 19April2021						
205	Reinforced Concrete Column	EA	6	6	0	0	0

S1 beam chalking looking west

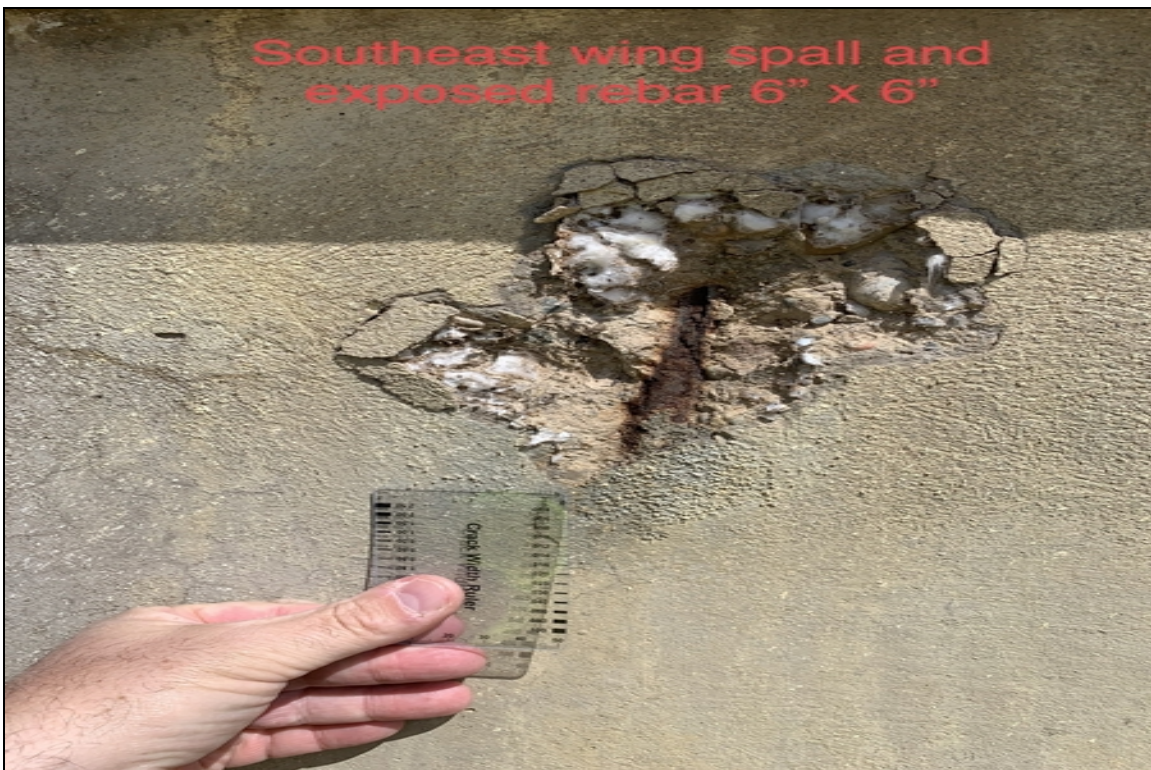
SE wing spall and exposed rebar 6"x6"

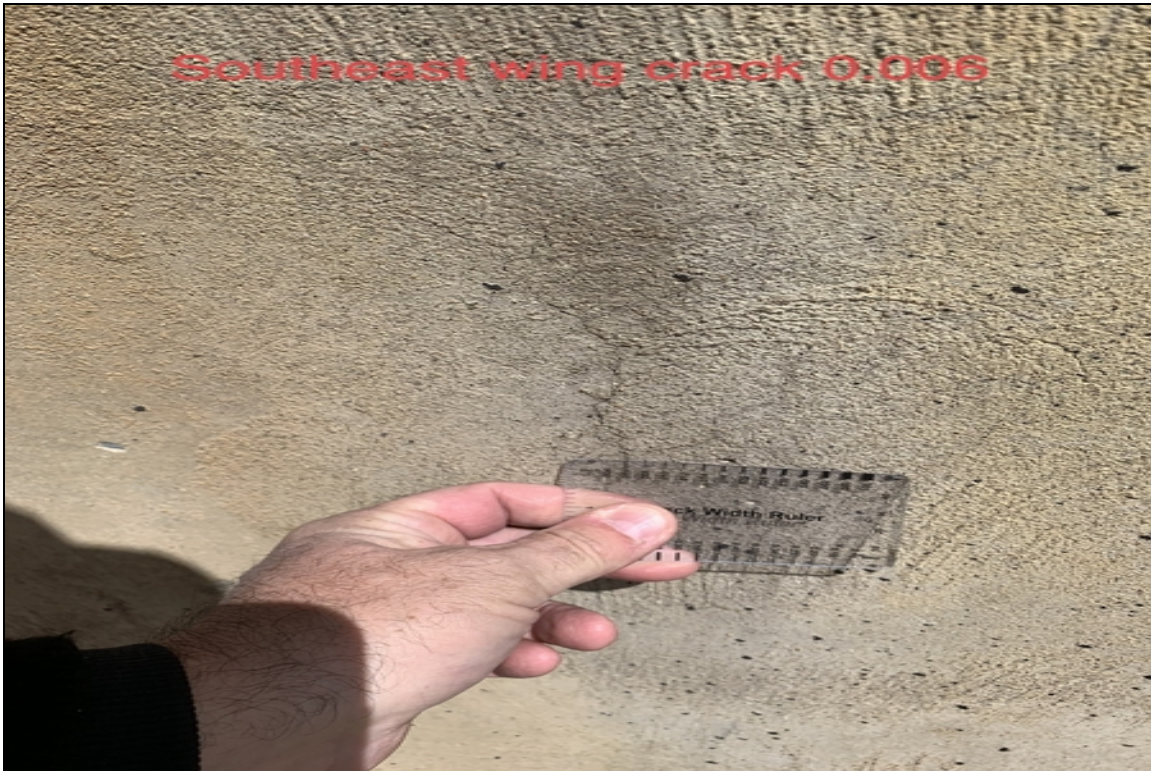
SE wing crack .006

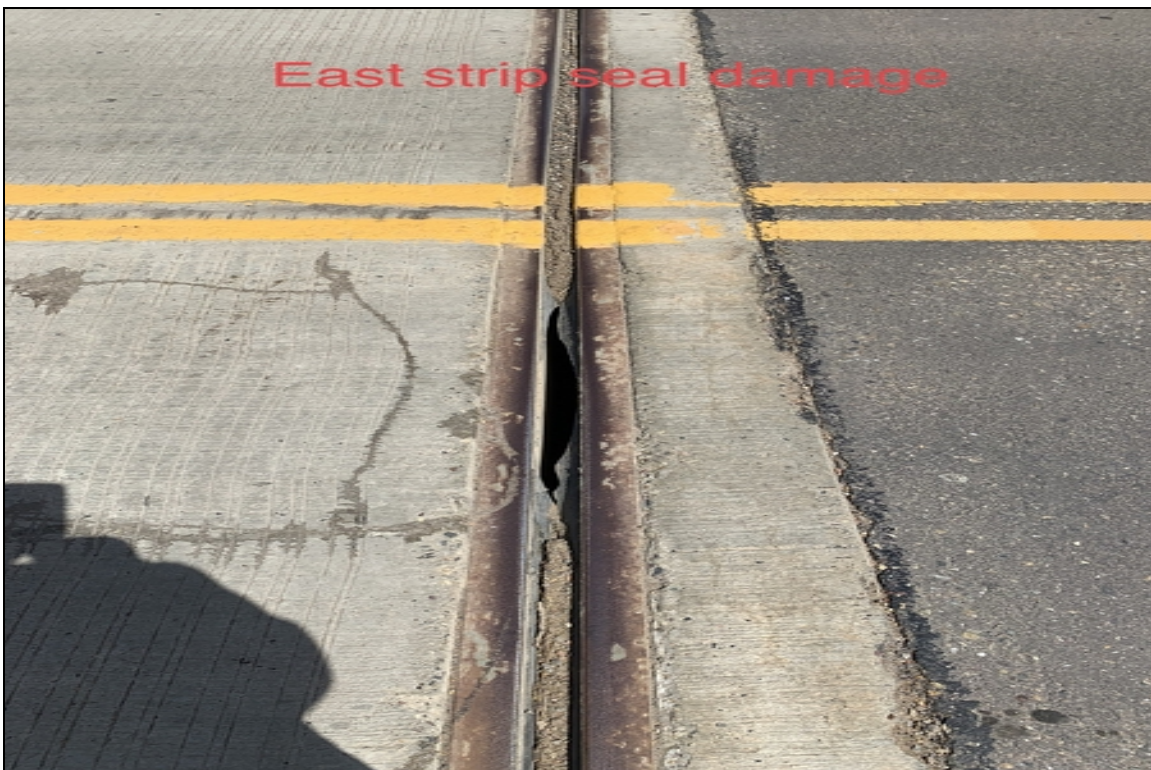
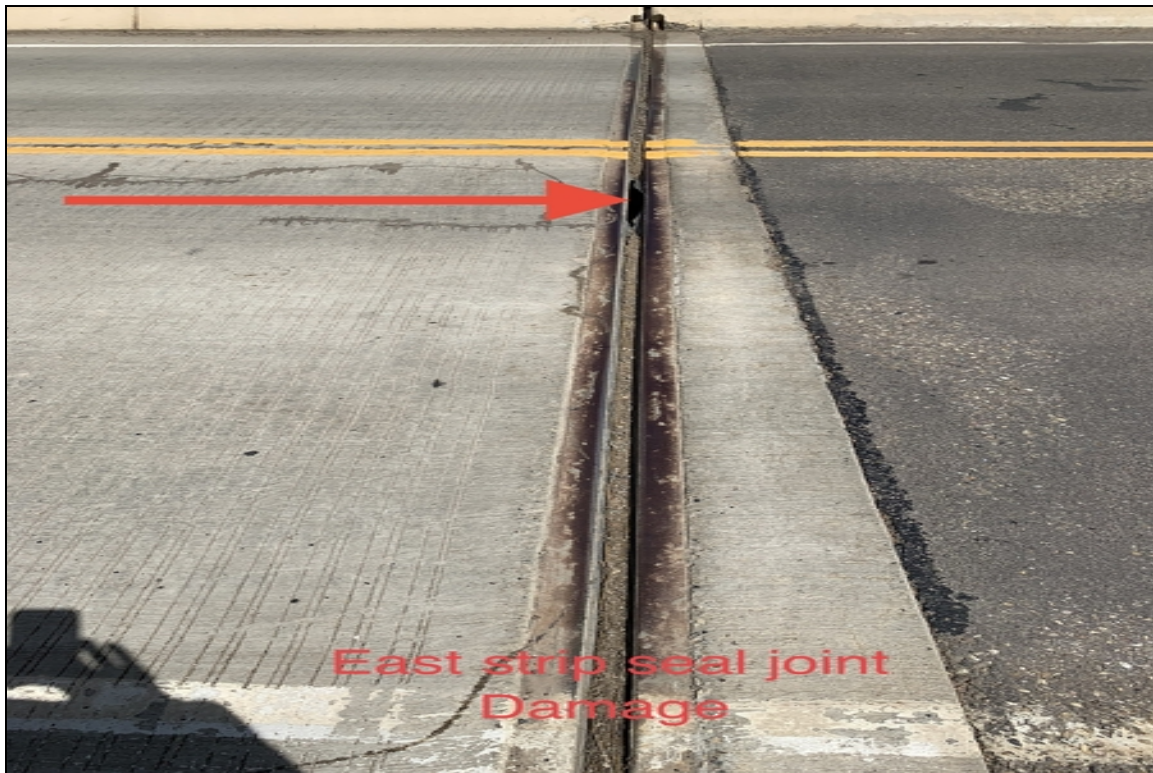
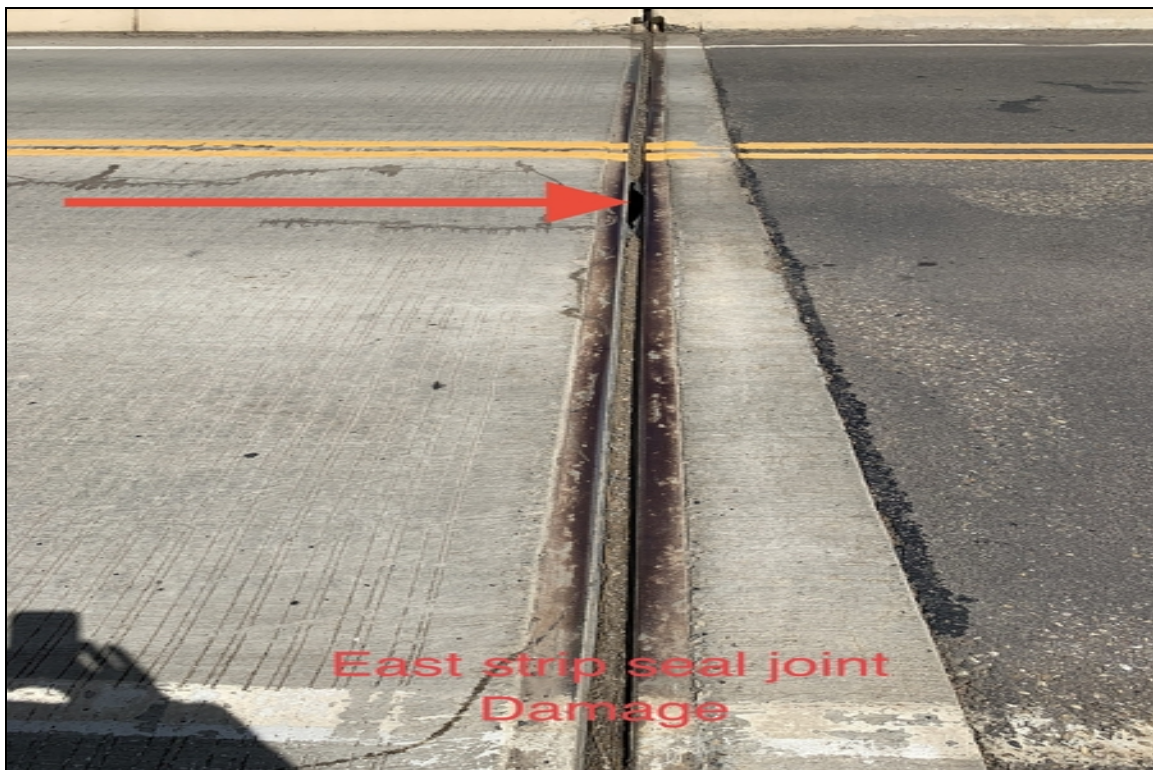
East strip seal damage

East strip seal joint damage

Both joints are filled with debris and the East joint has a hole approximately 3 feet in length next to centerline in the east bound lane.

Recommend to replace the East joint seal and remove debris from the West joint seal. 19April2021

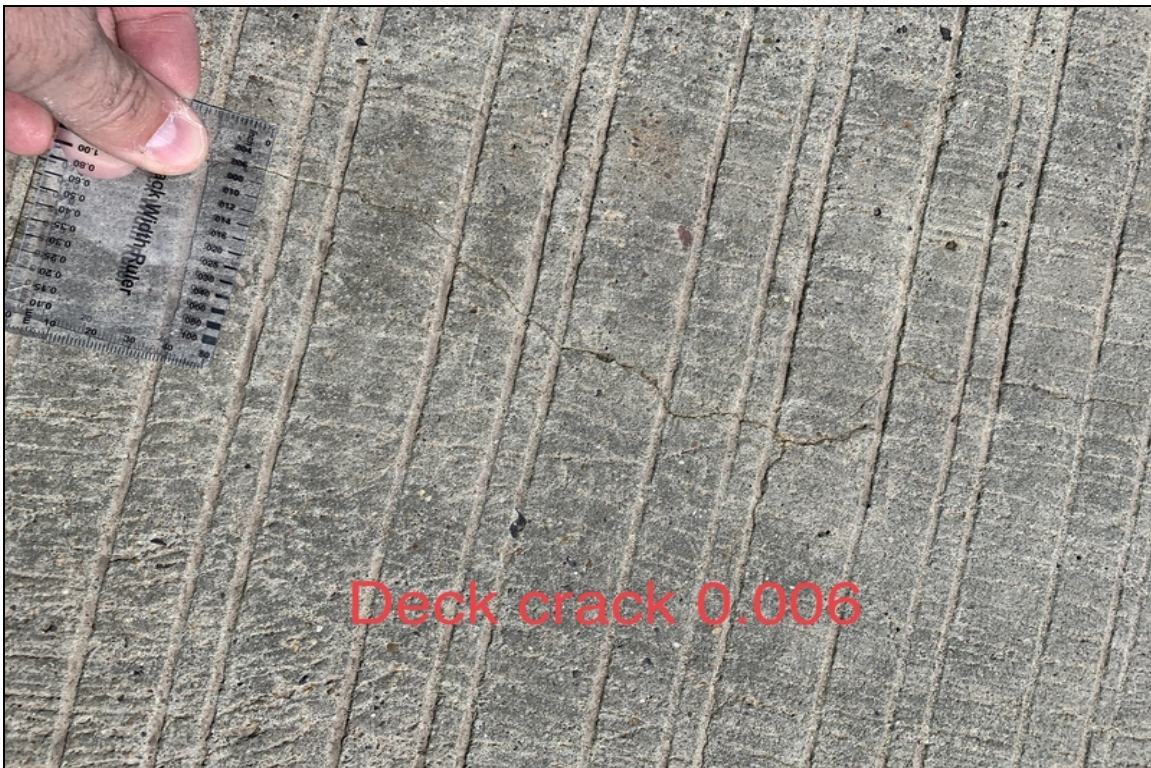
Deck crack .006

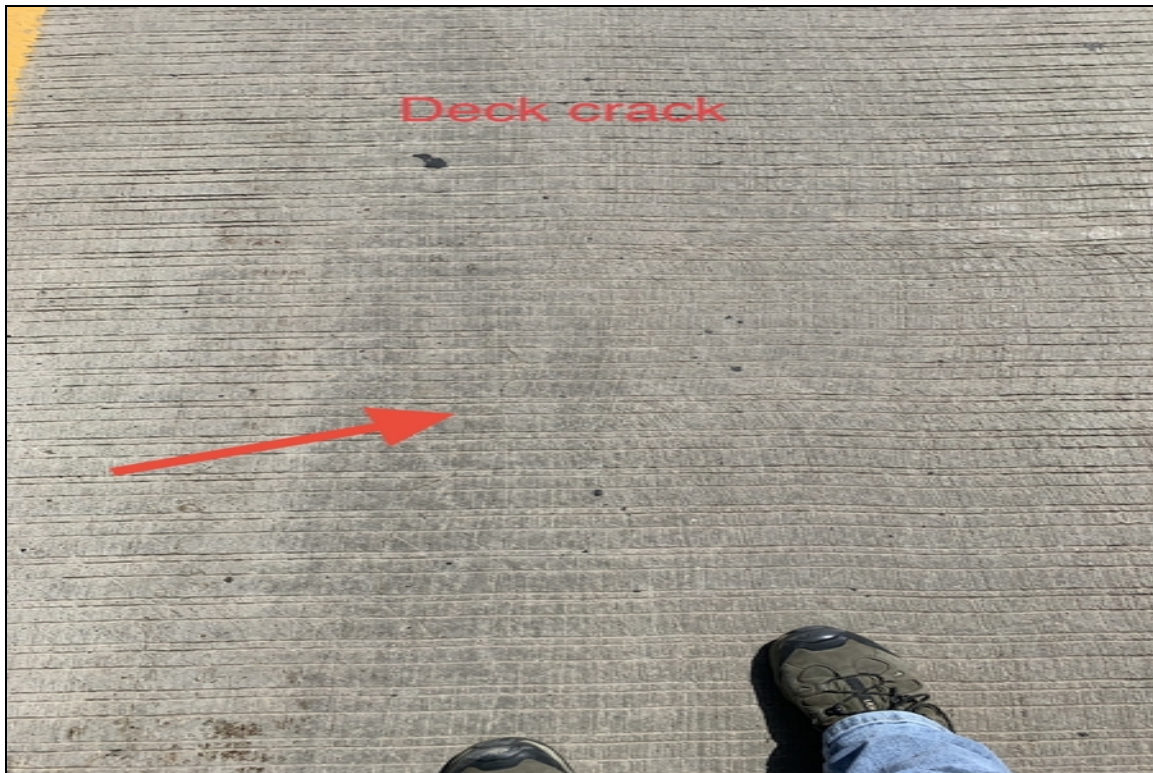
Deck crack

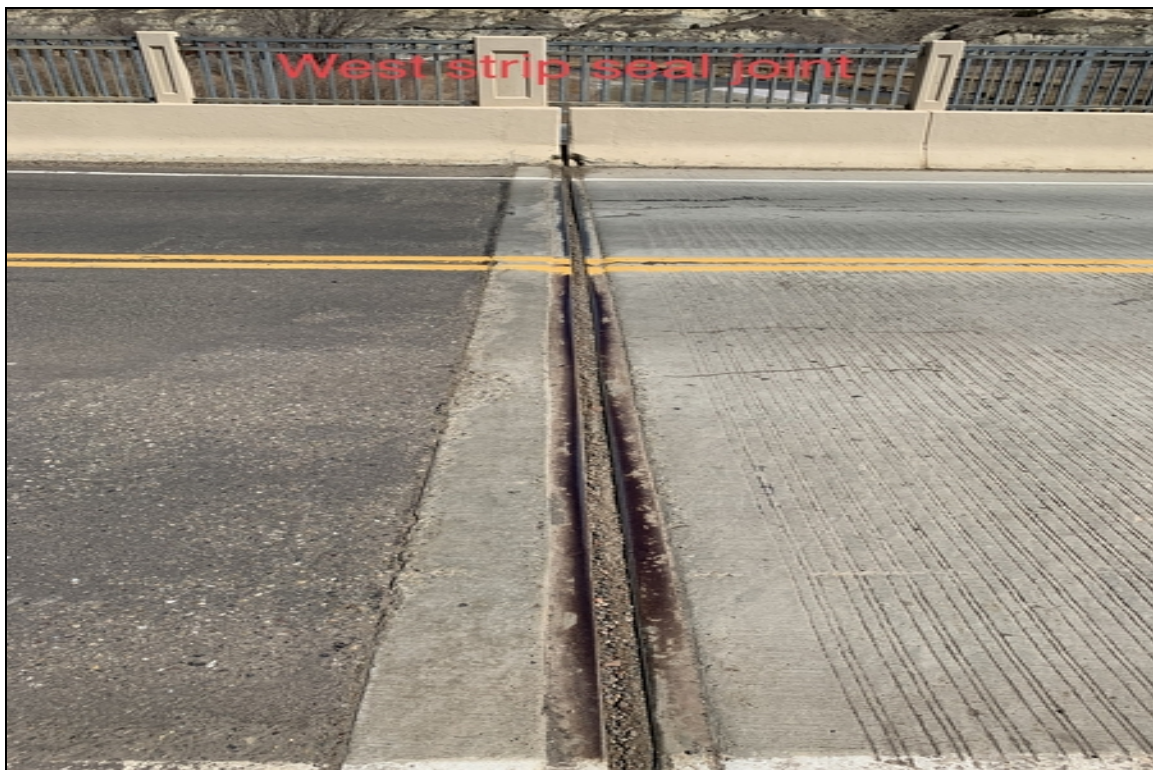
West strip seal

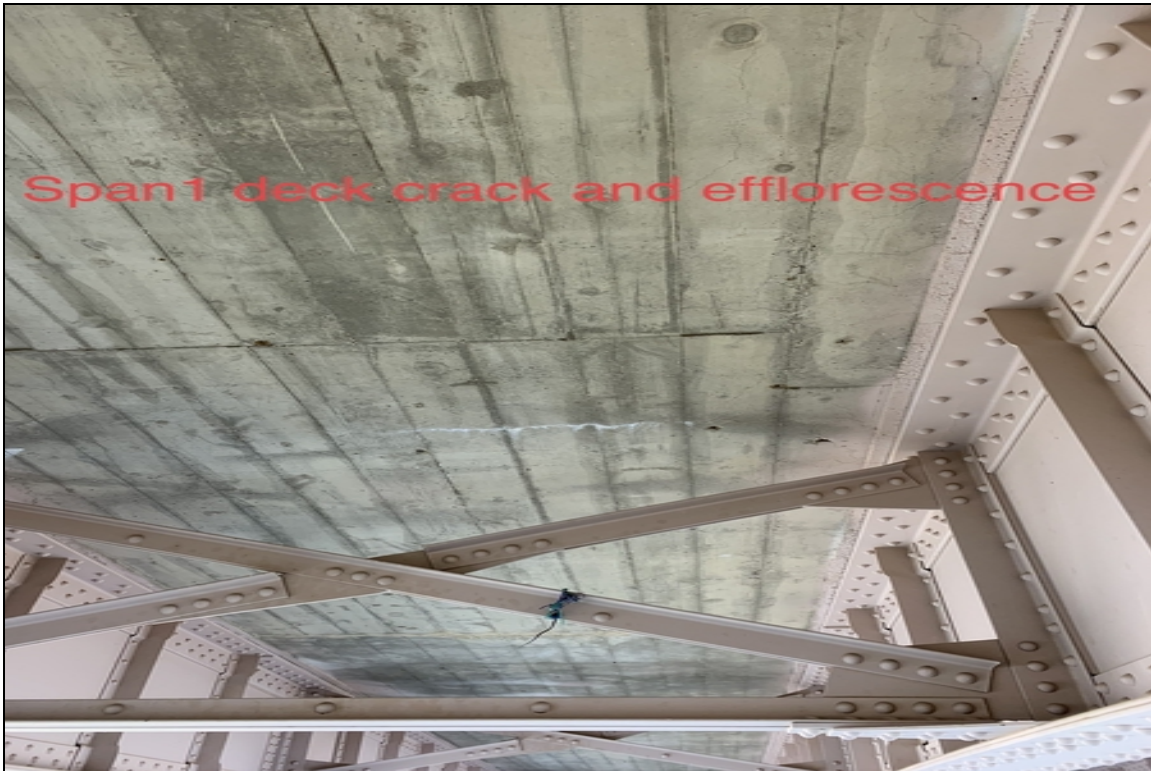
NBI Remarks: Efflorescent staining through cracks on the underside of the deck and sidewalk.

Span 1 deck crack and efflorescence

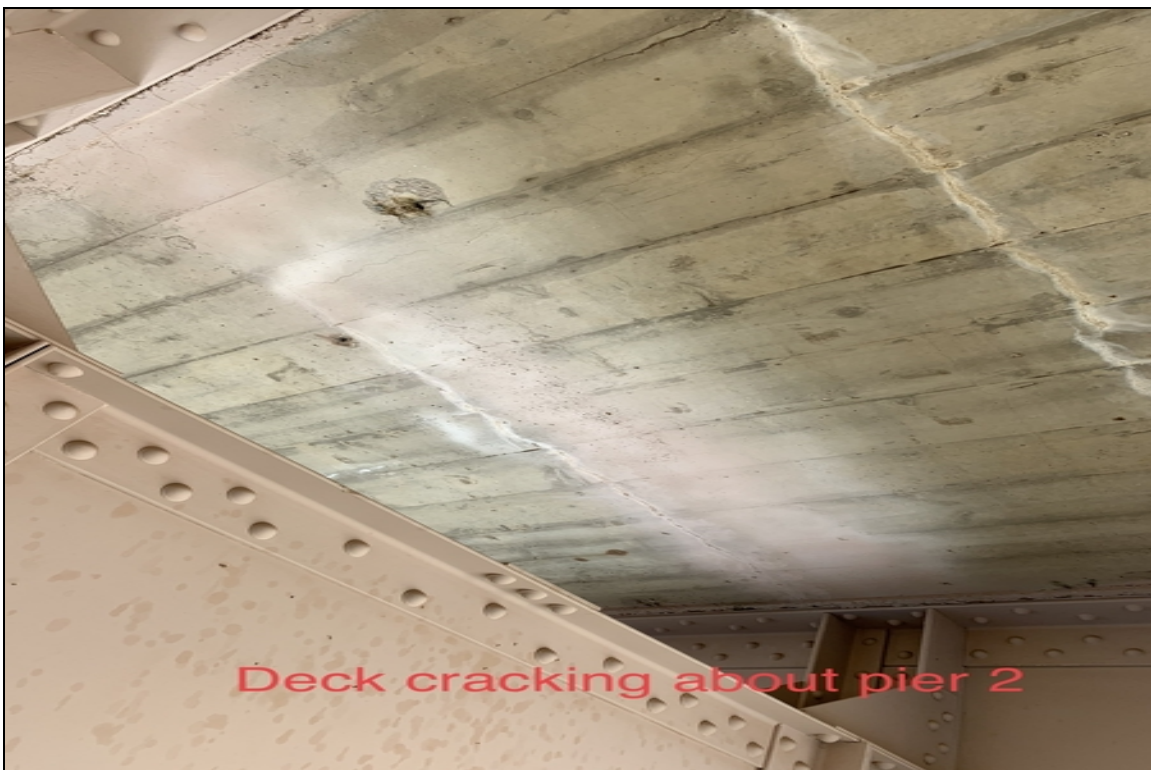
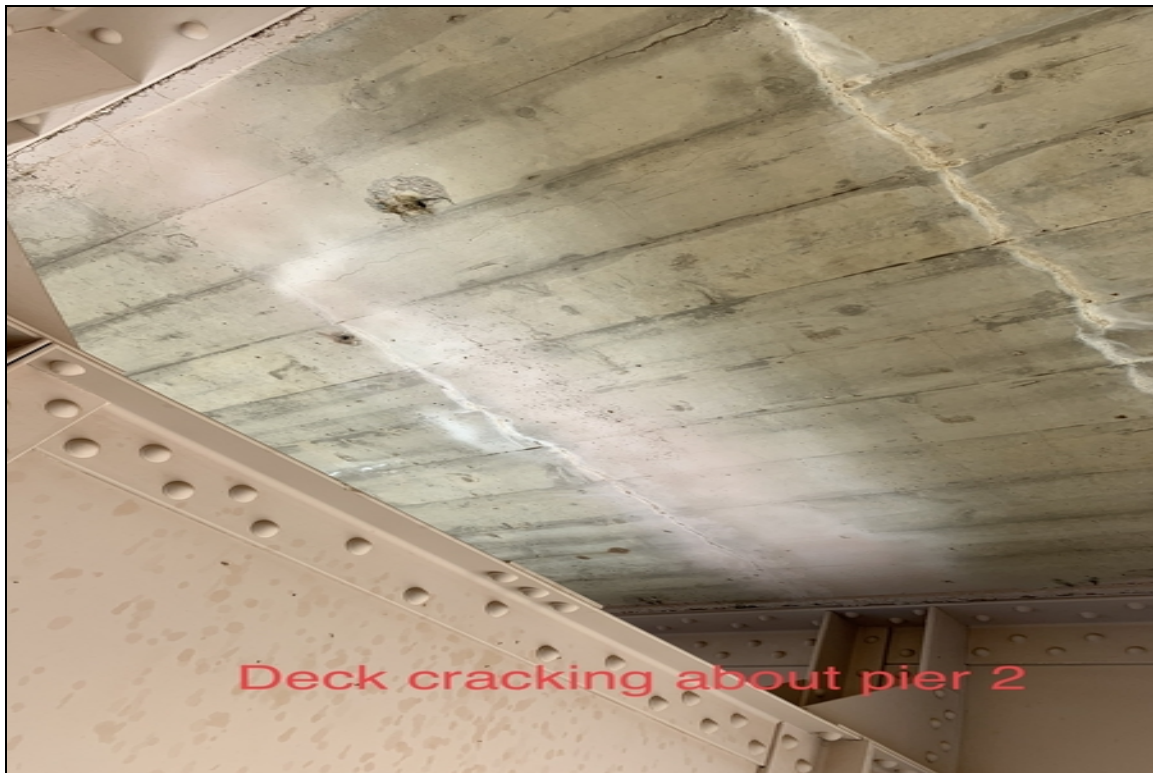
Deck cracking above pier 2 with small pop out

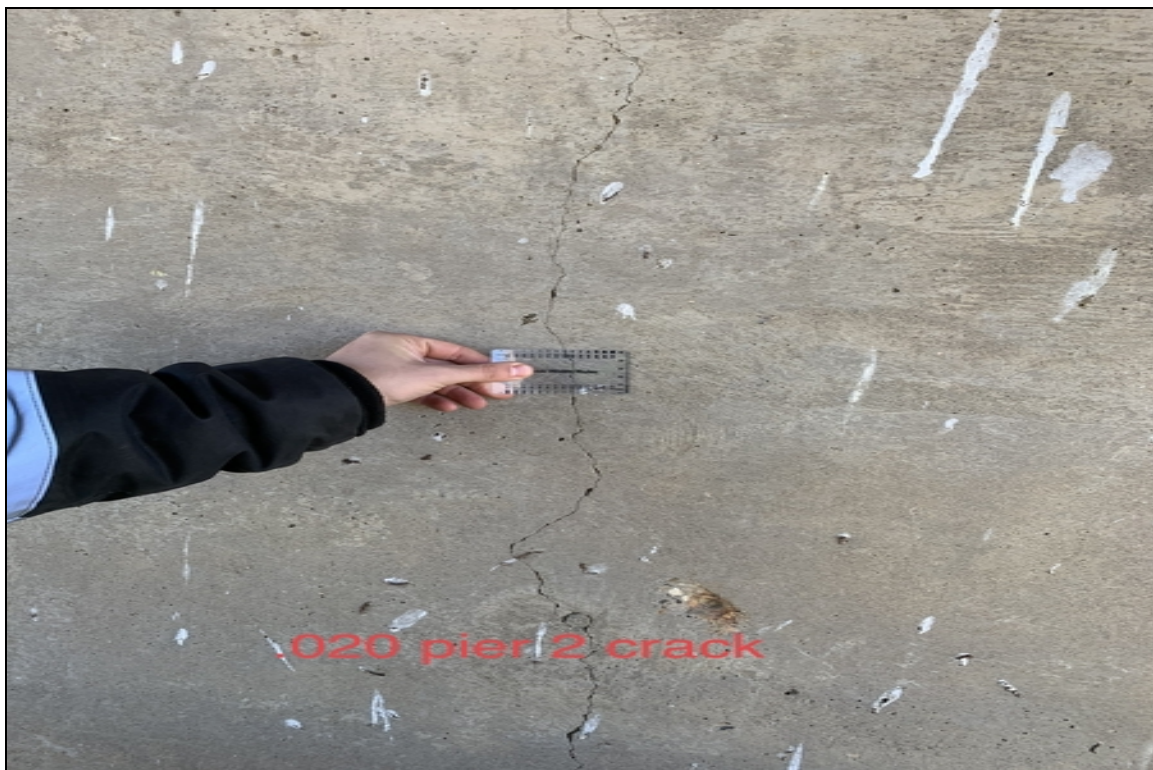
ELEM	DESCRIPTION	UNITS	TOTAL	CS1	CS2	CS3	CS4
210	Reinforced Concrete Pier Wall	LF	75	68	7	0	0
1130	Cracking (RC and Other)	LF	7	0	7	0	0
(210-1130)							
piers have some vertical cracks and scaling. - 11/19/2019							
Pier 2 has 2 cracks that measured approximately 0.020 in width. Pier 3 has 3 cracks that measured approximately 0.020 in width. Pier 4 has 2 cracks that measured approximately 0.020 in width. 19April2021							
215	Reinforced Concrete Abutment	LF	112	106	6	0	0
1130	Cracking (RC and Other)	LF	6	0	6	0	0
(215-1130)							
portion of abutment have vertical cracks and spalls - 11/19/2019							
Abutment 5 has 1 crack in the approximate center of the abutment that measured 0.008 in width. Abutment 1 has approximately 5 cracks that ranged from 0.006 to 0.008 in width. 19April2021							
234	Reinforced Concrete Pier Cap	LF	105	96	9	0	0
1130	Cracking (RC and Other)	LF	9	0	9	0	0
(234-1130)

.020 pier 2 crack

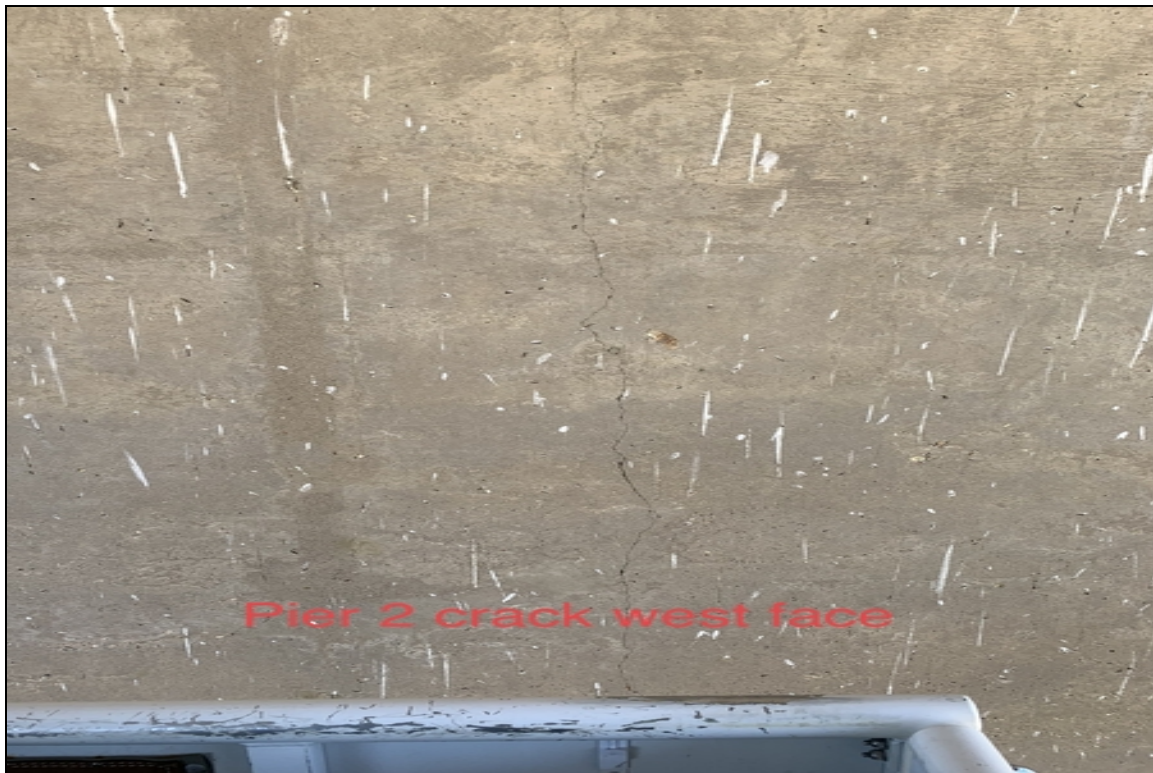
Piers have vertical cracks and some scaling.

Pier 2 crack west face

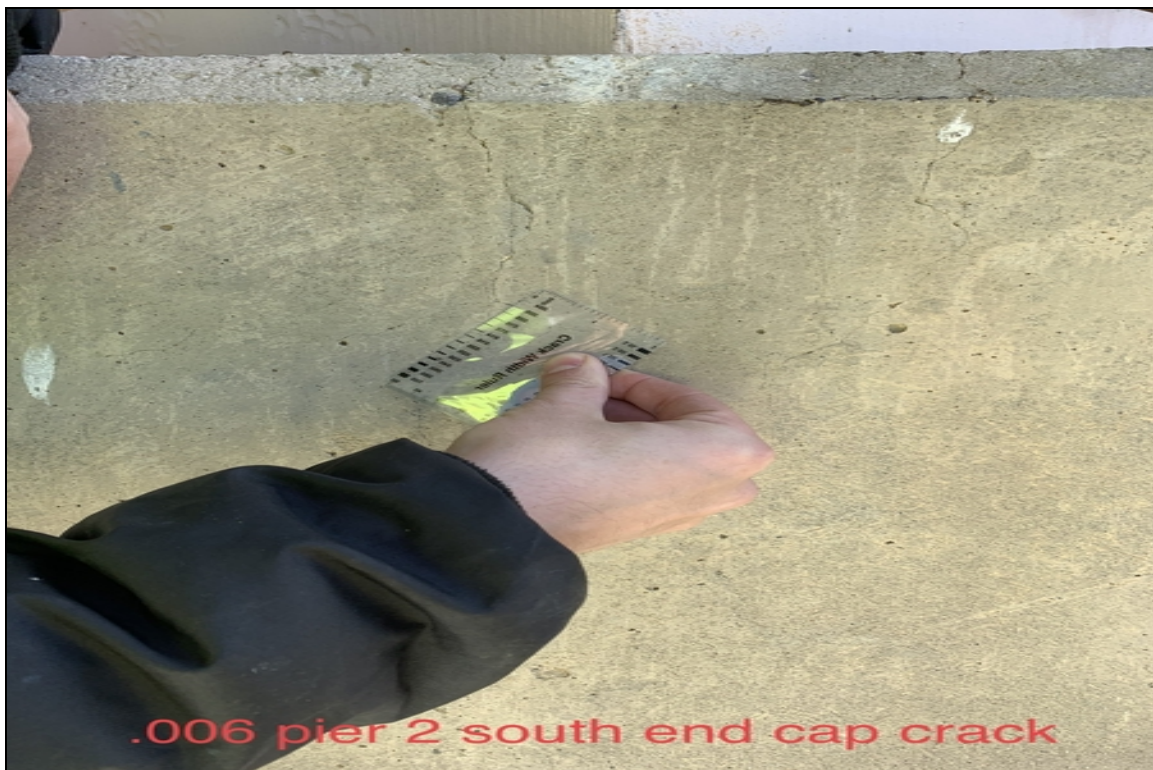
north side of pier cap pier 4 cracking - 11/19/2019							
Pier 2 and pier 3 pier caps have approximately 2 feet of cracking on the South end s of each cap. These cracks average approximately 0.006 in width. 19April2021							
303	Assembly Joint with Seal	LF	95	0	0	92	3
2330	Seal Damage	LF	3	0	0	0	3
2350	Debris Impaction	LF	92	0	0	92	0
(303-2330)							
Both joints are filled with debris and the East joint has a hole approximately 3 feet in length next to centerline in the east bound lane. 19April2021							
(303-2350)							
impaction debris starting to cause joint to fail - 11/19/2019							
Both joints are filled with debris and the East joint has a hole approximately 3 feet in length next to centerline in the east bound lane. 19April2021							
311	Movable Bearing	EA	16	0	16	0	0
1000	Corrosion	EA	16	0	16	0	0
515	Steel Protective Coating	SF	80	0	80	0	0
3440	Effectiveness (Steel Protective Coatings)	SF	80	0	80	0	0

.006 pier 2 south end cap

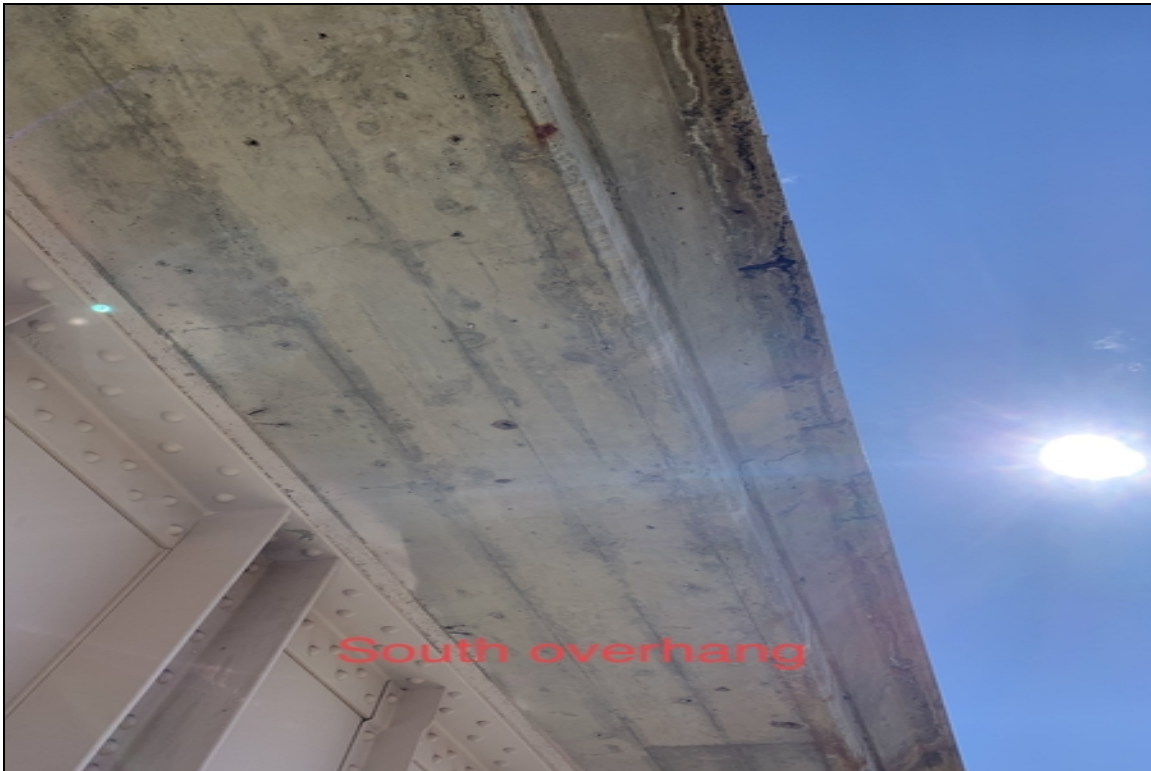
South side soffit spalling exposed rebar

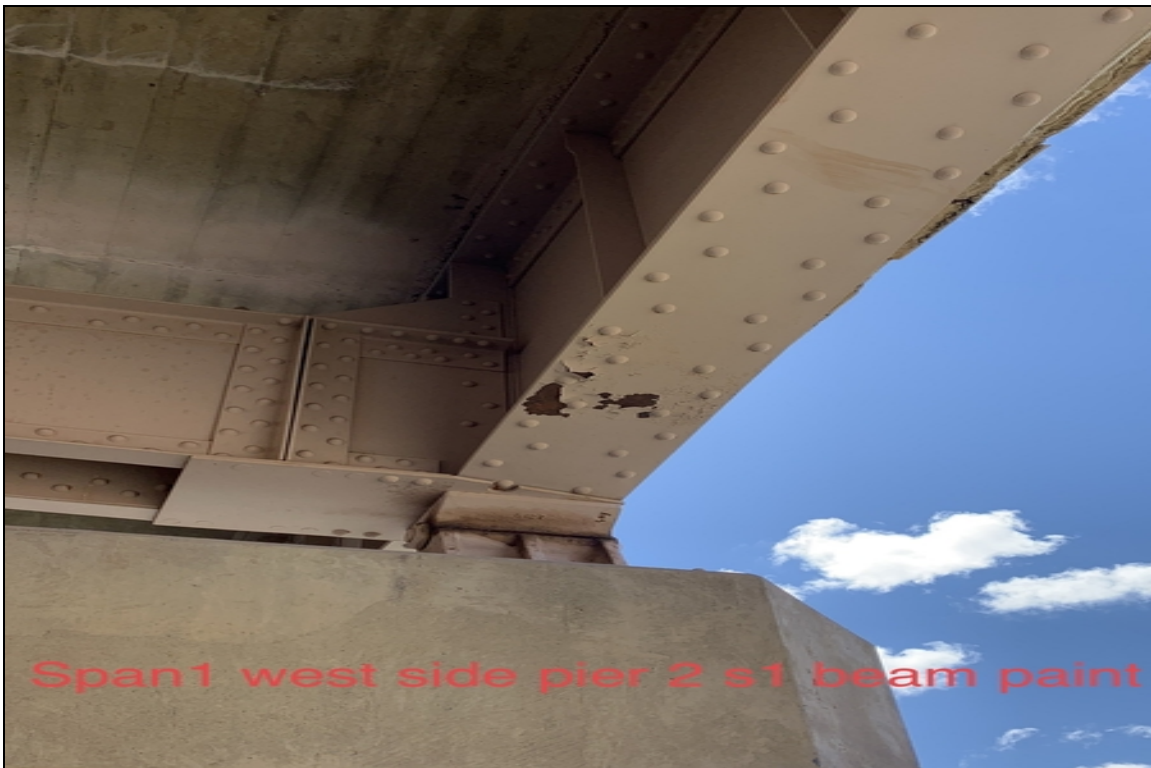
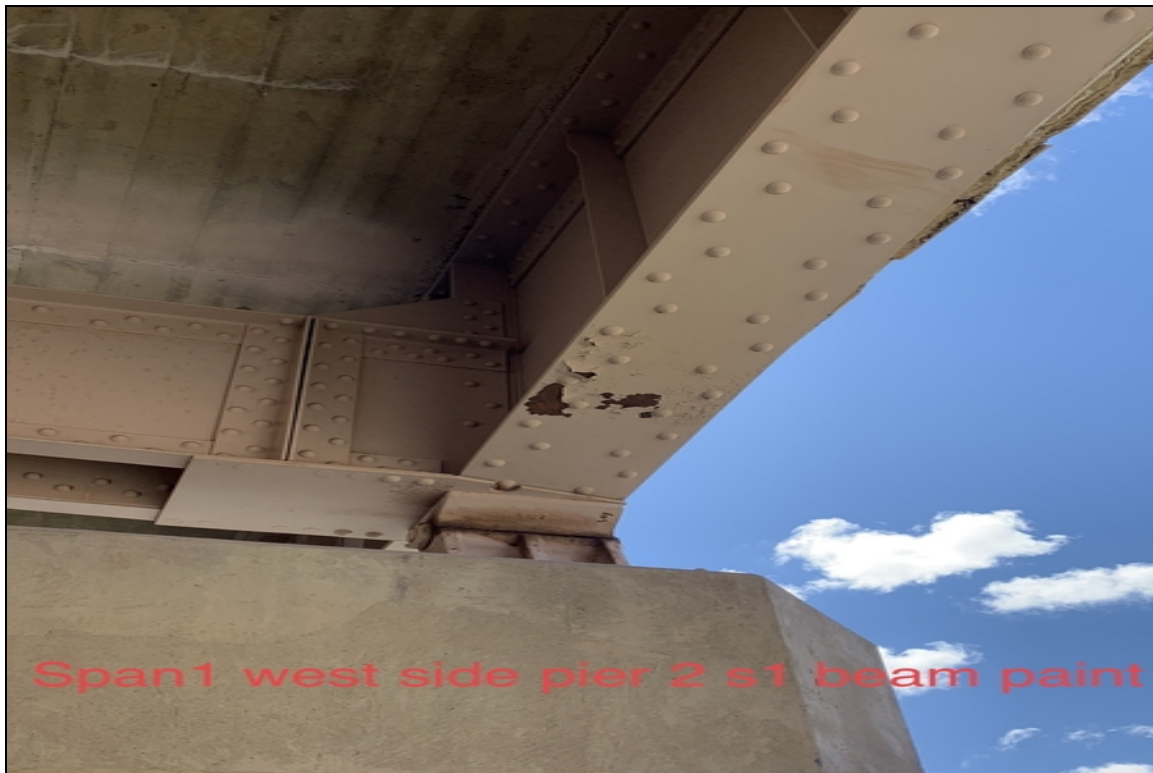
Span 1 west side pier 2 s1 beam paint failure

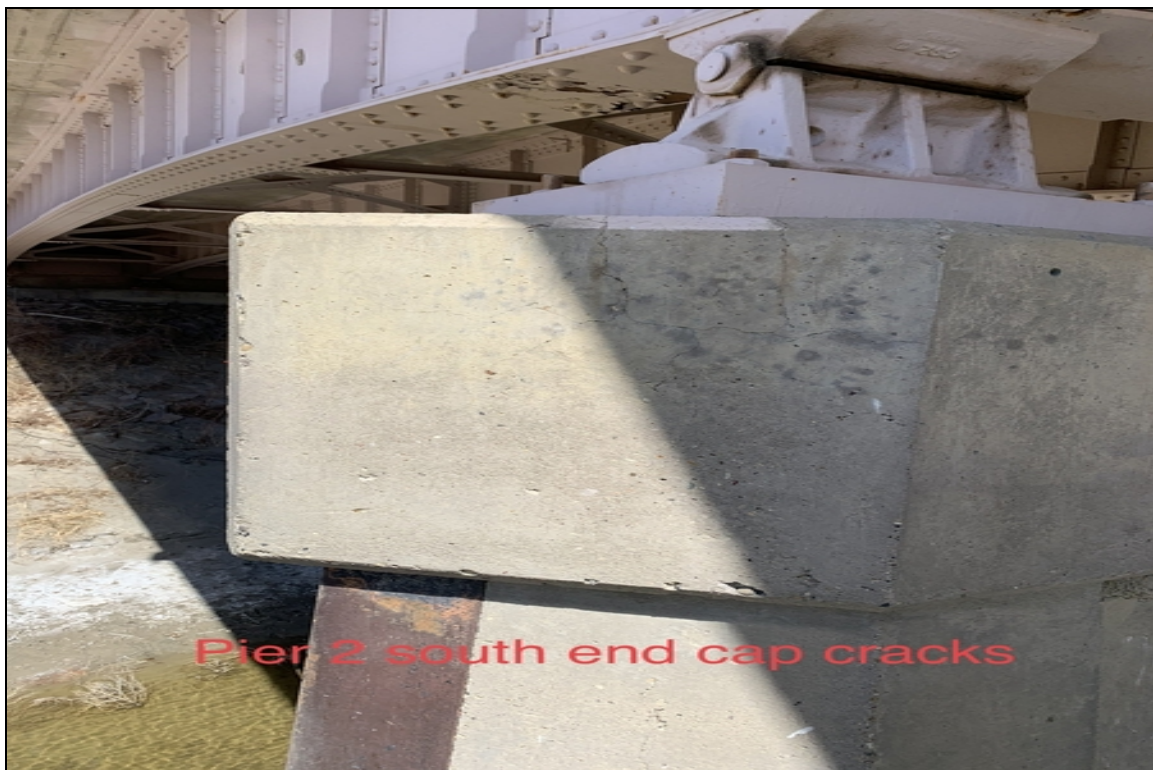
Pier 2 south end cap cracks

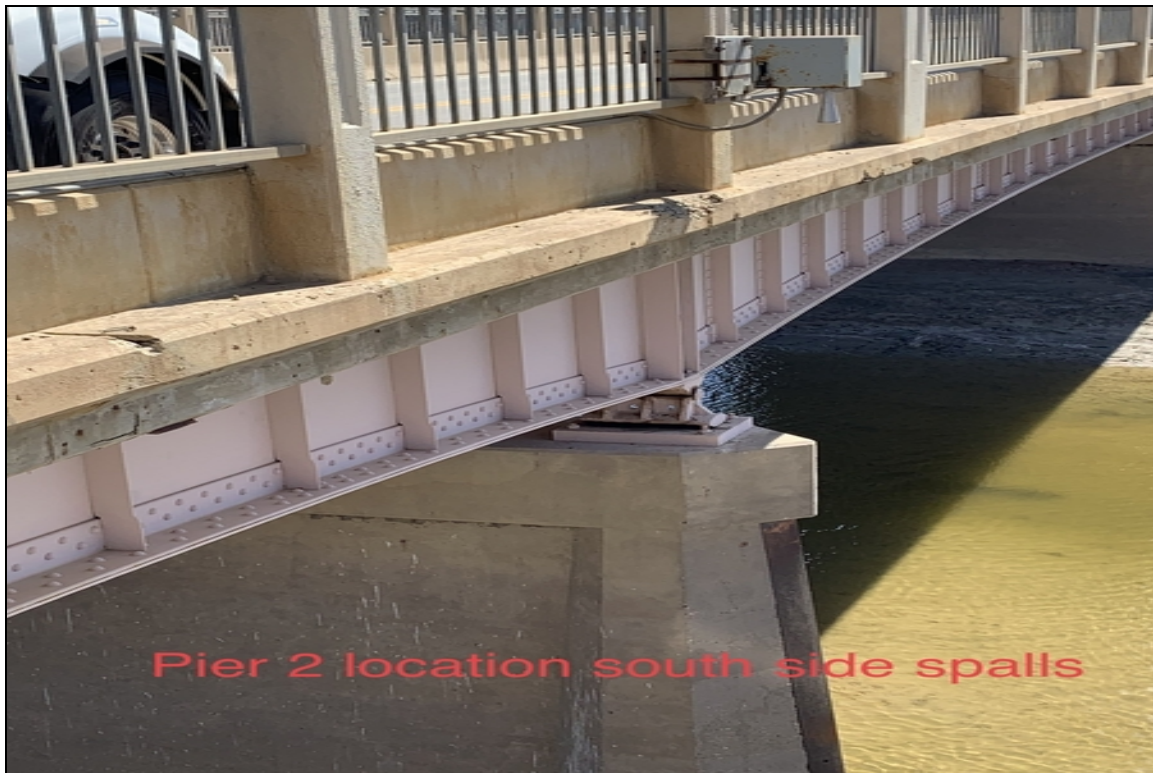
Pier 2 location south over hang spalls

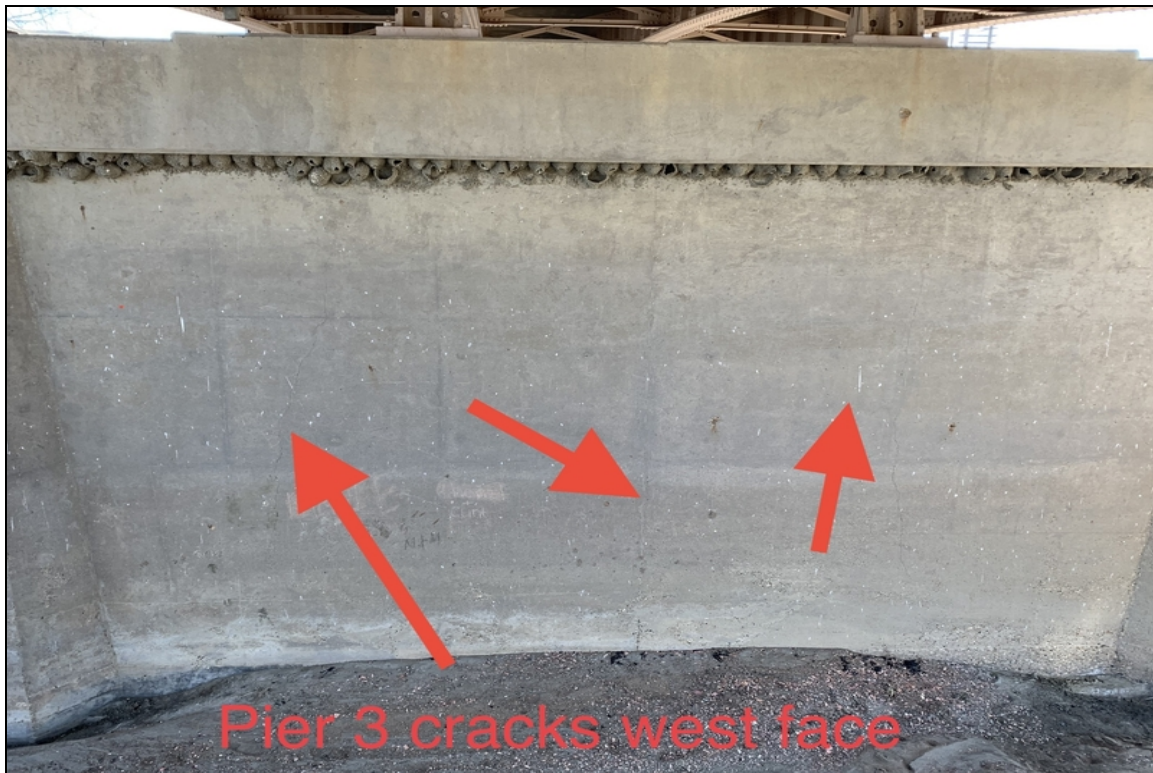
Pier 3 cracks west face
