2 SOUTHEAST OF I-94

IDENTIFICATION	
(1) State Names	North Dakota
(8) Structure Number	0094-901.376
(5) Inventory Route	00094
(2) Highway Agency District	65
(3) County Code	Billings, North Dakota

(4) Place Code	51900
(6) Features Intersected	LITTLE MISSOURI RIVER
(7) Facility Carried	I-94 BUSINESS LOOP
(9) Location	2 SOUTHEAST OF I-94
(11) Mile Point	900.807 mi

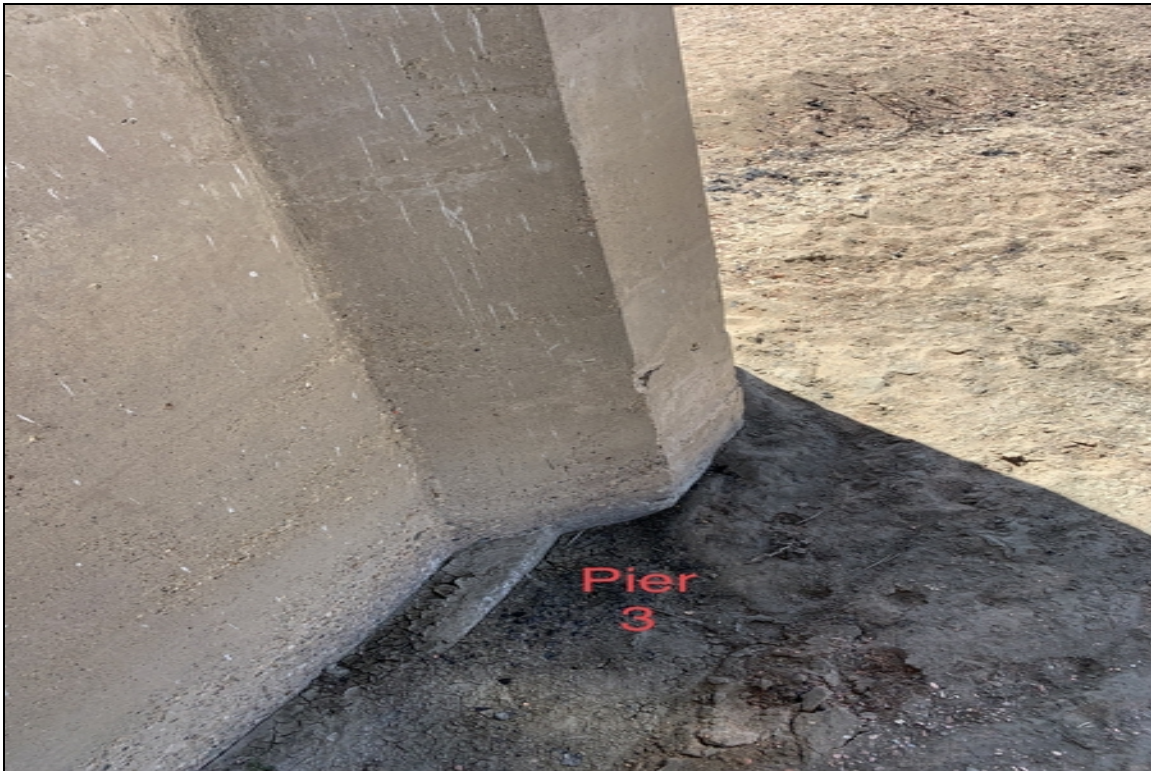
Pier 3 scaling

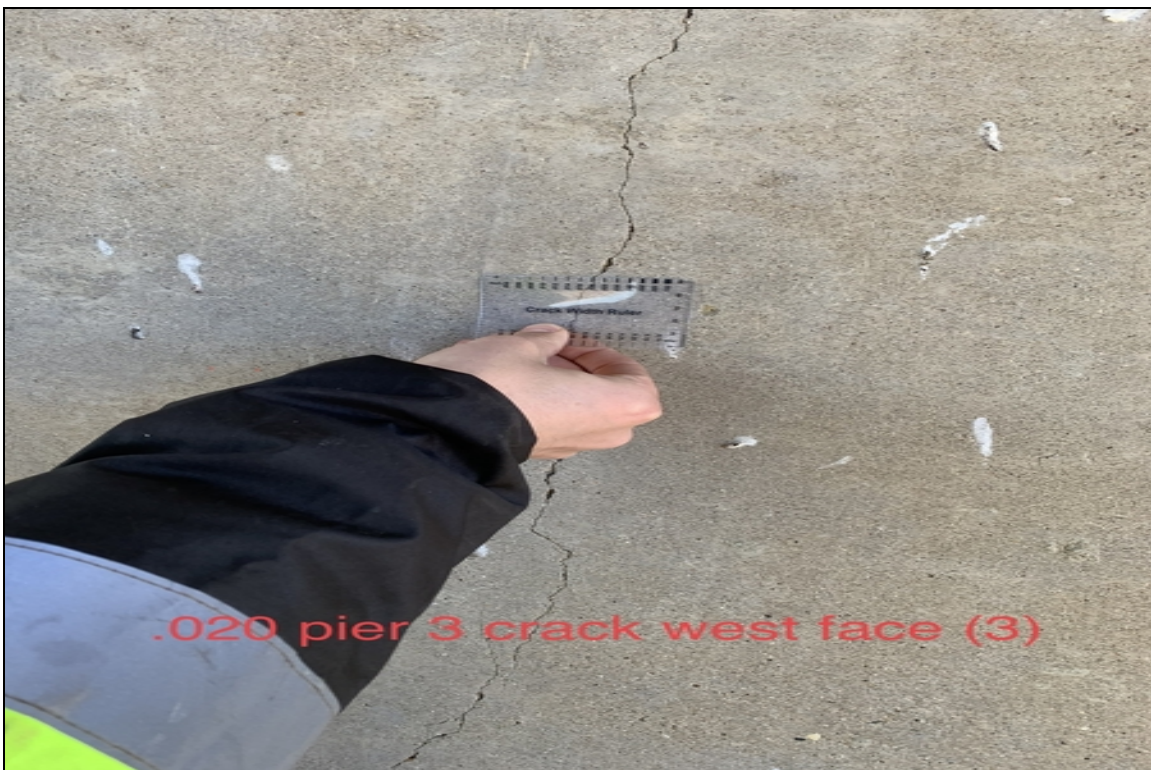
ELEM	DESCRIPTION	UNITS	TOTAL	CS1	CS2	CS3	CS4
210	Reinforced Concrete Pier Wall	LF	75	68	7	0	0
1130	Cracking (RC and Other)	LF	7	0	7	0	0
(210-1130)							
piers have some vertical cracks and scaling. - 11/19/2019							
Pier 2 has 2 cracks that measured approximately 0.020 in width. Pier 3 has 3 cracks that measured approximately 0.020 in width. Pier 4 has 2 cracks that measured approximately 0.020 in width. 19April2021							
215	Reinforced Concrete Abutment	LF	112	106	6	0	0
1130	Cracking (RC and Other)	LF	6	0	6	0	0
(215-1130)							
portion of abutment have vertical cracks and spalls - 11/19/2019							
Abutment 5 has 1 crack in the approximate center of the abutment that measured 0.008 in width. Abutment 1 has approximately 5 cracks that ranged from 0.006 to 0.008 in width. 19April2021							
234	Reinforced Concrete Pier Cap	LF	105	96	9	0	0
1130	Cracking (RC and Other)	LF	9	0	9	0	0
(234-1130)

.020 pier 3 cracks

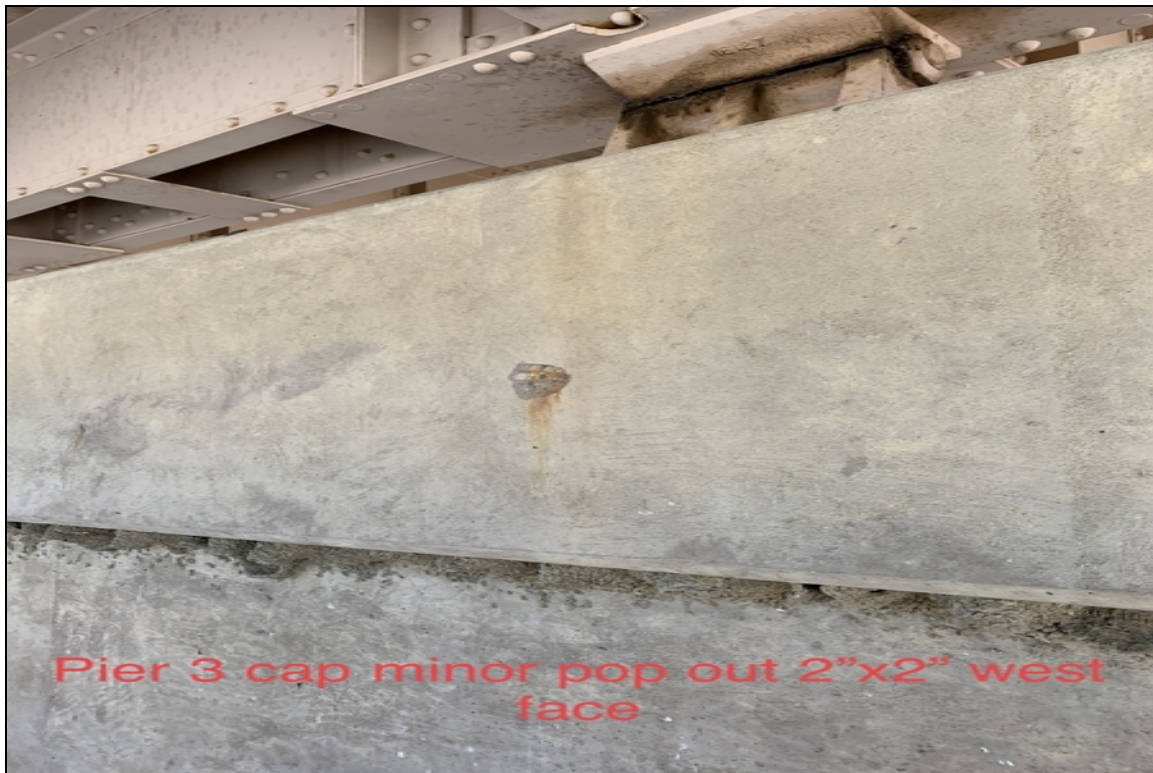
Pier 3 cap minor pop out 2"x2" west face

Pier 3 cap minor pop out 2"x2"

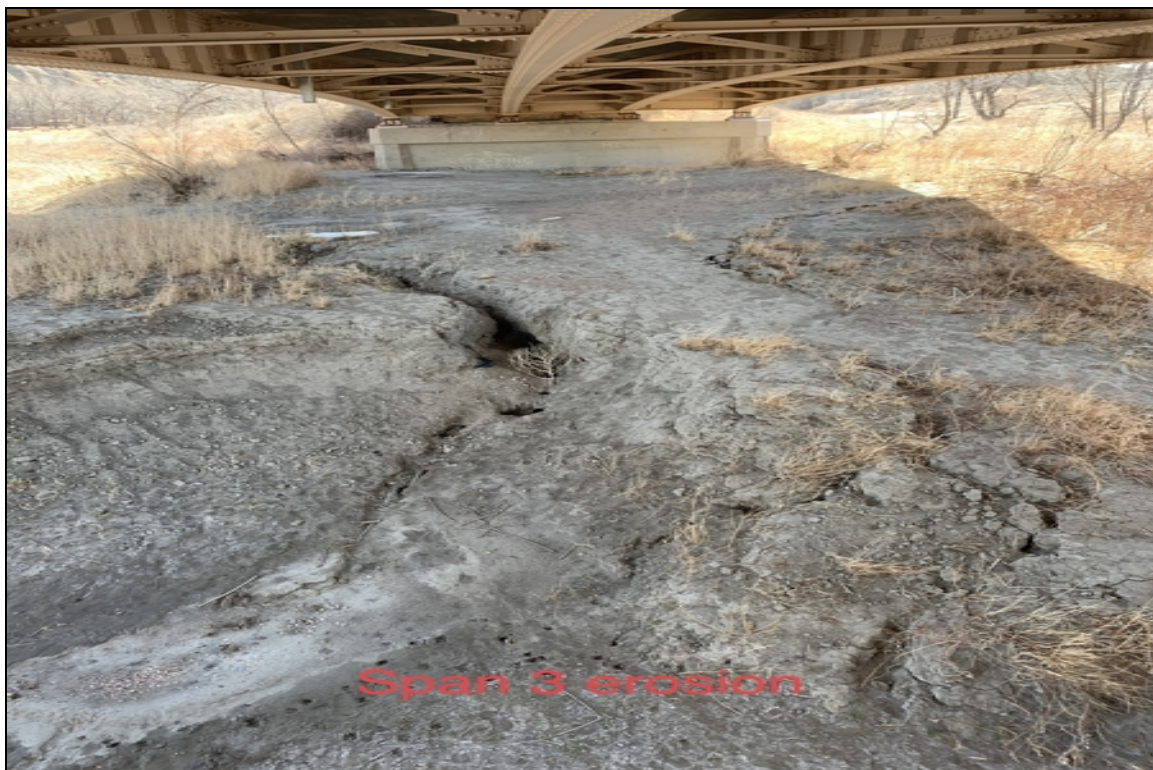
Span 3 erosion

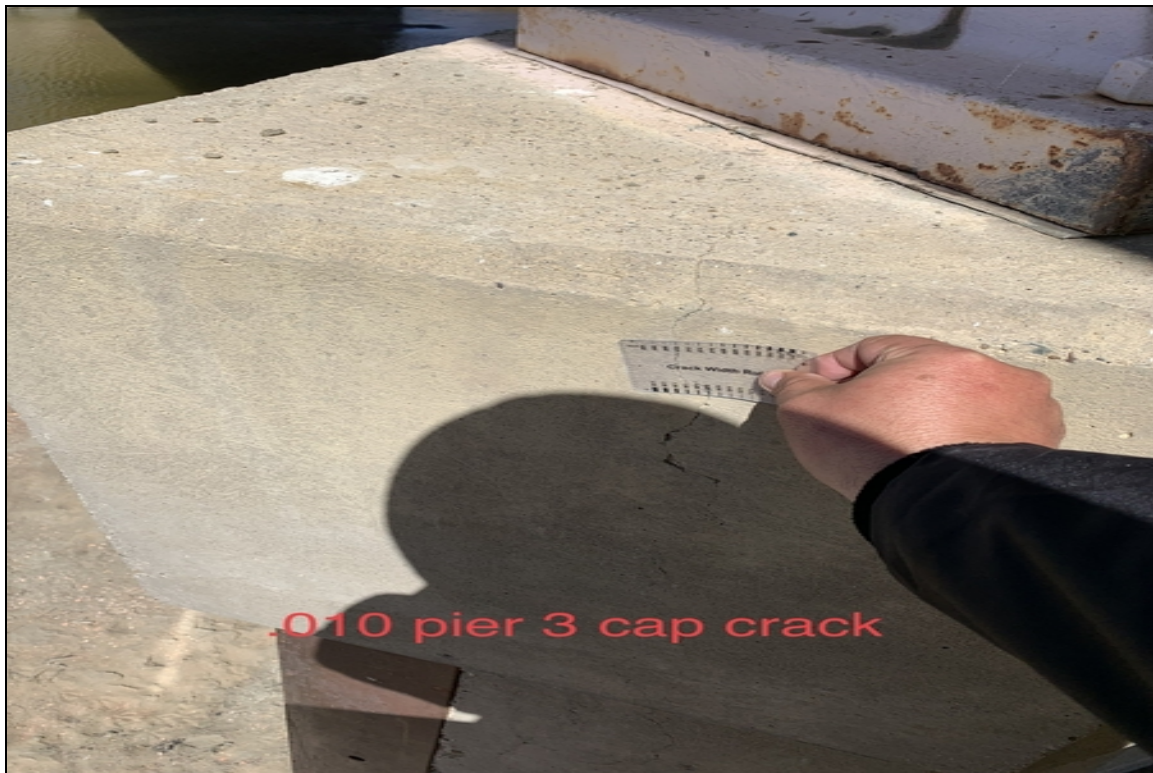
.010 pier 3 cap crack

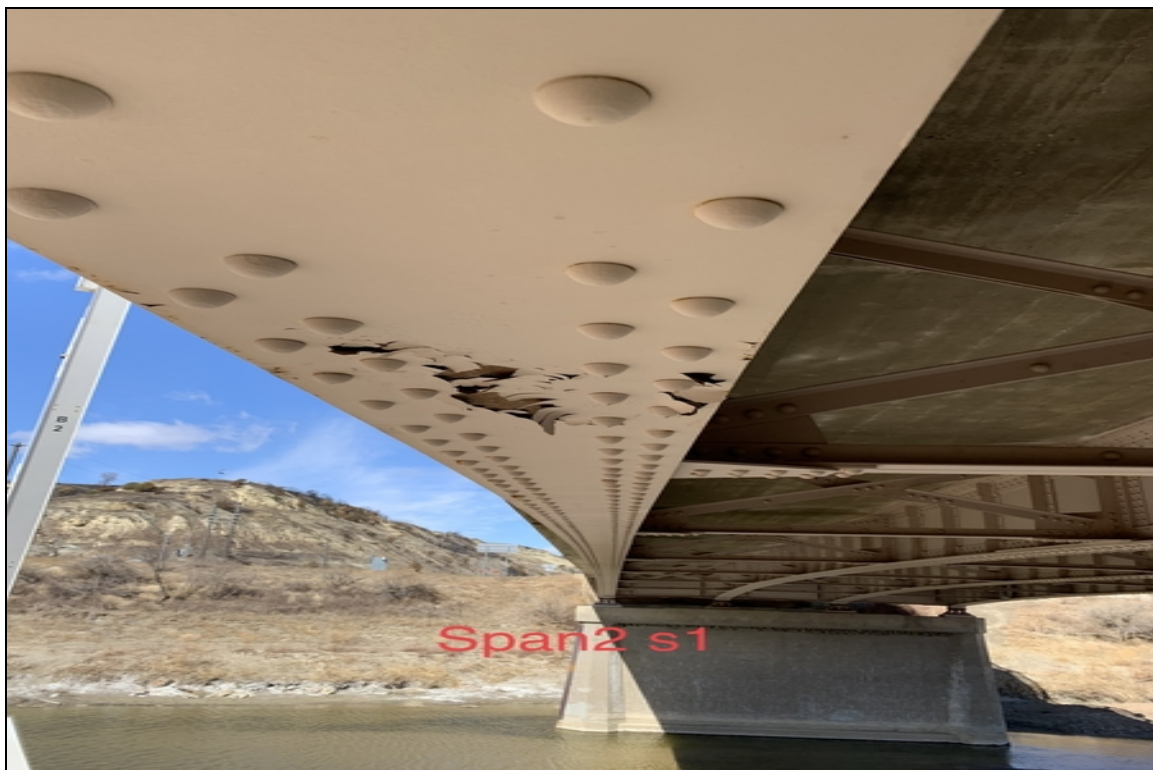
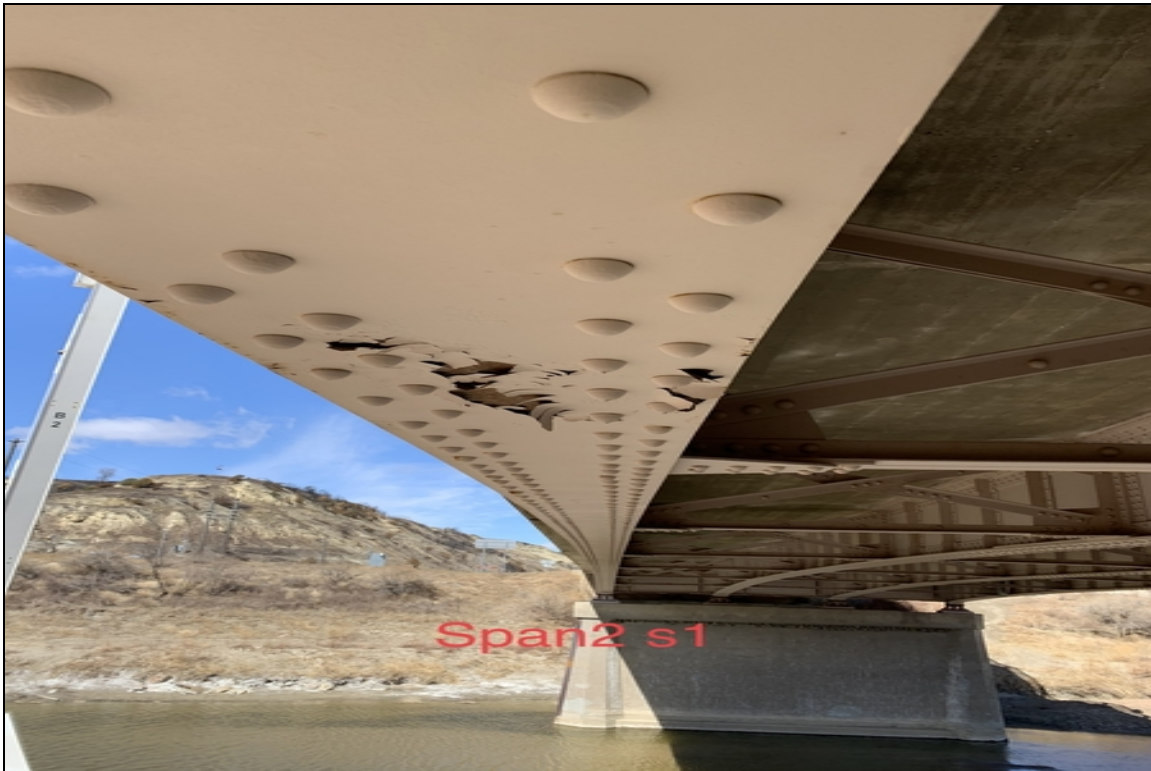
Span 2 s1 paint failure

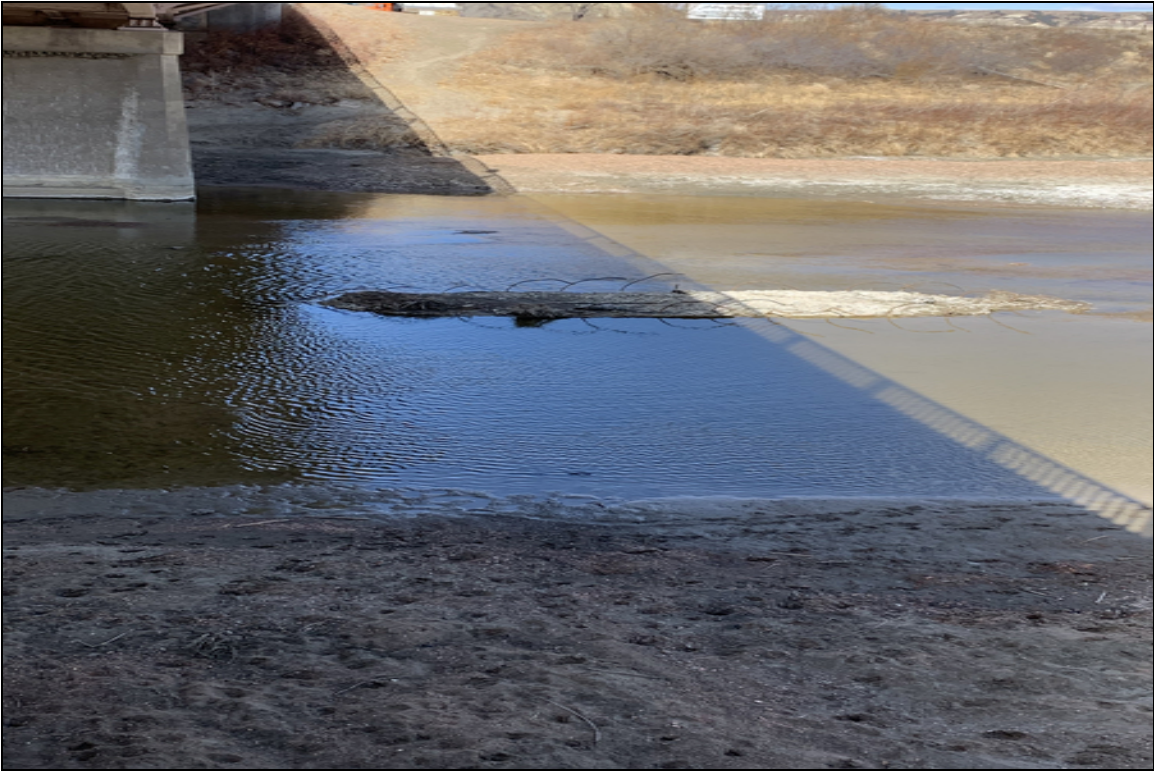
Channel debris

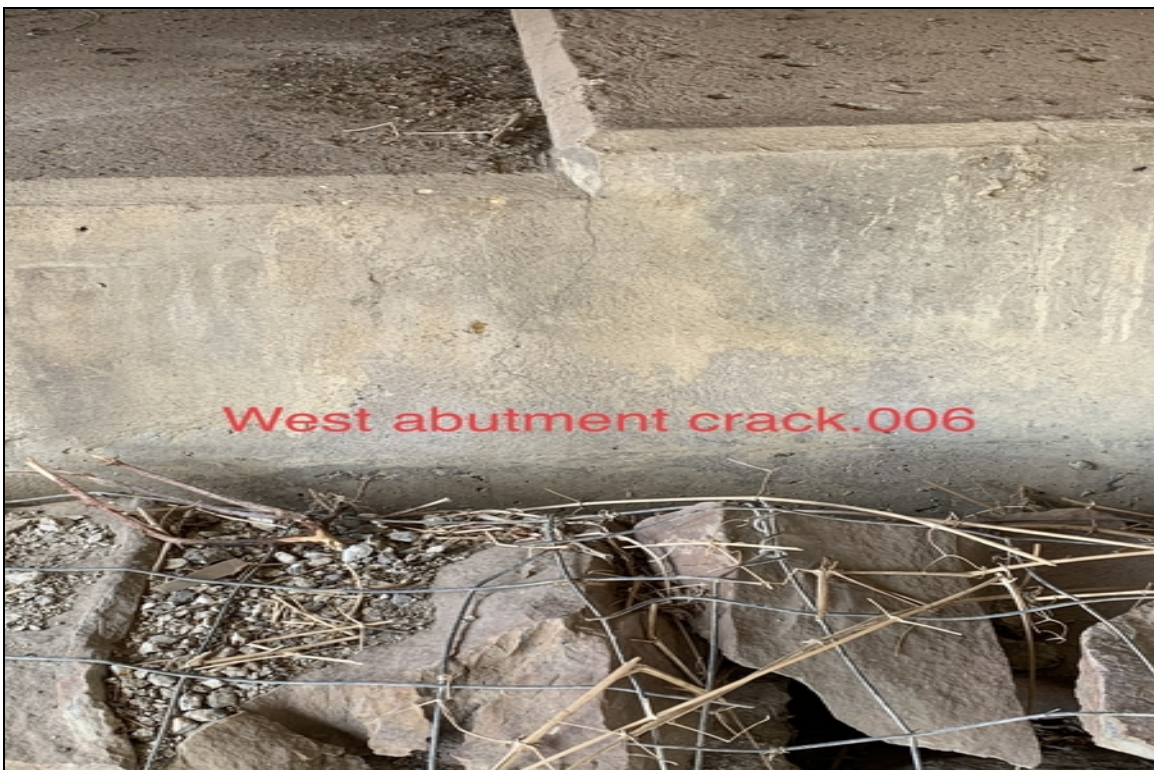
West abutment crack .006

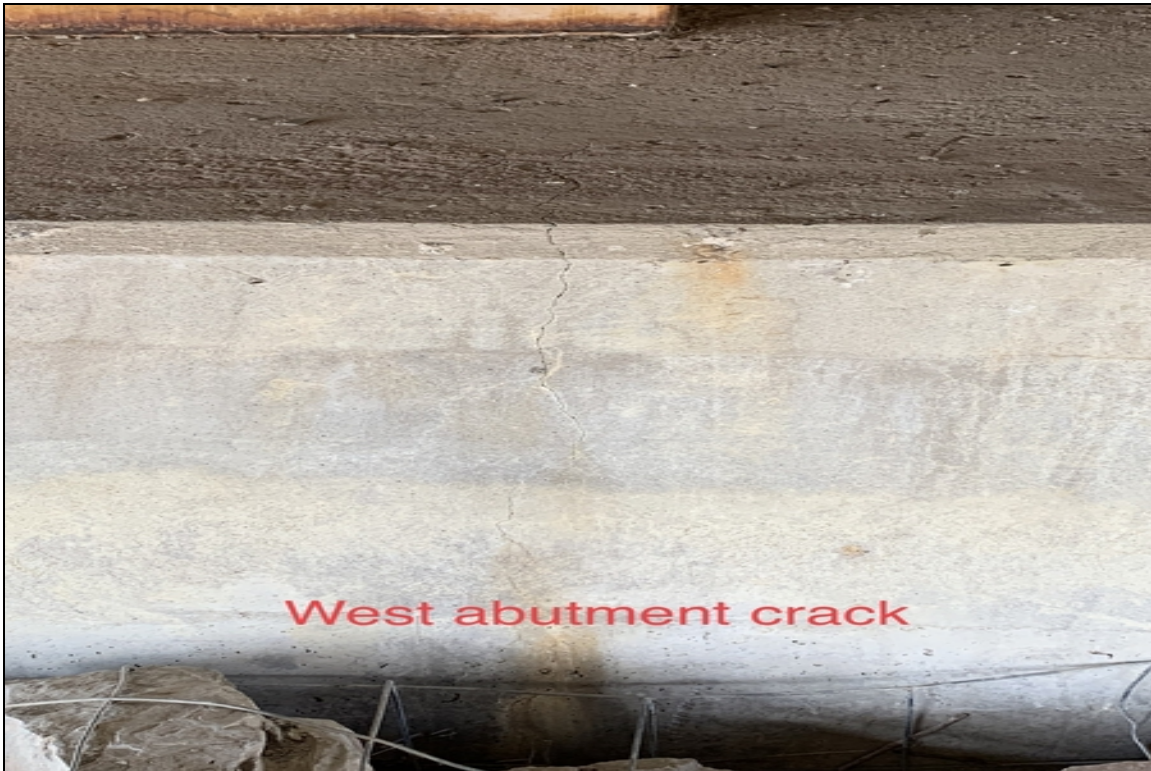
West abutment crack

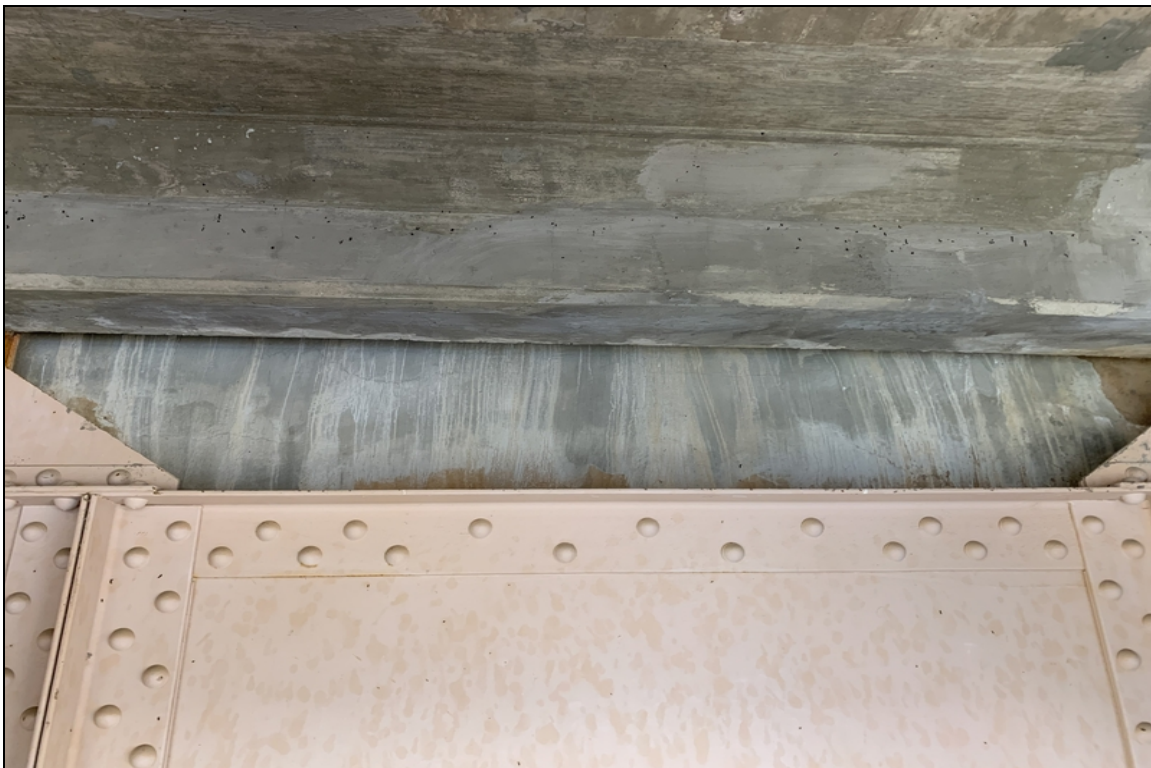
West backwall and deck lips repairs

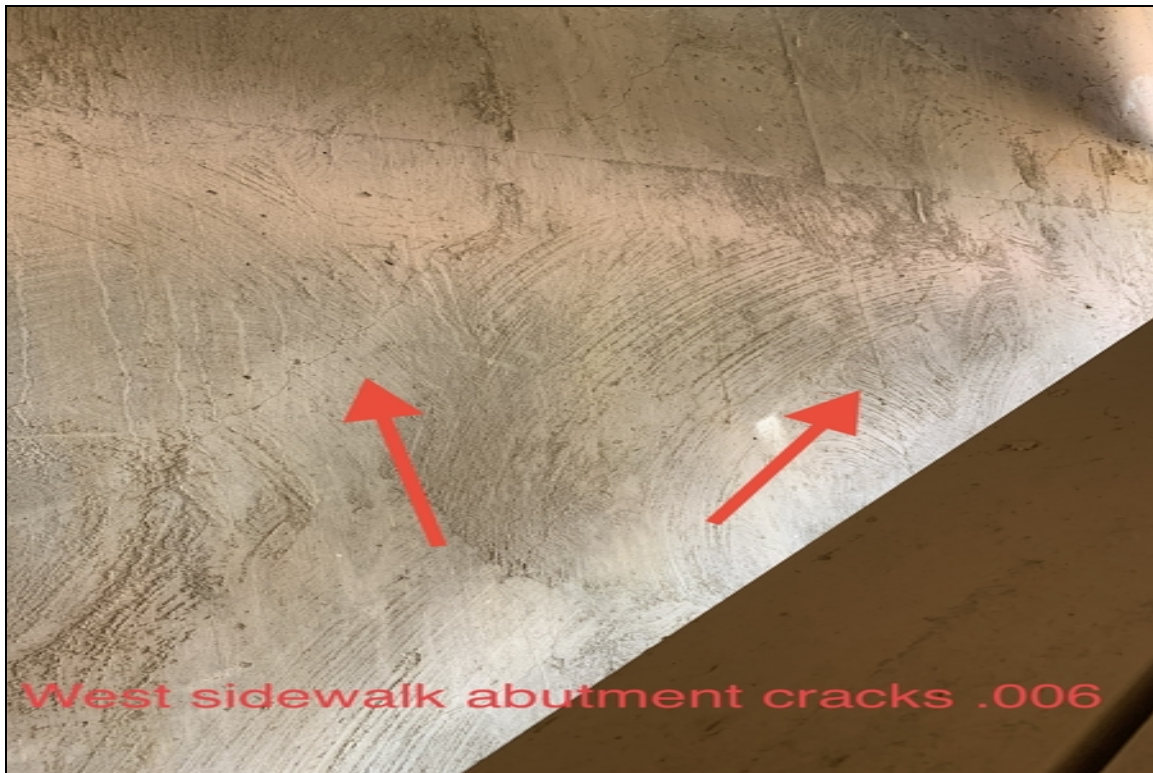
West sidewalk abutment cracks .006

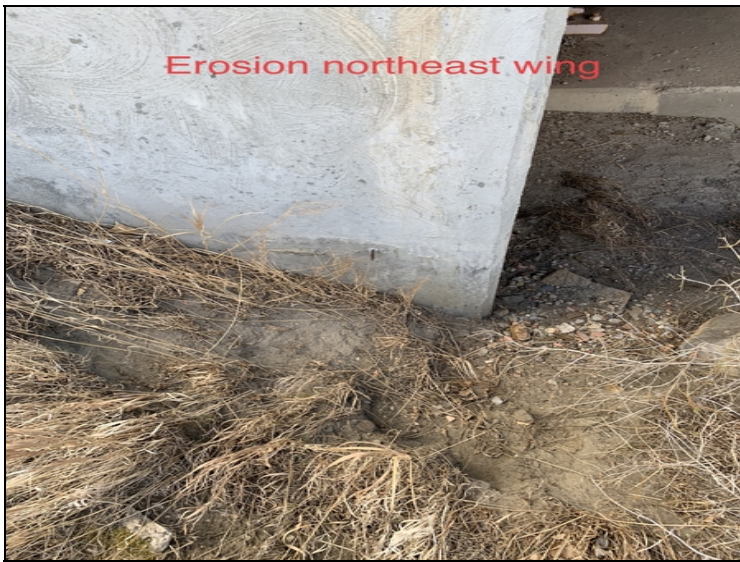
There is some erosion occurring around the bottom of the Northeast wing.

Erosion NE wing

Recommend replacing lost material due to erosion. 19April2021
