UNDERWATER BRIDGE INSPECTION REPORT

Bridge No.: 0023-046.203	Inspection Start Date: 7/20/2023	Inspection Firm: Engineering Operations
County: McKenzie	Facility Carried: IRRFB ND Highway 23	Feature Intersected: Missouri River
Inspection Team: Sam Williams (Team Leader) Taylor White Jonathan Ivey Karl Davis Tyler Liebman

Bridge 0023-046.203 carries North Dakota Highway 23 over Missouri River in McKenzie County. The substructure consists of two reinforced concrete abutments and fourteen reinforced concrete piers (columns), all founded on steel pipe pile supported footings. Piers 2 through 15 were inspected under this contract. The bridge substructures are numbered from **west to east** in accordance with NDDOT's procedures. A Level 3 underwater inspection was performed from the high-water line to the channel bottom and found the substructure units to be in overall **good** condition.

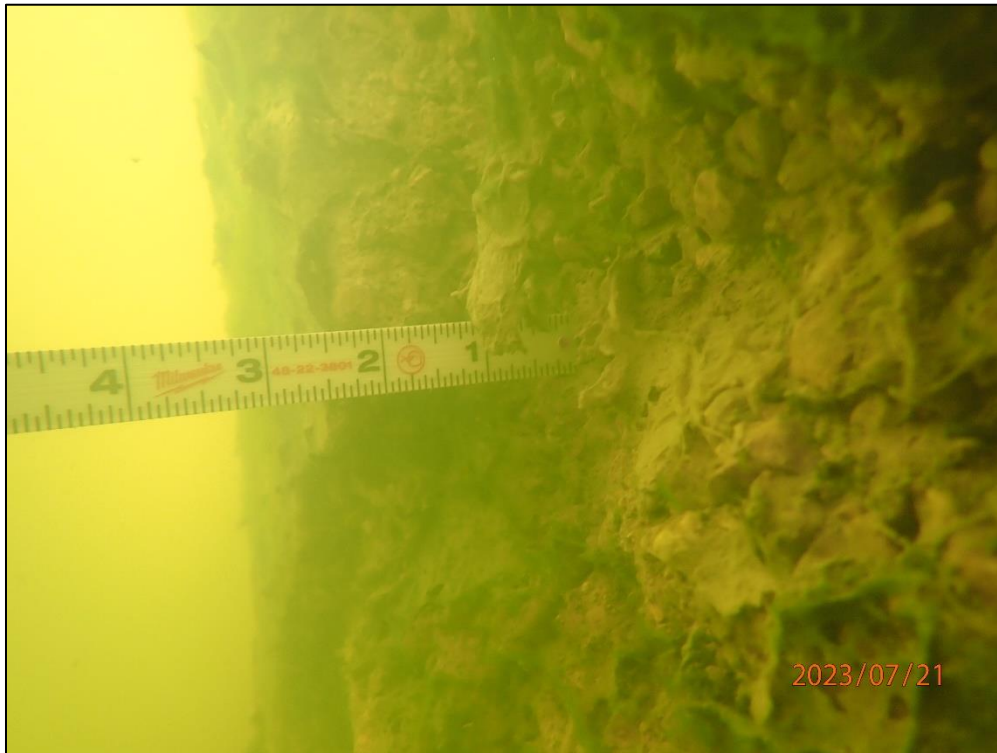
Element 205 – CS3: (1080) Pier 9 column has a spall, 4 feet high x 2 feet wide x 3 inch deep spall, in the southeast quadrant, 13 feet above the top of the footing (1 Each). Refer to Photo 1.

Photo 1 – Pier 9 Spall in Southeast Quadrant

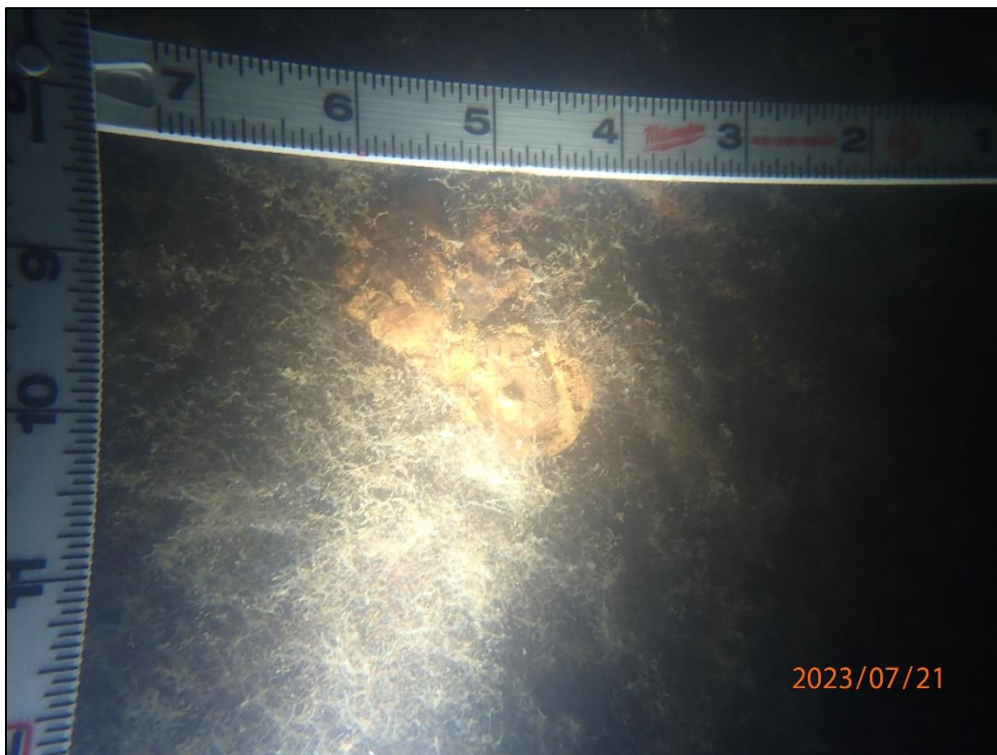
Element 225 – CS2: (1000) All pipe piles have rust nodules, 1/8 inch to 3/4 inch in diameter, covering approximately 50% of the total surface area, with less than 5% section loss (163 Each). Refer to Photos 2 and 3.

Photo 2 – Typical Steel Pile Rust Nodule

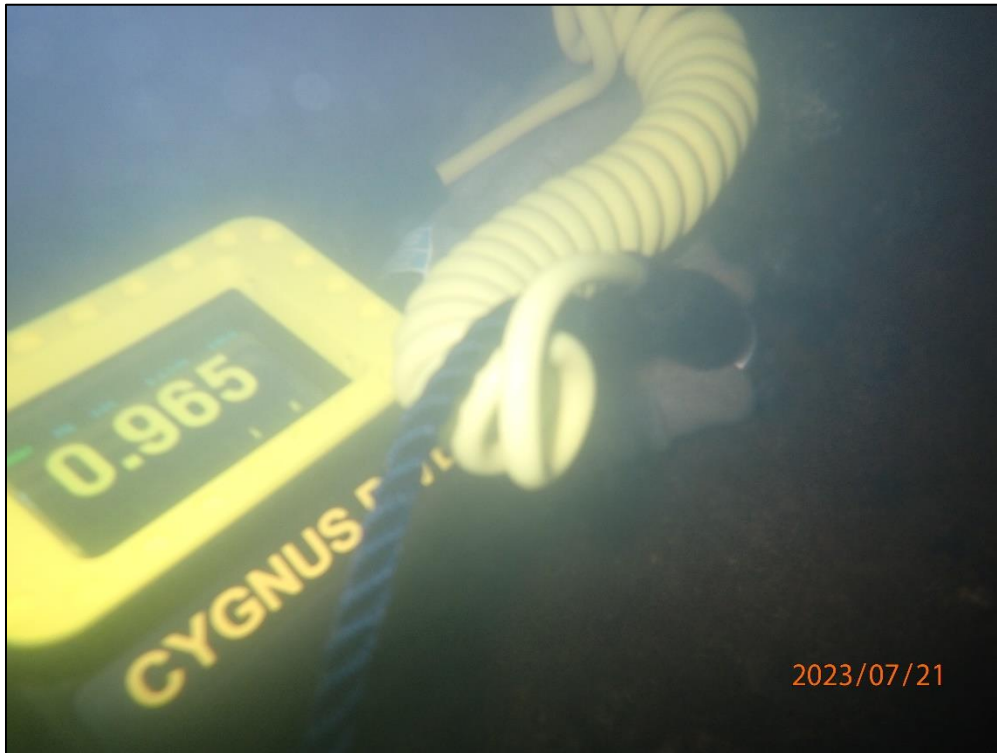
Photo 3 – Typical Remaining Thickness of Steel Pipe Piles

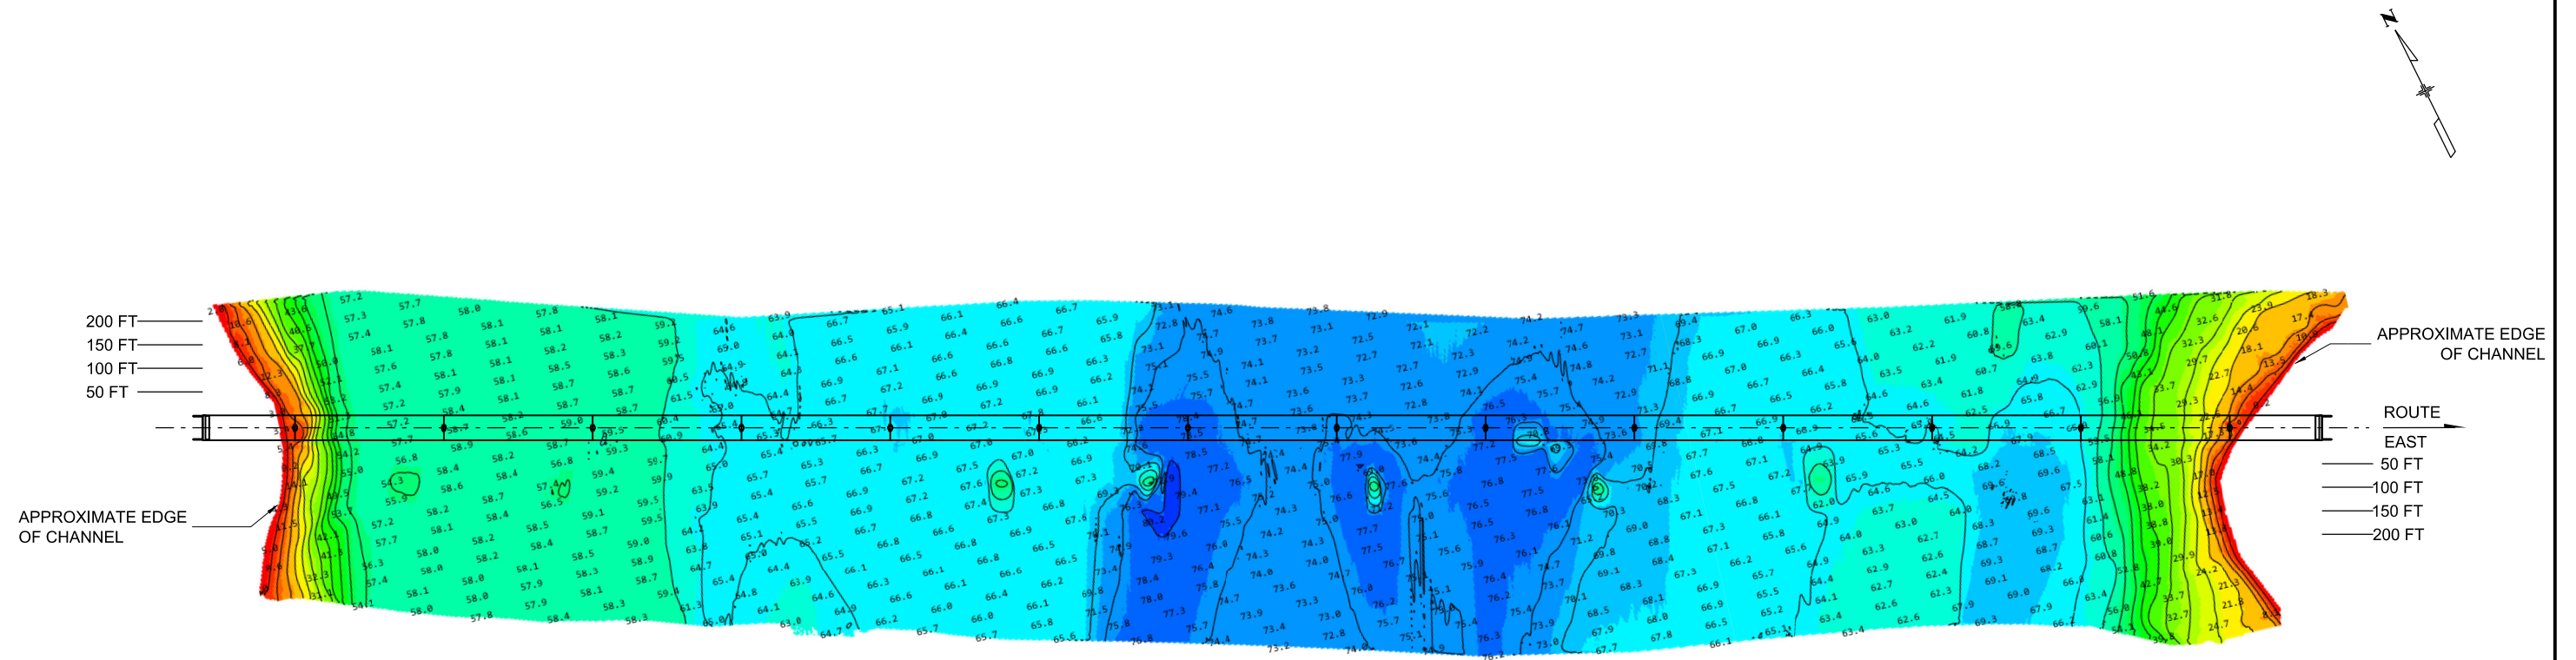
Date of
Inspection: 07/21/2023
Figure No.: A-1.1

The channel is well aligned with the substructure units. The channel bottom is comprised of sandy gravel and soft silt with 3 to 12 inches of probe rod penetration. Random construction debris is scattered about the channel bottom. The banks are armored with riprap and are stable. There are no signs of significant scour or bank erosion. Refer to Figure A-1 for contours.

- ALL CHANNEL PROFILE DATA COLLECTED IN THE FIELD IS ACCURATE $\pm 1/2$ FT.
- AT THE TIME OF INSPECTION, THE WATERLINE WAS 16.0 FT ABOVE THE TOP OF THE FOOTING AT PIER 10, CORRESPONDING TO A WATERLINE ELEVATION OF 1843.0 FT.
