GEOTECHNICAL REPORT
Valley City SW Backslope Slide Repair,
2-094(185)290 PCN 23338
VALLEY CITY, NORTH DAKOTA

Subject: GEOTECHNICAL REPORT, VALLEY CITY SW BACKSLOPE SLIDE REPAIR,
2-094(185)290 PCN 23338, VALLEY CITY, NORTH DAKOTA

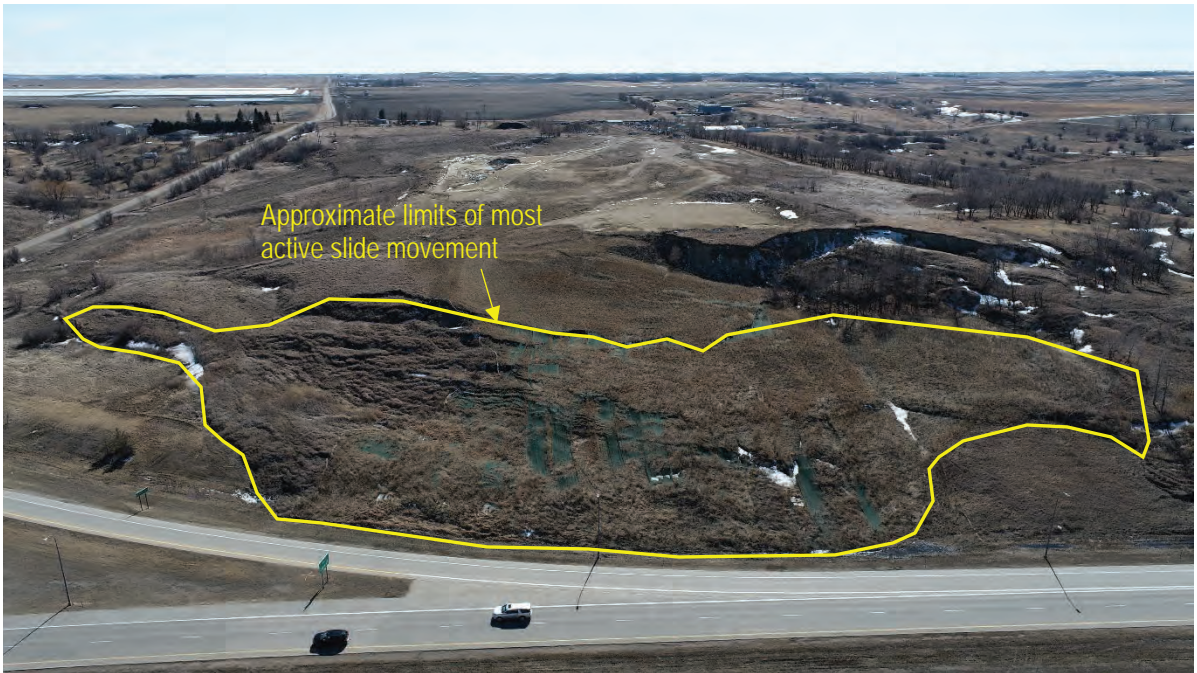
- The lower portion of the graded slope has continued to fail since being regraded in 2019 (see Exhibit 3-2).
- The lower limit of the movement is characterized by an overridden toe feature with ponded water in parts of the drainage ditch (see Exhibit 3-3). Landslide debris is spilling over the toe of the failure and accumulating in the drainage ditch. Drilling the material that has spilled into the ditch was not possible due to access issues, but we anticipate that the thickness of the spilled-over debris is less than 10 feet.

Exhibit 3-1: Site Reconnaissance Photo 1 - Overview of the landslide complex taken from the north side of Interstate 94, looking south. Green fabric on the slope is an erosion control blanket/turf reinforcement mat (TRM) placed during a grading project in 2019.

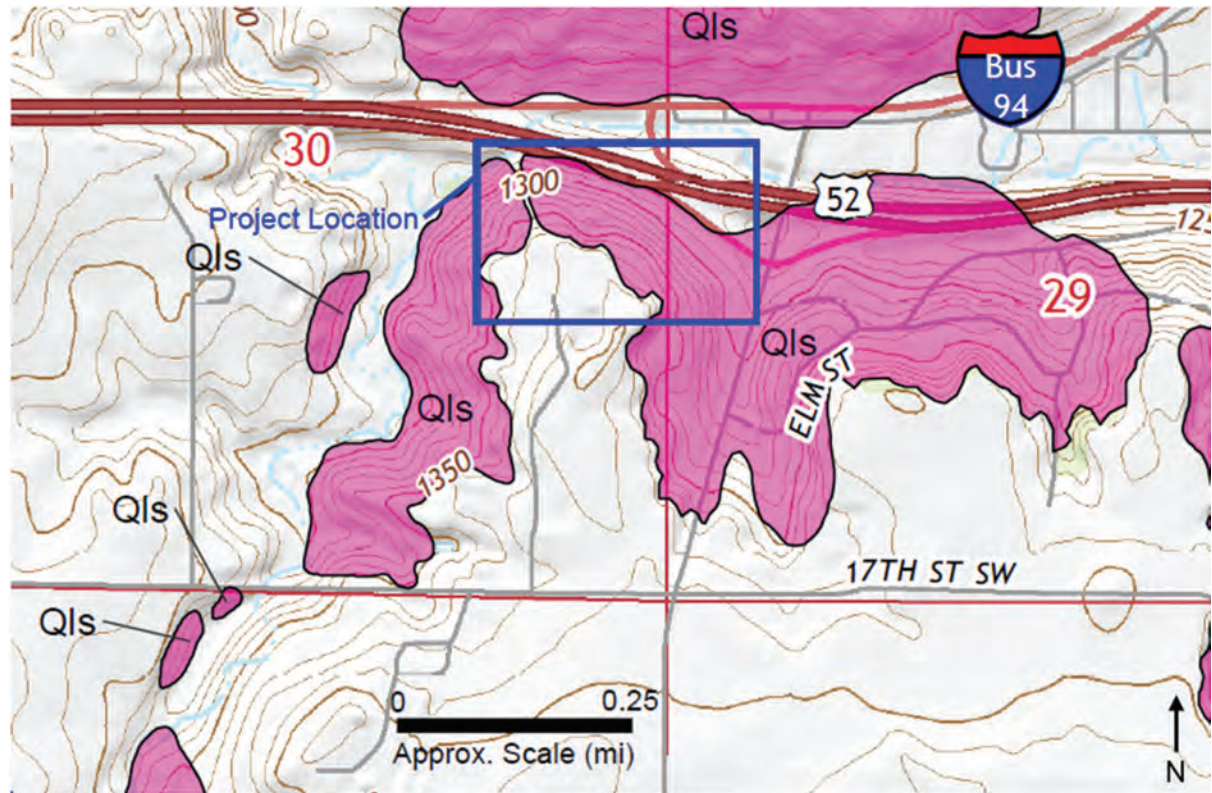
Exhibit 5-1: Landslide Map of Project Site

A review of the Surface Geology - Valley City West Quadrangle, North Dakota (Manz, 2008) indicates that the surficial geology at the site consists primarily of Quaternary-age glacial and/or preglacial landslide deposits overlying Cretaceous-age Pierre Formation shale (referred to on the boring logs and figures as Pierre Shale). Quaternary-age glacial till is also indicated in the vicinity of the Project site. The Pierre Formation is described as “dark gray, fissile, non-calcareous shale ... Prone to slope failure.” Landslide mapping from the North Dakota Geological Survey (Anderson, 2020) indicates that the Project area is part of a much larger landslide complex (see Exhibit 5-1). This complex, and other nearby slide complexes,
