**ND HIGHWAY 11 over DRAINAGE DITCH**

**Location: 13 EAST ND HIGHWAY 1**

**Inspection Date: 06/17/2025**

| IDENTIFICATION | |
|---|---|
| (8) Structure Number | 0011-118.863 |

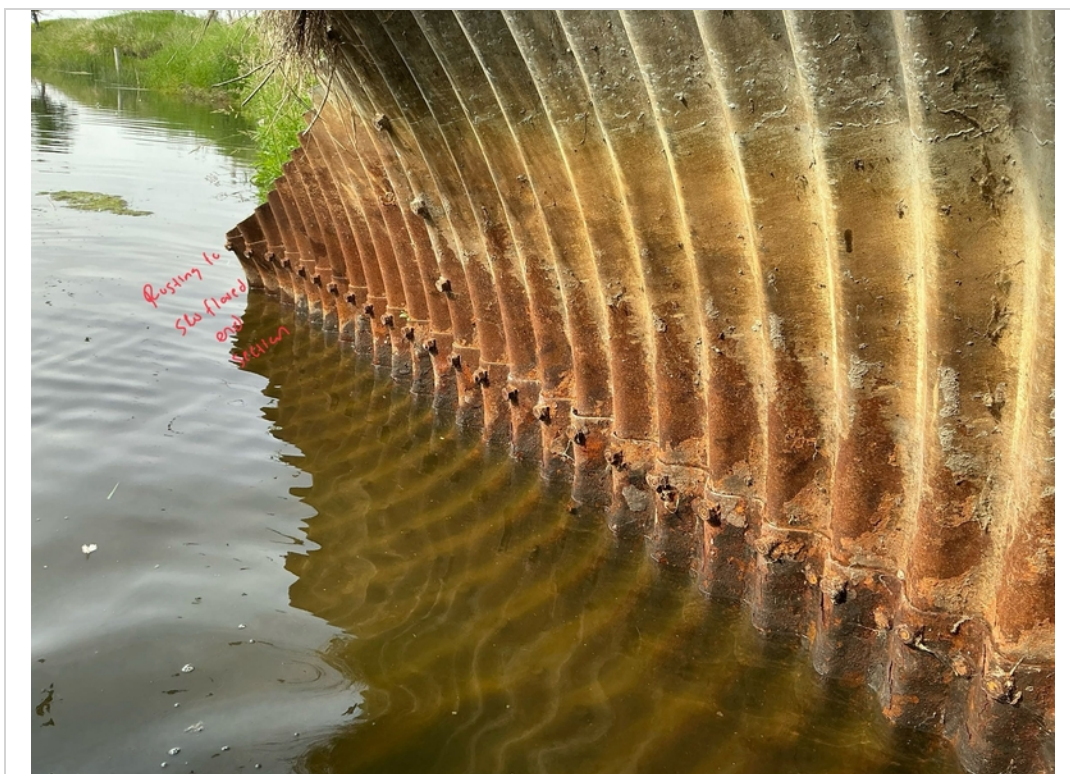
Both Flared End Sections Rusting to Lower Portion.

Facing SW. Rusting to South Flared End Section. Typical all Corners.

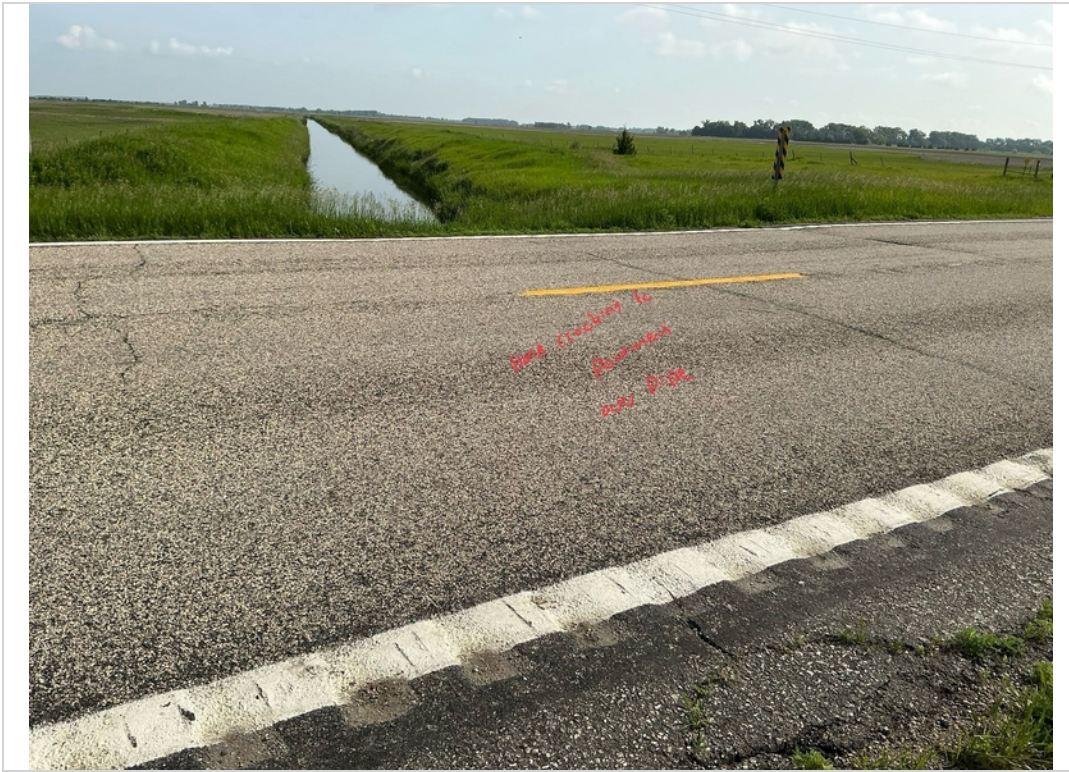
6/21/2023 - Some Transverse Cracking to HMA Pavement across Pipe.

Facing North. Cracking to HMA Pavement over Pipe.

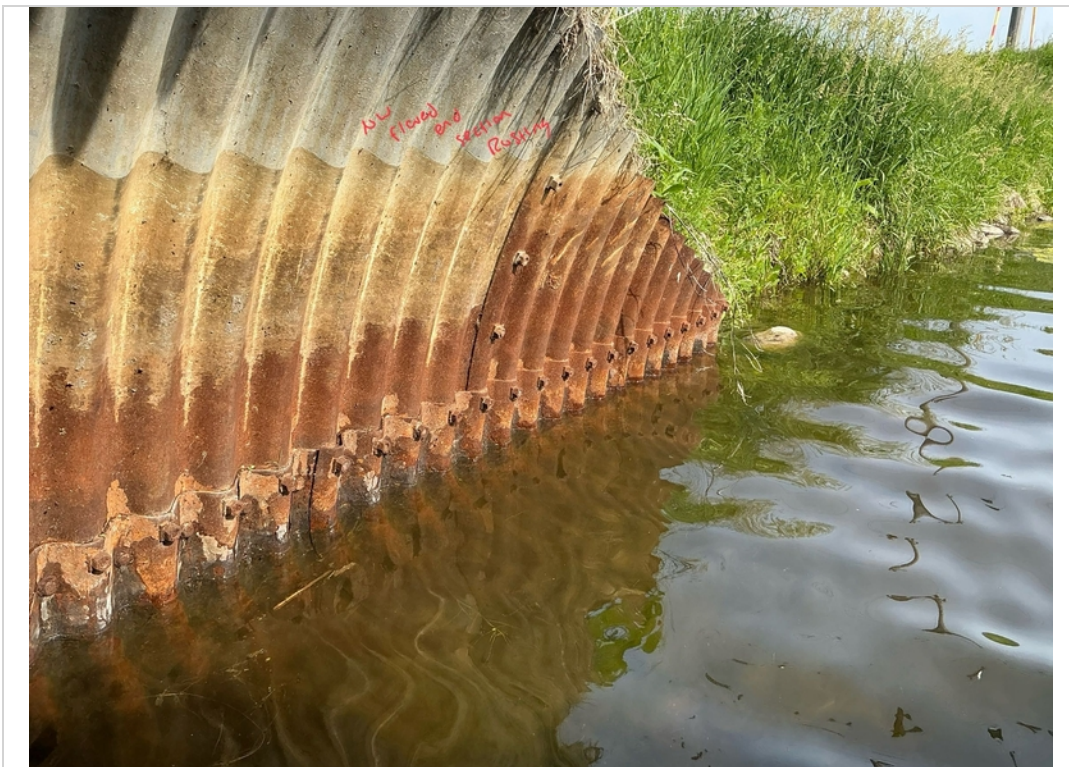
Facing North. Rusting to NW Flared End Section. Typical

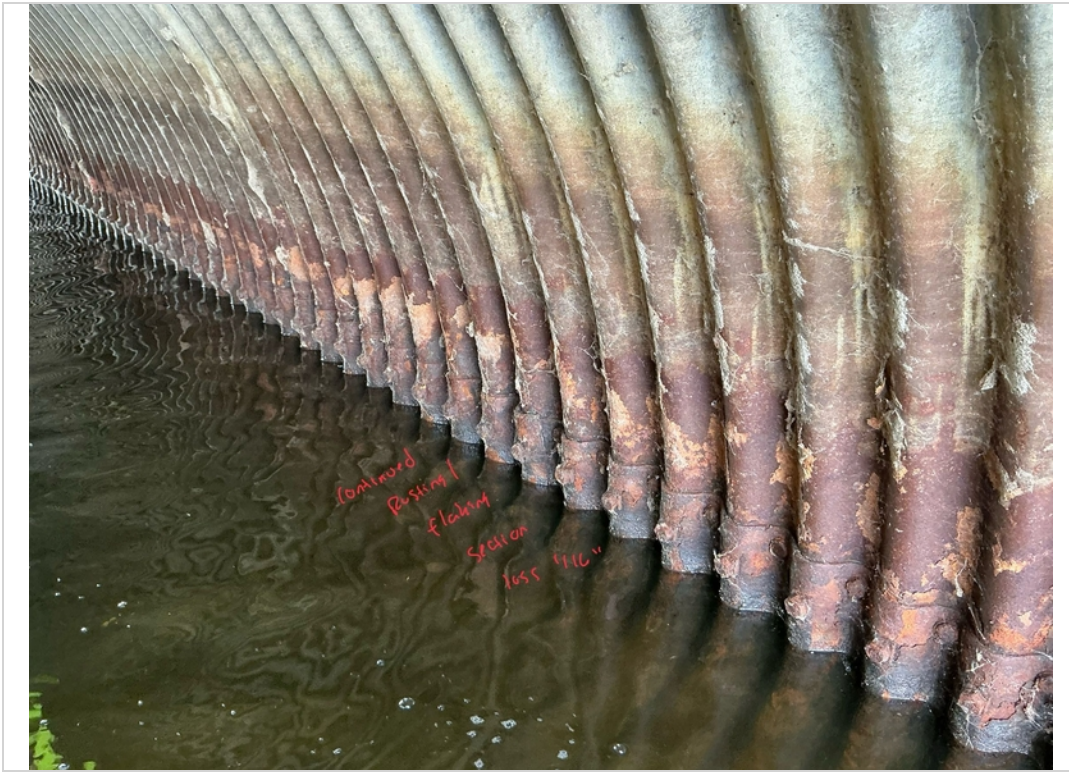
6/21/2023, 6/17/2025 - Continued Flaking of Coating and Pipe beginning to occur along both sides of Pipe throughout.  
Estimated section loss 1/16'.

Facing NE. Moderate Rusting with Flaking and Section Loss to Pipe.

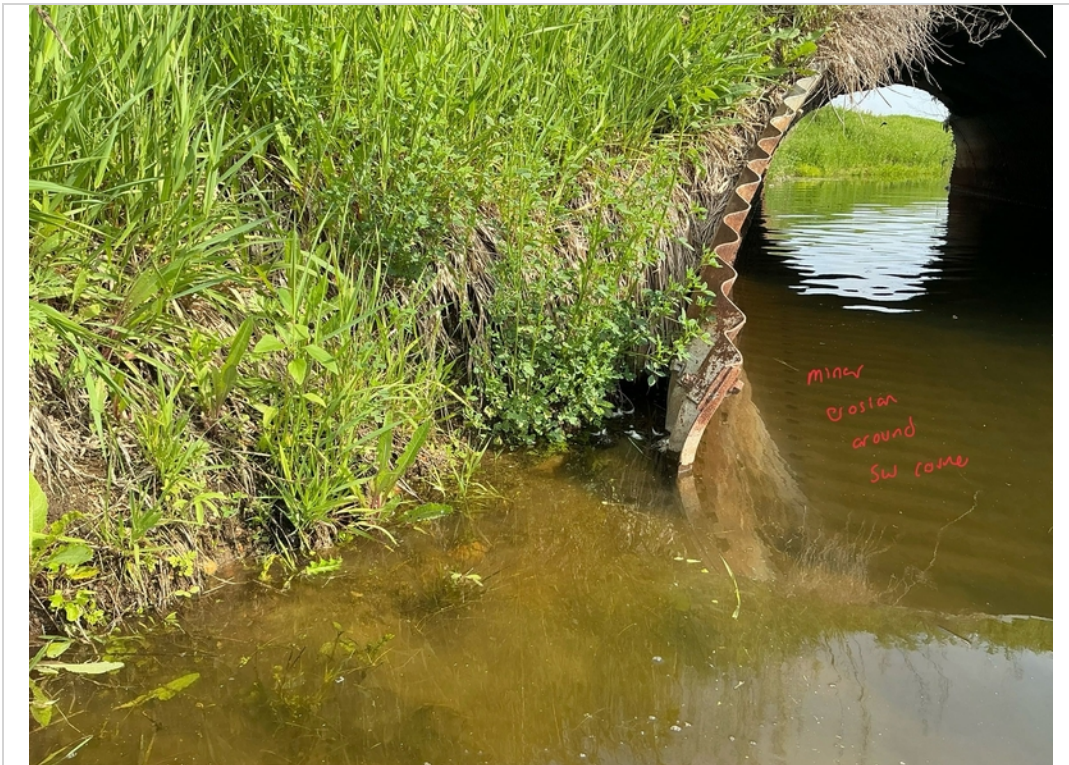
Rip Rap being displaced with some erosion occurring around all Flared End Section Corners.

Facing North. Minor Erosion around SW Flared end Section. Typical all corners.

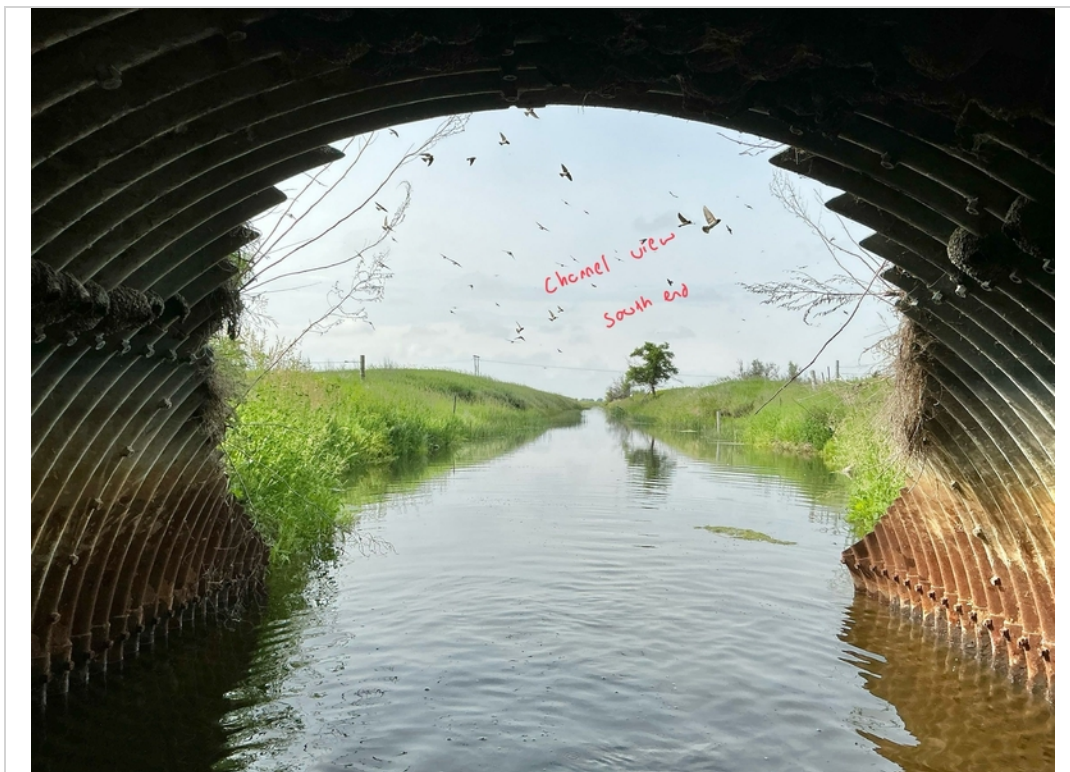
6/21/2023, 6/17/2025 - Channel Banks sloughing with some erosion Upstream and Downstream

Facing South. Channel View South End.

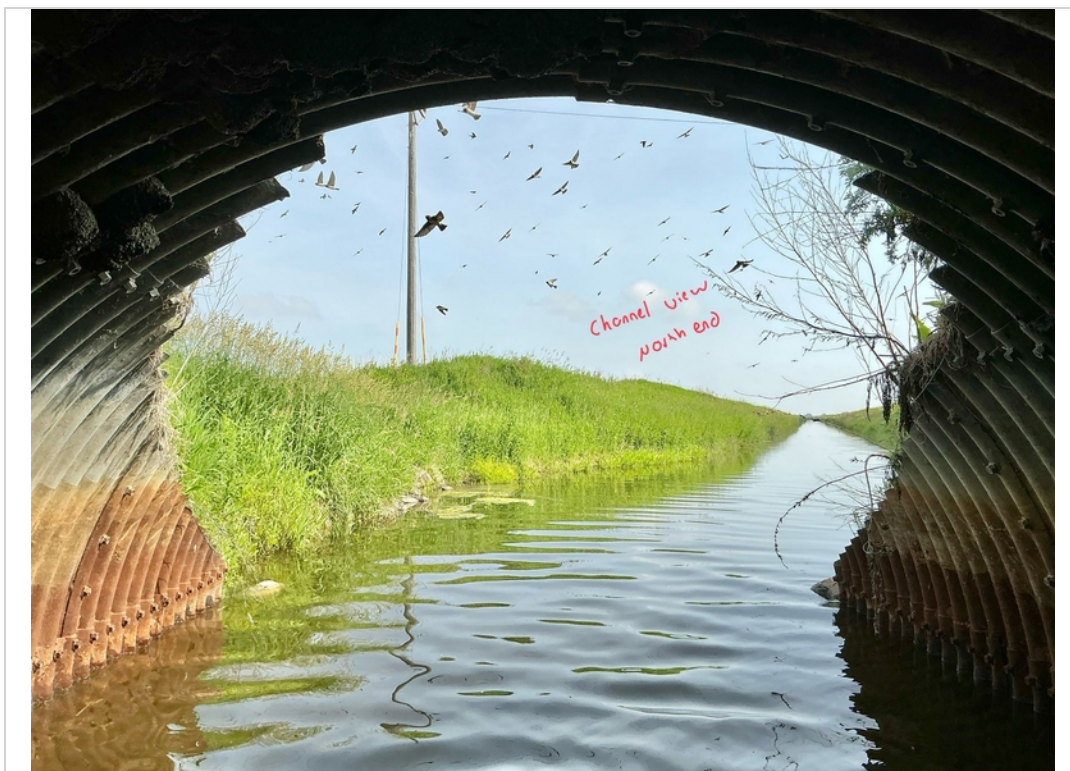
Facing North. Channel View near North End.

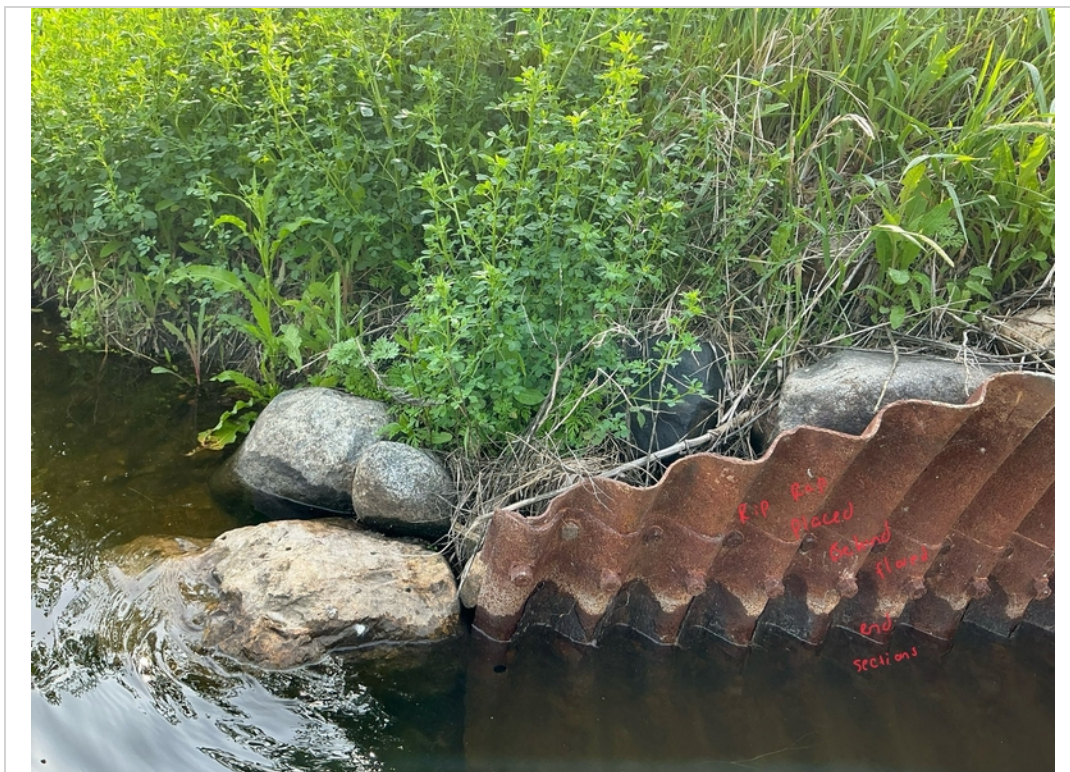
Facing East. Rip Rap placed behind NE Flared End Section. Typical all corners.

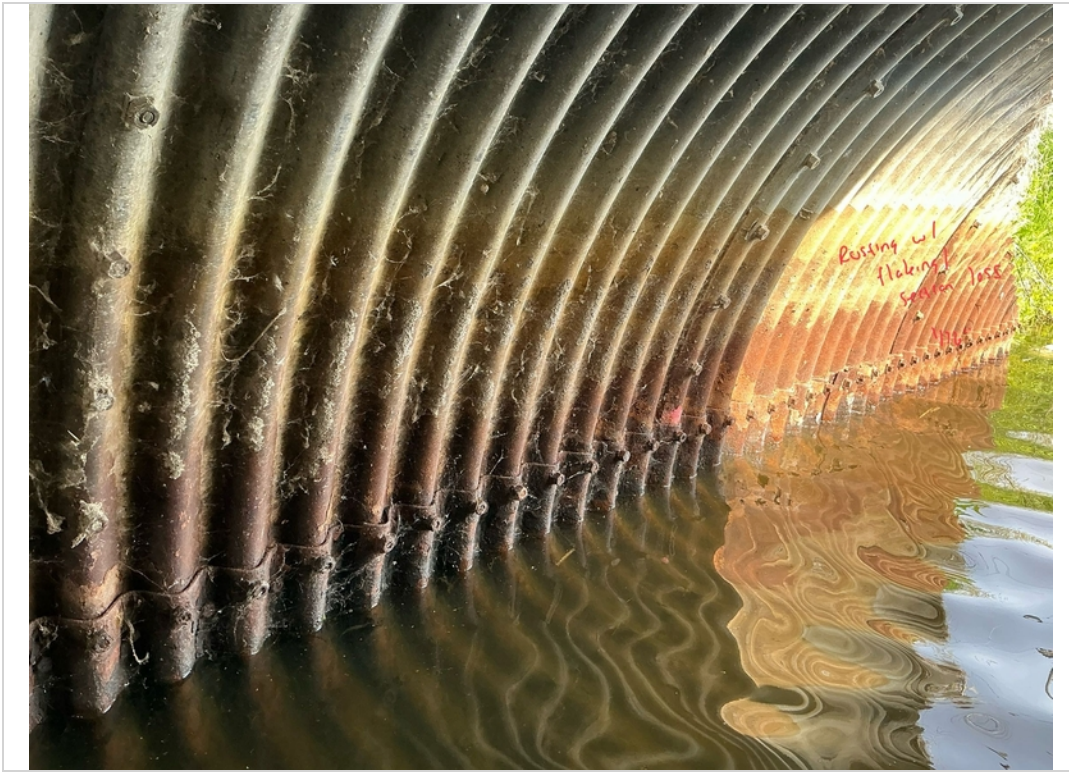
Facing NW. Rusting with Flaking and Section Loss to Pipe Sides.

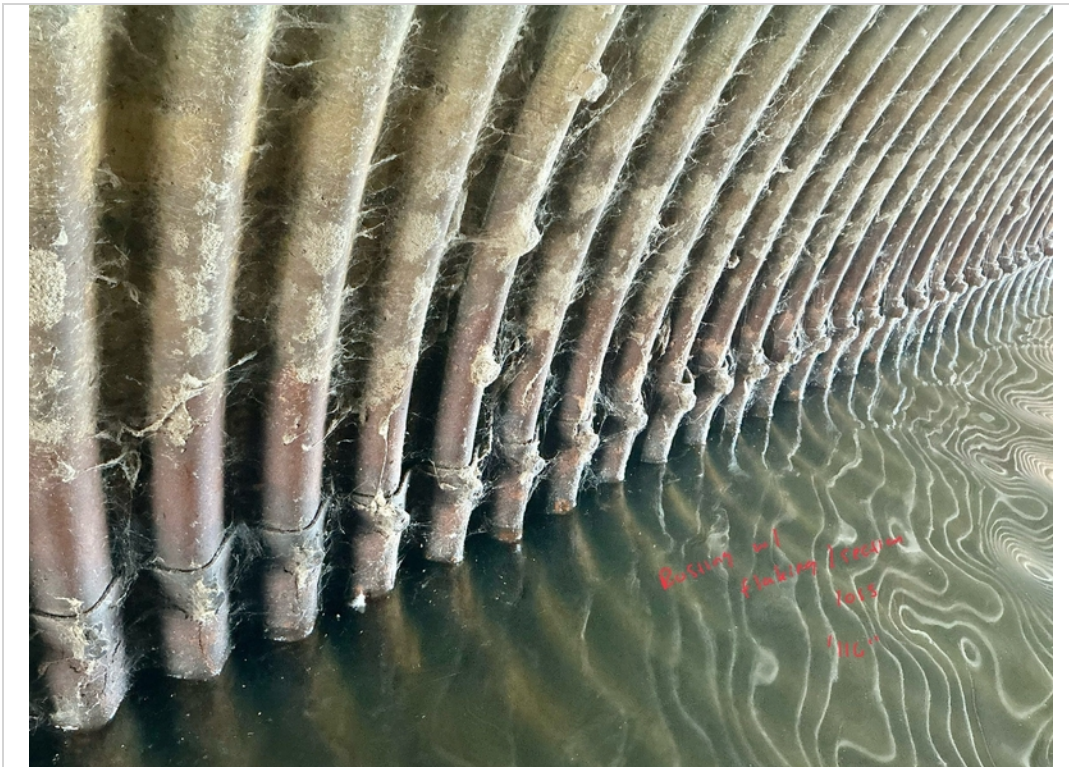
| ELEMENTS | DESCRIPTION | UNITS | TOTAL | CS1 | CS2 | CS3 | CS4 |
|---|---|---|---|---|---|---|---|
| (1000-240) Slightly corrosion at the water line. - 12/19/2019<br>6/9/2021 - Rusting to lower 1/3 of culvert throughout entire length beginning around the lower connection to the floor. See Photos.<br>6/21/2023 - Areas of CS 2 Rusting to Lower Portion of Pipe from above Connection Seam to Floor.<br>Moderate CS 3 Rusting with flaking and section loss up to 1/16" beginning to occur along East Wall near Mid Length. See Photos.<br>6/17/2025 - Advancement of Moderate CS 3 Rusting with Flaking and Section Loss continuing along water line and Lower connection seam throughout. Estimated Section Loss 1/16". See Photos. | | | | | | | |

Facing NW. Rusting with Flaking and Section Loss to Lower Portion of Pipe along Connection Seam.

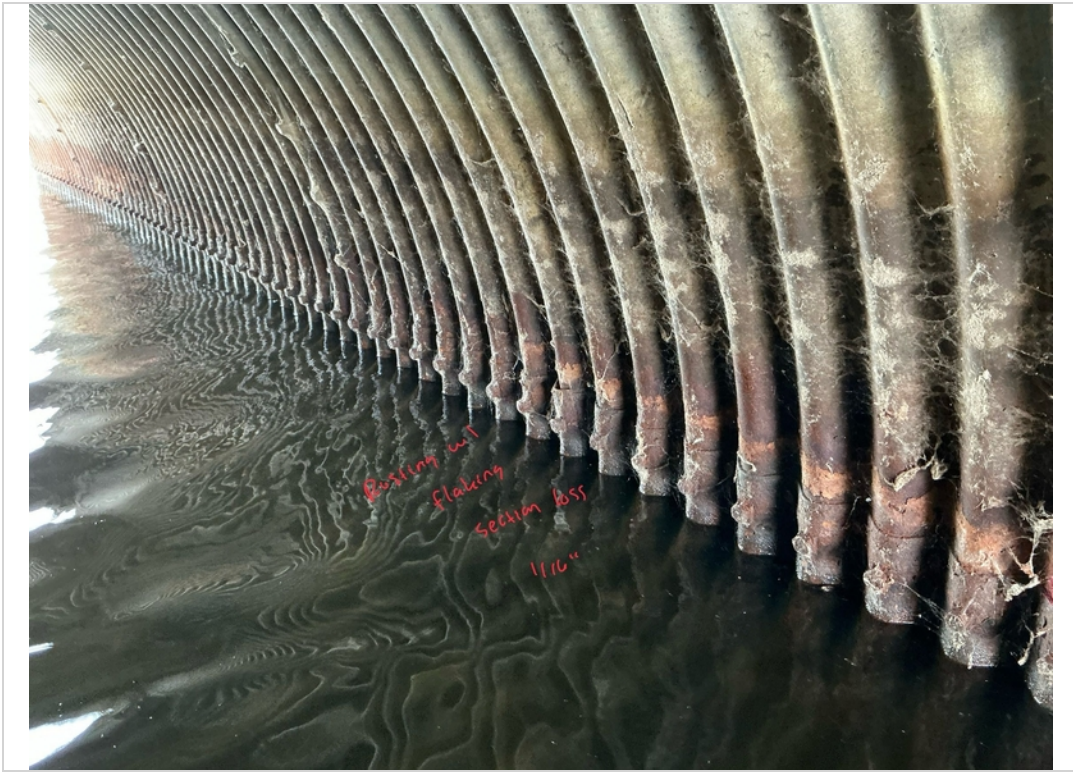
Facing NE. Rusting with Flaking and Section Loss along Connection Seam to Lower Portion of Pipe.

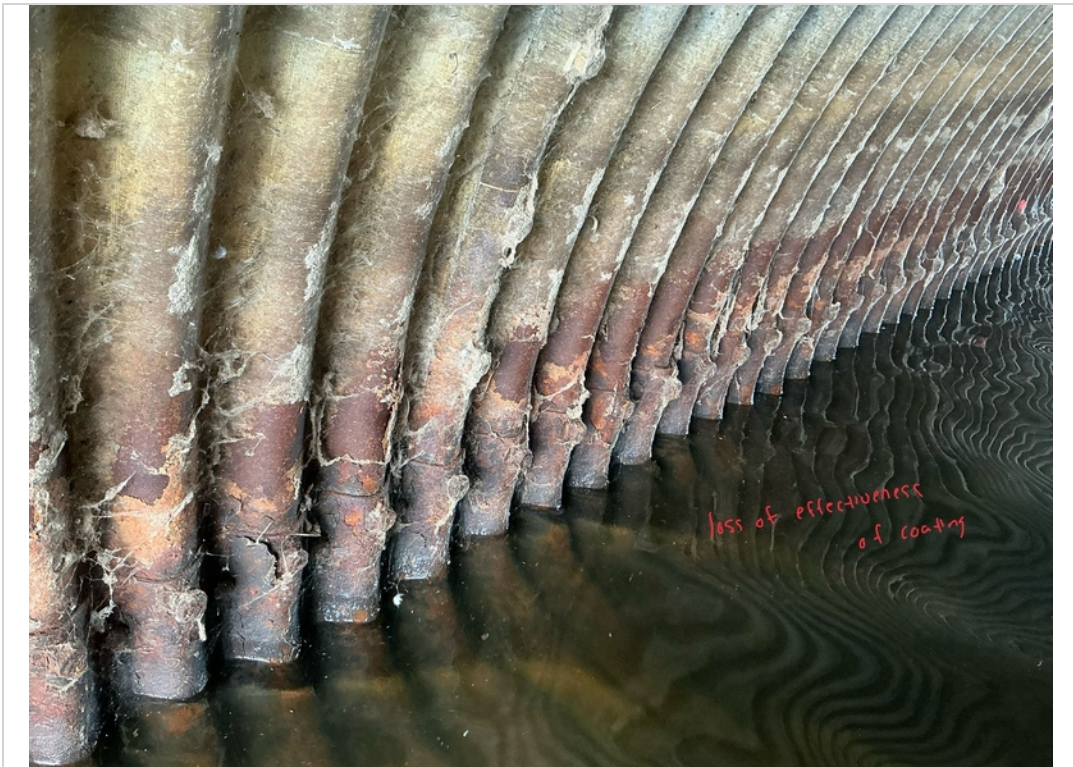
| ELEMENTS | DESCRIPTION | UNITS | TOTAL | CS1 | CS2 | CS3 | CS4 |
|---|---|---|---|---|---|---|---|
| (3440-515-240) No effectiveness under water line. - 12/19/2019<br>6/9/2021 - Areas of Moderate CS 3 Limited Effectiveness above the lower connection seal through pip length. Estimated 5%.<br>Areas of Severe CS 4 Loss of Effectiveness of coating to lower portion of the pipe throughout beginning along the lower connection to the pipe floor. Estimated 33%. See Photos.<br>6/21/2023 - No Change to Condition State or Quantity. See Photos.<br>6/17/2025 - Areas of Moderate CS 3 Limited Effectiveness above the lower connection seal through pip length. Estimated 5%.<br>Continued Areas of Severe CS 4 Loss of Effectiveness of coating to lower portion of the pipe throughout beginning along the lower connection to the pipe floor. Estimated 40%. See Photos. | | | | | | | |

Facing NW. Loss of Effectiveness of coating

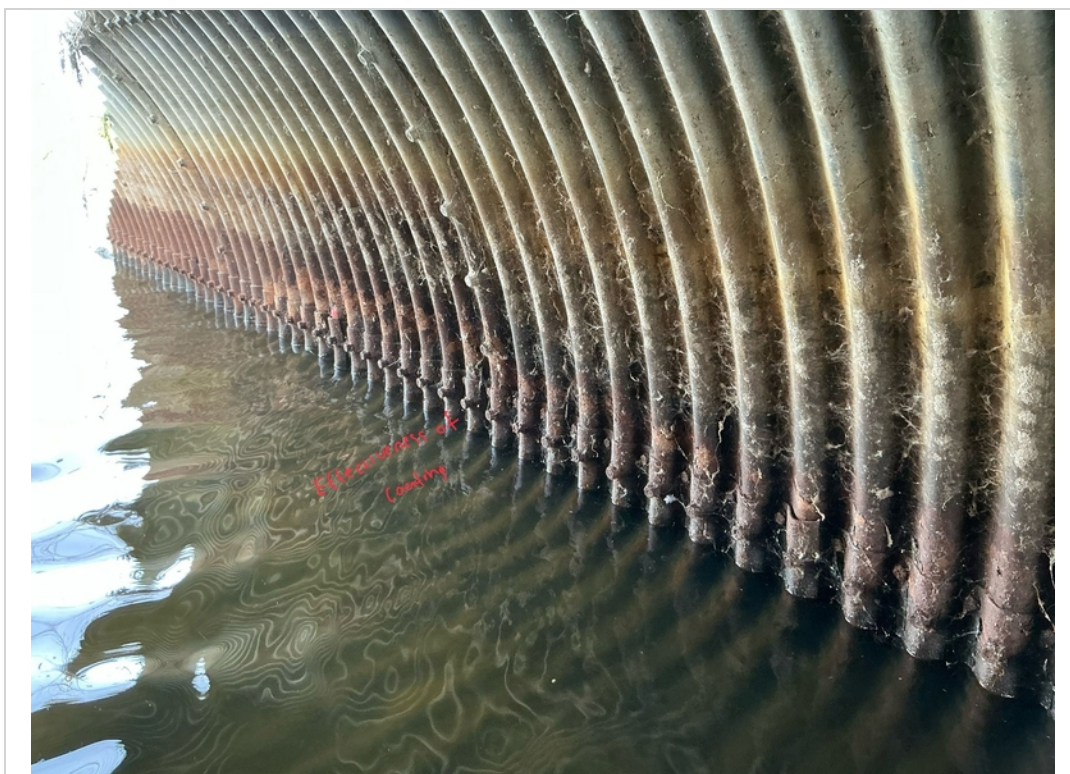
Facing NE. Effectiveness of coating to Pipe East Side.

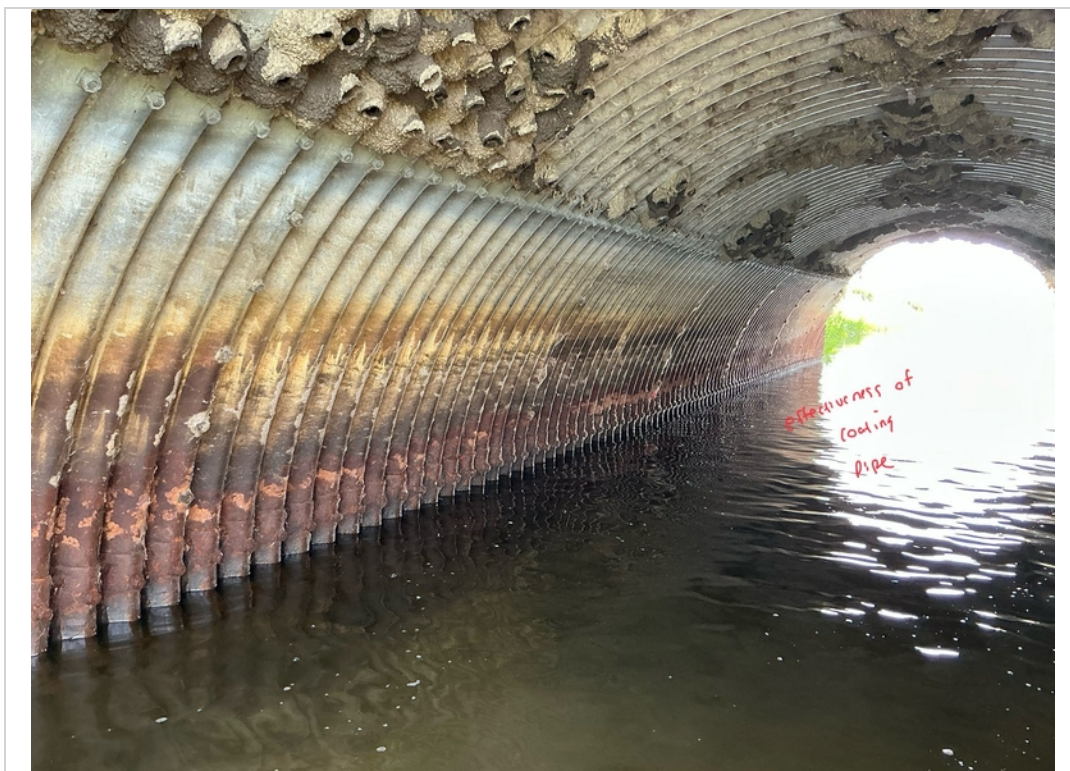
Facing South. Effectiveness of coating throughout Pipe.
