Route:00011 Log:141.361

District 68, County 41 - Sargent

| IDENTIFICATION | |
|---|---|
| (8) Structure Number | 0011-141.391 |
| (6) Features Intersected | WILD RICE RIVER |

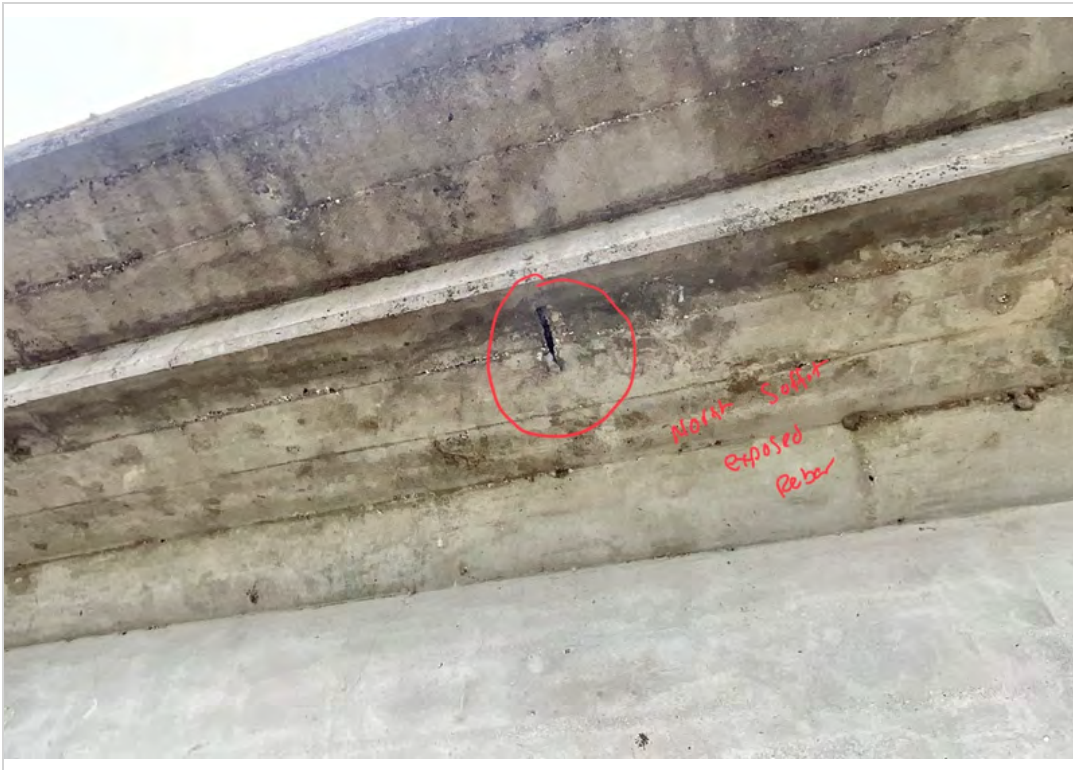
Facing South and Upwards. Exposed rebar to North Soffit of Top Flange Deck.

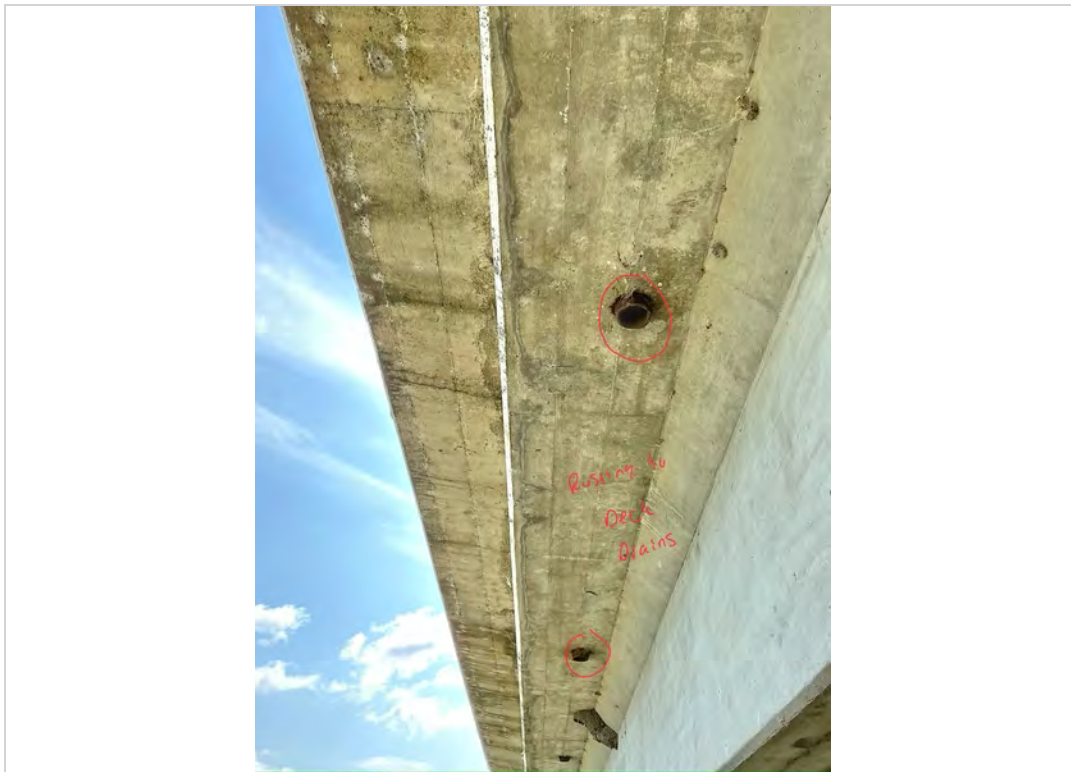
Rusting to Deck Drains on both Ends.

Facing East and Upwards. Rusting to Deck Drains.

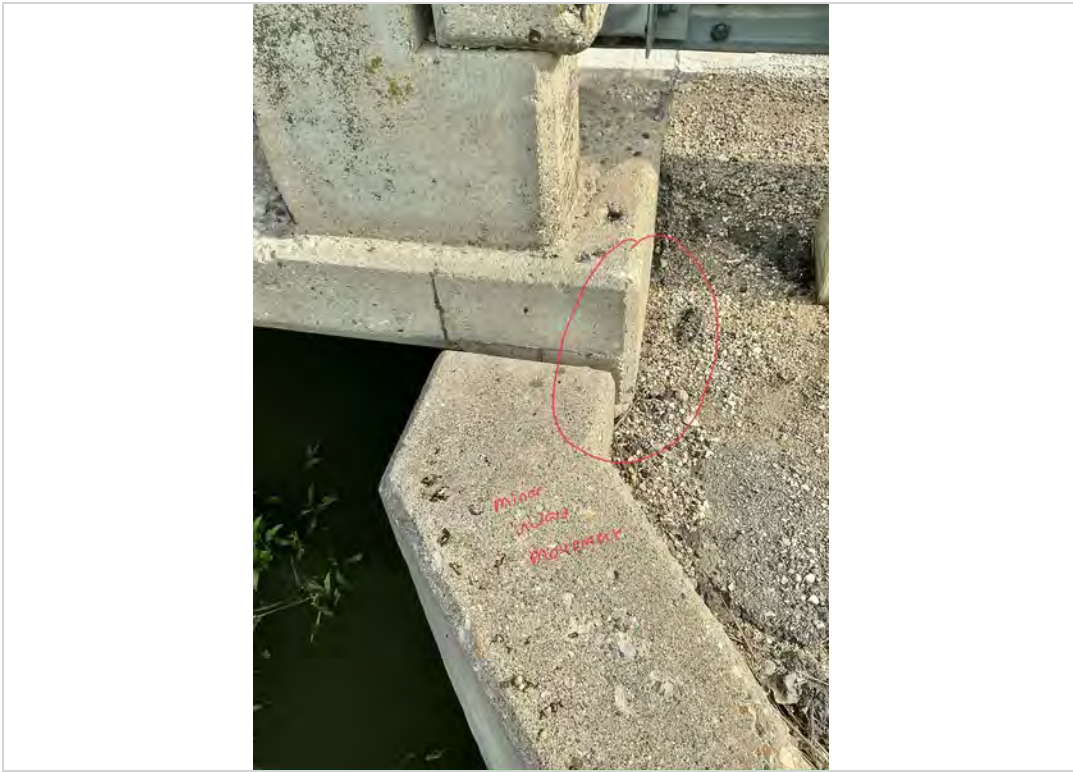
Inward Movement observed at NW and NE Corners.

Facing North. Inward Movement at Top, SE Corner. Typical all Corners.

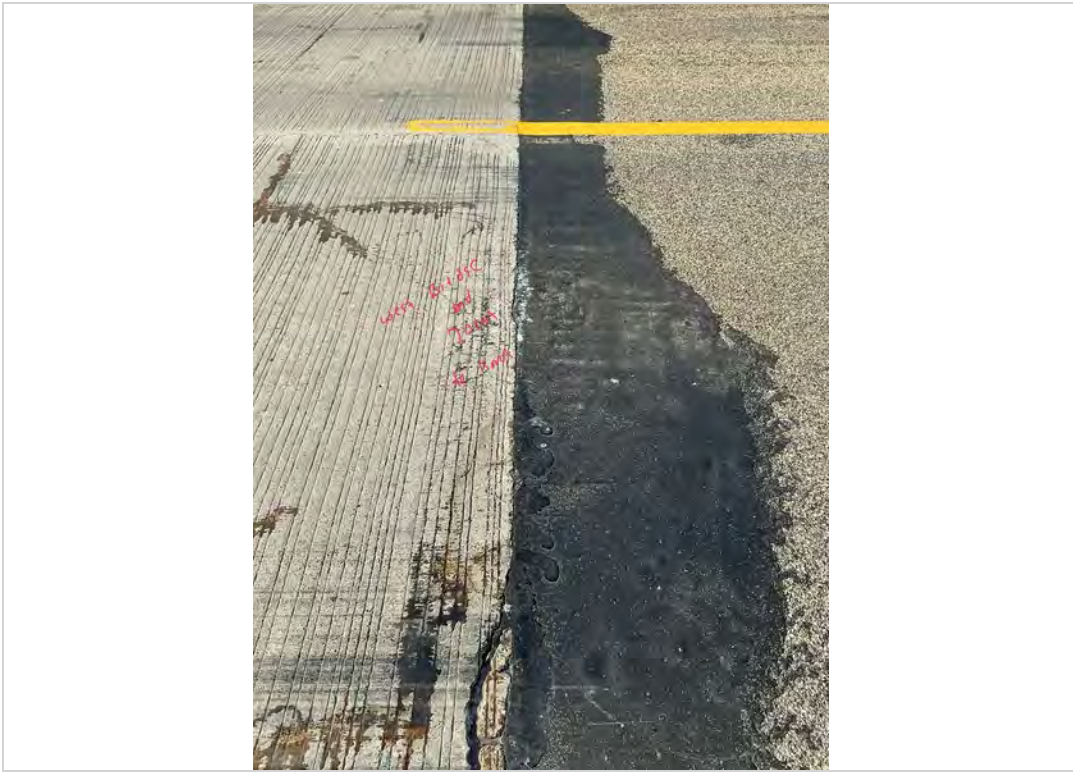
Facing West and Downward. West Bridge End Joint

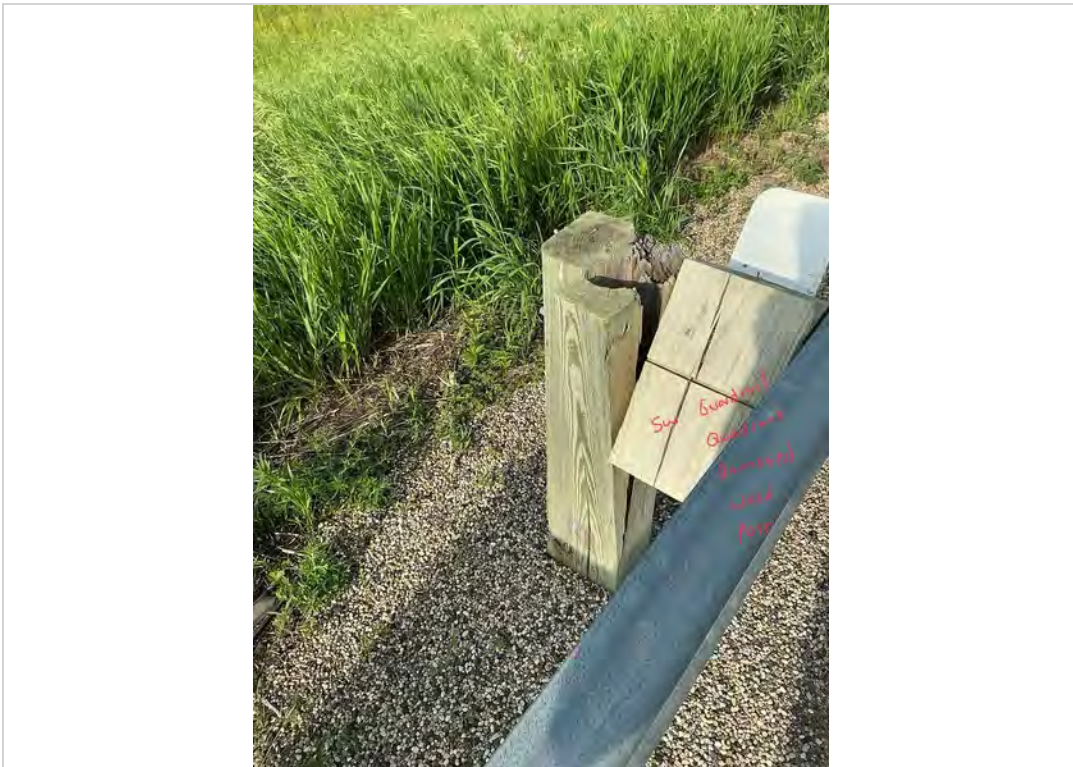
6/21/2023 - SW approach guard rail has 2 cracked/broken and unattached posts.

Facing SW. Cracked/Split Wood Post SW Guardrail Quadrant.

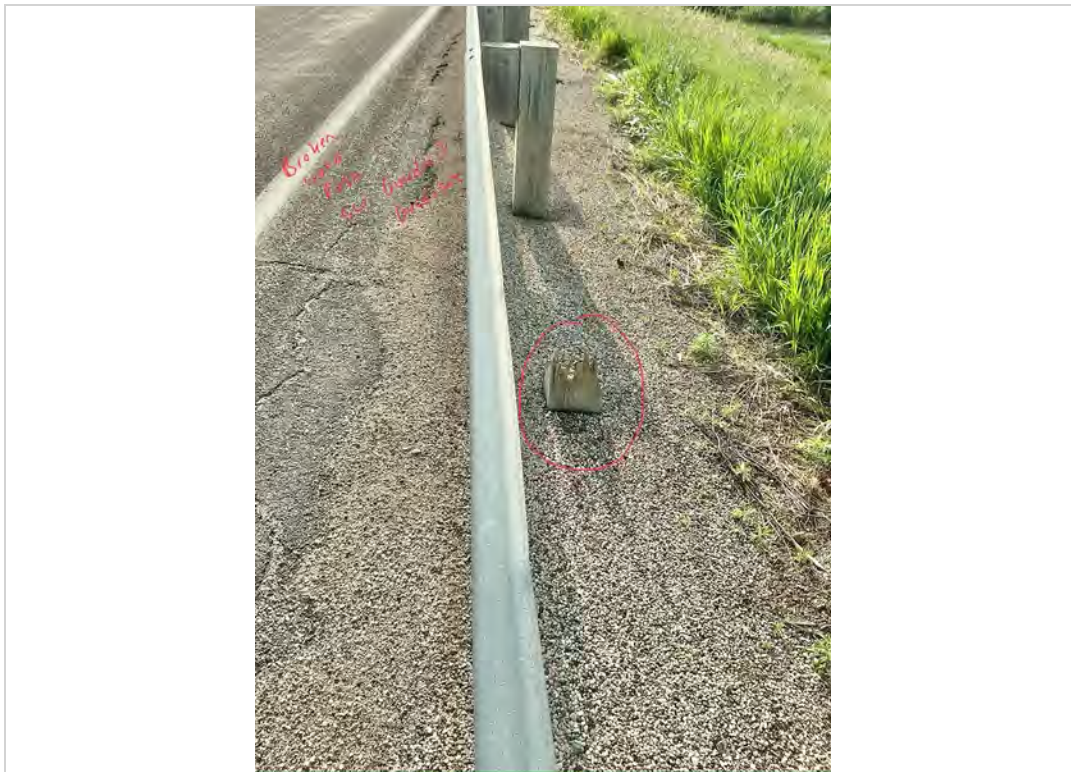
Facing East. Broken Wood Post SW Guardrail Quadrant.

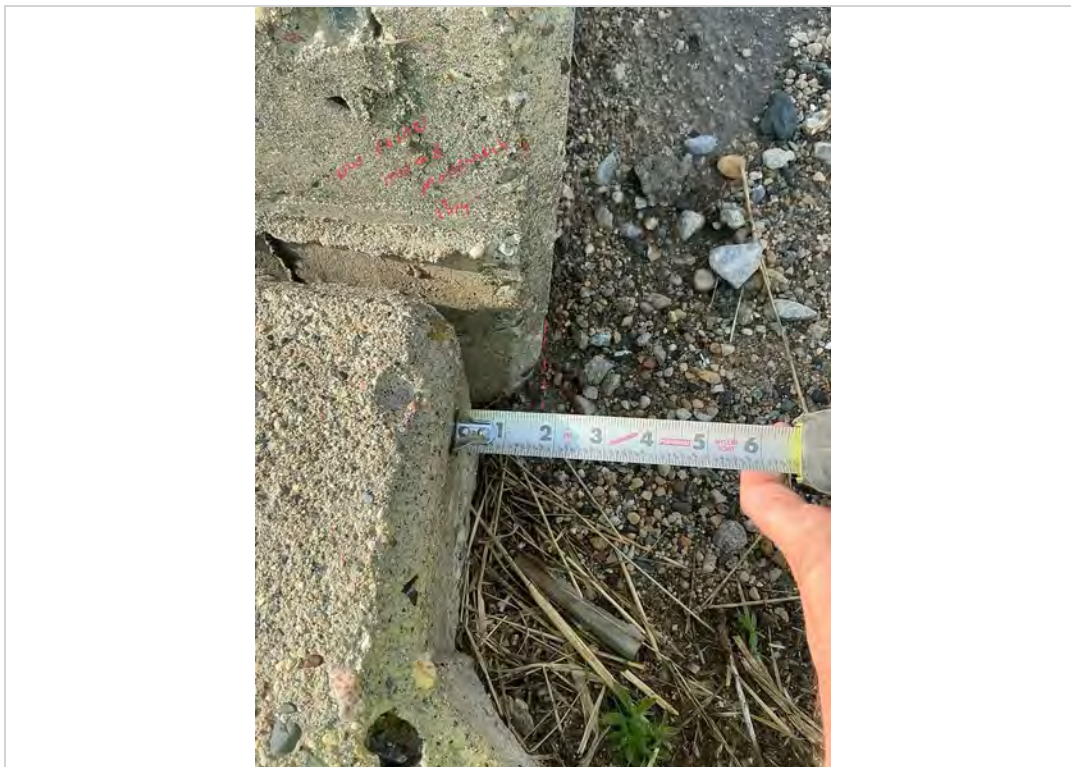
NW and SW Corner measured - 1 3/4", 2021 Previous at NW Corner was 1 1/2"

Facing South and Downward. Inward Movement of NW Corner of Structure.

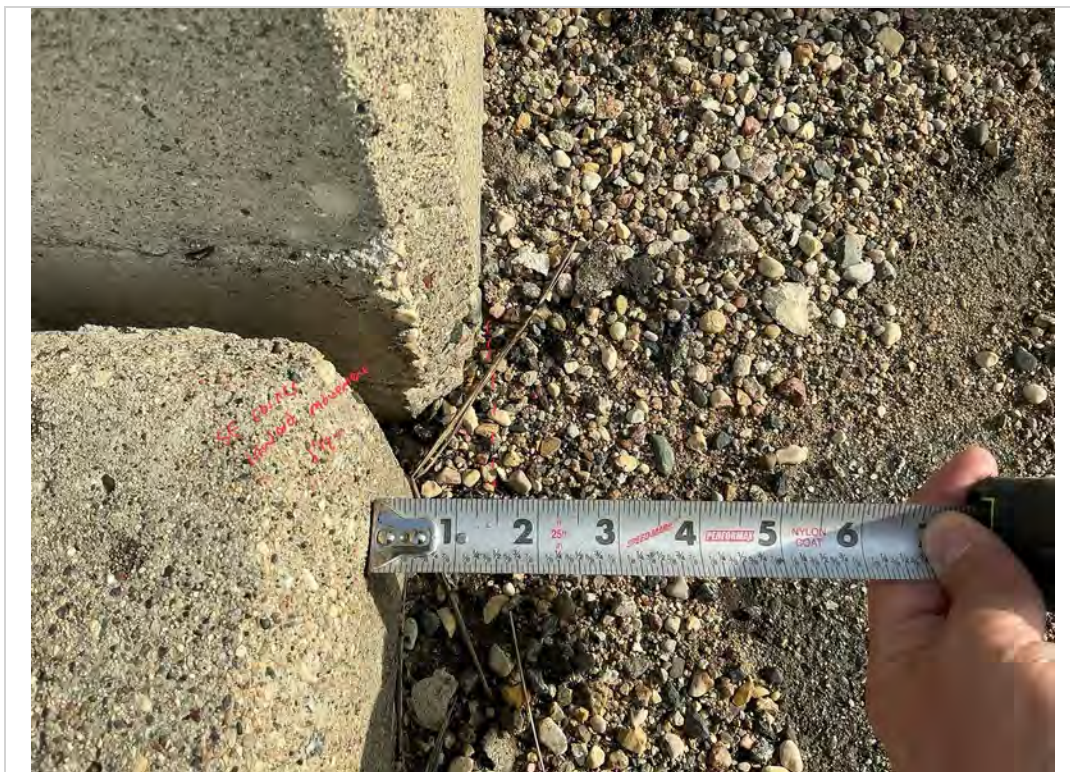
NE and SE Corner measured - 1 1/2". 2021 Previous at NE Corner was 1".

Facing North. SE Inward Movement at Top of Wing.

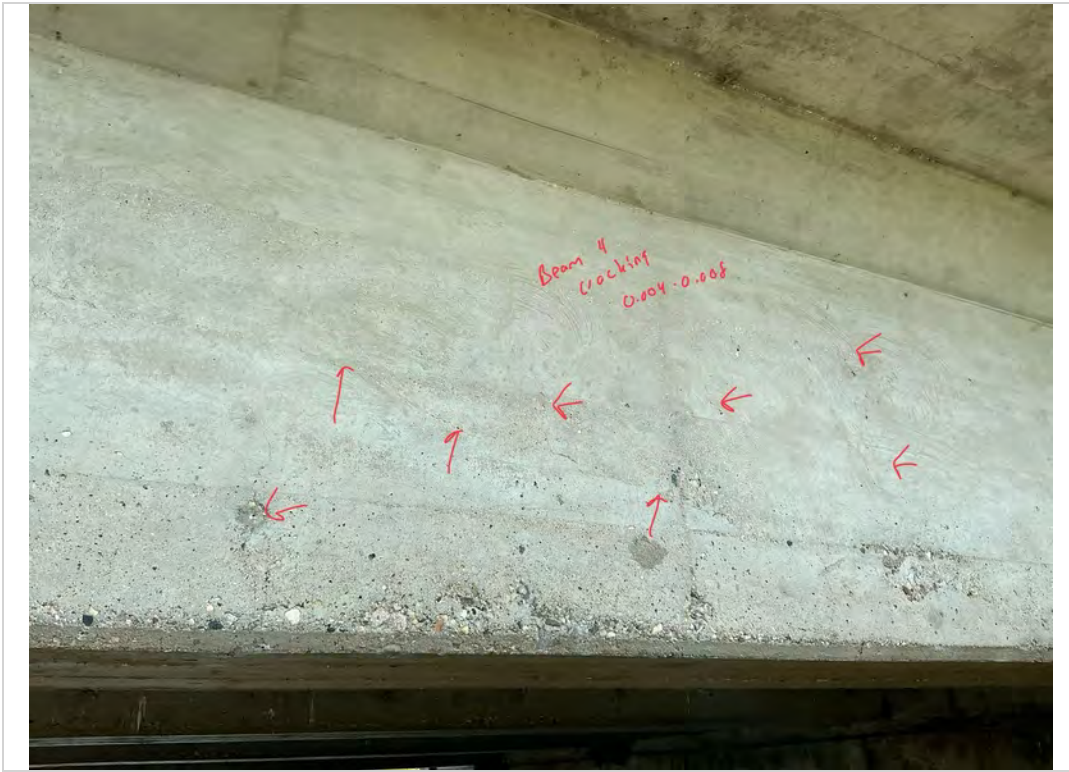
Vertical, Shear, and Various Cracks to Beams 1-4 with spacing 1' up to 4' and widths 0.004 to 0.008. Some shear cracking to Beams 1 and 4 near East End.

Facing NE and Upwards. Various cracking to Beam 4 near East End.

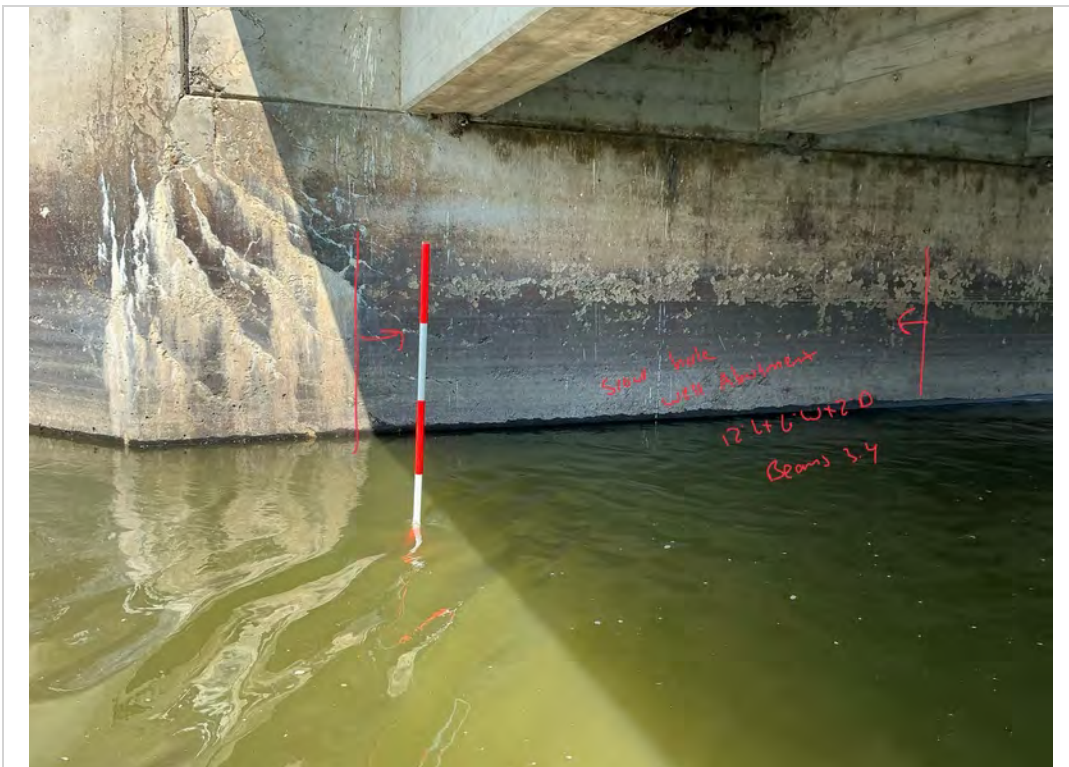
Scour Hole along West Abutment with an area now 12'L x 6'W x 2'D, 2023 Previous 23'L x 6'W x 4' to 4 1/2'D. 2021 Previous area 15' L x 3' W x 1'-6" Deep mainly within center area. No Undermining observed along West Abutment. Area has silted in with current flow conditions.

Facing West. General of Scour Hole along West Abutment near South End.

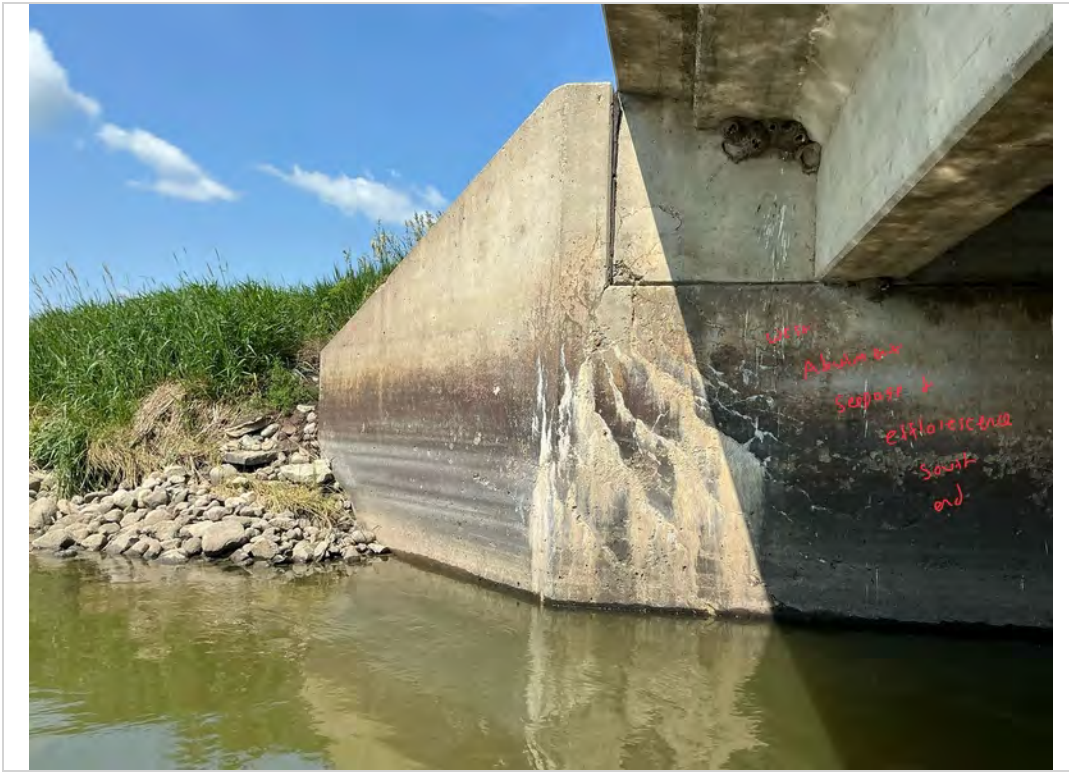
Moderate U-Shape to Diagonal Cracking to Corners of both Abutments with seepage and efflorescence.

Facing West. U-Shaped Cracking with Seepage and Efflorescence to West Abutment South End.

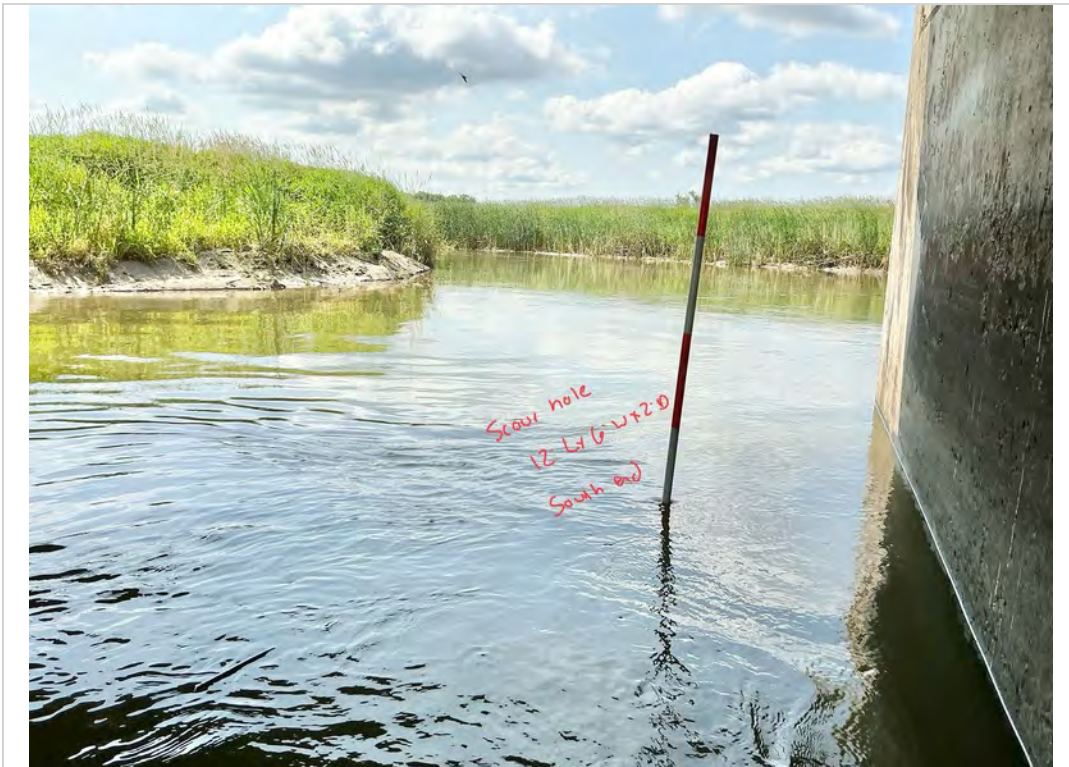
Facing South. Range Pole used to determine Scour Depth along West Abutment.

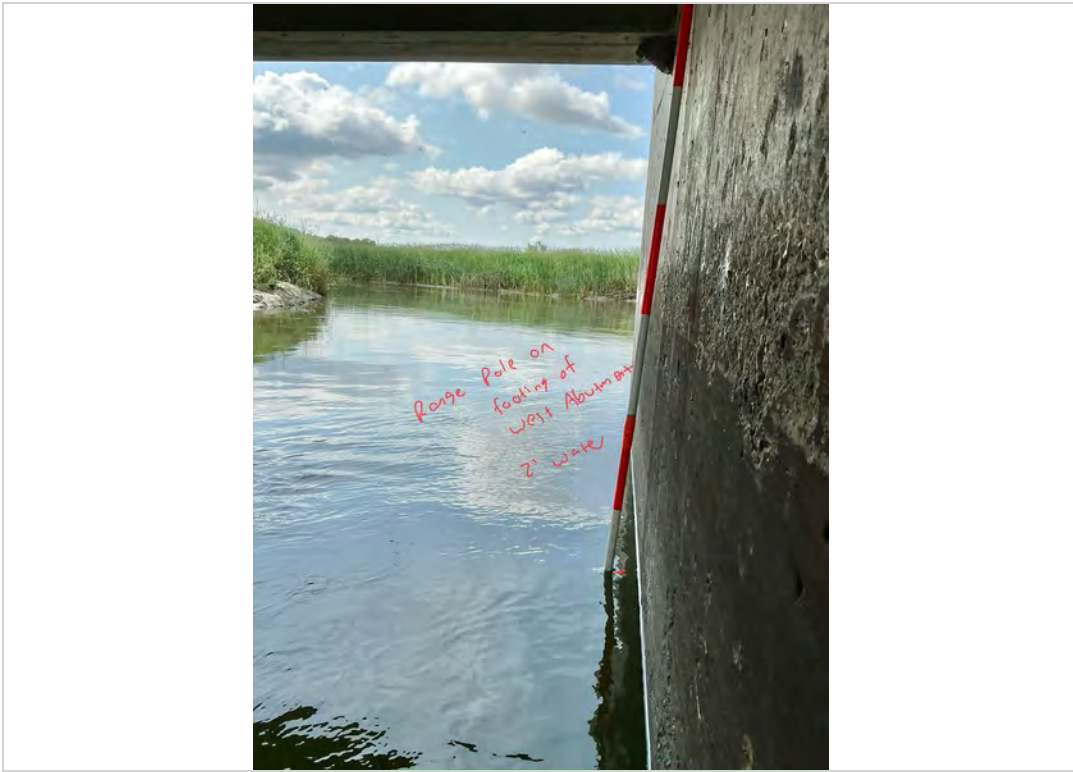
Facing South. Range Pole I used to determine water depth along Exposed Top of Footing.

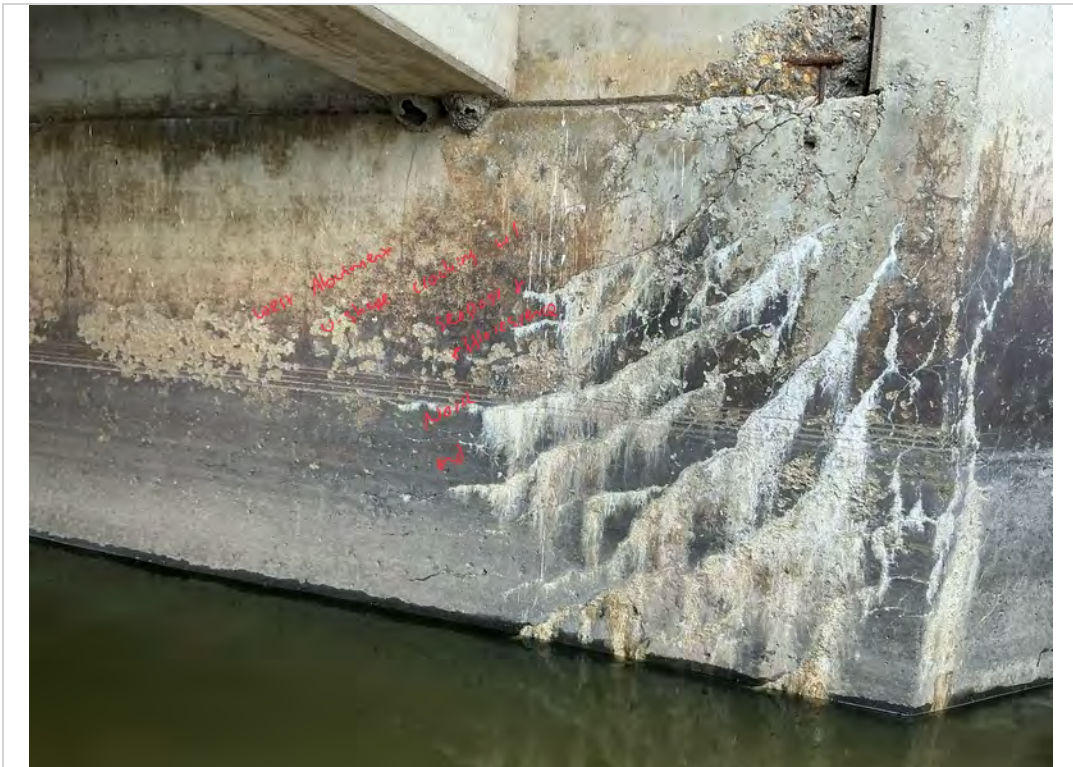
Facing West. U-Shaped Cracking with Seepage and efflorescence to West Abutment North end.

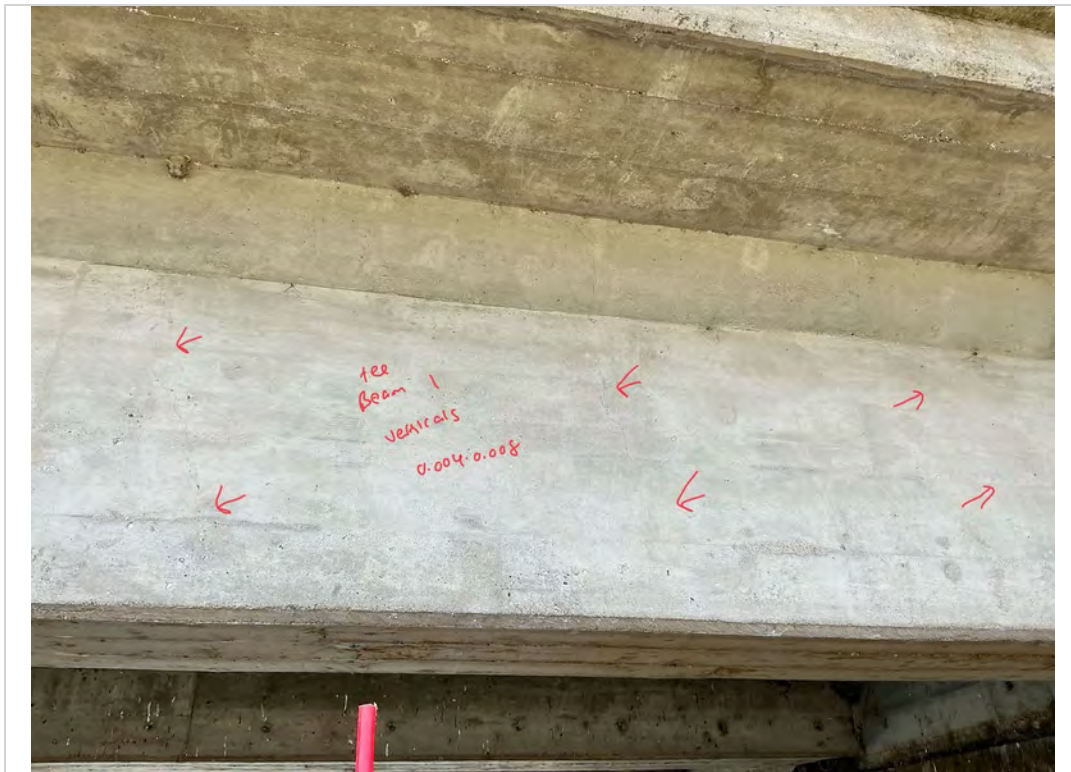
Facing South. Minor Vertical cracks to Beam 1.

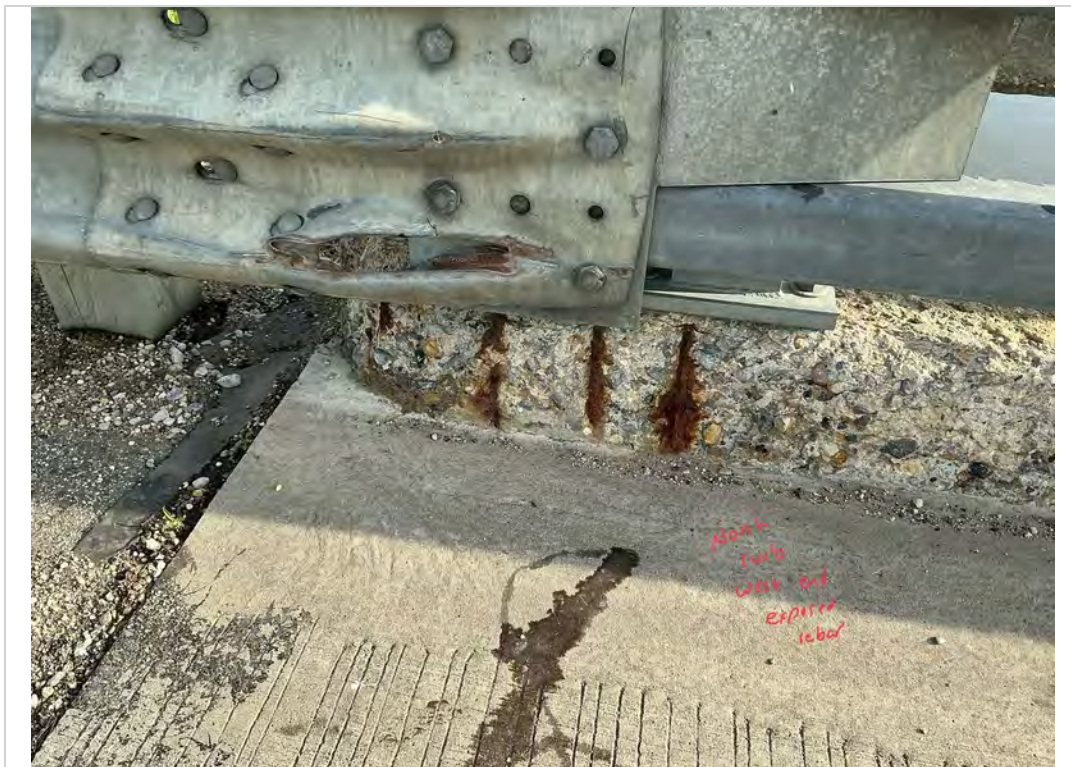
Facing North. Exposed Rebar to North Curb West End.

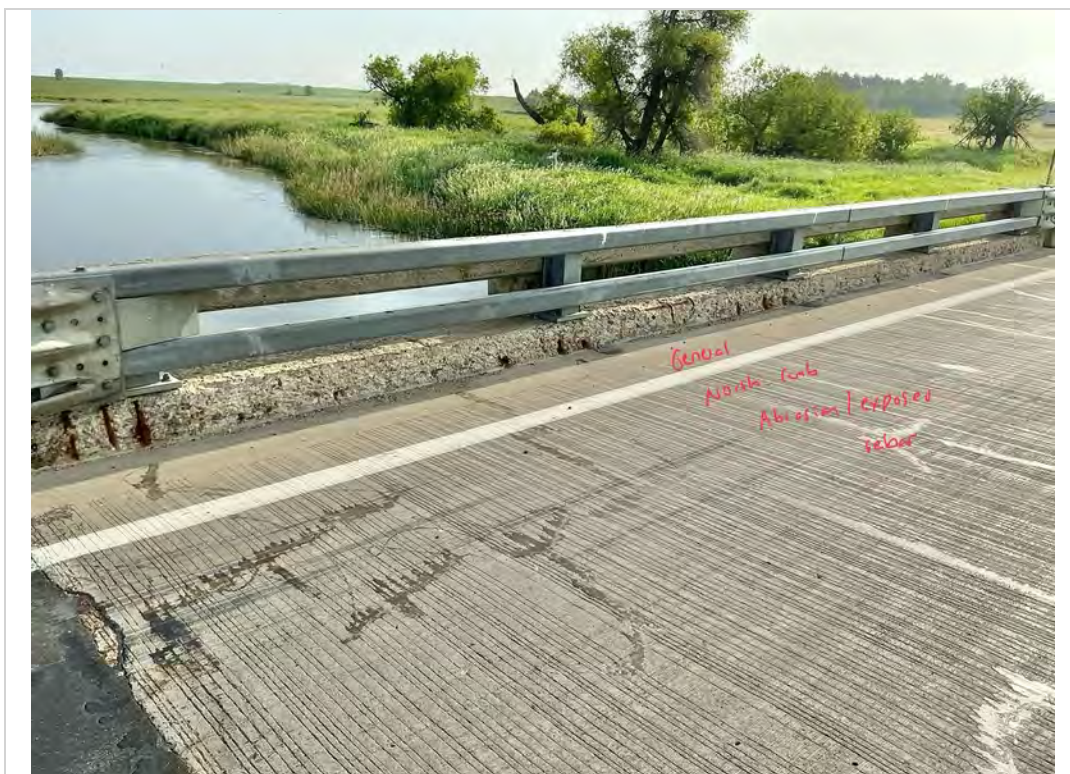
Facing NE. General of North Curb with Abrasion and Exposed rebar.

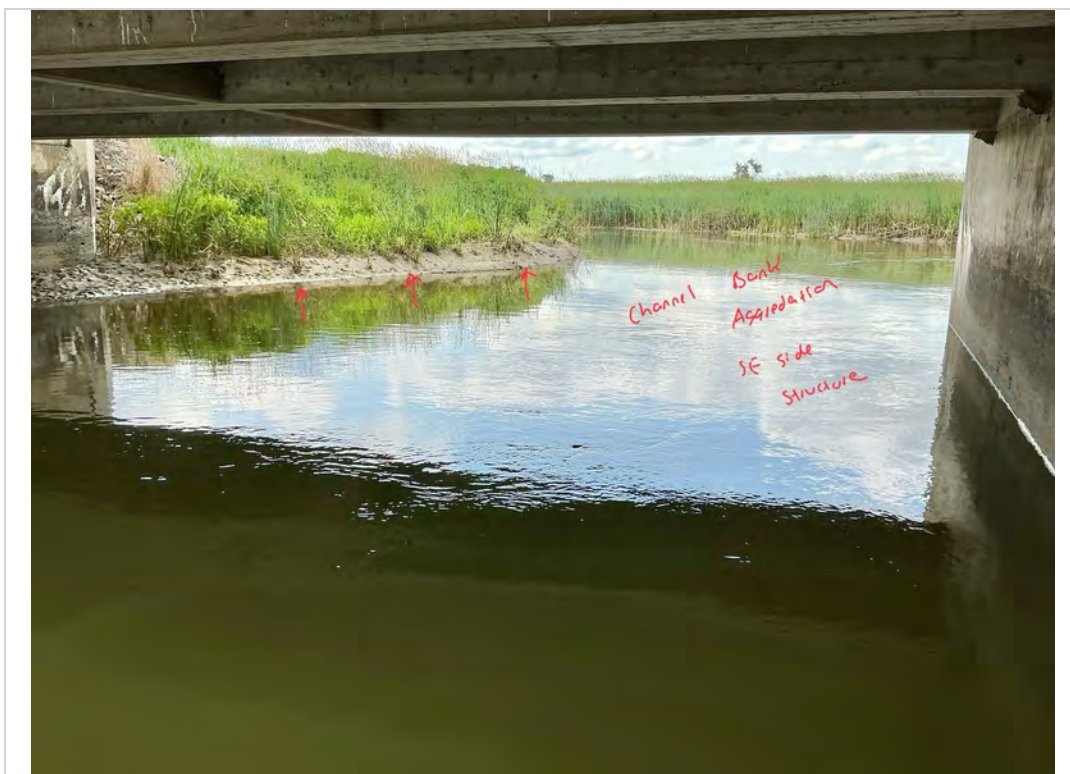
Aggradation along East Bank Upstream from Structure causing some migrating of the West Bank to the West.

Facing South. East Channel Bank Aggradation South of Structure.

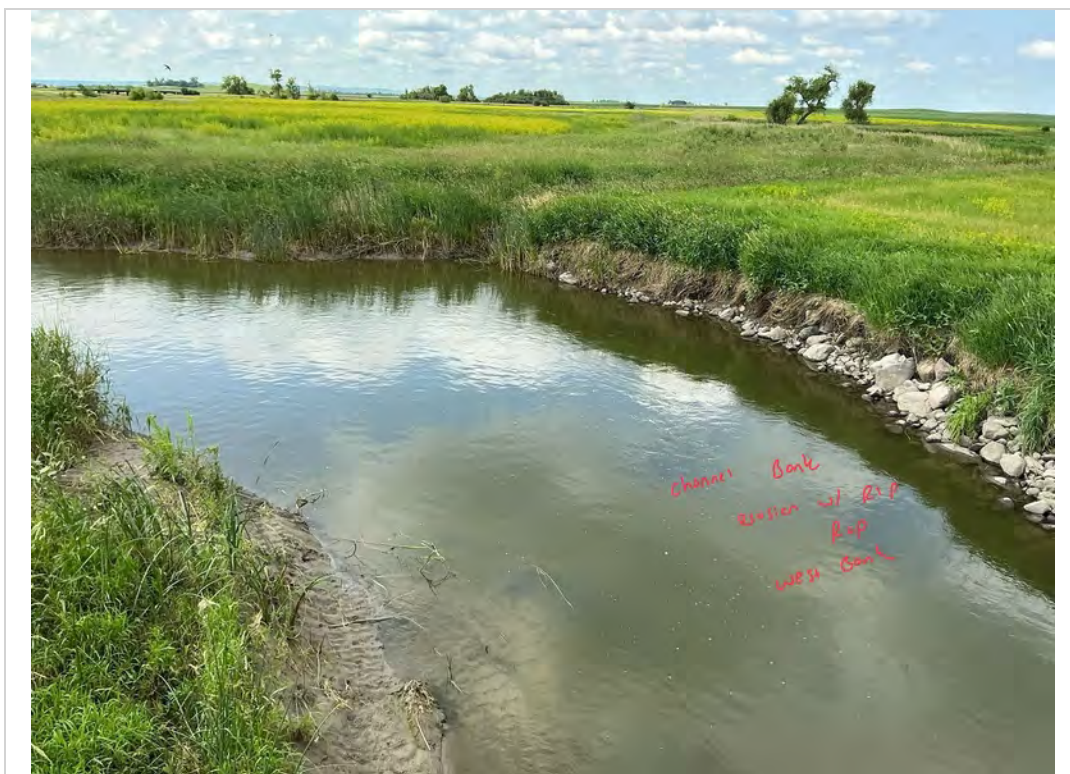
Facing SW. Channel Bank Erosion along West Side of Bank South of Structure.

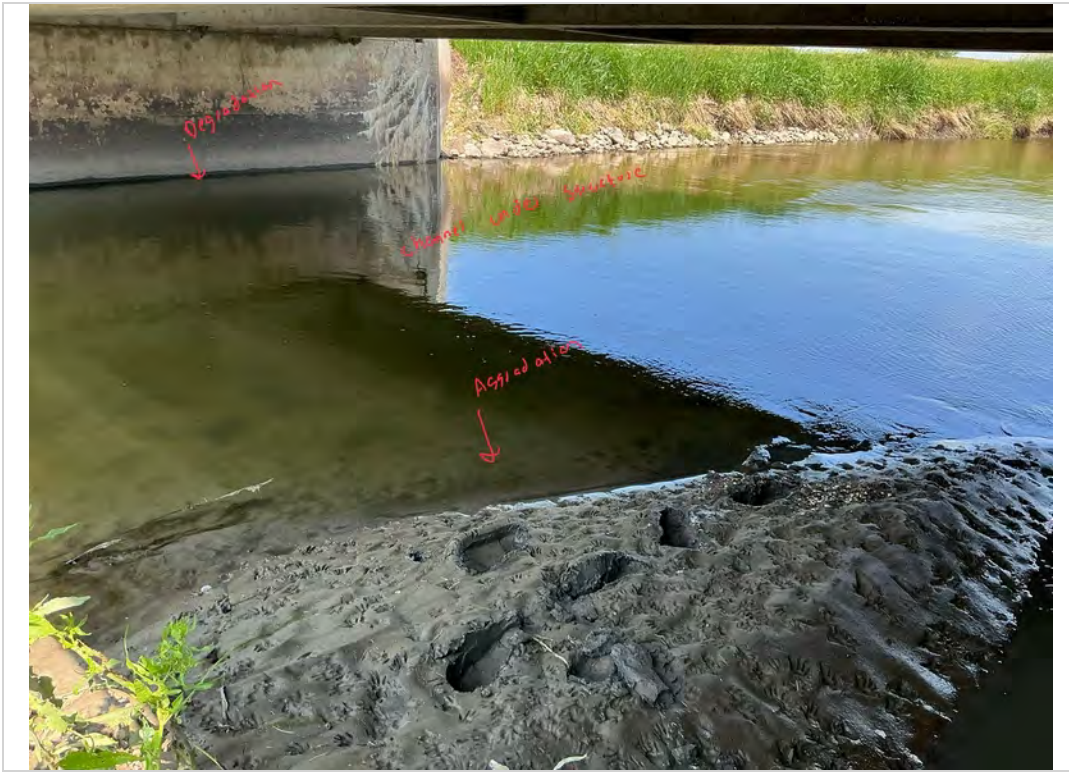
Uneven stream bed channel from Abutment to center of channel with an elevation difference estimated now 5', Previous 3'. Degradation along West Abutment and Aggradation along East Abutment.

Facing NW. Channel Aggradation and Degradation under structure.

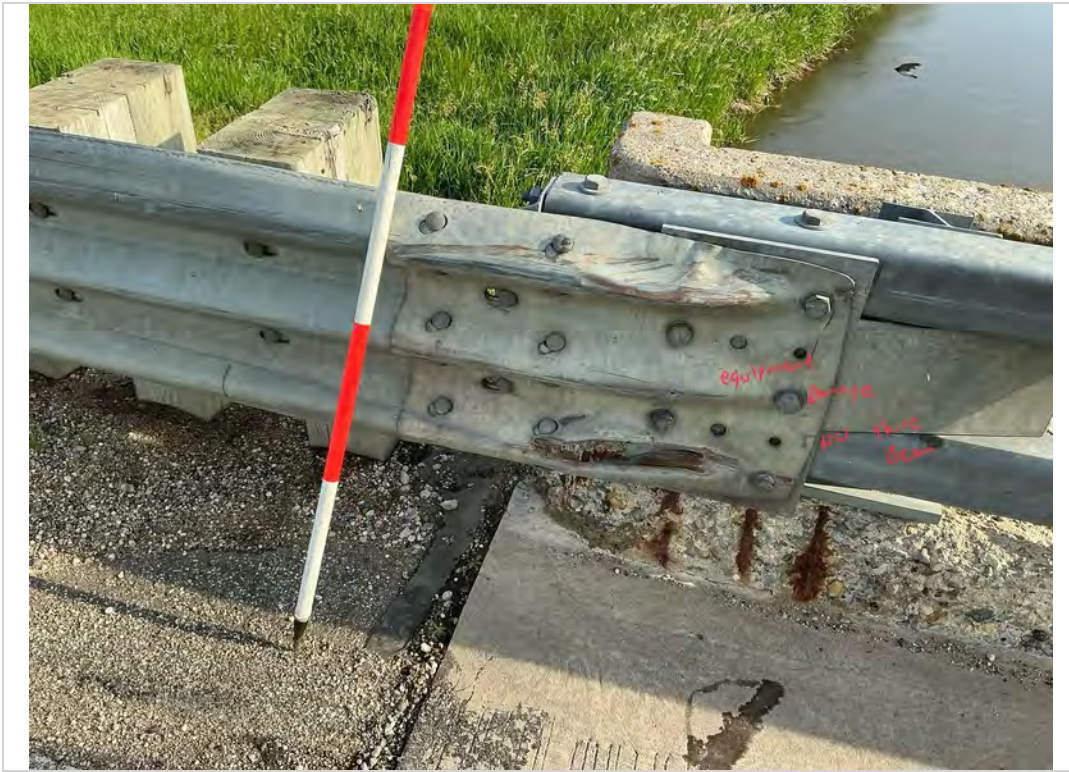
6/17/2025 - NW Thrie Beam Connection with Equipment Damage.

Facing North. Equipment Damage to NW Thrie Beam Connection.

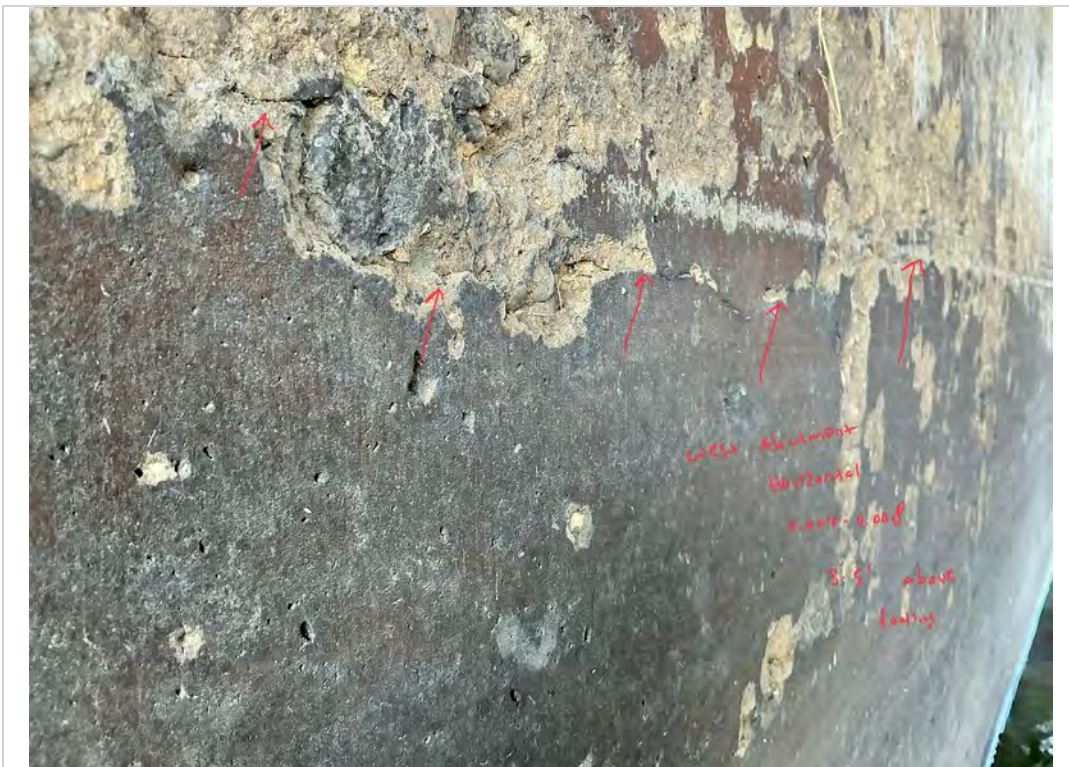
Facing NW. Minor Vertical and Horizontal Cracking to West Abutment.

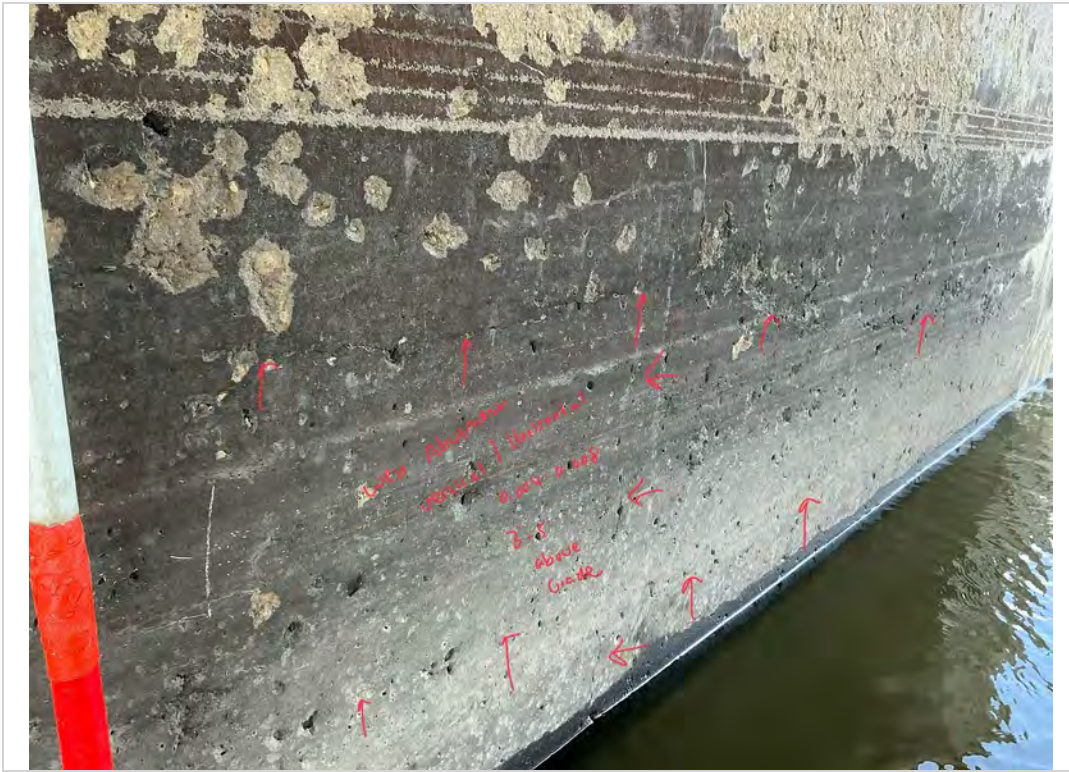
Facing NW. Vertical and Horizontal Cracking to West Abutment near North End.

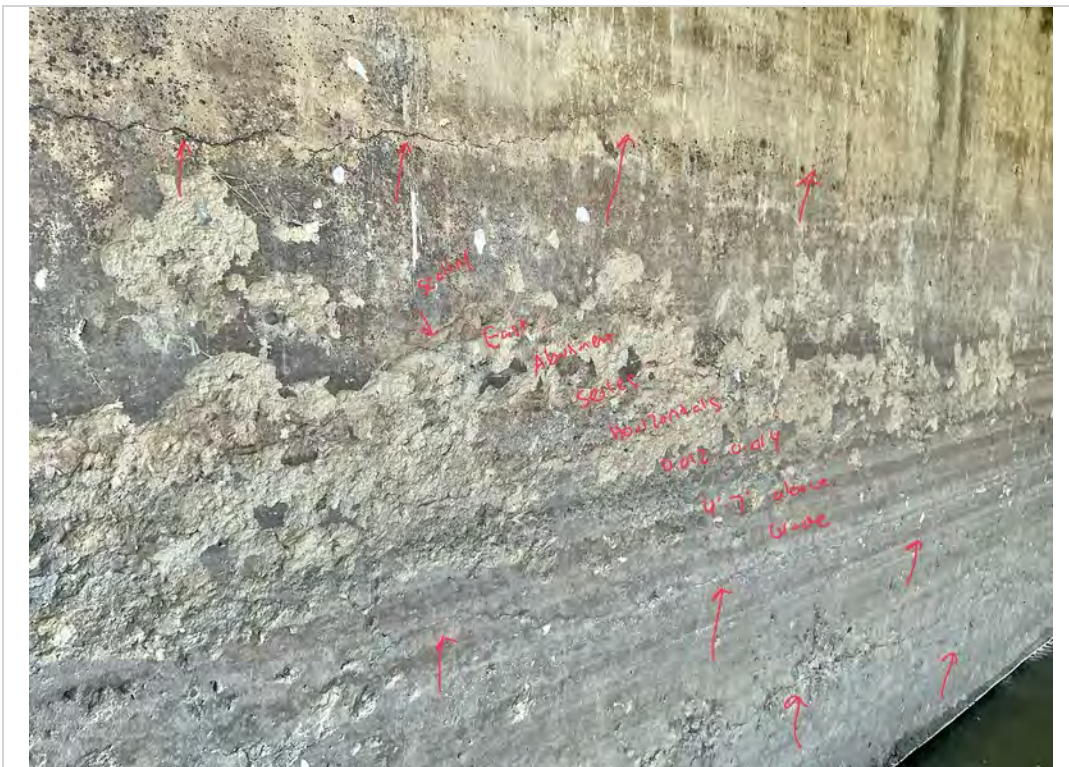
Facing SE. Some Minor Scaling with Series Horizontal Cracking to East Abutment.

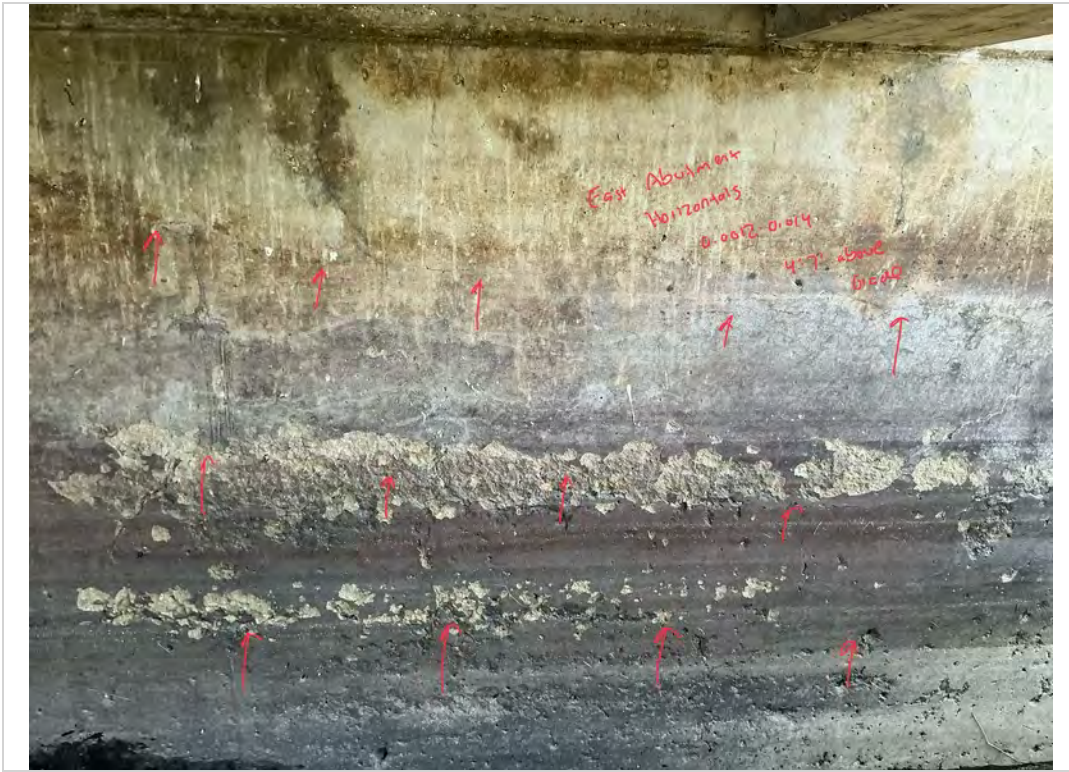
Facing East. Series of Horizontal Cracking to East Abutment.

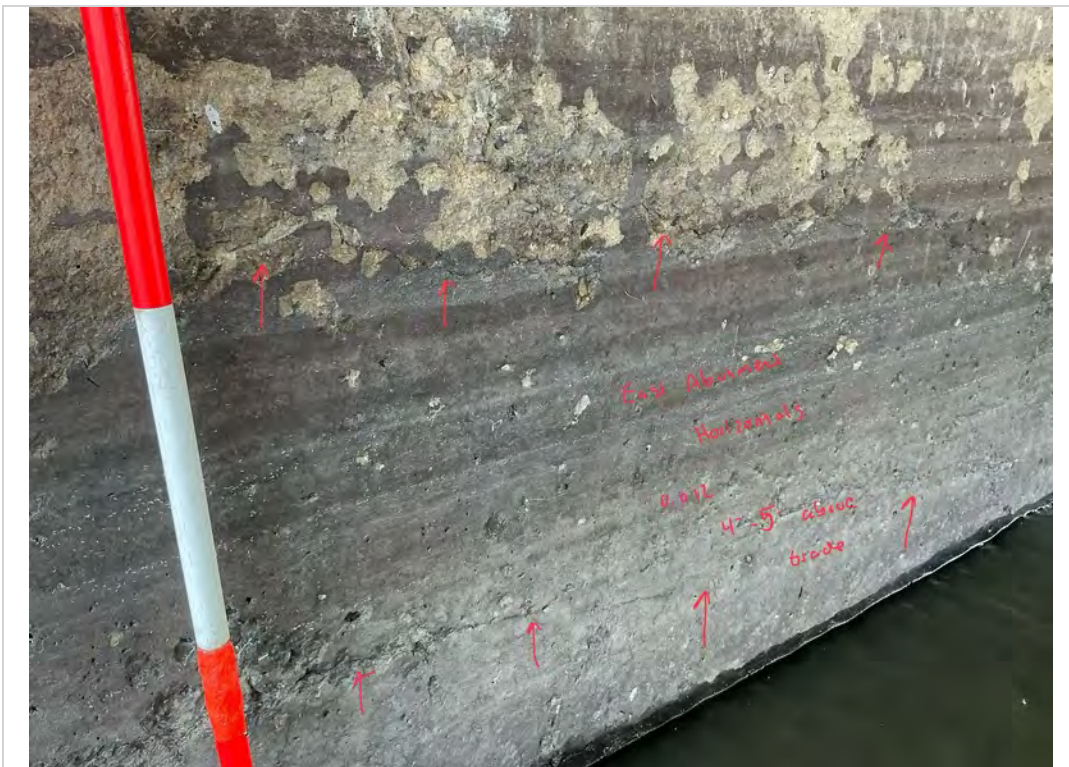
Facing SE. Continued Series of Horizontal Cracking to East Abutment

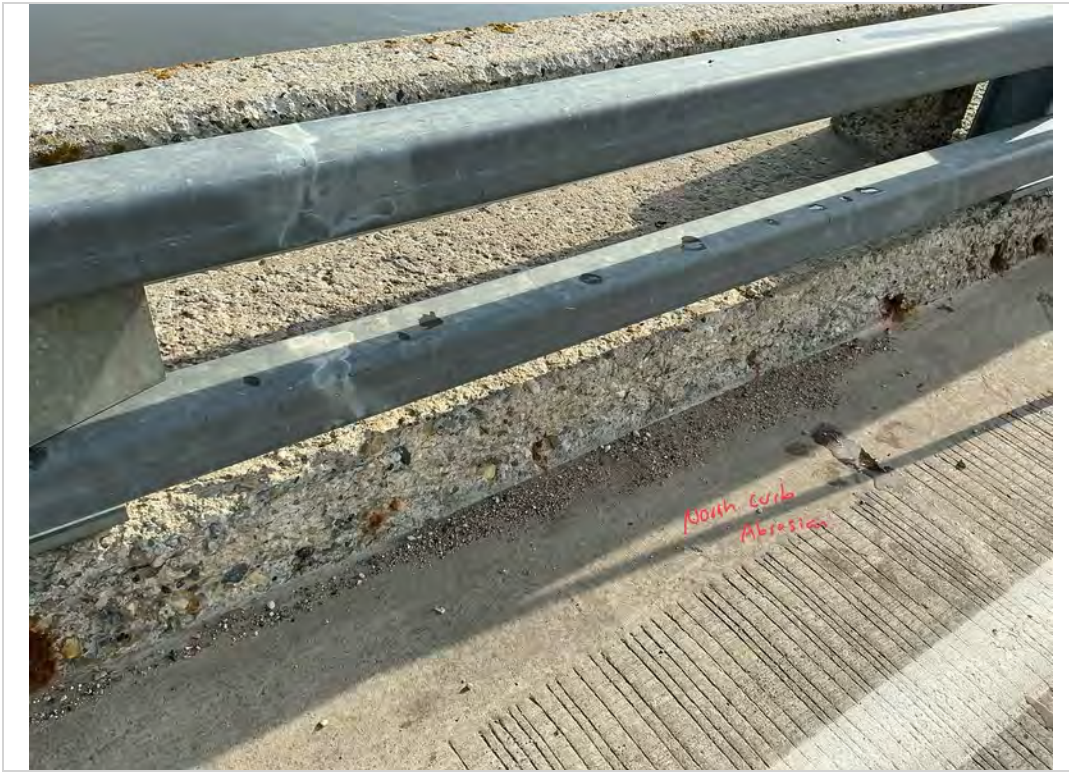
Facing NE. Abrasion to North Curb.
