Route:00011 Log:141.361

District 68, County 41 - Sargent

| IDENTIFICATION | |
|---|---|
| (8) Structure Number | 0011-141.391 |
| (6) Features Intersected | WILD RICE RIVER |

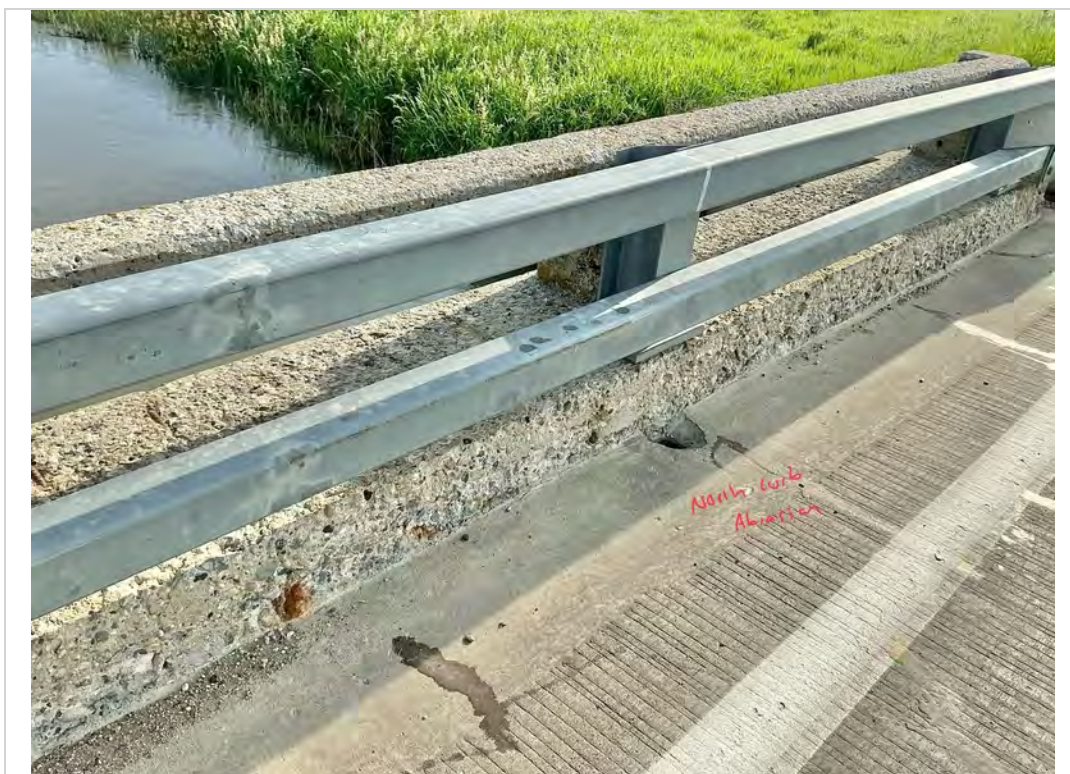
Facing NE. Abrasion to North Curb East End

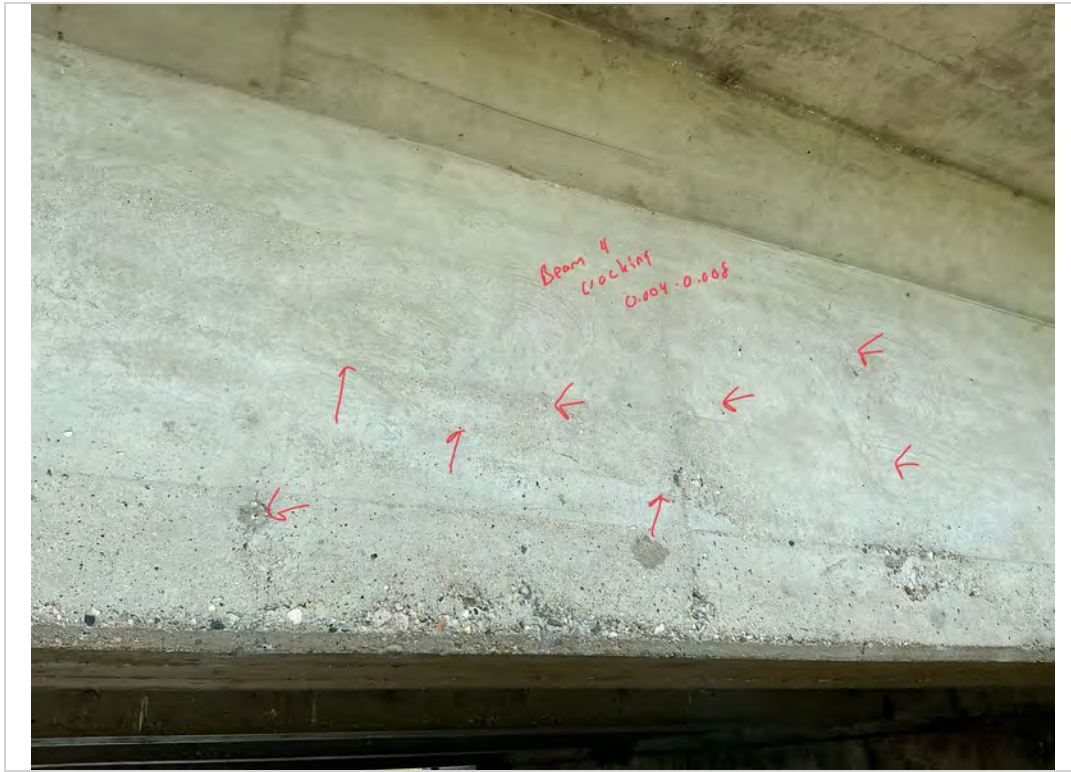
Facing NE and Upwards. Various cracking to Beam 4 near East End.

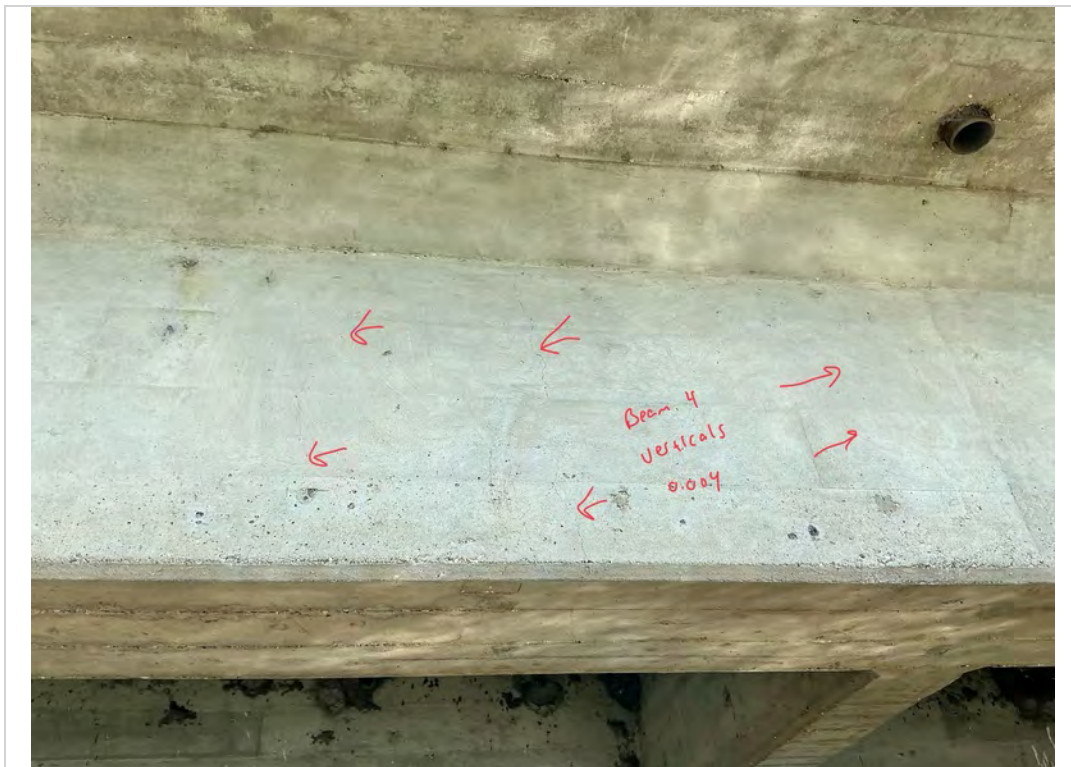
Facing North. Vertical cracks to Beam 4.

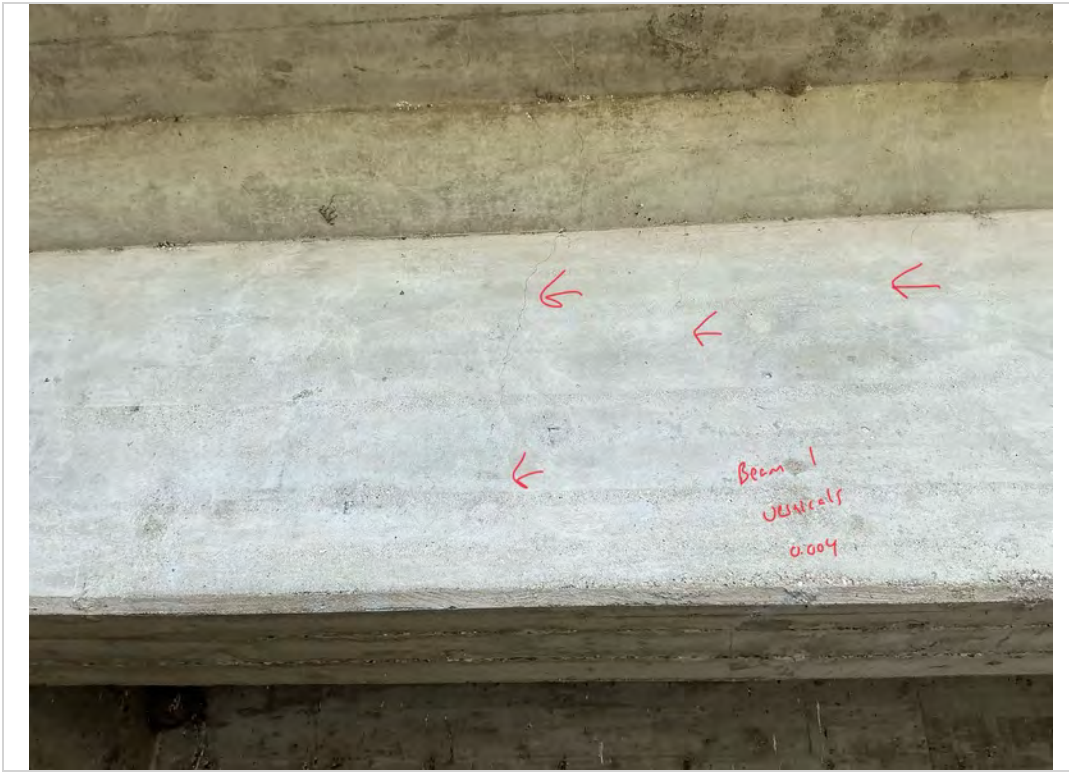
Facing South. Minor Vertical Cracks to Beam 1.

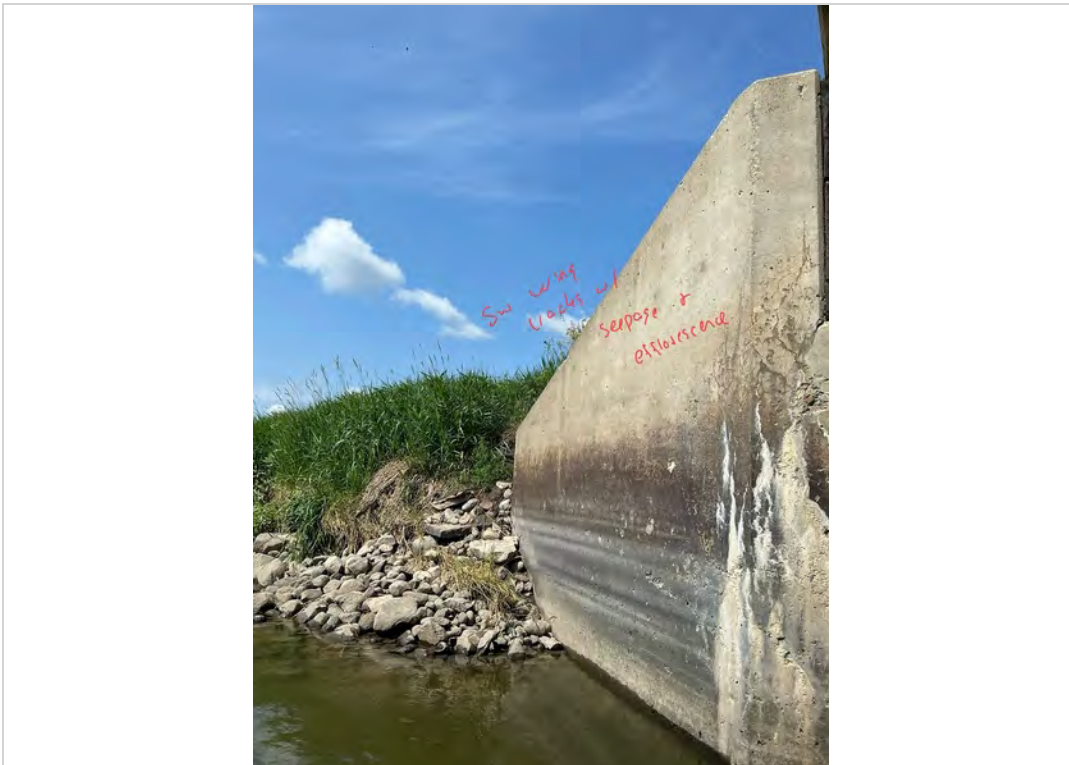
Facing West. Seepage and Efflorescence to SW Wing.

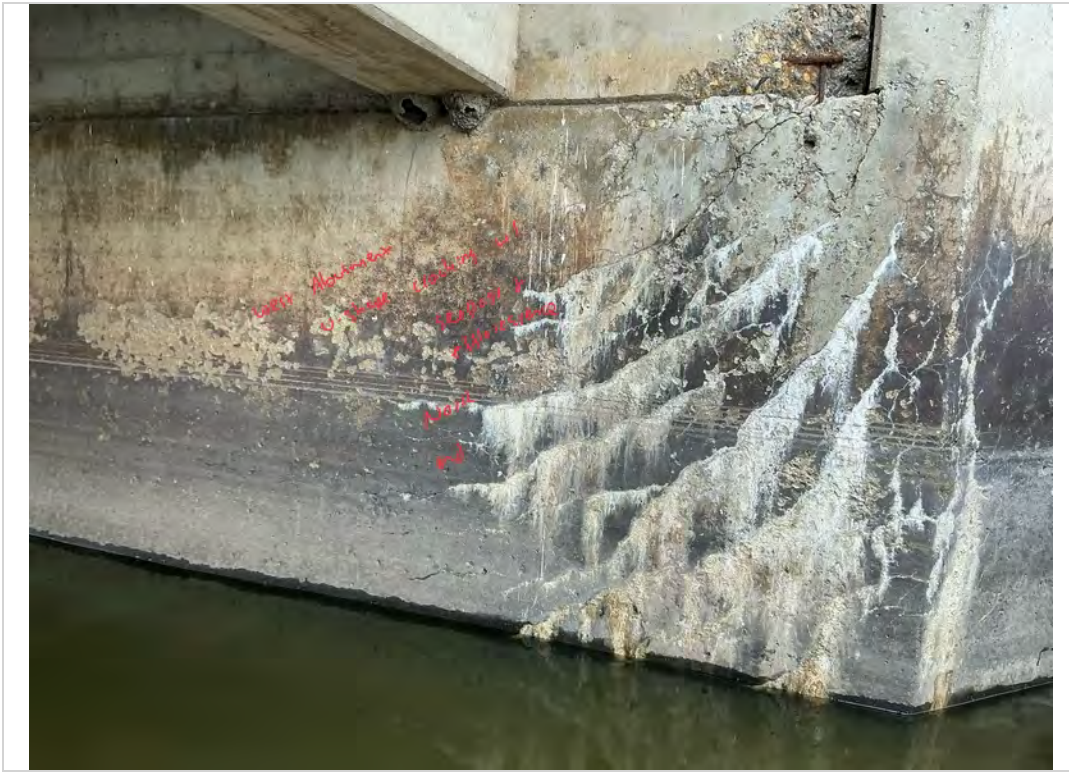
Facing West. U-Shaped Cracking with Seepage and efflorescence to West Abutment North end.

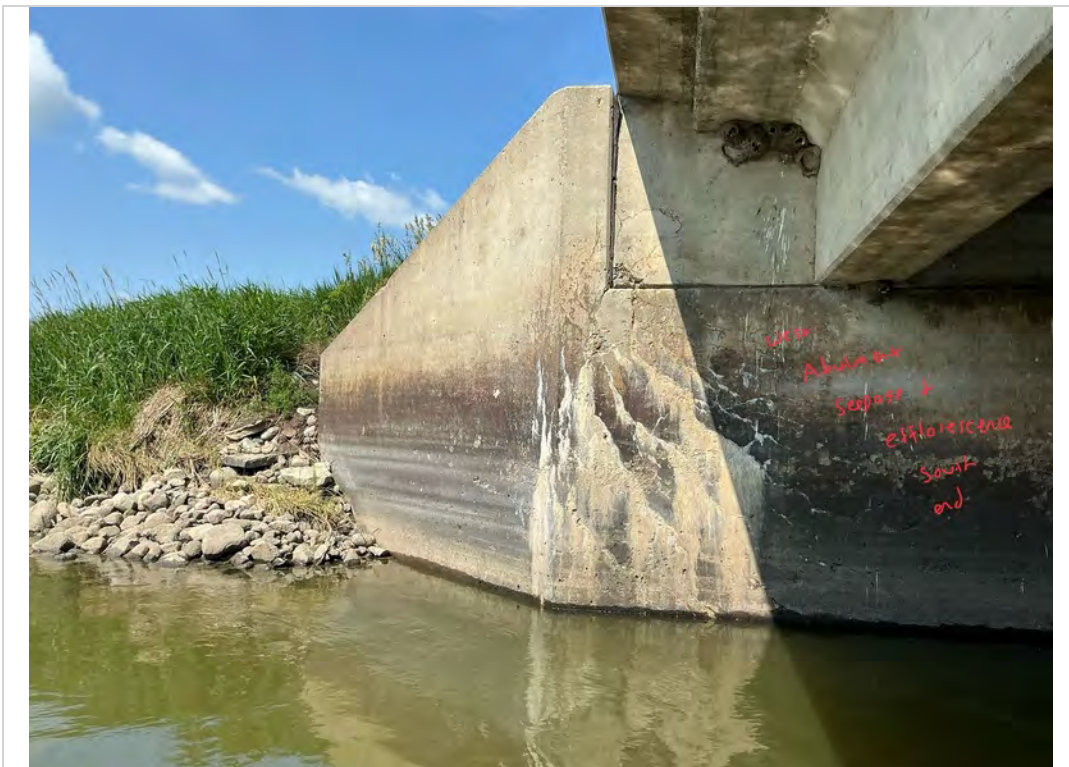
Facing West. U-Shaped Cracking with Seepage and Efflorescence to West Abutment South End.

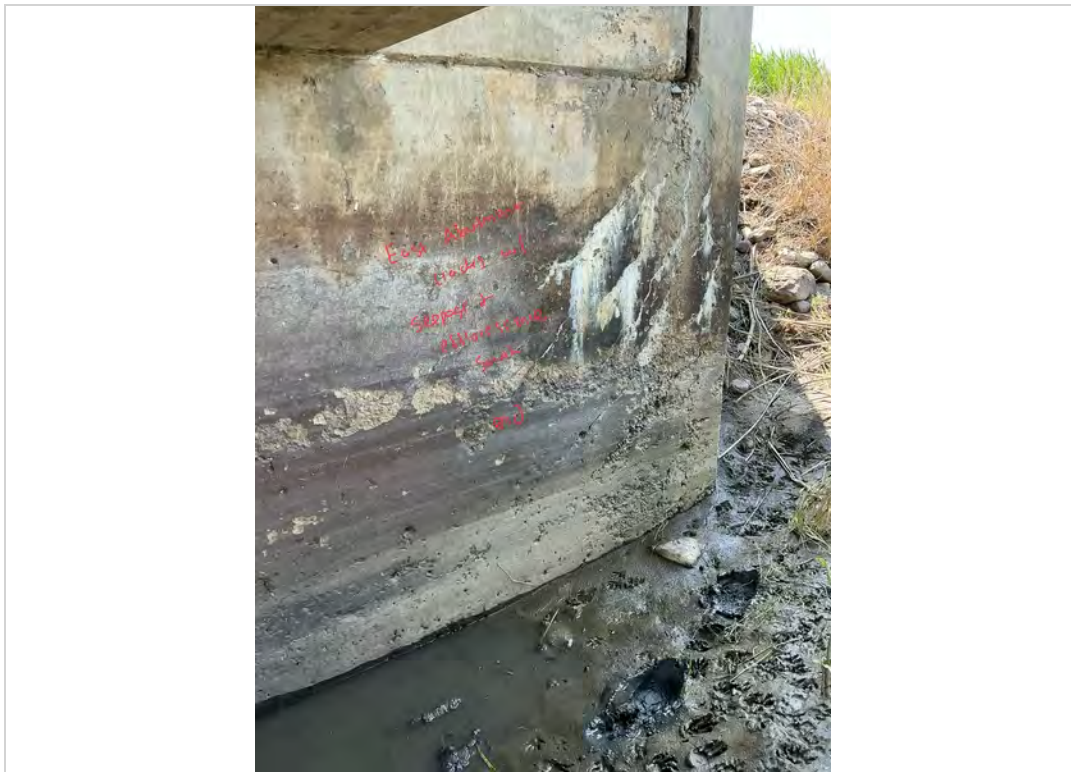
Facing SE. U-Shaped Cracking to East Abutment South end.

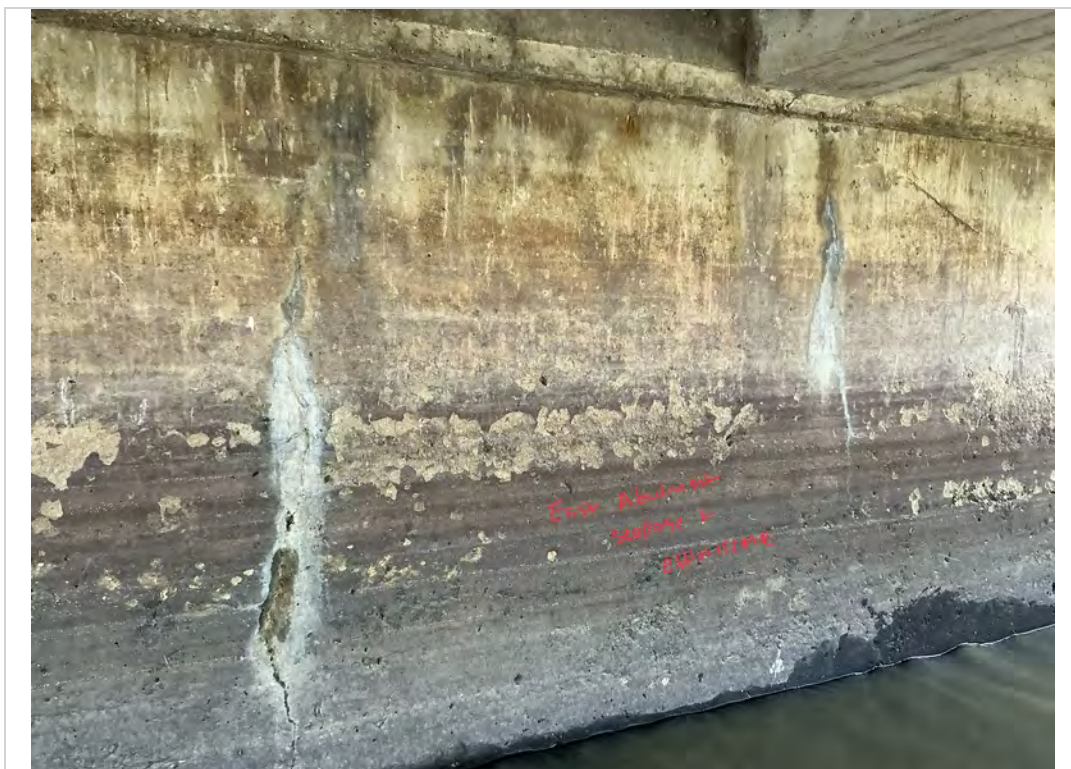
Facing East. Vertical Cracks with Seepage and Efflorescence to East Abutment.

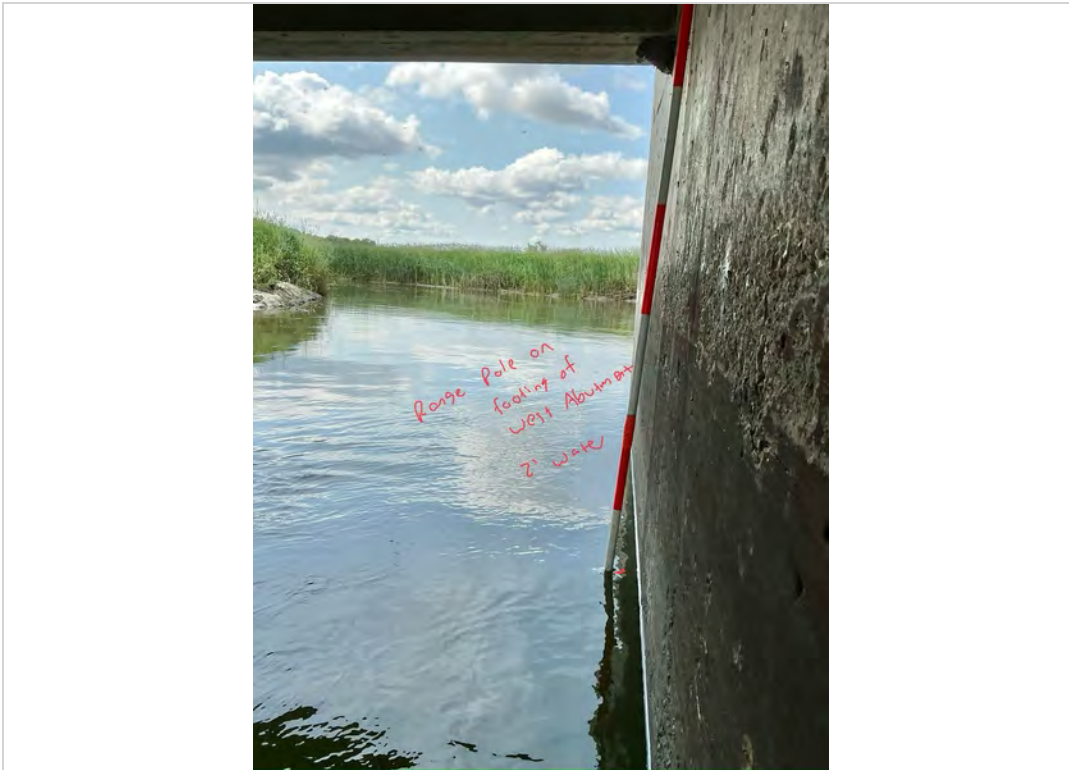
Facing South. Range Pole I used to determine water depth along Exposed Top of Footing.

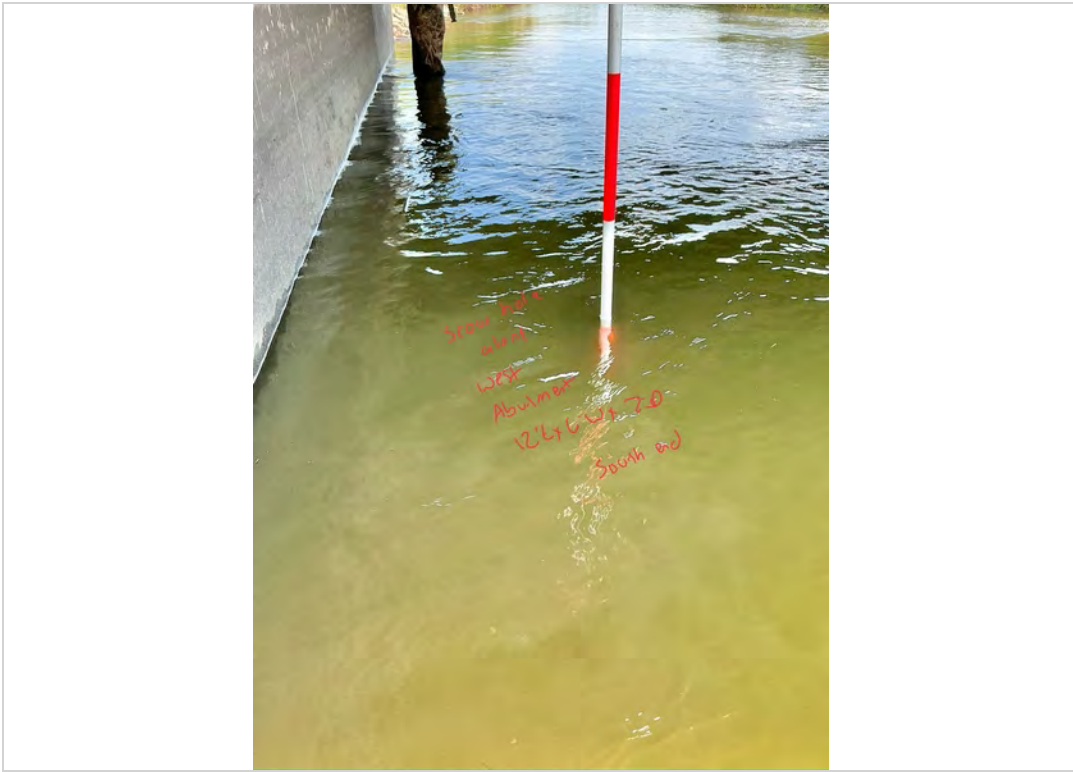
Facing North. Another View of the Scour Hole Depth along West Abutment near South End.

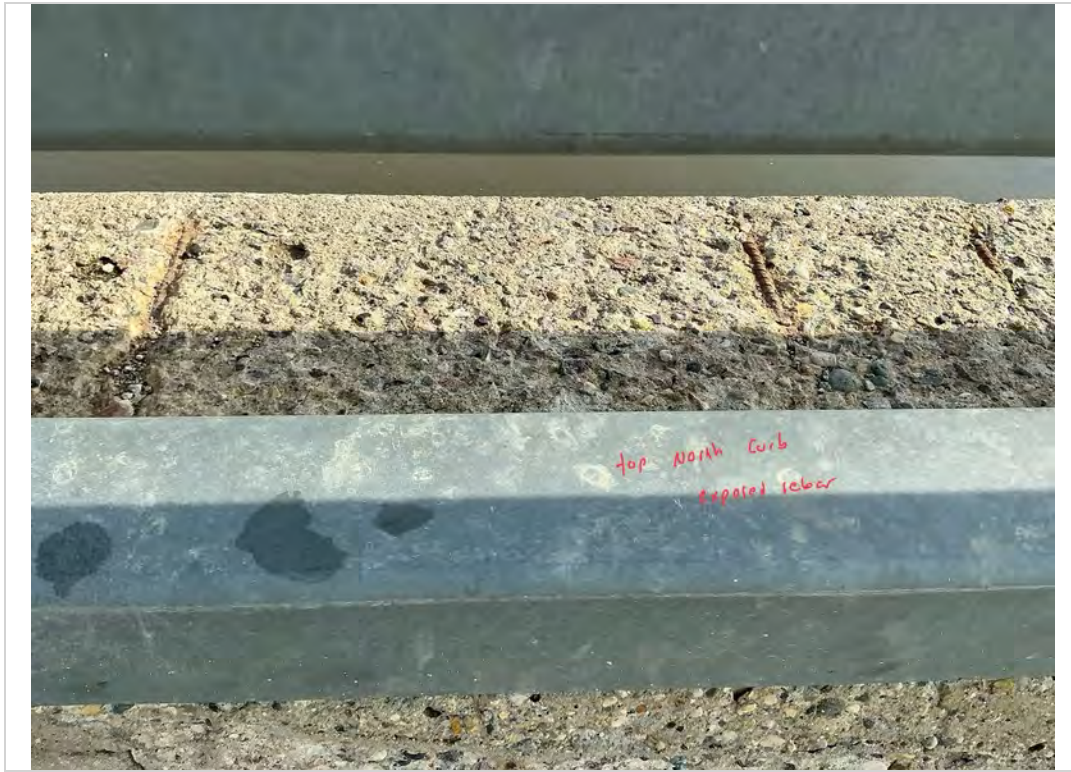
Facing South. Exposed Rebar to Top of North Curb.

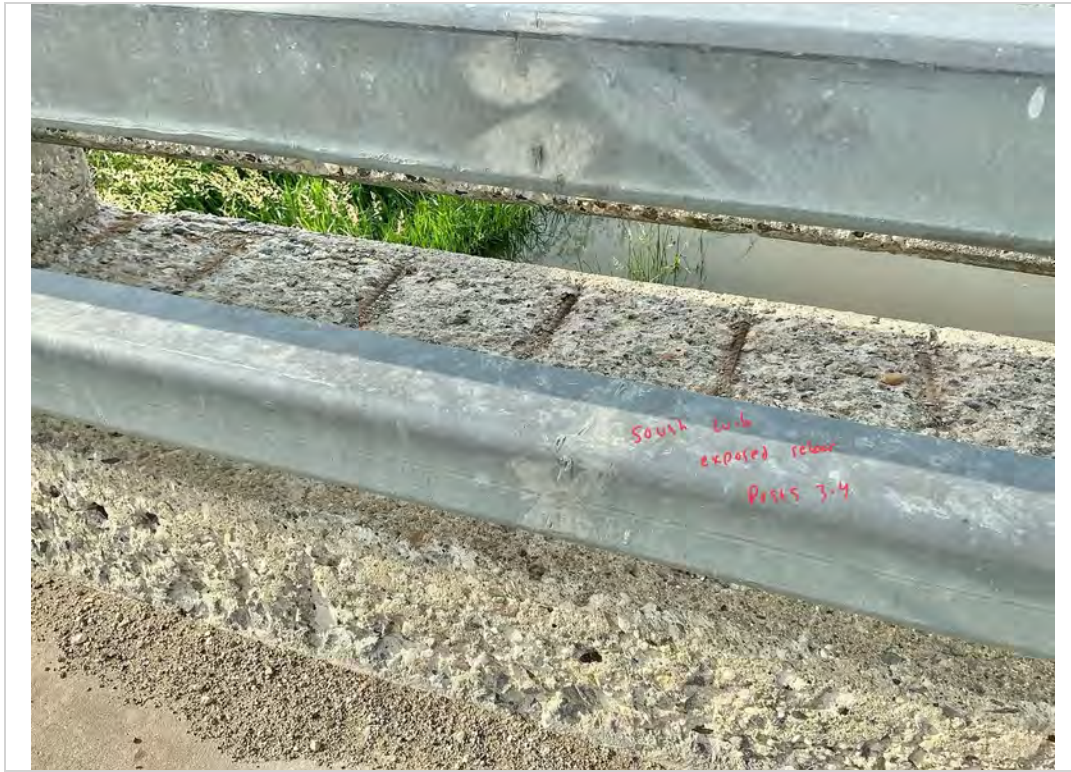
Facing South. Exposed Rebar to Top of South Curb.

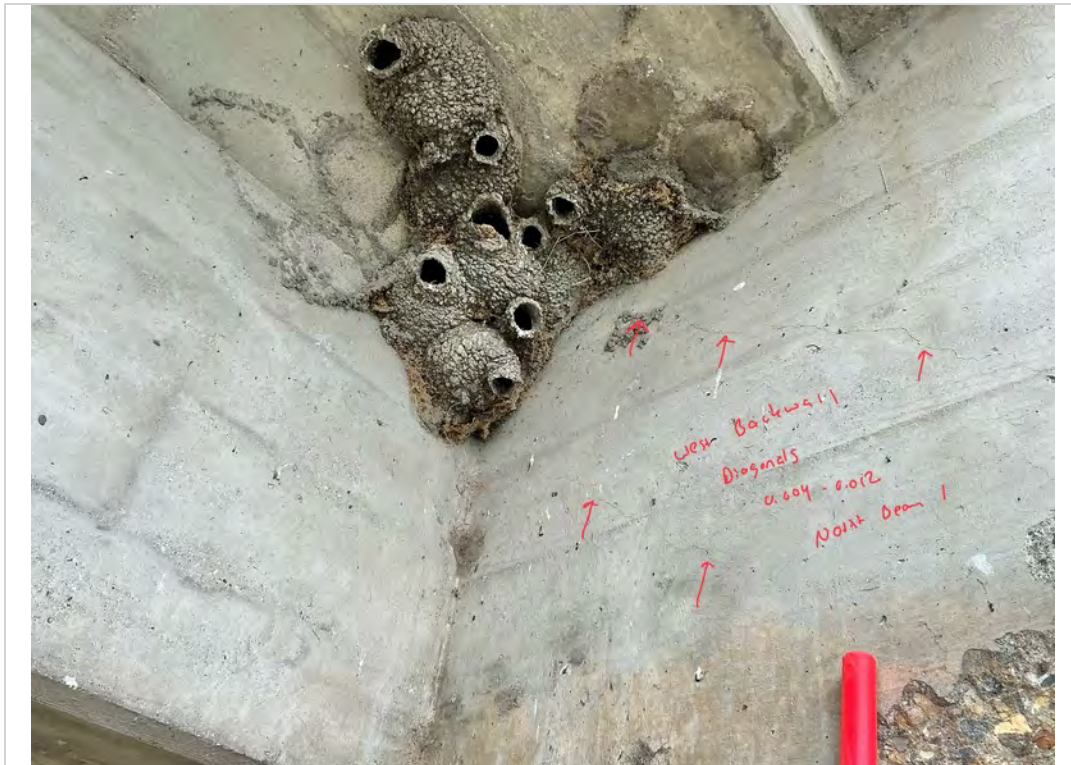
Facing SW and Upwards. Diagonal Cracks to West Backwall North Beam 1.

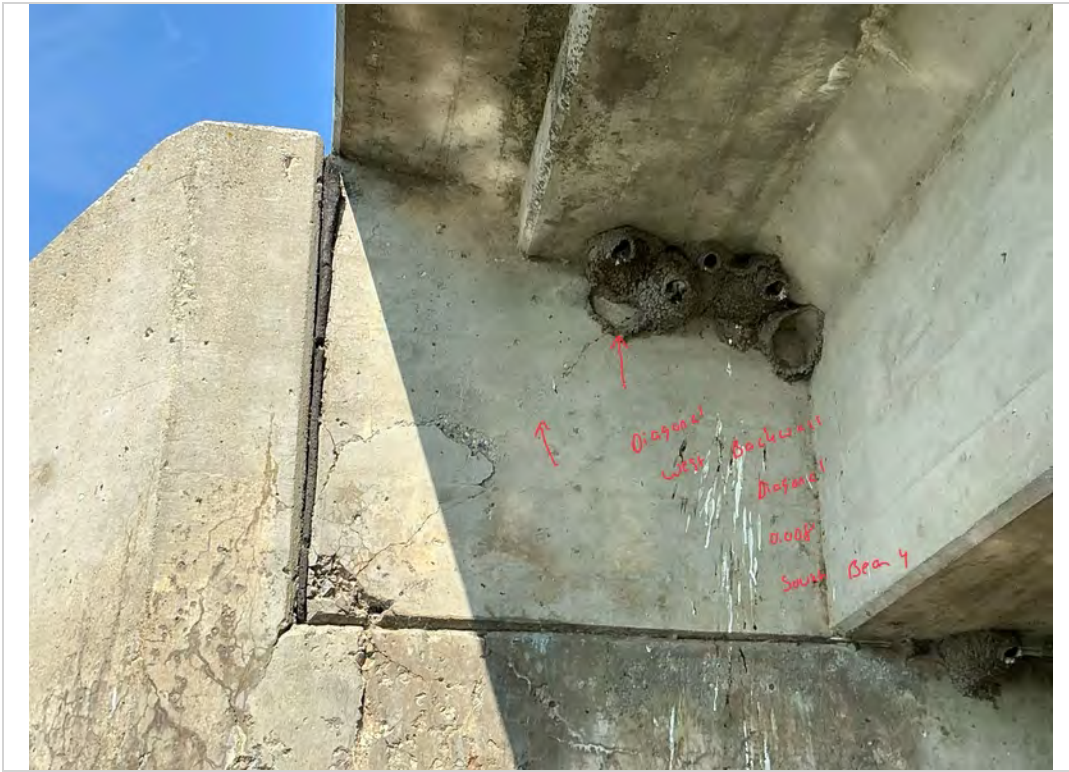
Facing West. Cracking to West Backwall South Beam 4.

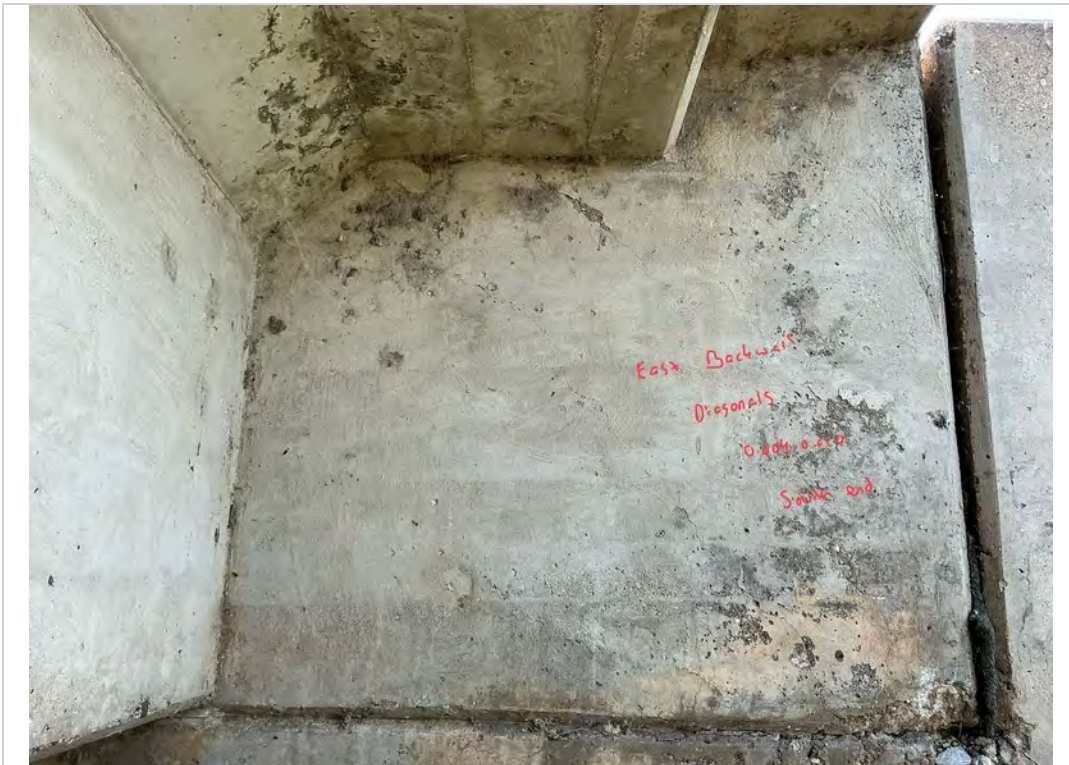
Facing East. Diagonal Cracking to East Backwall South End.

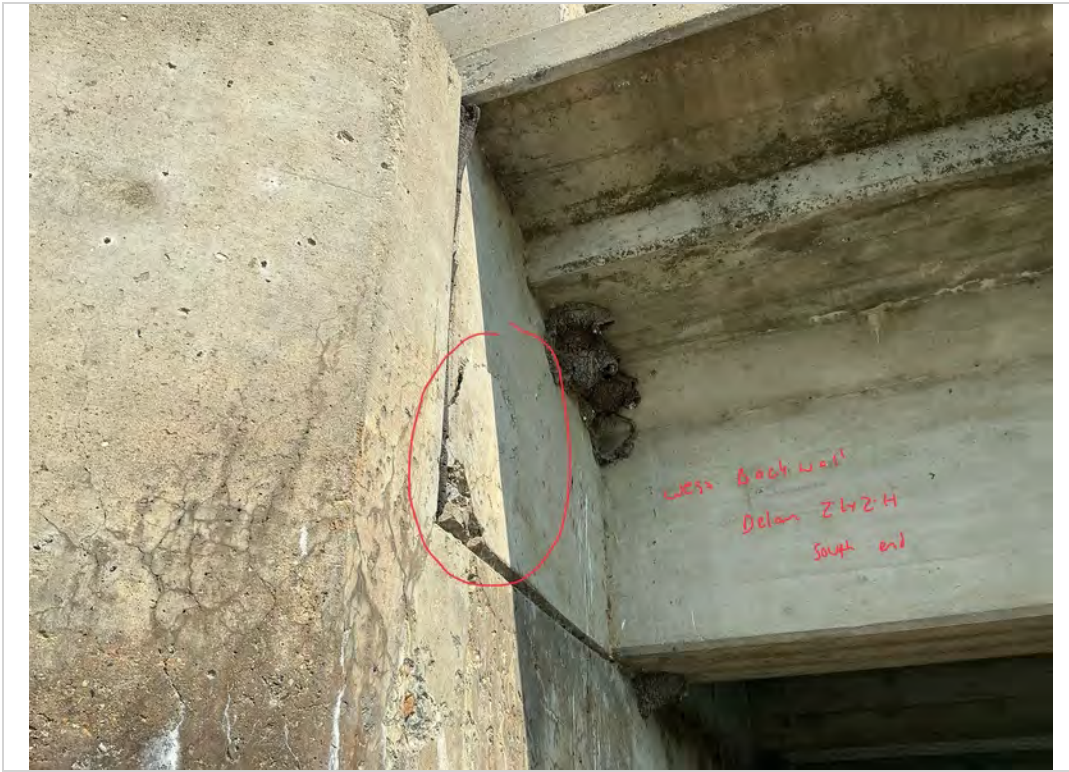
Facing North. Delam to West Backwall South End.

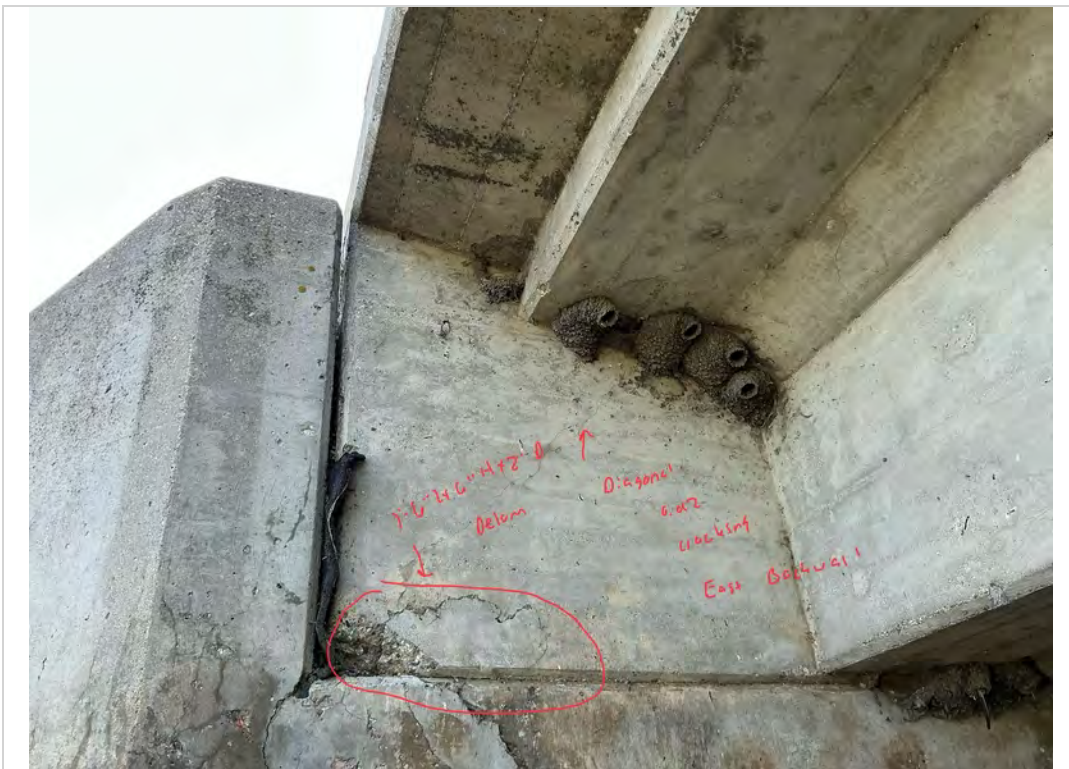
Facing East. Delam area and Diagonal Cracking to East Backwall North Beam 1.

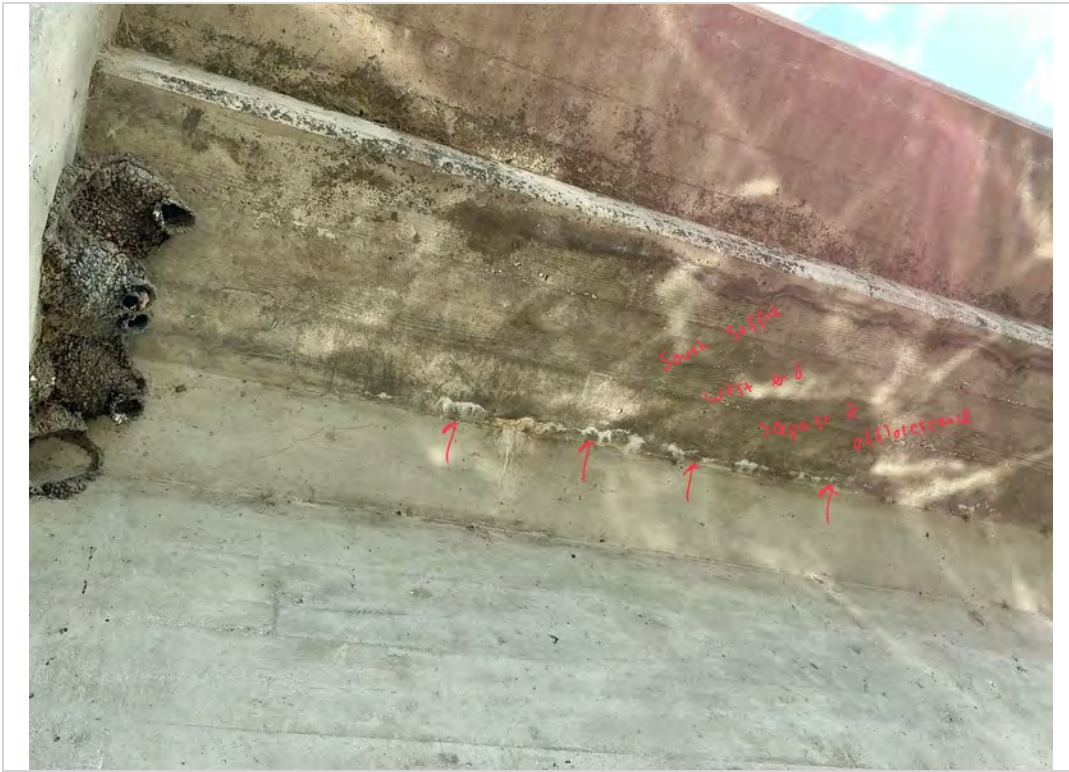
Facing North and Upwards. South Soffit with Seepage and Efflorescence.

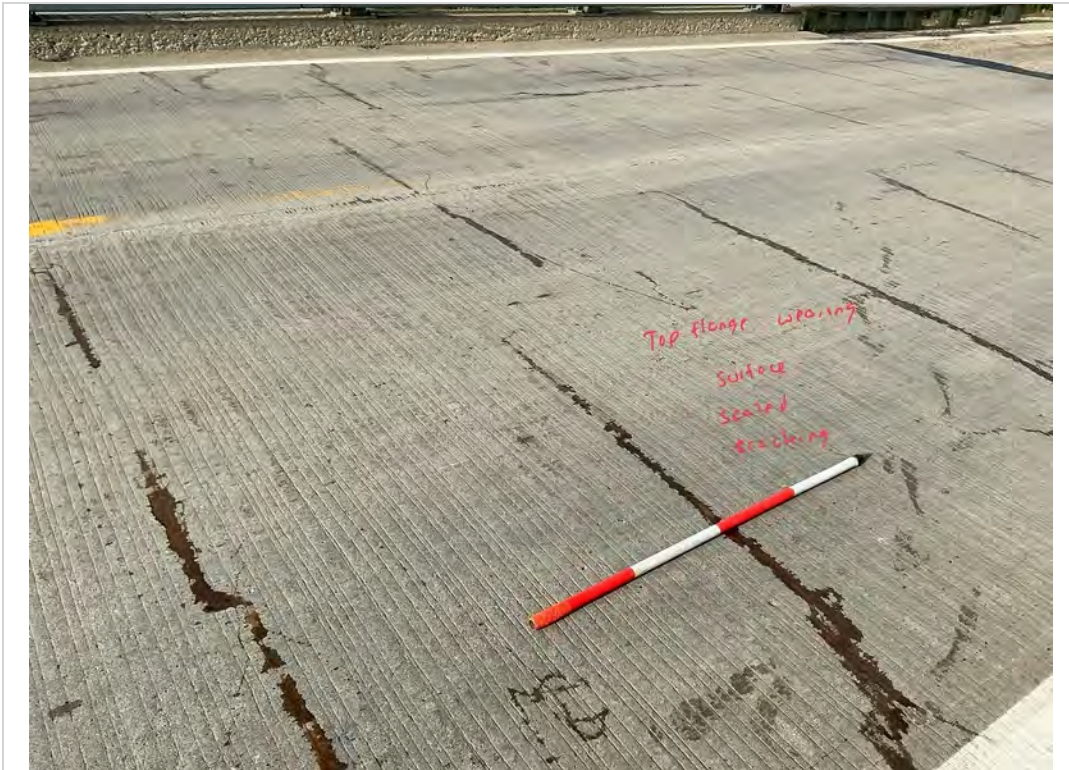
Facing South. Sealed Transverse Cracking to Top Flange Deck Wearing Surface.

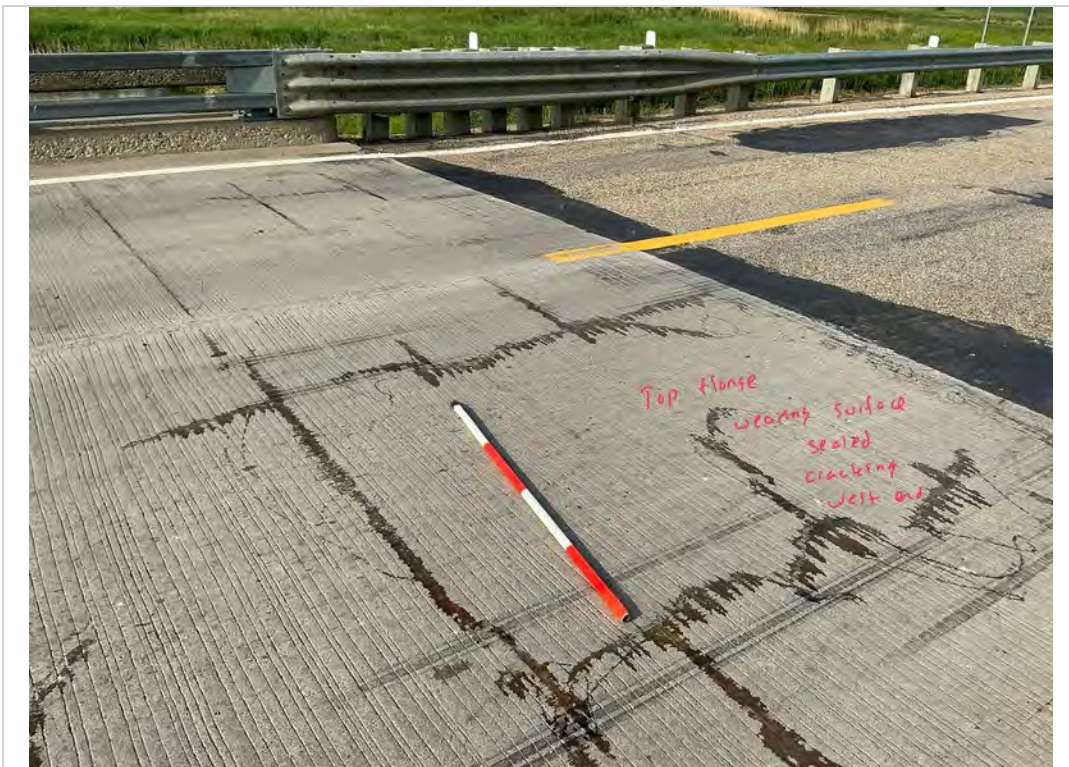
Facing SW. Sealed Cracking to Top Flange Deck Wearing Surface West End.

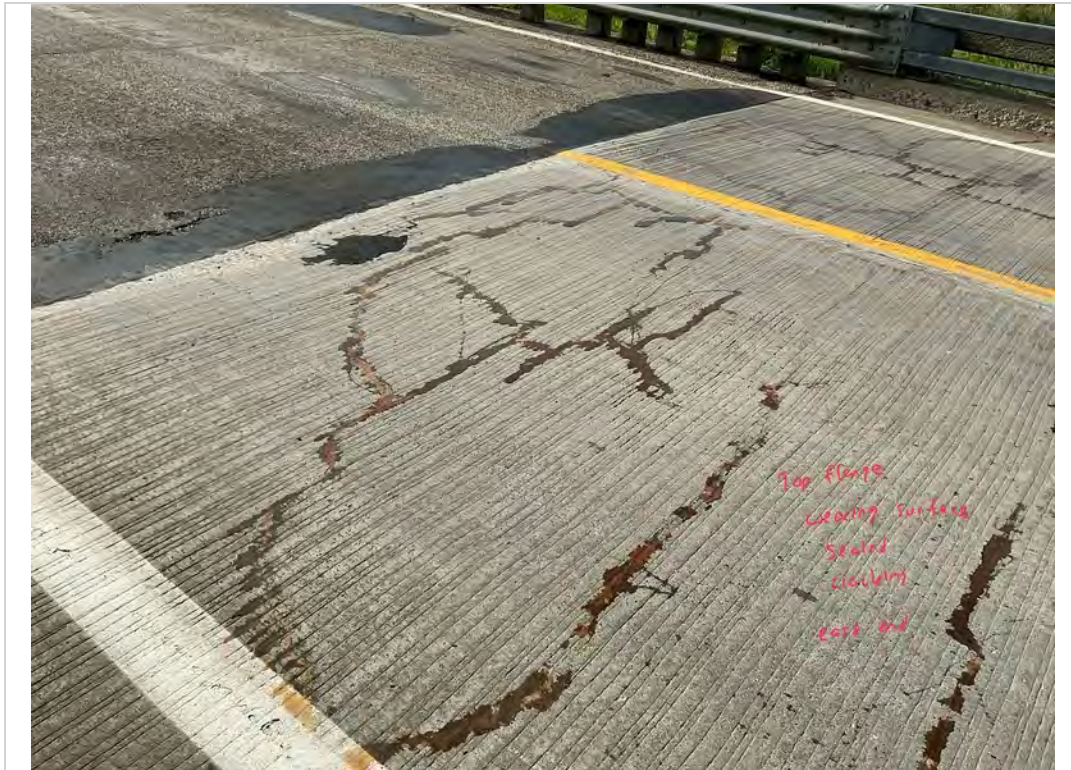
Facing SE. Sealed Cracking to Top Flange Deck Wearing Surface East End.

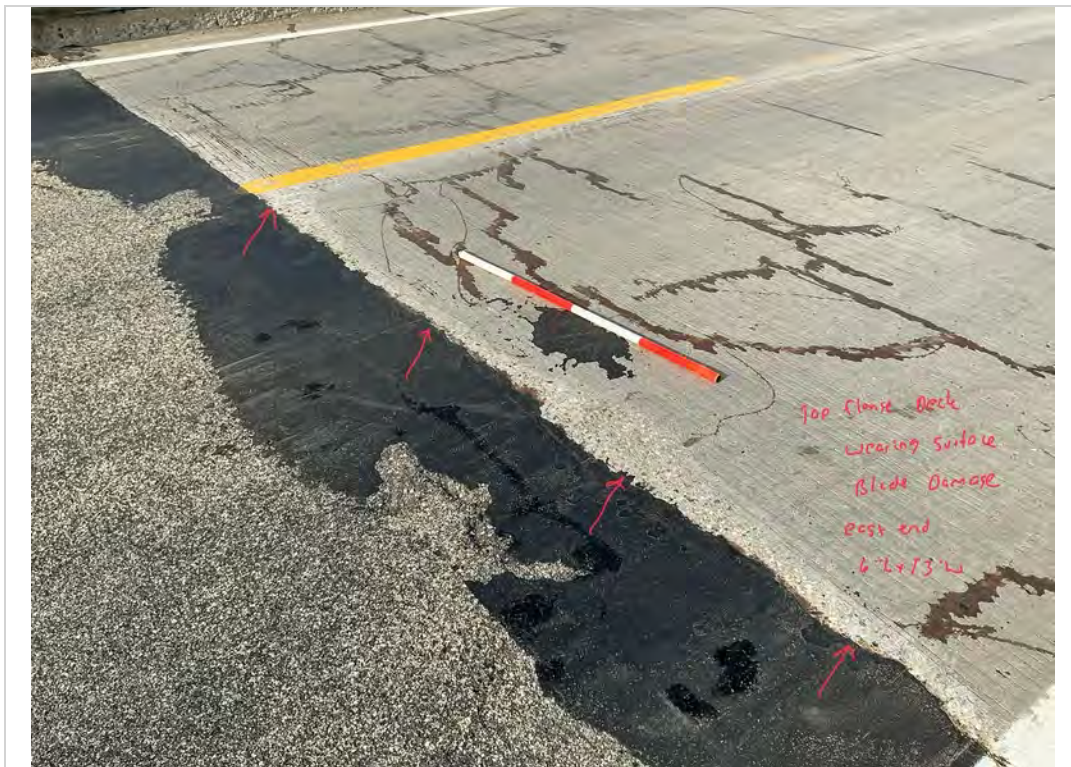
Facing SW. Blade Damage to East End of Top Flange Deck Wearing Surface.

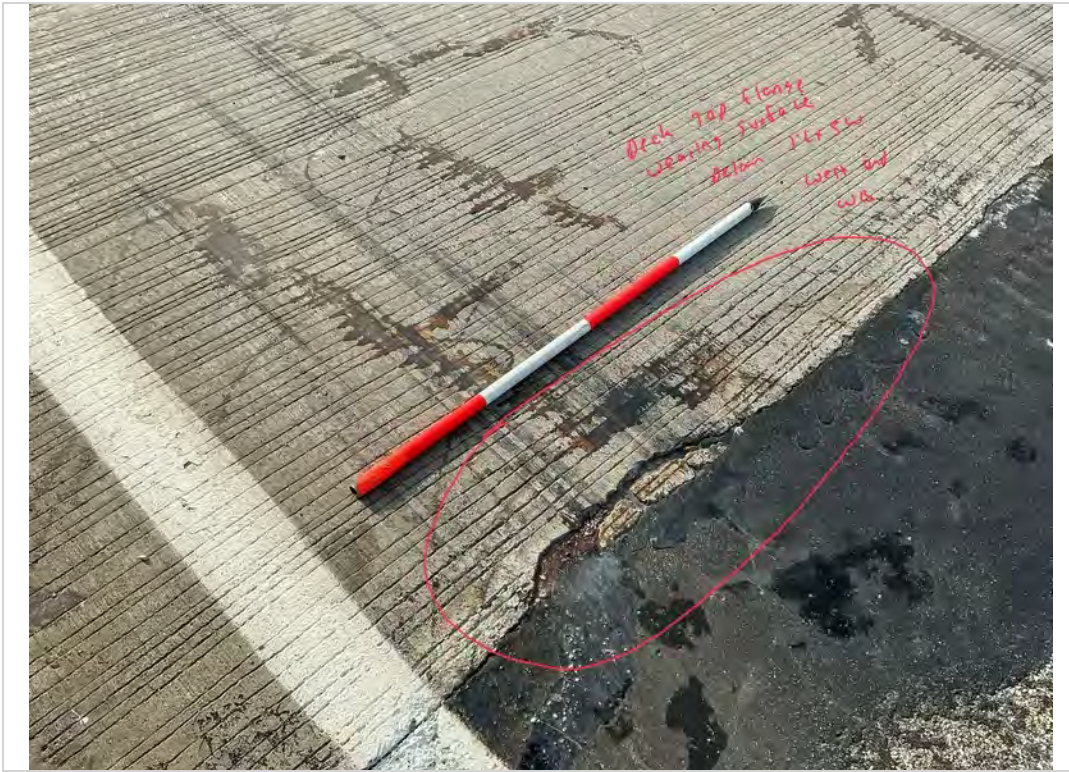
Facing SE. Moderate Delam, Spall to West End of Top Flange Deck Wearing Surface.

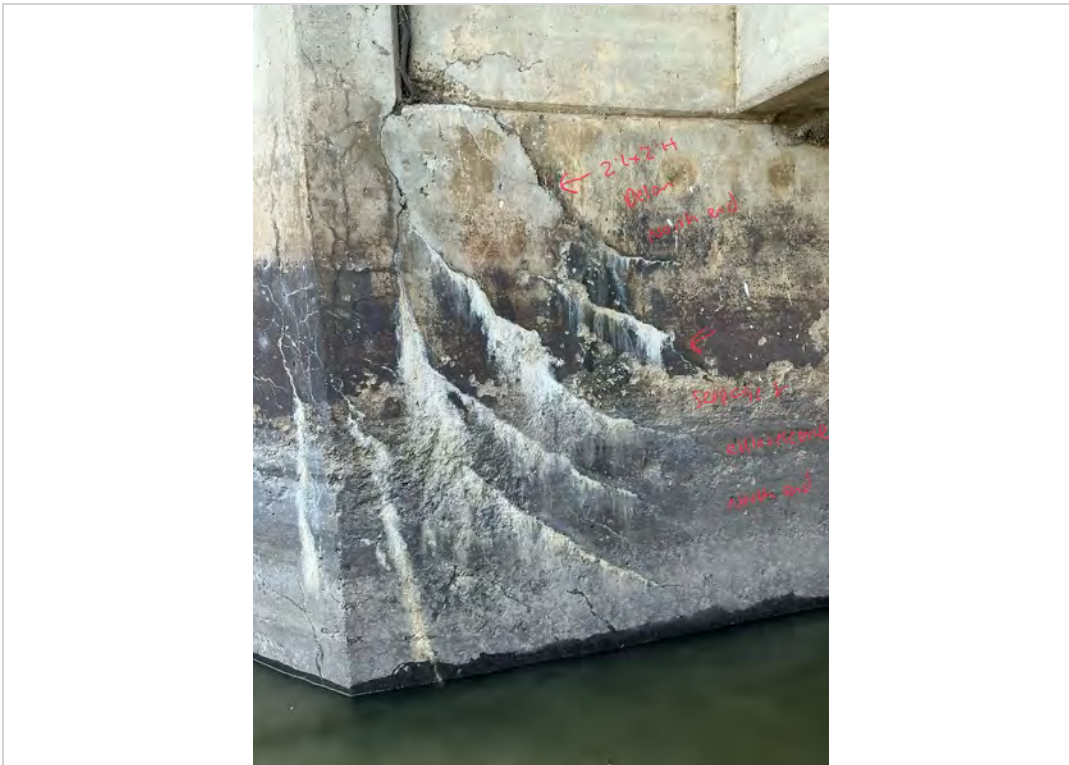
Facing East. U-Shaped Seepage and Efflorescence with Delam area to East Abutment North End.

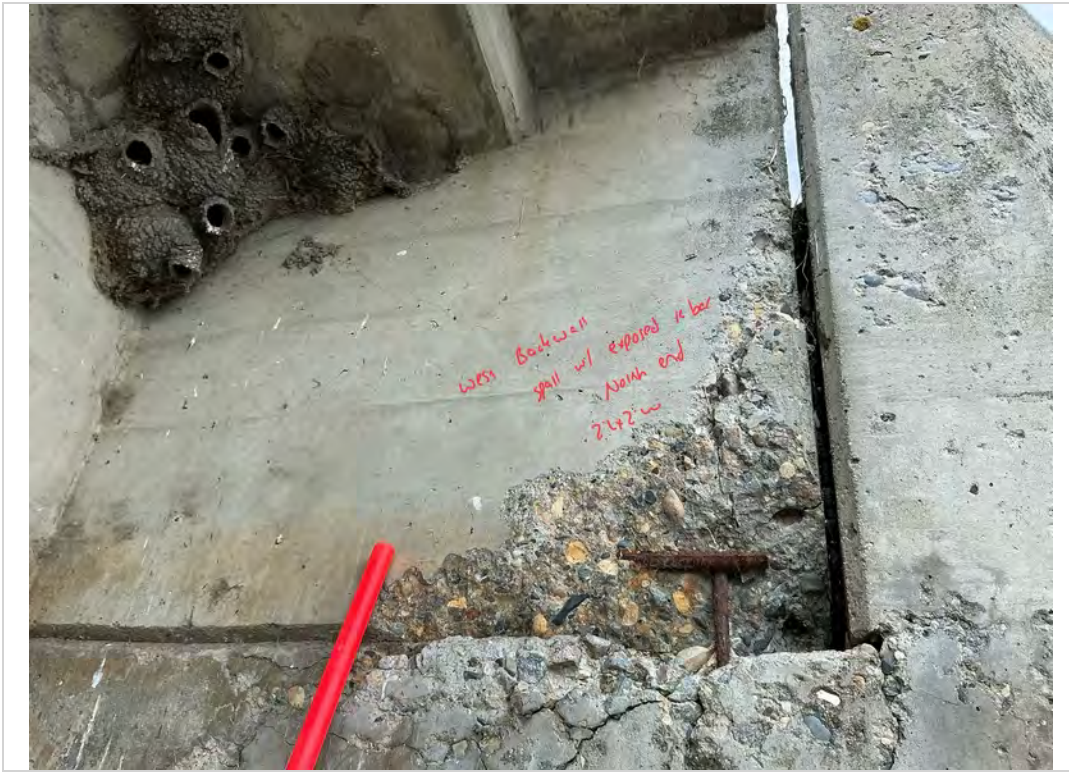
Facing West. Spalling with Exposed Rebar to West Backwall North End.

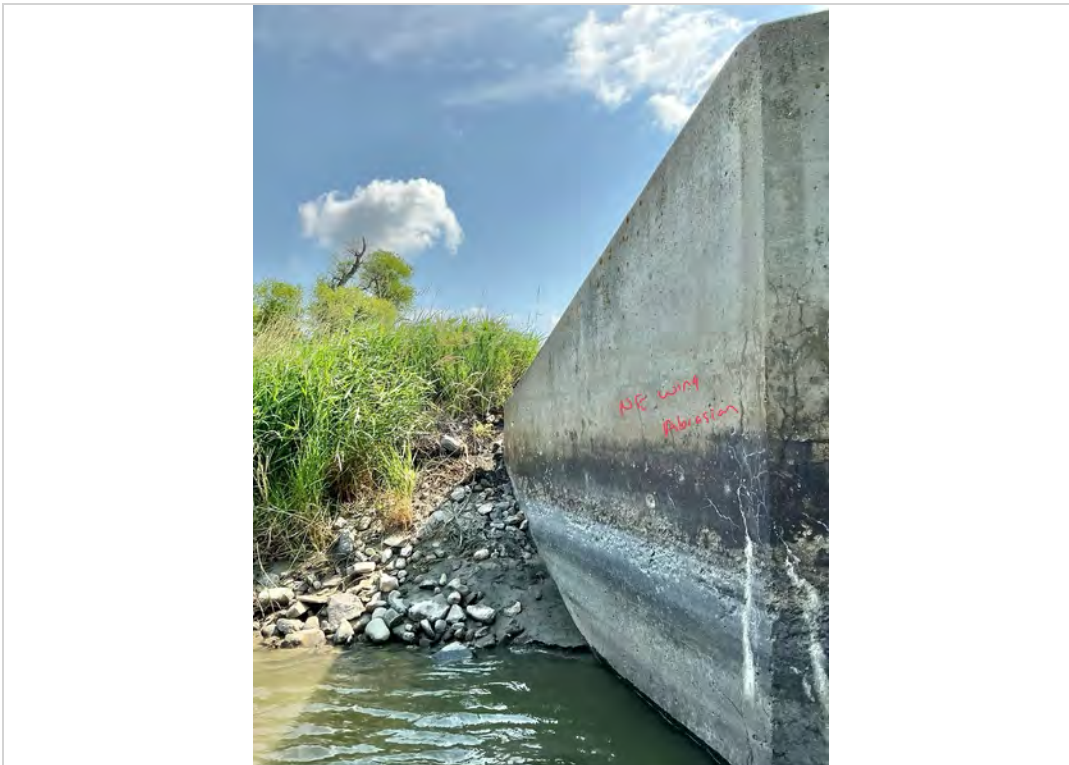
Facing East. Abrasion to NE Wing.
