Route:00011 Log:141.361

District 68, County 41 - Sargent

| IDENTIFICATION | |
|---|---|
| (8) Structure Number | 0011-141.391 |
| (6) Features Intersected | WILD RICE RIVER |

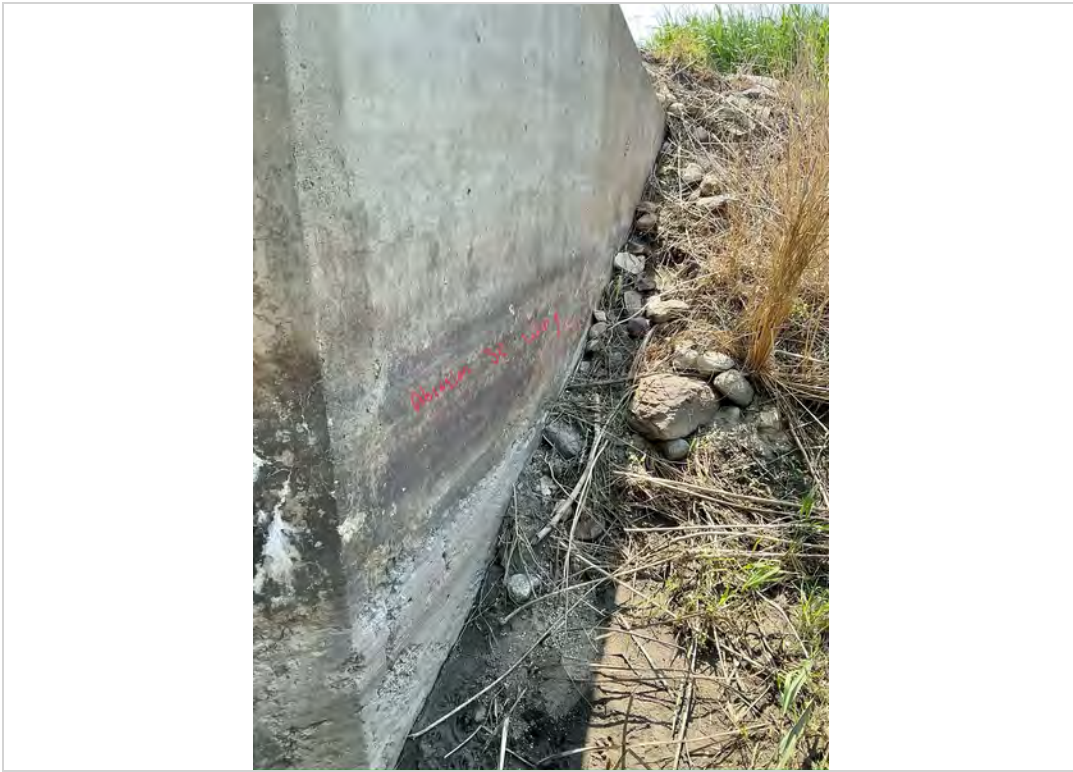
Facing East. Abrasion along Face of SE Wing.

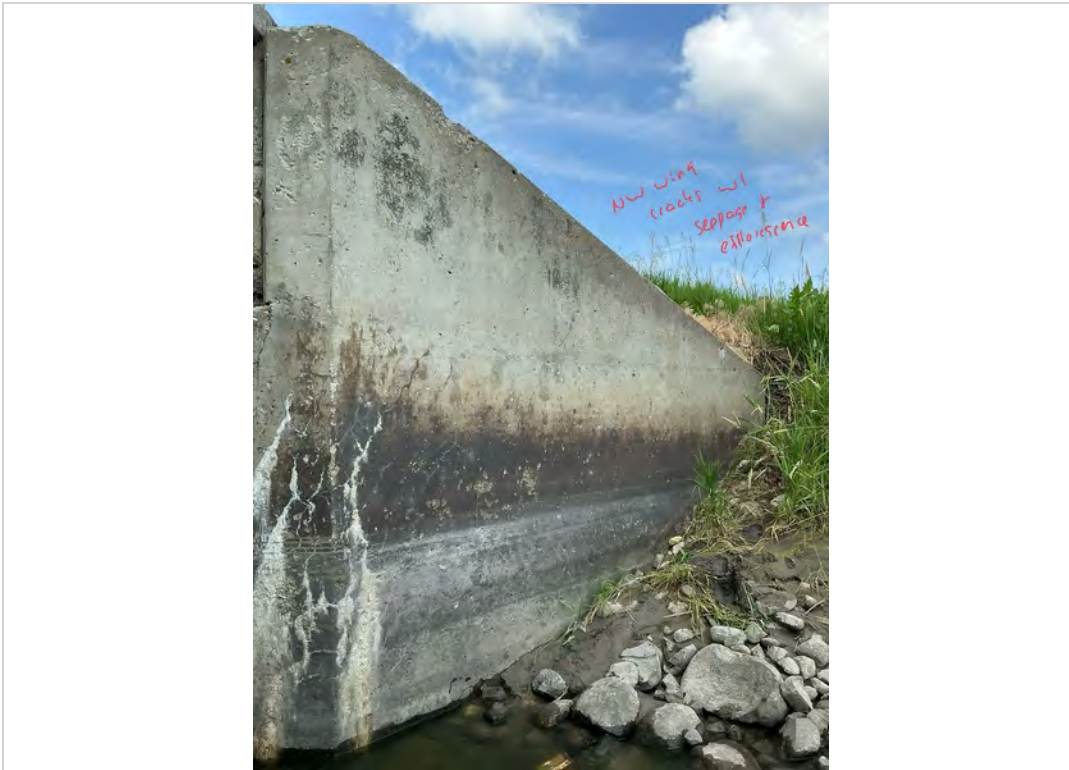
Facing West. NW Wing with Cracking, Seepage, and Efflorescence.

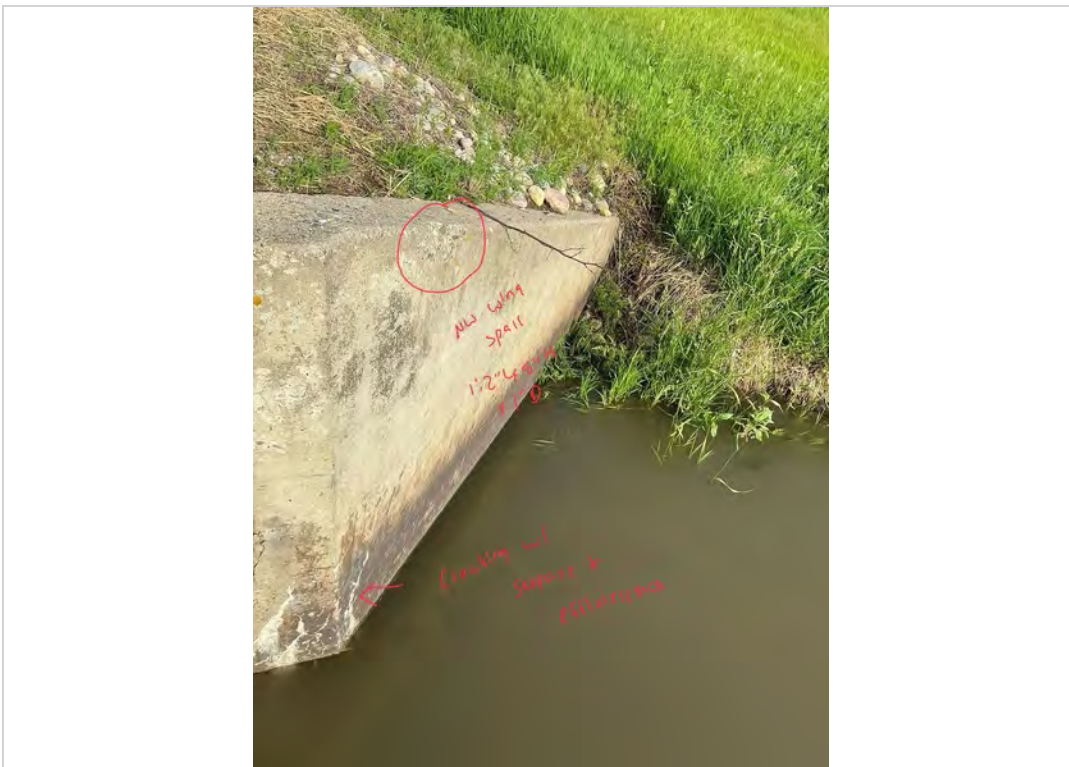
Facing West. Spall along Top with Cracking, Seepage, Efflorescence to NW Wing.

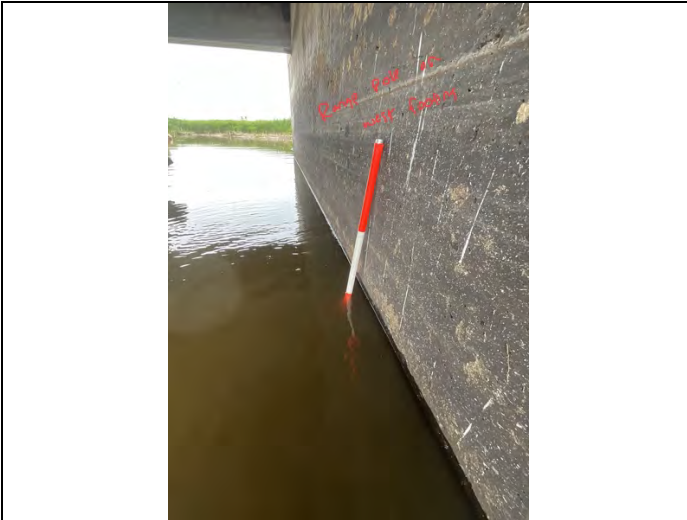
Scour along West Abutment Exposing Footing with a depth below top of footing at now at +3', previous 1'-6". Area is now 12'L x 6'W x 2'D, 2023 Previous area 23'L x 6'W x 4' to 4 1/2' D. 2021 Previous area 15' L x 3' W. East Abutment Footing Exposed.

Facing South. Range Pole used to show Exposed Footing along Abutment.

Recommendation to place Loose Rip Rap along both Abutments. See Photos.

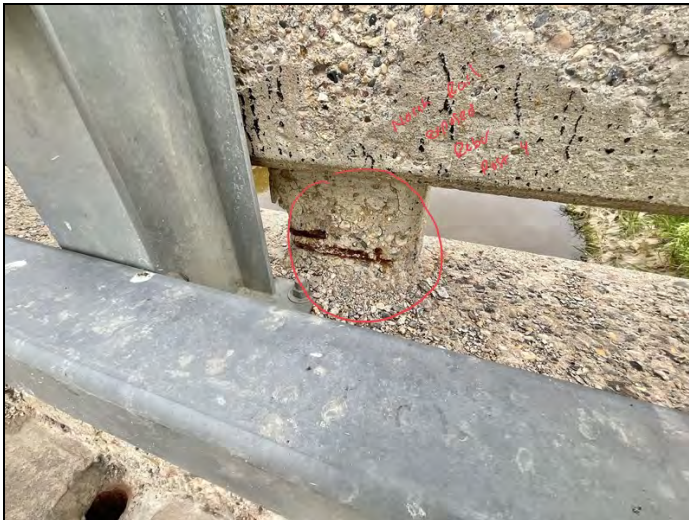
Facing North. Exposed Rebar to North Railing Post 4.

Recommendation to update Railing to current standards. See Photos.

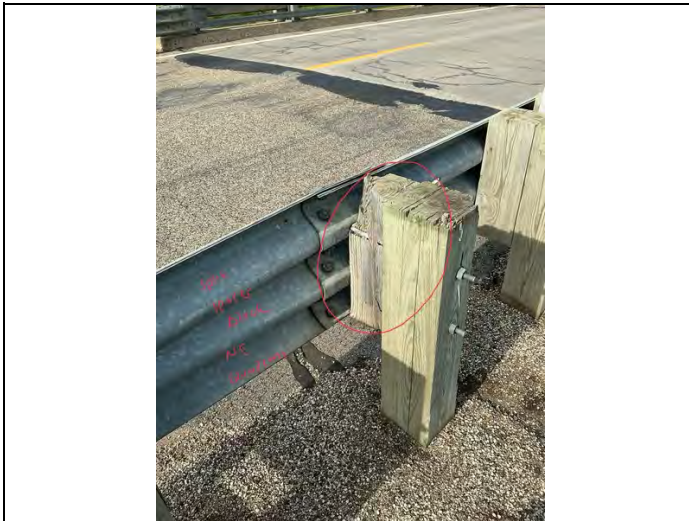
Two Split/Cracked Wood Posts with 1 Post not connected to W-Beam within SW Quadrant.  
NW Thrie Beam Damage at Connection to Metal Railing.  
Split Wood Spacer Block within NE Guardrail Quadrant.

Facing SW. Split Wood Spacer Block NE Quadrant.

Recommendation to replace wood posts and reset Thrie Beam. See Photos.

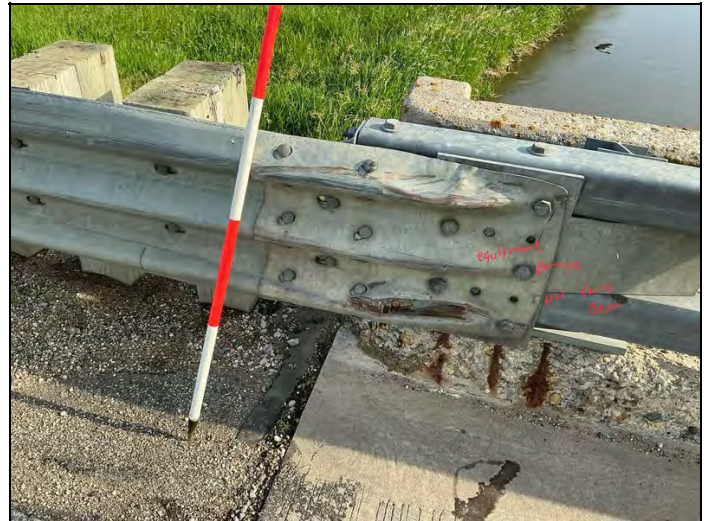
Facing North. Equipment Damage to NW Thrie Beam Connection.

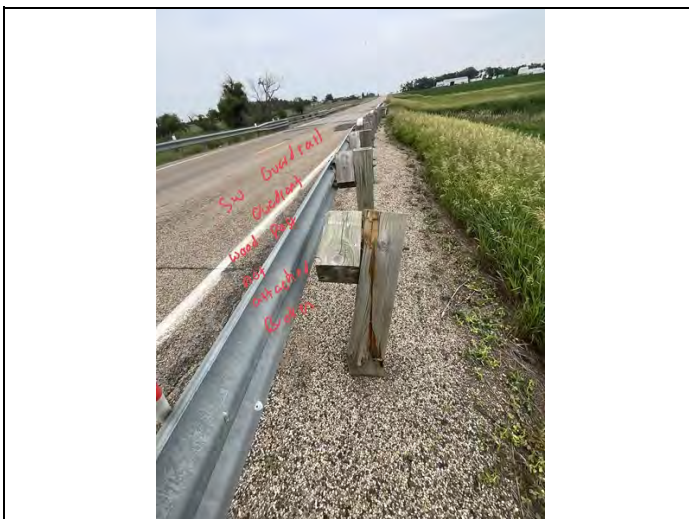
Facing East. Cracked and Broken Wood Post not attached to W-Beam SW Quadrant.
