North Dakota Department of Transportation

Project IM-1-094(233)182, PCN 23634 - Sterling, ND

Sterling Interchange Bridge Reconstruction (I-94 Exit 182)

Proposed Construction – Sterling Interchange

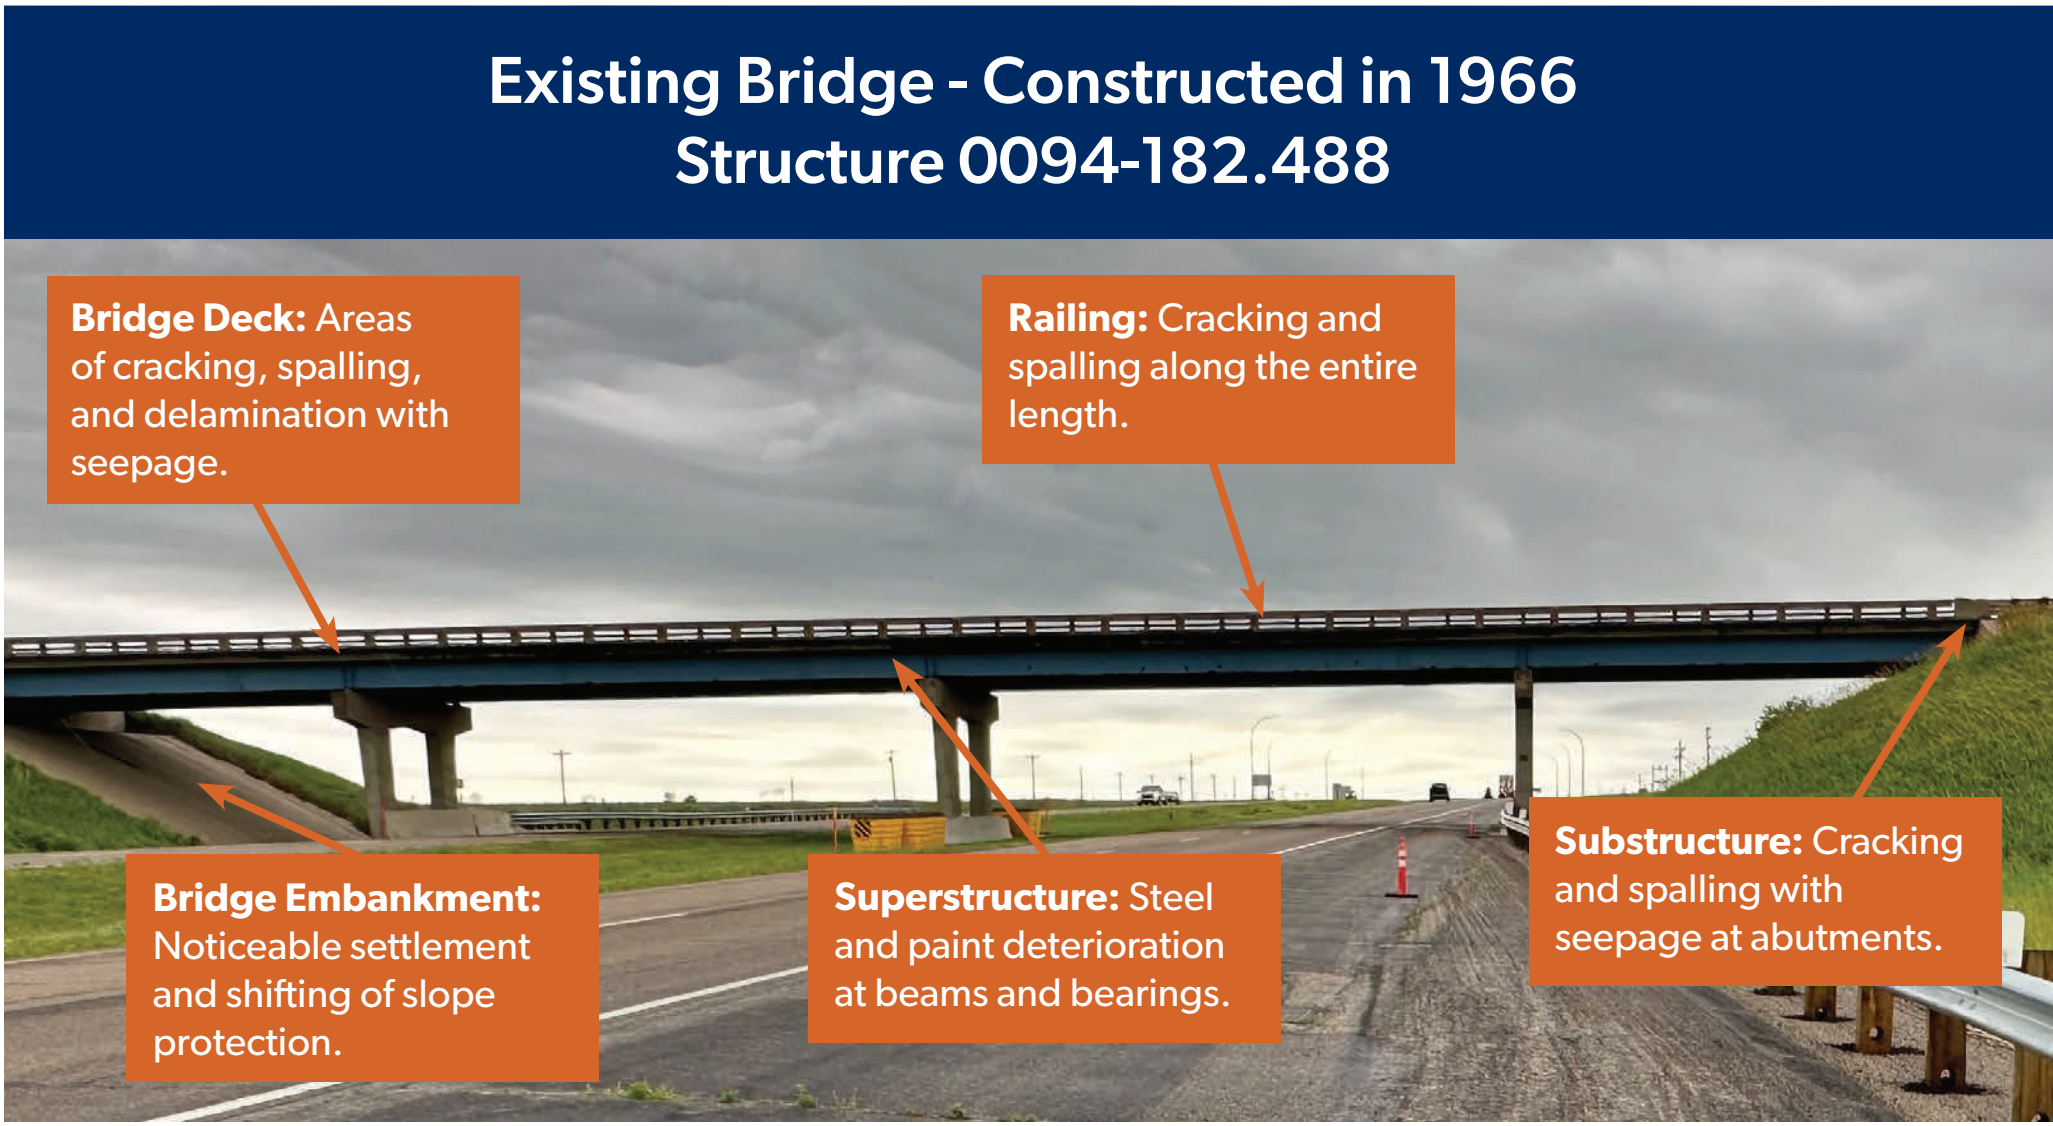
Existing Bridge - Constructed in 1966 Structure 0094-182.488

- Spans – 4
- Length – 240'
- Width – 30'
- Railing Height – 2'8 1/2"
- Vert. Clearance – 16'2" EB; 16'9" WB
- Bridge components have deteriorated requiring attention

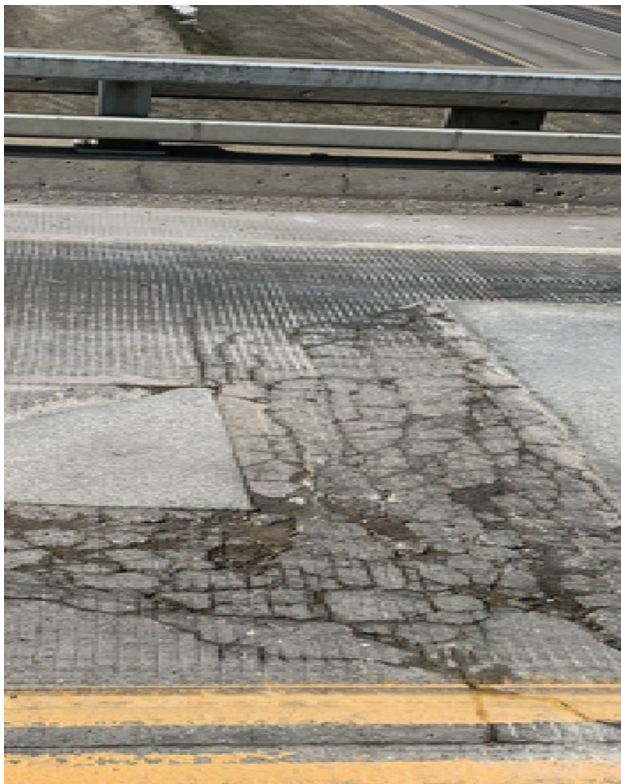
Deck cracking on roadway surface (photo taken prior to overlay)

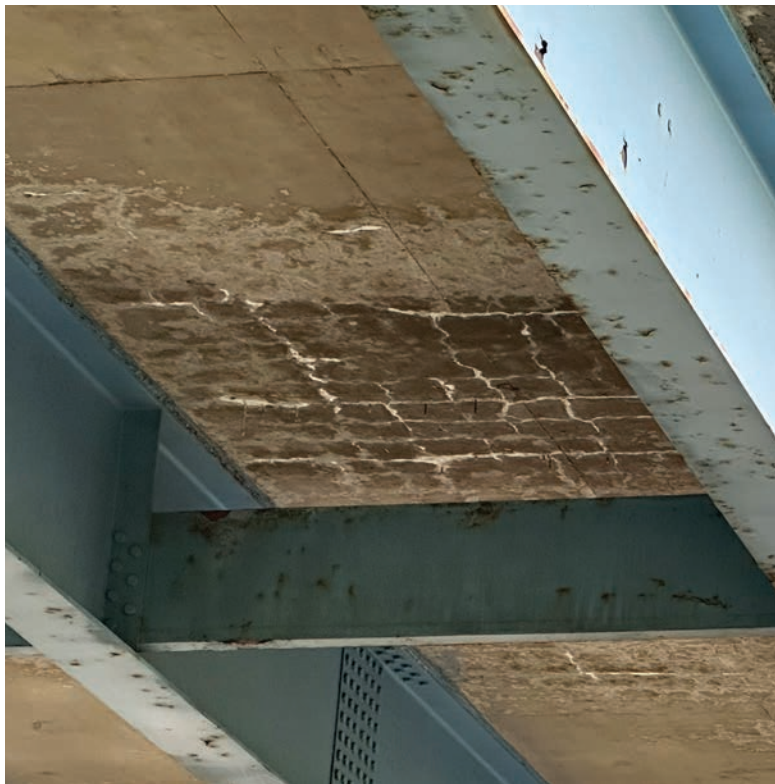
Deck cracking with efflorescence

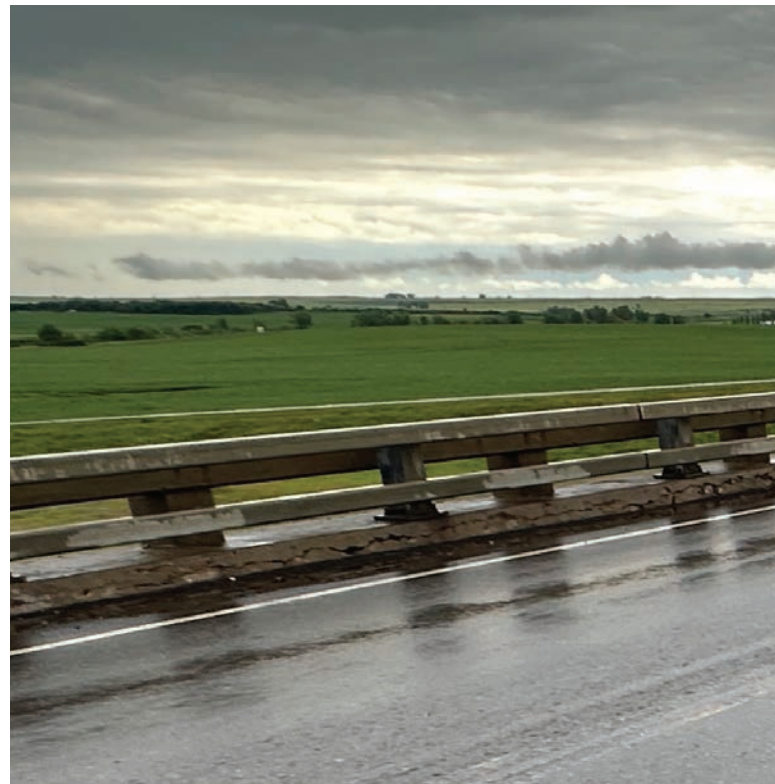
Spalling and cracking on bridge deck and curb sections

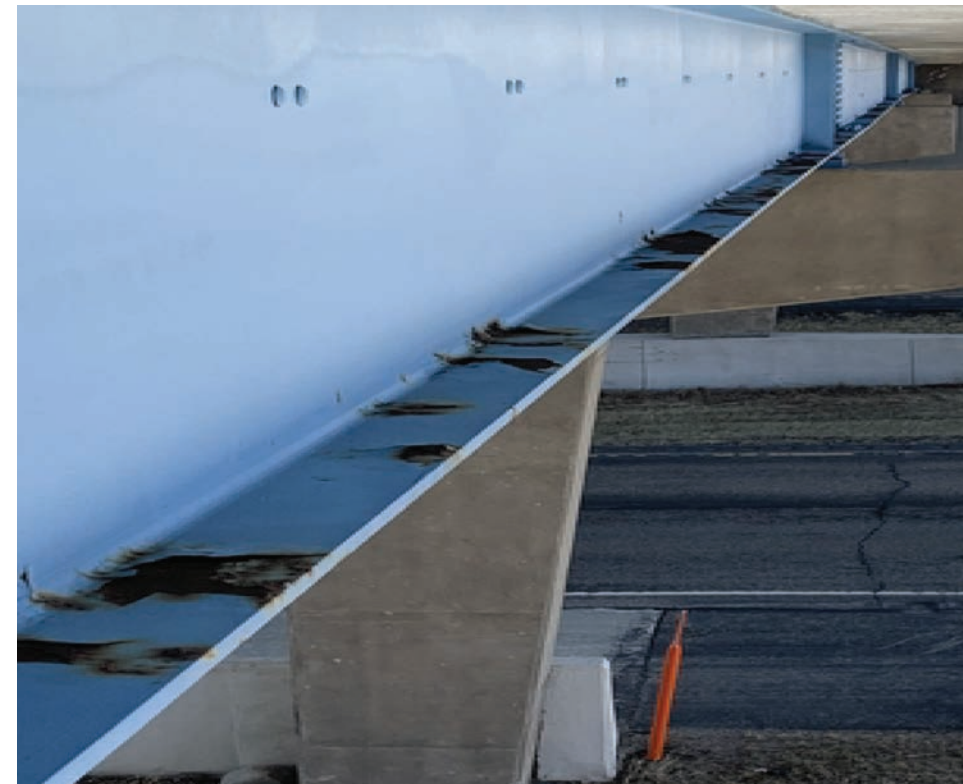
Steel corrosion and flaking paint
