ND 18 LANDSLIDE SLOPE STABILITY RECOMMENDATION

TO:	File
FROM:	Geotechnical Section
DATE:	12/20/2022
HIGHWAY:	ND 18
PROJECT NUMBER:	8-018(106)064
PCN:	23279
LOCATION:	8 North of Leonard, Maple River
SUBJECT:	ND 18 Landslide Slope Stability Recommendation

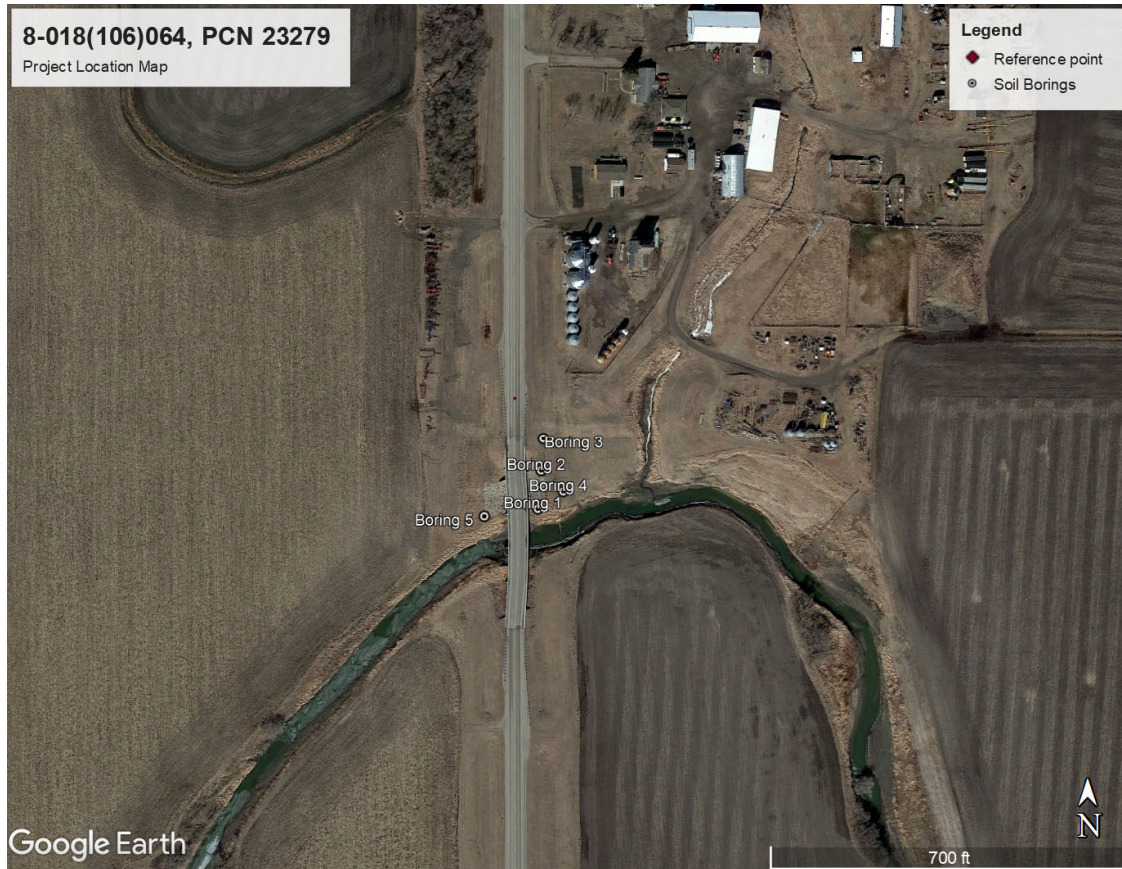
Figure 1 – Project Location and Soil Boring Locations

The geotechnical section was tasked to remediate an existing landslide that is occurring on ND 18 at approximately RP 64. The landslide is occurring on the northern bank of the maple river and is affecting the bridge structure (Bridge No. 0018-064.955) that crosses the Maple River. This landslide has been affecting the current structure since the early 2000's and is causing the north pier to lean. Soil borings were completed at this location and instrumentation was installed to identify the depth of the landslide movement and the water table characteristics. Figure 1 below shows an aerial picture of the project location and the soil borings completed:
