**NORTH DAKOTA
DEPARTMENT OF TRANSPORTATION**

Experimental Study ND 98-02

**Snow Management by the
Use of Snow Fence Systems**

Final Evaluation

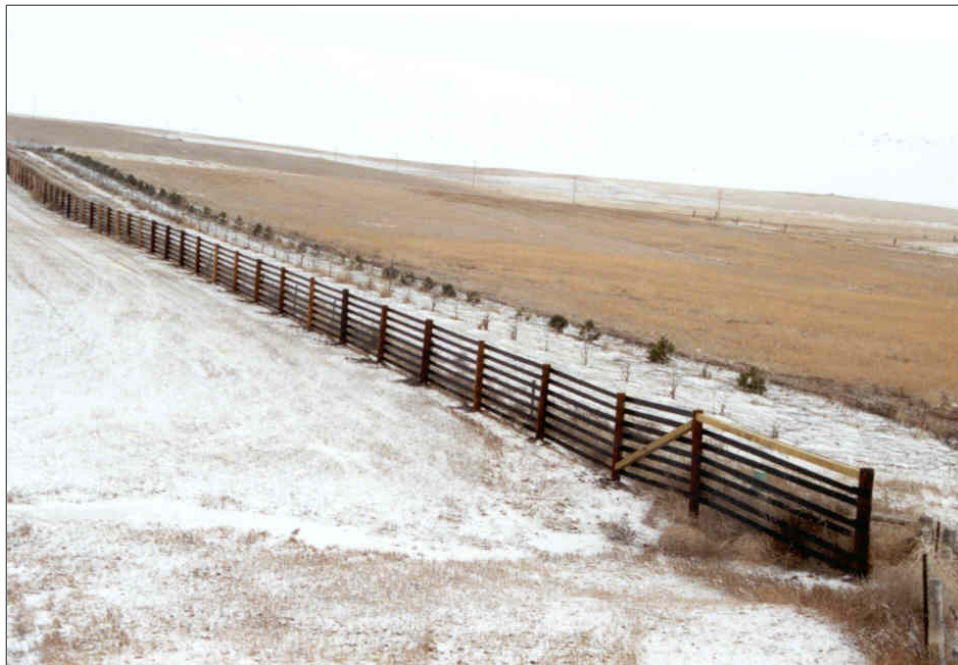
The North Dakota Department of Transportation (NDDOT) had installed demonstration structural snow fence systems at four sites located on the interstate system. These four sites were problem areas due to poor visibility and snow accumulation on the roadway. One of the sites had an existing living snow fence, consisting of a young shelterbelt of Ash and Pine trees. Photo 1 shows a six feet tall structural snow fence with the living snow fence in February 1998.

Photo 1 - Structural snow fence and living snow fence in February 1998.
