**NORTH DAKOTA
DEPARTMENT OF TRANSPORTATION**

Experimental Study ND 98-02

**Snow Management by the
Use of Snow Fence Systems**

Second Evaluation

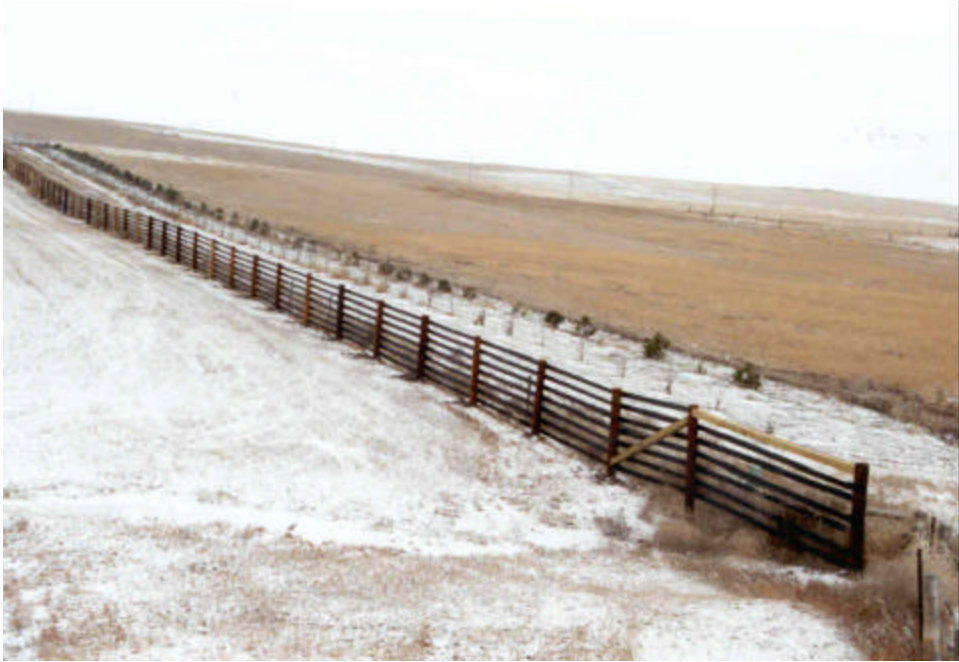
North Dakota Department of Transportation (NDDOT) has installed demonstration structural snow fence systems at four sites located on the interstate system. These four sites were problem areas due to poor visibility and snow accumulation on the roadway. One of the sites has an existing living snow fence, consisting of a young shelterbelt of Ash and Pine trees. Photo 1 shows a six feet tall structural snow fence with the living snow fence in February 1998.

Photo 1 - Structural snow fence and living snow fence in February 1998.
