GEOTECHNICAL REPORT
Valley City SW Backslope Slide Repair,
2-094(185)290 PCN 23338
VALLEY CITY, NORTH DAKOTA

Subject: GEOTECHNICAL REPORT, VALLEY CITY SW BACKSLOPE SLIDE REPAIR,
2-094(185)290 PCN 23338, VALLEY CITY, NORTH DAKOTA

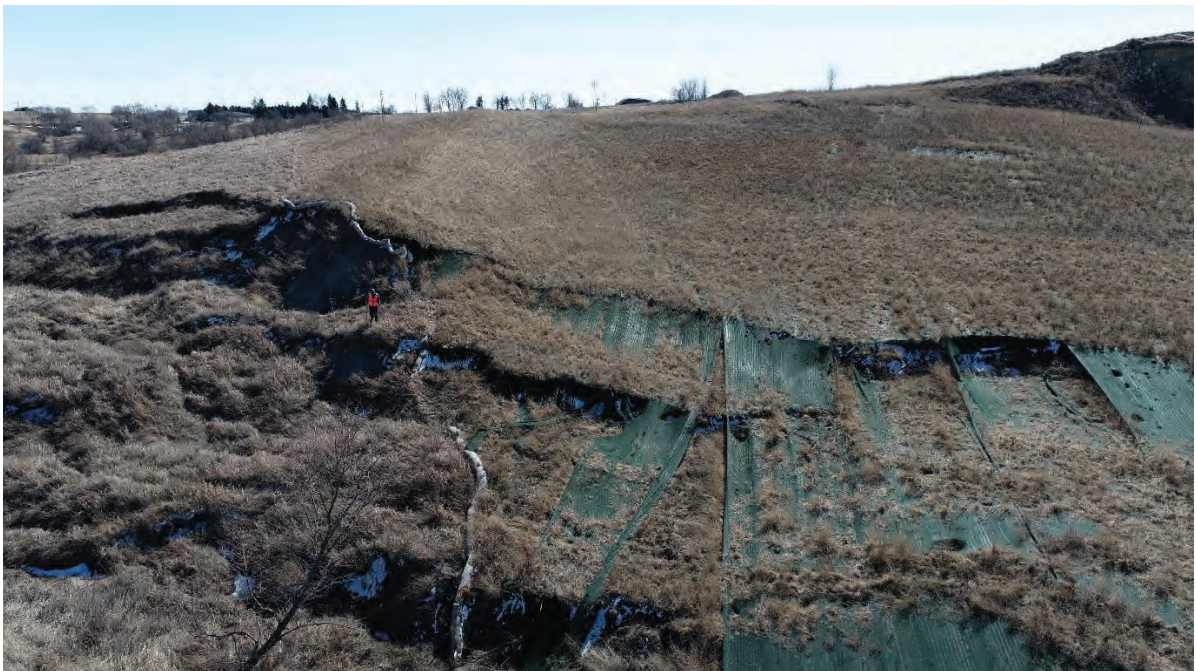
- The lower portion of the graded slope has continued to fail since being regraded in 2019 (see Exhibit 3-2).
- The lower limit of the movement is characterized by an overridden toe feature with ponded water in parts of the drainage ditch (see Exhibit 3-3). Landslide debris is spilling over the toe of the failure and accumulating in the drainage ditch. Drilling the material that has spilled into the ditch was not possible due to access issues, but we anticipate that the thickness of the spilled-over debris is less than 10 feet.

Exhibit 3-2: Site Reconnaissance Photo 2 - View of the stretched TRM (green fabric) and the disturbed soil erosion control log at the eastern grading tie-in point.

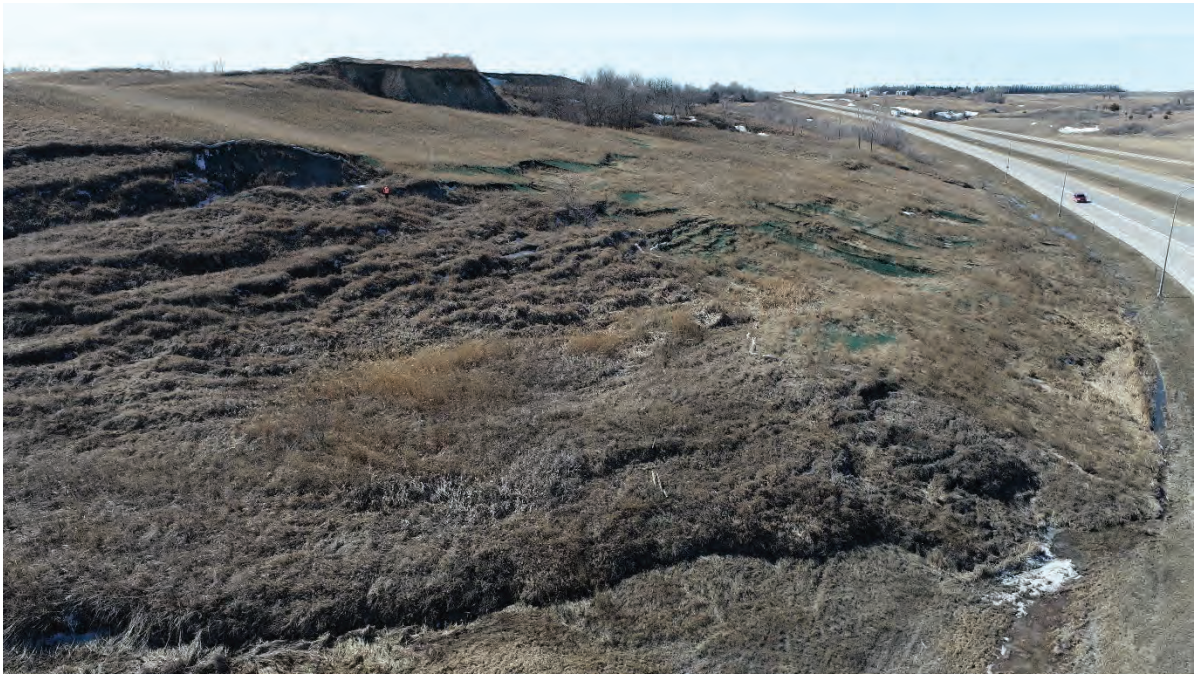
Exhibit 3-3: Site Reconnaissance Photo 3 - View of part of the slide mass with the overriding toe feature, facing west. Note the person in the orange vest in the upper left for scale.

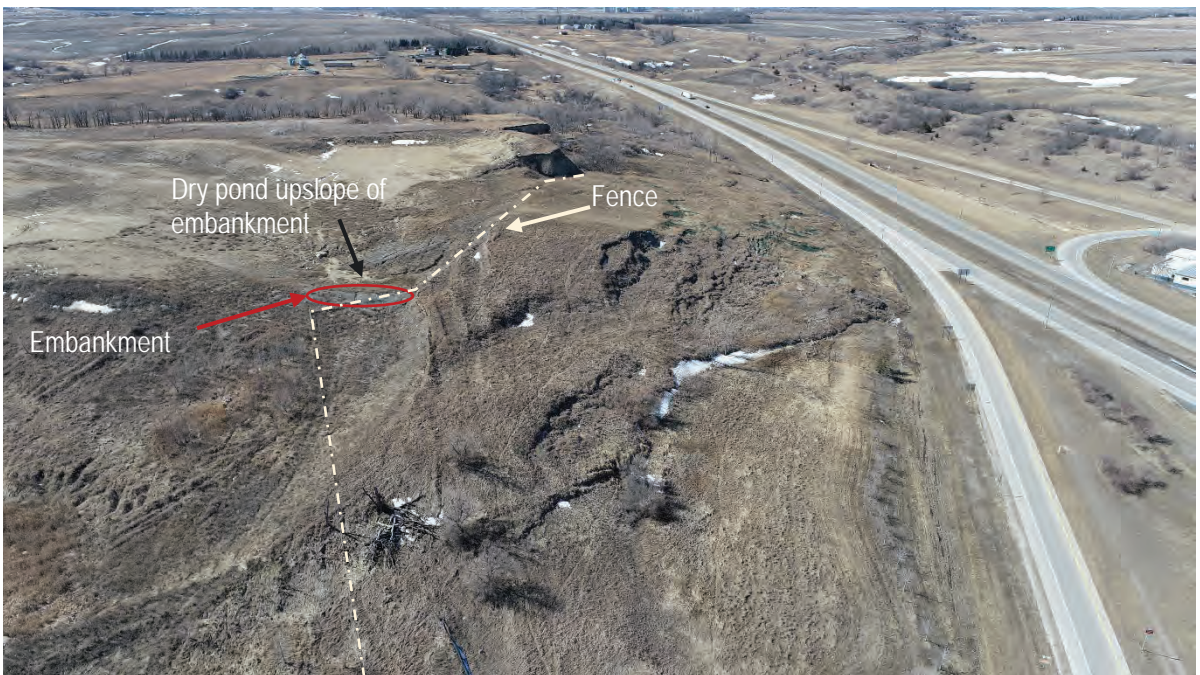
Exhibit 3-4: Site Reconnaissance Photo 4 - View of the slide mass with location of embankment and dry pond, facing west.

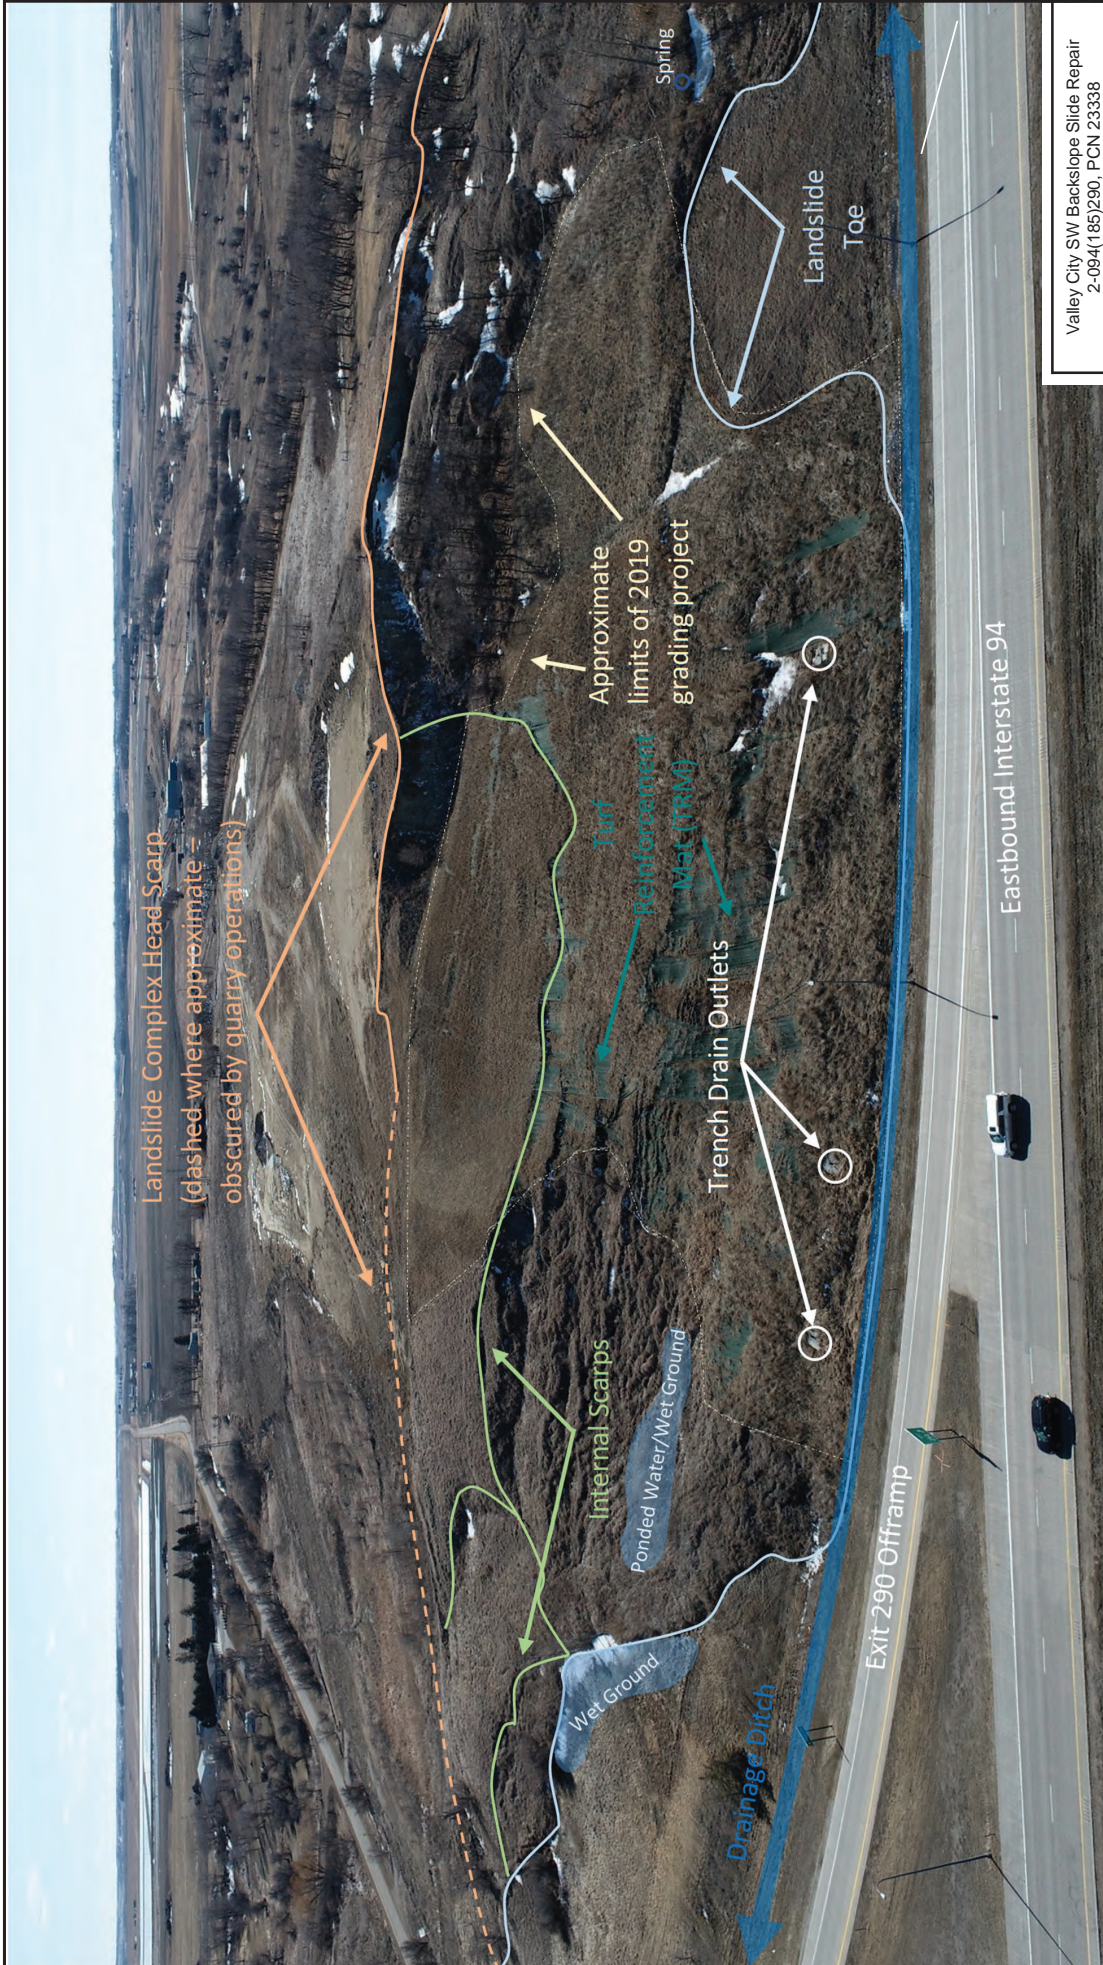
FIG. 3

recently as 2010. The estimated landslide limits as well as internal features are shown on Figure 3.

- Hydrophytic vegetation (cattails) and ponded water were visible in March 2022 (and in June 2022 during drilling) at several locations within the landslide footprint (see Figure 3).

1. Photo taken on March 31, 2022. View due south from the north side of Interstate 94..
2. This figure schematically depicts mapped landslide-induced geomorphic features and other features.

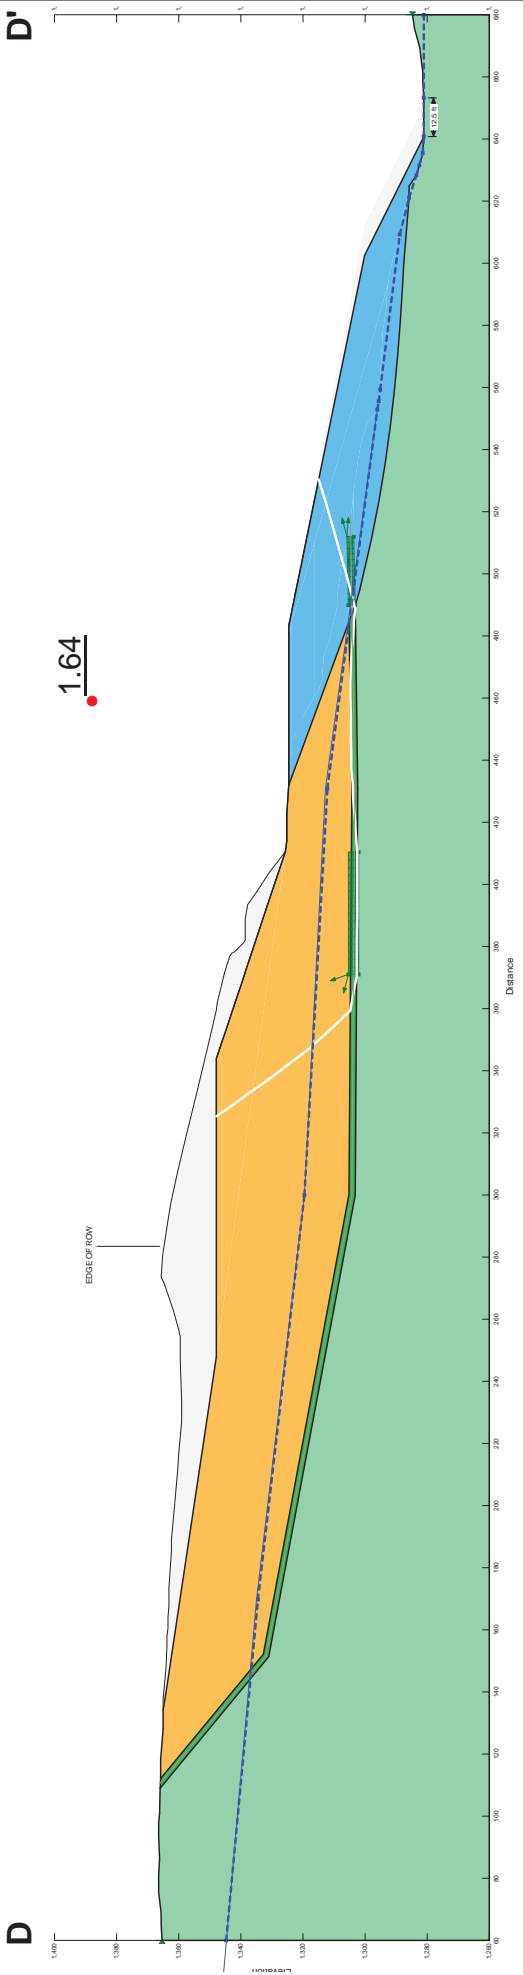
FIG. D-19

Color	Name	Material Model	Unit Weight (pcf)	Strength Function	Effective Cohesion (psf)	Effective Friction Angle (°)	C-Horizontal (psf)	C-Vertical (psf)	Phi-Horizontal (°)	Phi-Vertical (°)
Light Green	Bedrock (Anisotropic)	Anisotropic Strength	125				70	100	22	24
Blue	Buttress Fill	Mohr-Coulomb	125		0	28				
Orange	Overburden	Mohr-Coulomb	120		0	24				
Dark Green	Slip Surf	Shear/Normal Fn.	120	D-D', LL=100, CF>50

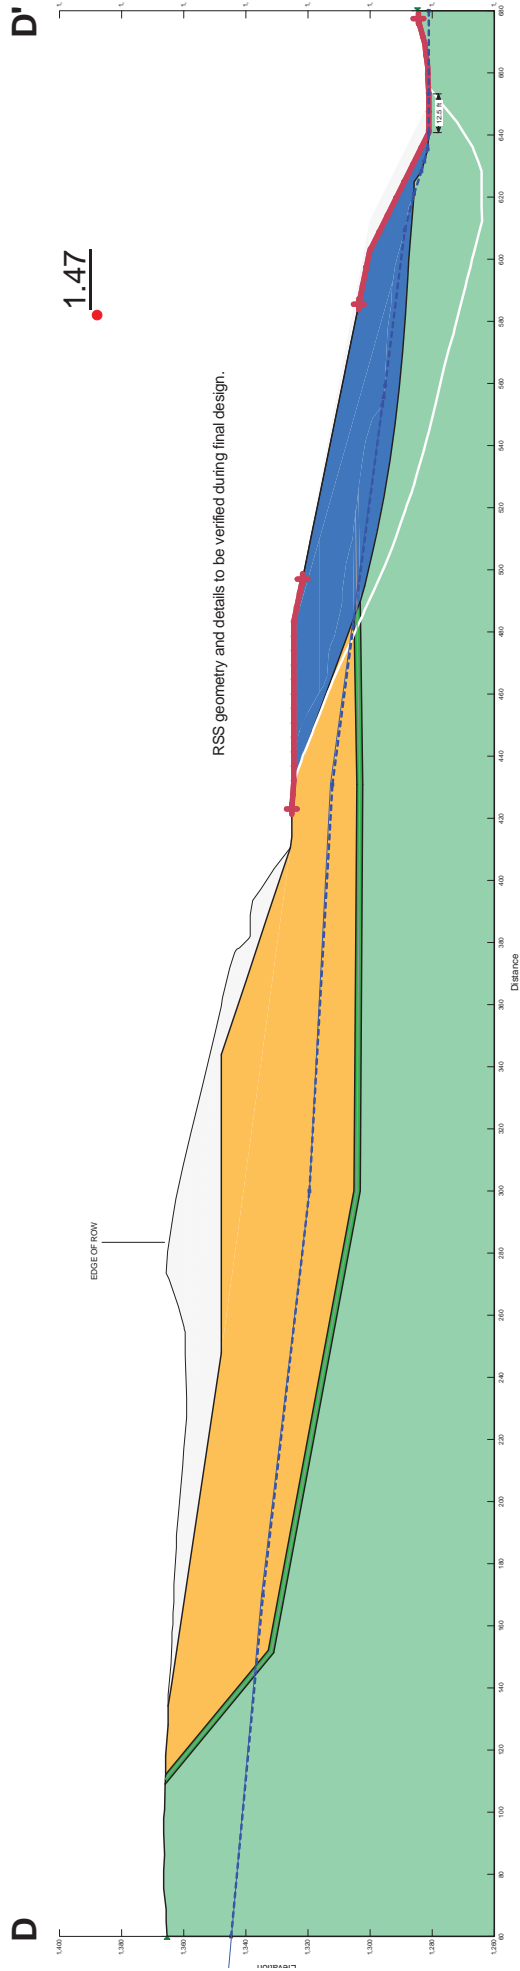
FIG. D-20

Color	Name	Material Model	Unit Weight (pcf)	Strength Function	Effective Cohesion (psf)	Effective Friction Angle (°)	C-Horizontal (psf)	C-Vertical (psf)	Phi-Horizontal (°)	Phi-Vertical (°)
Light Green	Bedrock (Anisotropic)	Anisotropic Strength	125				70	100	22	24
Orange	Overburden	Mohr-Coulomb	120		0	24				
Blue	Reinforced Buttress Fill (RSS)	Mohr-Coulomb	125		1,500	28				
Dark Green	Slip Surf	Shear/Normal Fn.	120	D-D', LL=100, CF>50

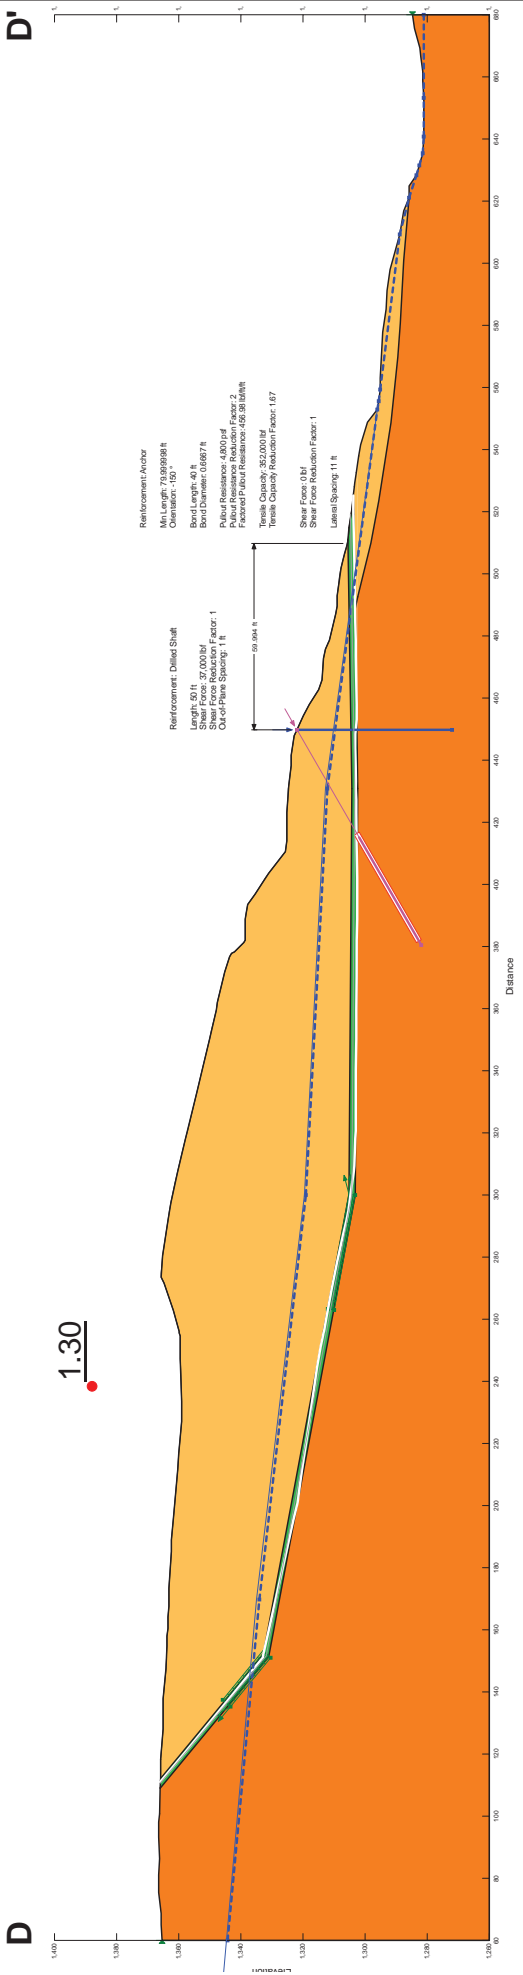
SHANNON & WILSON, INC.
Geotechnical and Environmental Consultants
FIG. D-21

Color	Name	Material Model	Unit Weight (pcf)	Strength Function	Effective Cohesion (psf)	Effective Friction Angle (°)
Orange	Bedrock	Mohr-Coulomb	125		100	24
Yellow	Overburden	Mohr-Coulomb	120		0	24
Green	Slip Surf	Shear/Normal Fn.	120	D-D', LL=100, CF>50
