Route:00011 Log:141.361

District 68, County 41 - Sargent

| IDENTIFICATION | |
|---|---|
| (8) Structure Number | 0011-141.391 |
| (6) Features Intersected | WILD RICE RIVER |

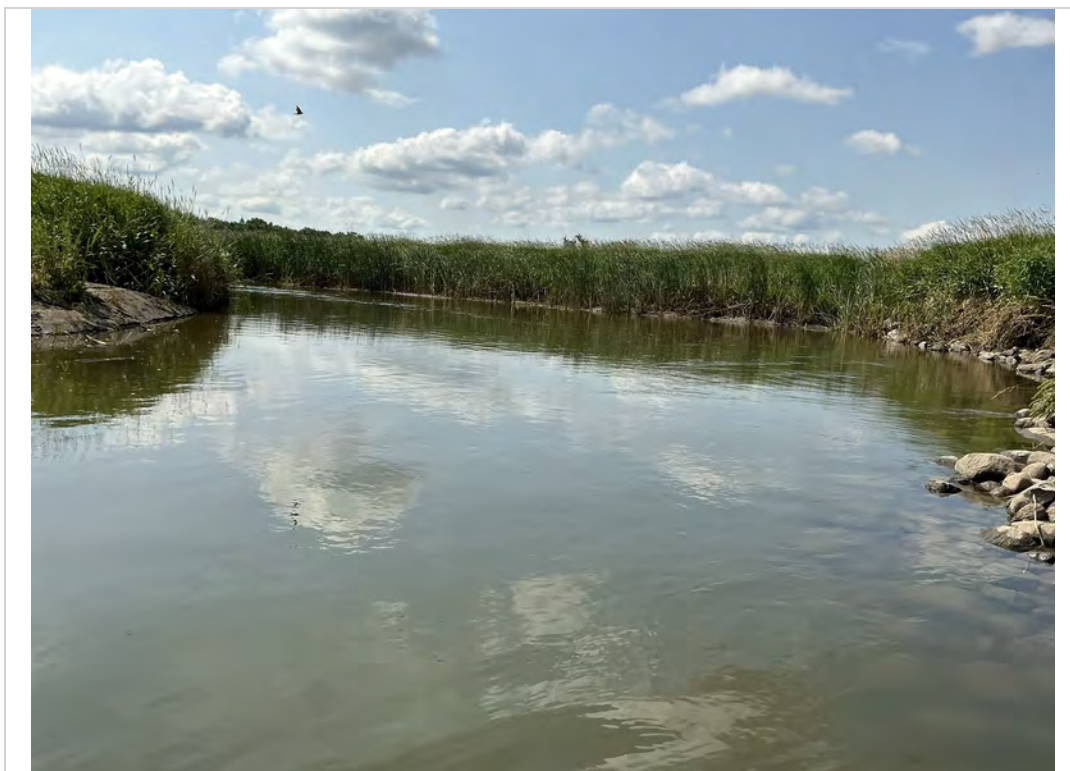
Facing SW. Channel Bank Erosion along West Side of Bank South of Structure.

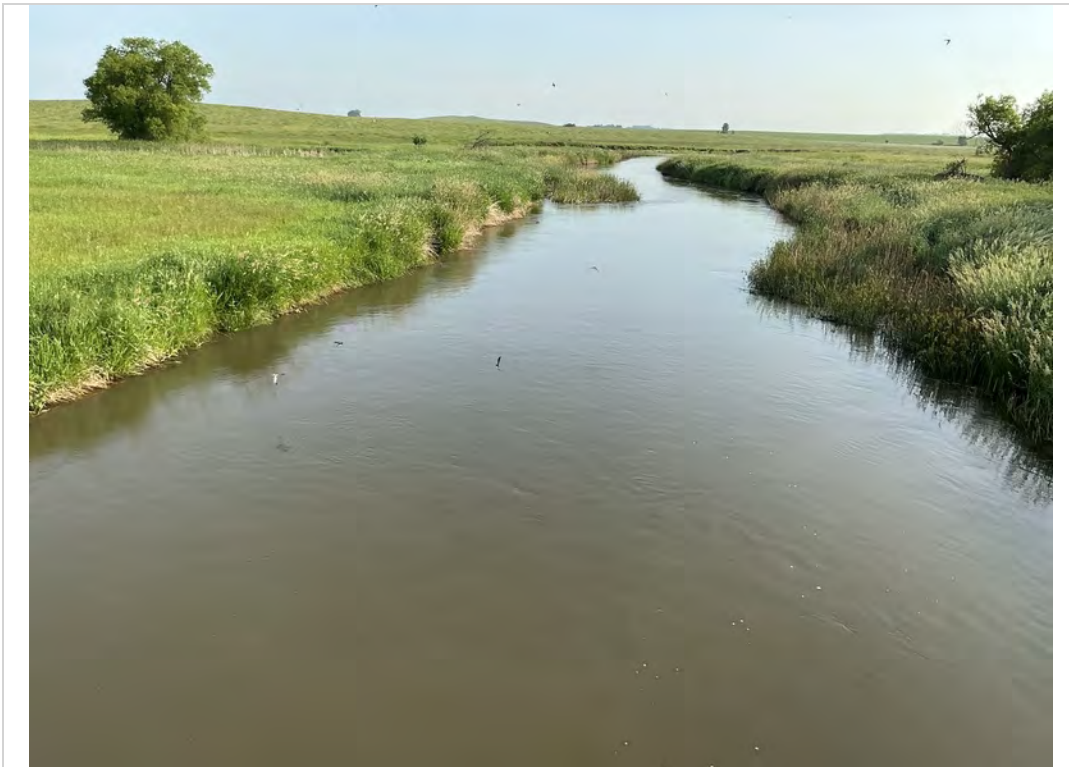
Uneven stream bed channel from Abutment to center of channel with an elevation difference estimated now 5', Previous 3'. Degradation along West Abutment and Aggradation along East Abutment.

Facing NW. Channel Aggradation and Degradation under structure.

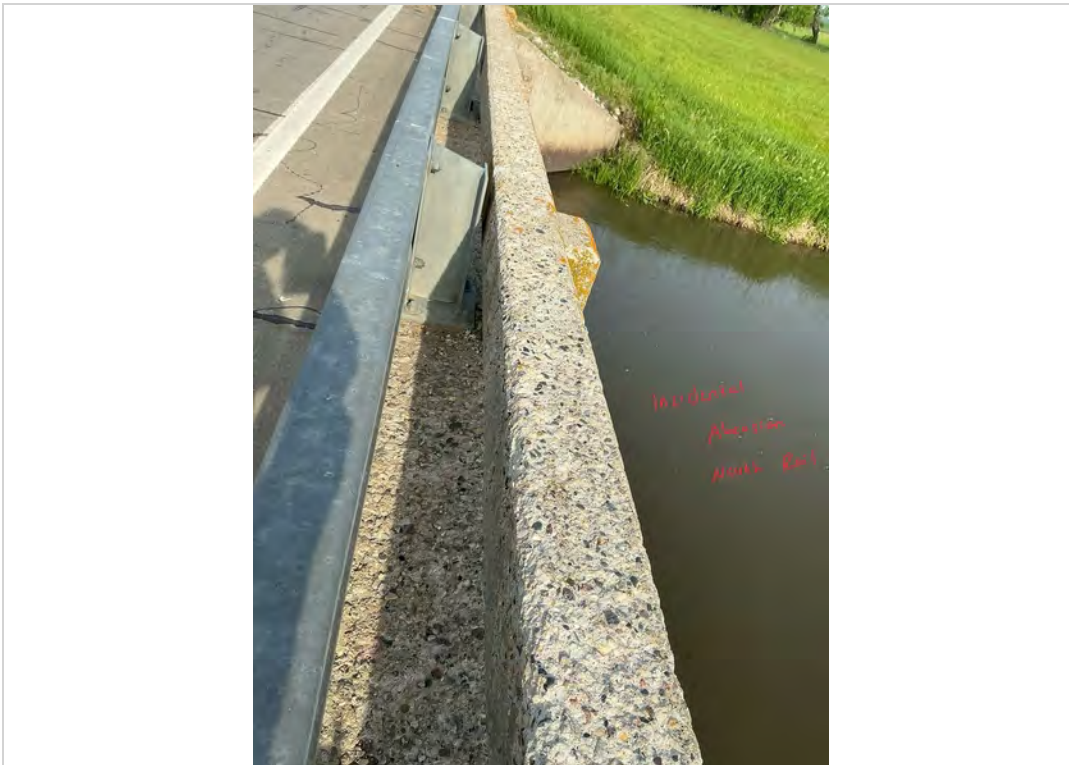
| ELEMENTS | DESCRIPTION | UNITS | TOTAL | CS1 | CS2 | CS3 | CS4 |
|---|---|---|---|---|---|---|---|
| (1190-331) Concrete curb has deteriorated and has exposed rebar - 8/19/2019<br>6/9/2021, 6/21/2023, 6/17/2025 - Areas of CS 2 Abrasion with Exposed Aggregate to curb and rail progressing with,<br>North Railing:<br>22 LF throughout.<br>South Railing:<br>32 LF throughout. See photos. | | | | | | | |

Facing NE. Abrasion to North Curb.

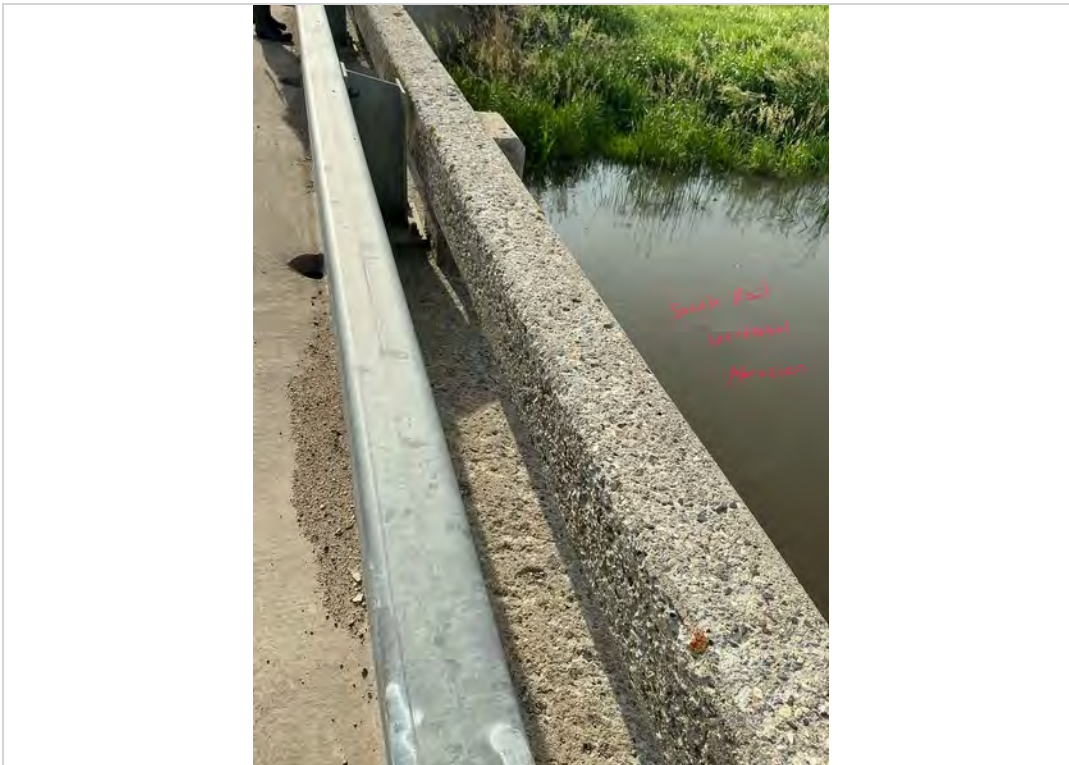
Facing SW. South Curb Abrasion.

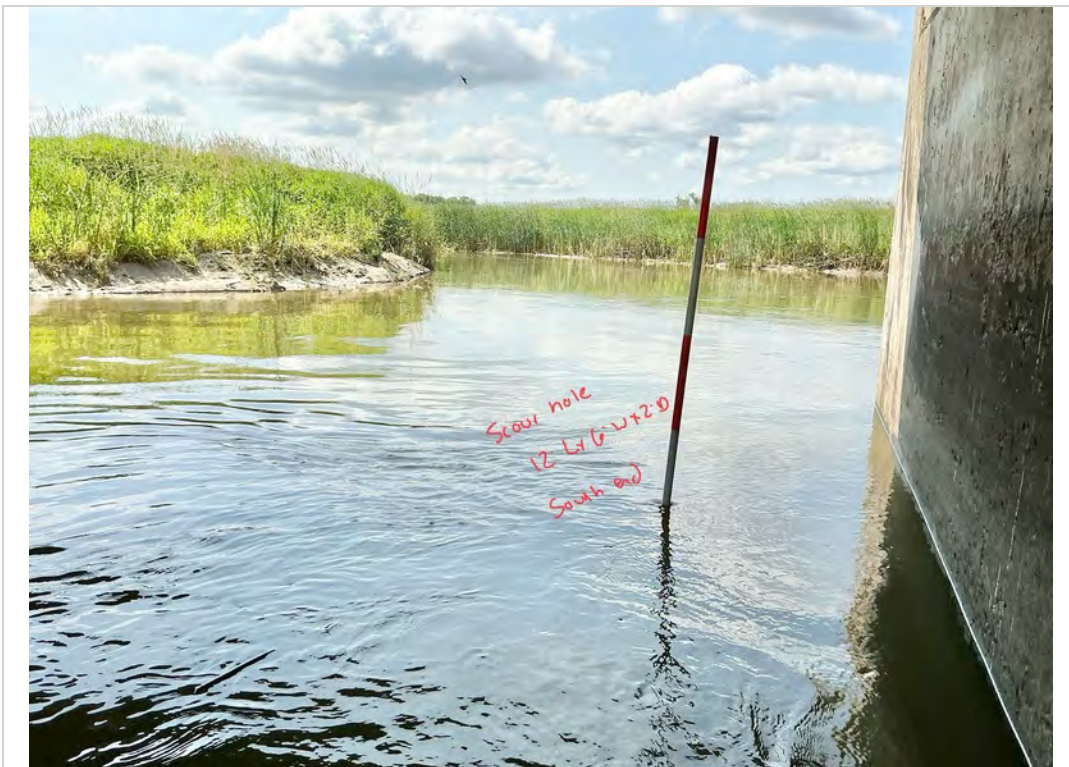
Scour Hole along West Abutment with an area now 12'L x 6'W x 2'D, 2023 Previous 23'L x 6'W x 4' to 4 1/2'D. 2021 Previous area 15' L x 3' W x 1'-6" Deep mainly within center area. No Undermining observed along West Abutment. Area has silted in with current flow conditions.

Facing South. Range Pole used to determine Scour Depth along West Abutment.

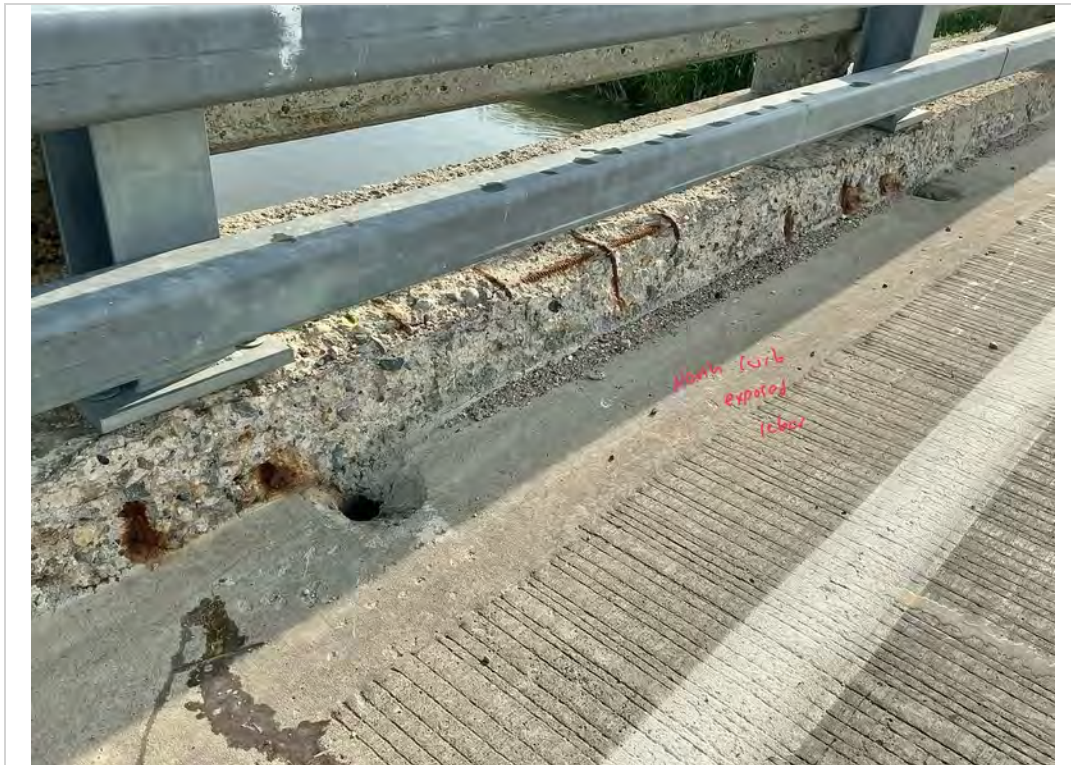
Facing NE. Abrasion with Exposed Rebar to North Curb.

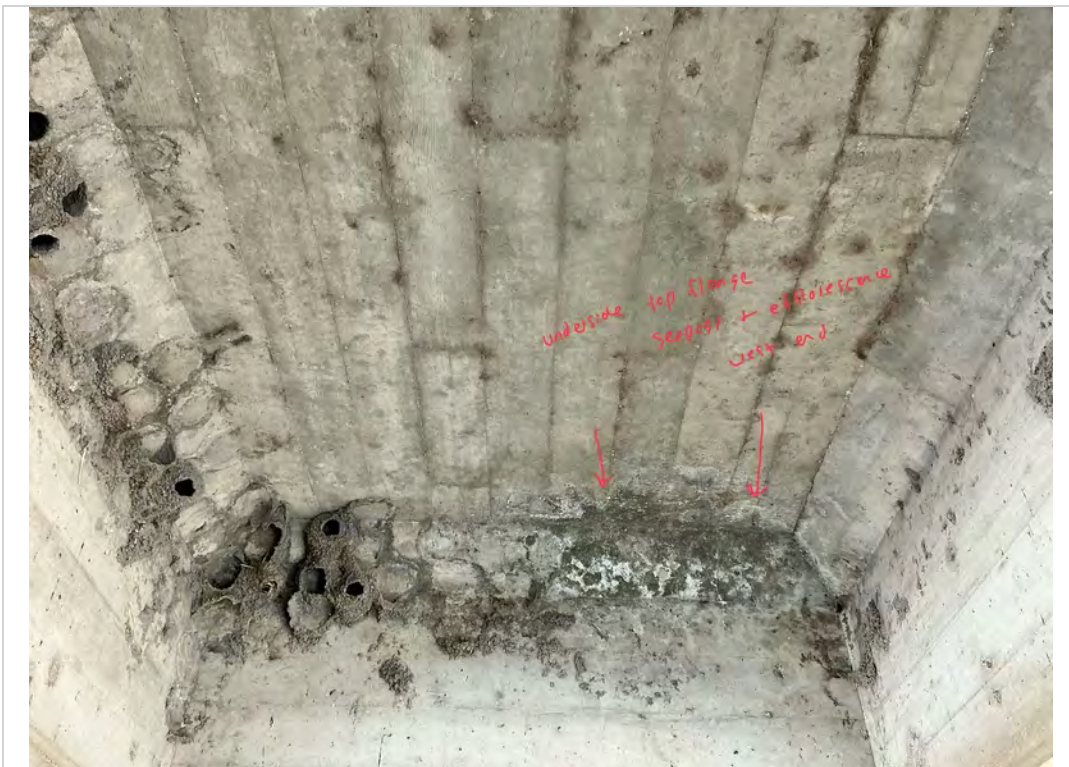
Facing West and Upwards. Seepage and Efflorescence to Underside Tee Beam West End.

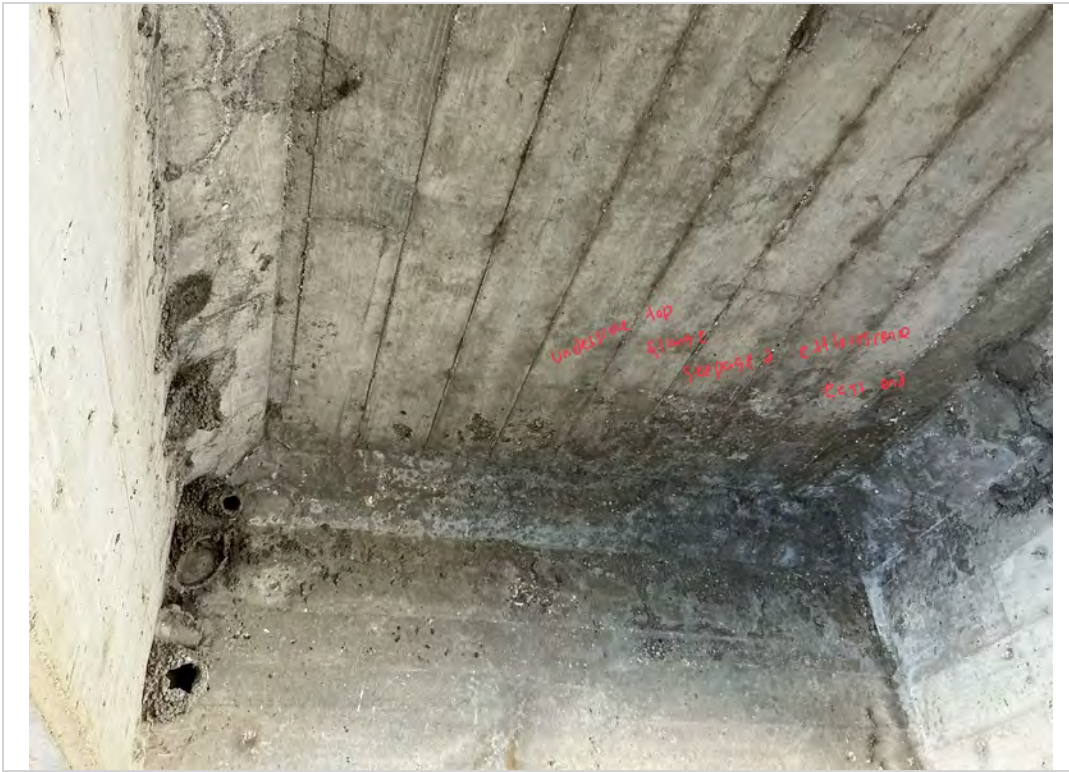
Facing East and Upwards. Underside Top Flange Seepage and Efflorescence East End.

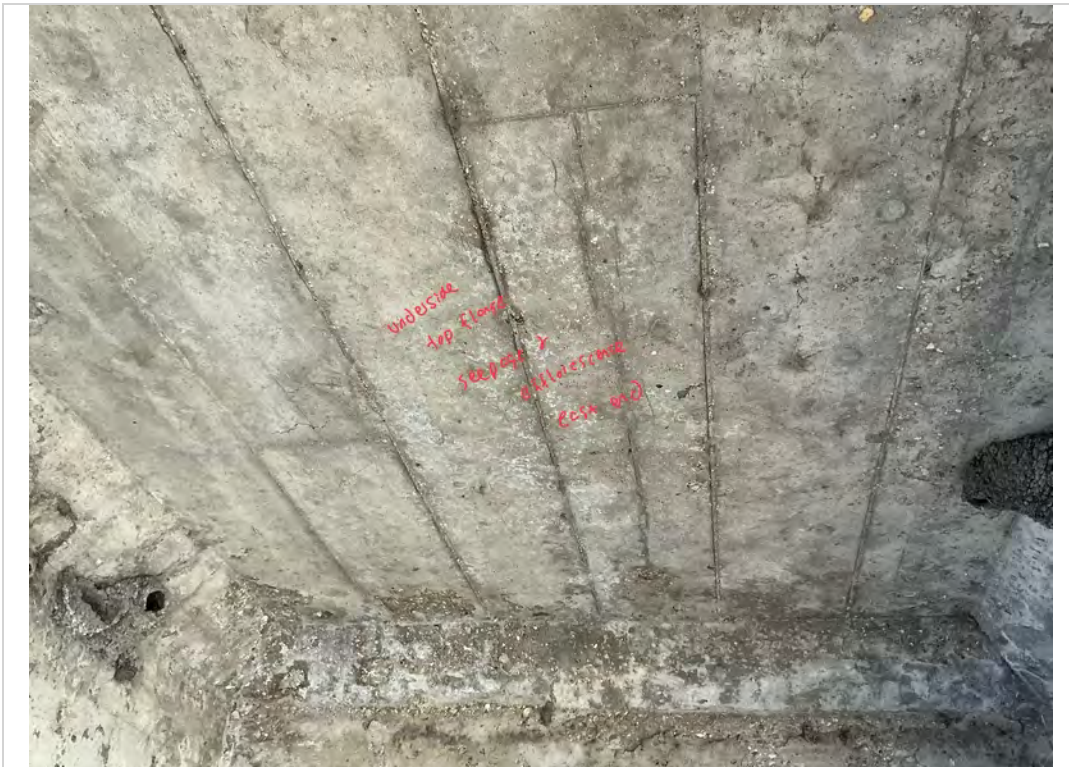
Facing East and Upwards. Underside Top Flange Deck with seepage and efflorescence East End.

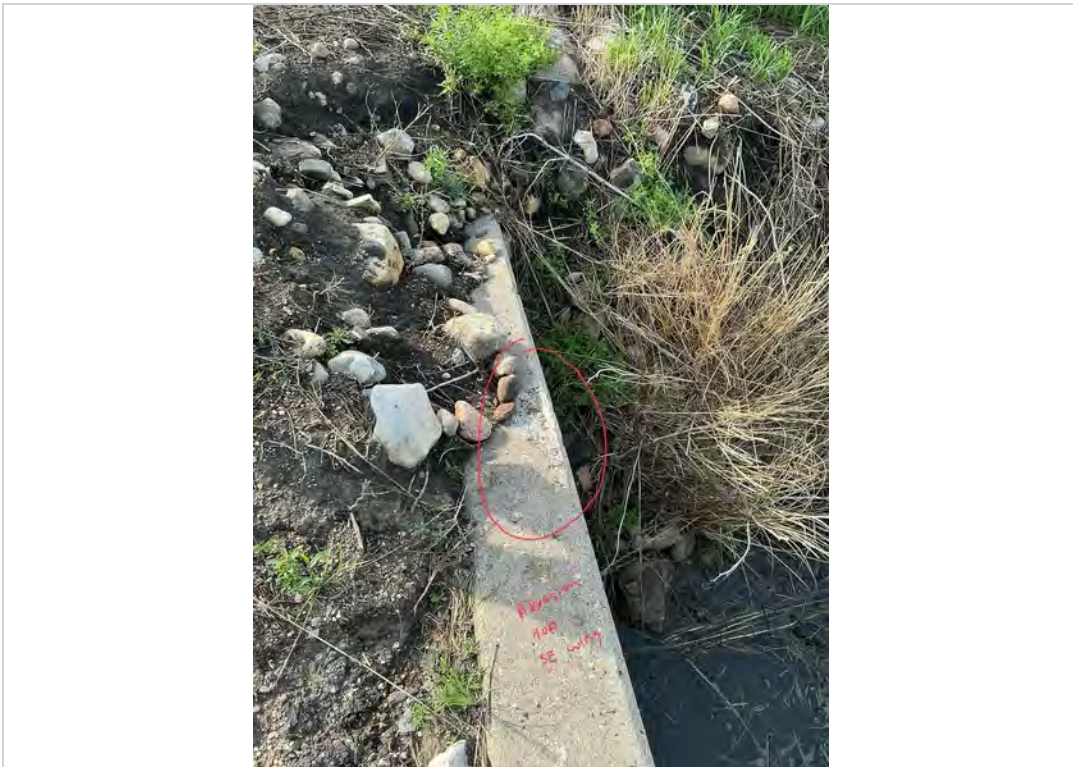
Facing SE and Downward. Abrasion along Top of SE Wing

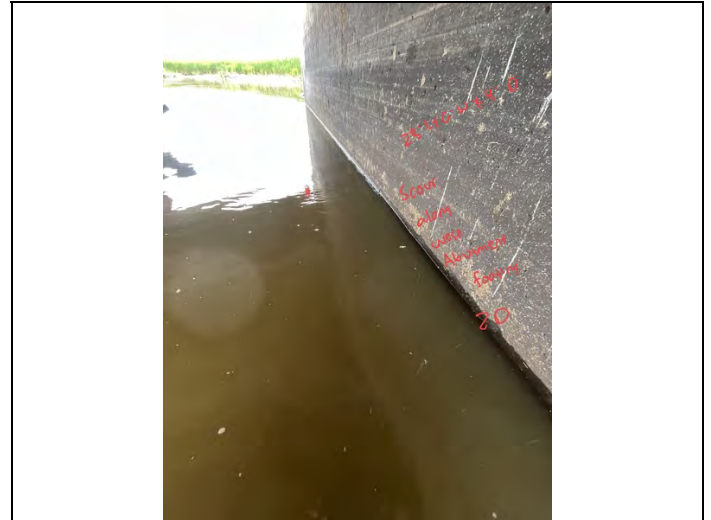
No Undermining Observed.

Facing South. Range Pole used to determine area of Scour along West Abutment.

Recommendation to place Loose Rip Rap along both Abutments. See Photos.

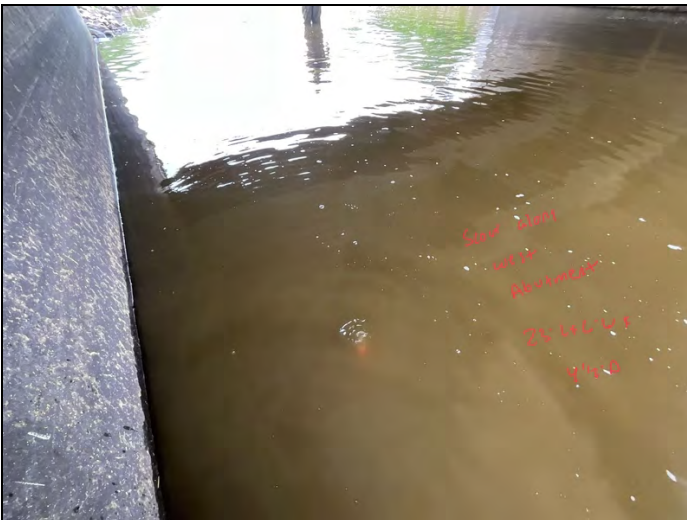
Facing North and Downward. Range Pole Submerged due to Scour along West Abutment.

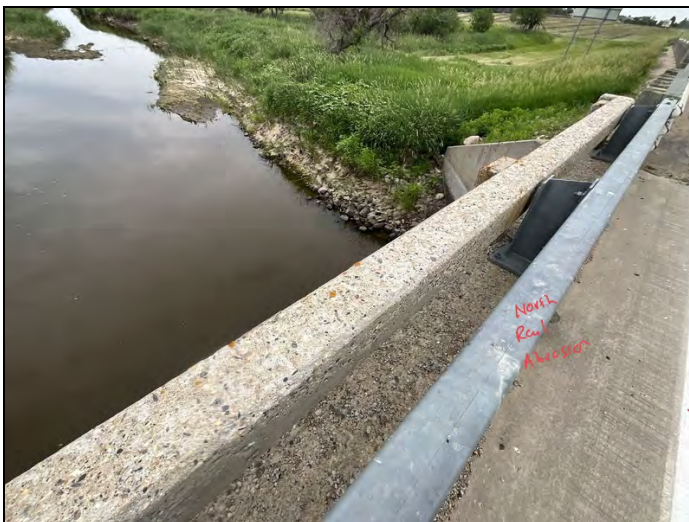
Facing NE. Abrasion along North Railing.

Recommendation to update Railing to current standards. See Photos.

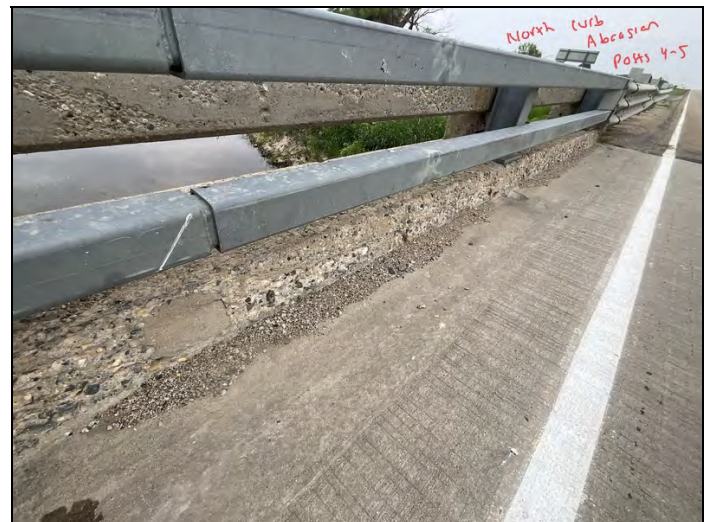
Facing NE. Moderate Abrasion along North Curb from Posts 4-5.

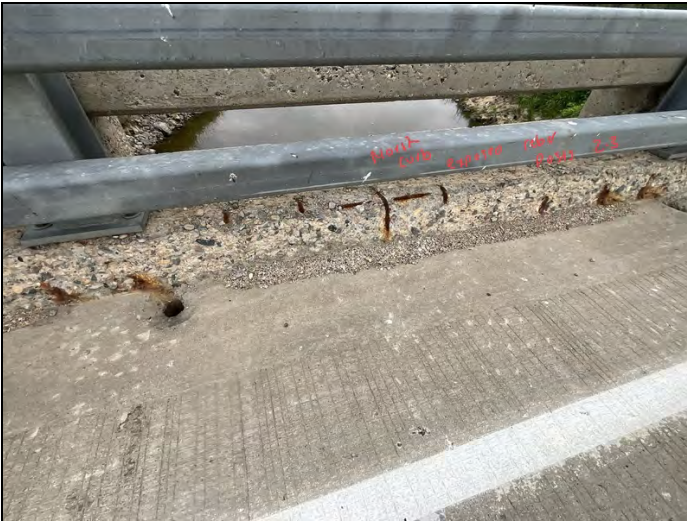
Facing North. Exposed Rebar to North Curb in-between Posts 2 and 3.

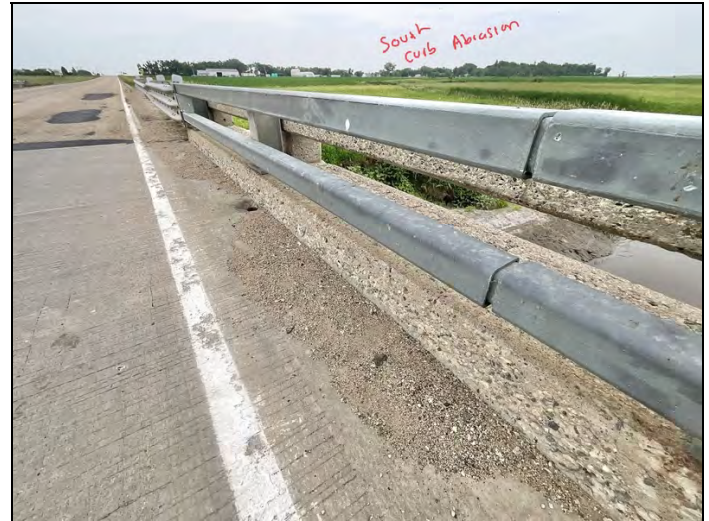
Facing East. Abrasion along South Curb.

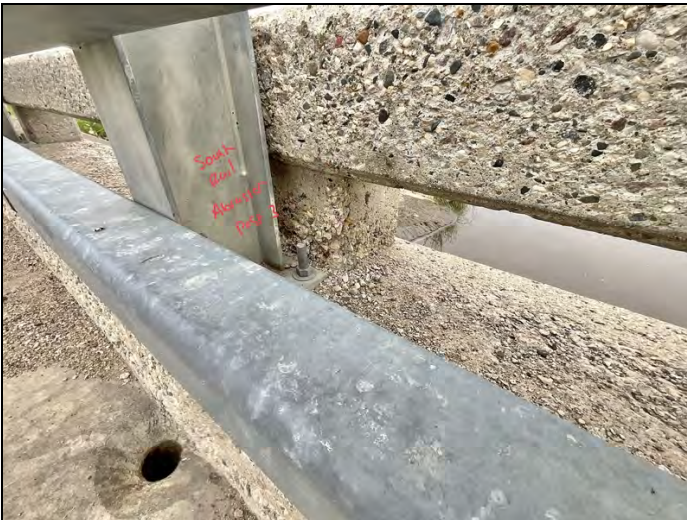
Facing SE. Moderate Abrasion to South Rail Post 3.

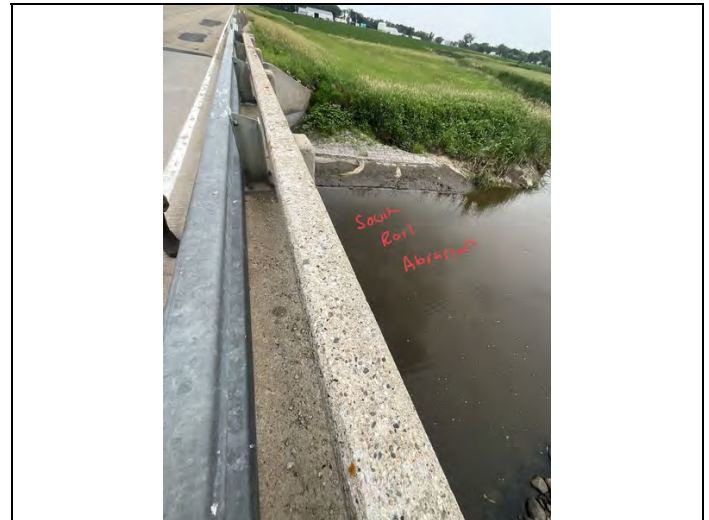
Facing East. Abrasion to South Railing.
