16 WEST OF JCT. US 85

IDENTIFICATION		
(1) State Names	North Dakota	
(8) Structure Number	0094-026.422 L	
(5) Inventory Route	00094	
(2) Highway Agency District	65	
(3) County Code	Billings, North Dakota

(4) Place Code	0	
(6) Features Intersected	SHEEP CREEK	
(7) Facility Carried	INTERSTATE 94	
(9) Location	16 WEST OF JCT. US 85	
(11) Mile Point	26.416 mi	
(12) Base Highway Network	Yes

Team Lead: Jake Mertz, **Inspection Date:** May 18, 2021

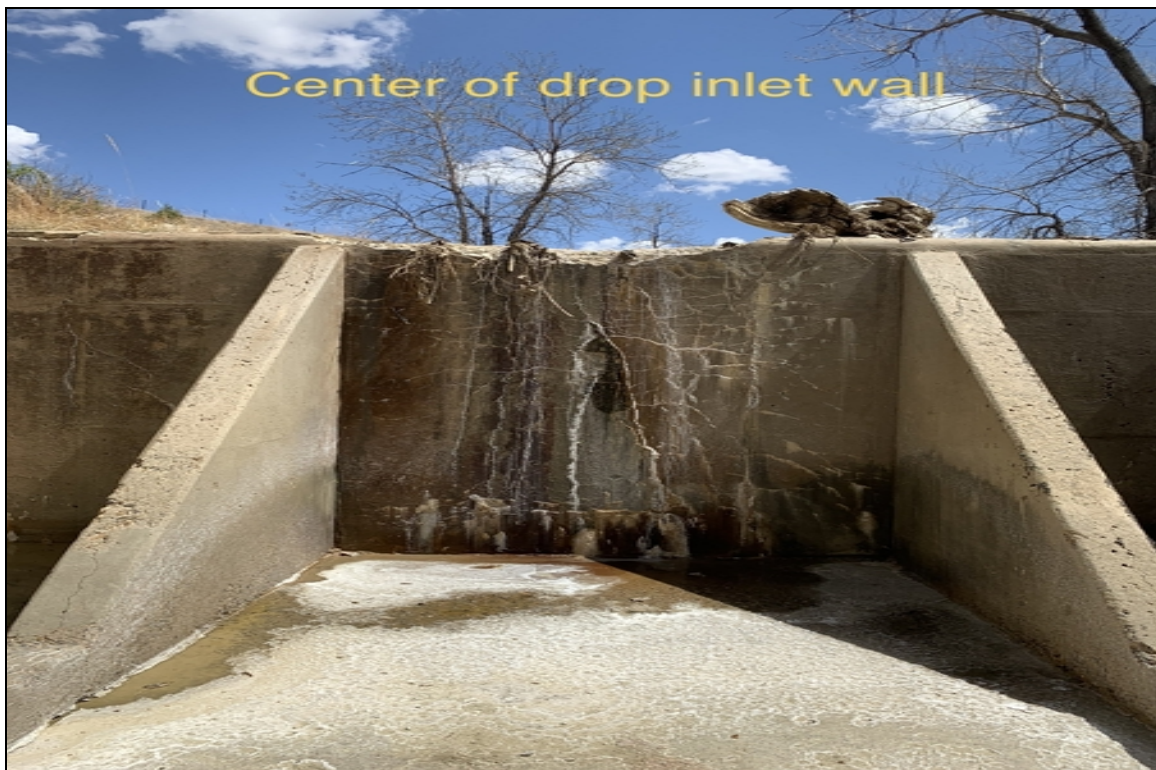
Center of drop inlet wall

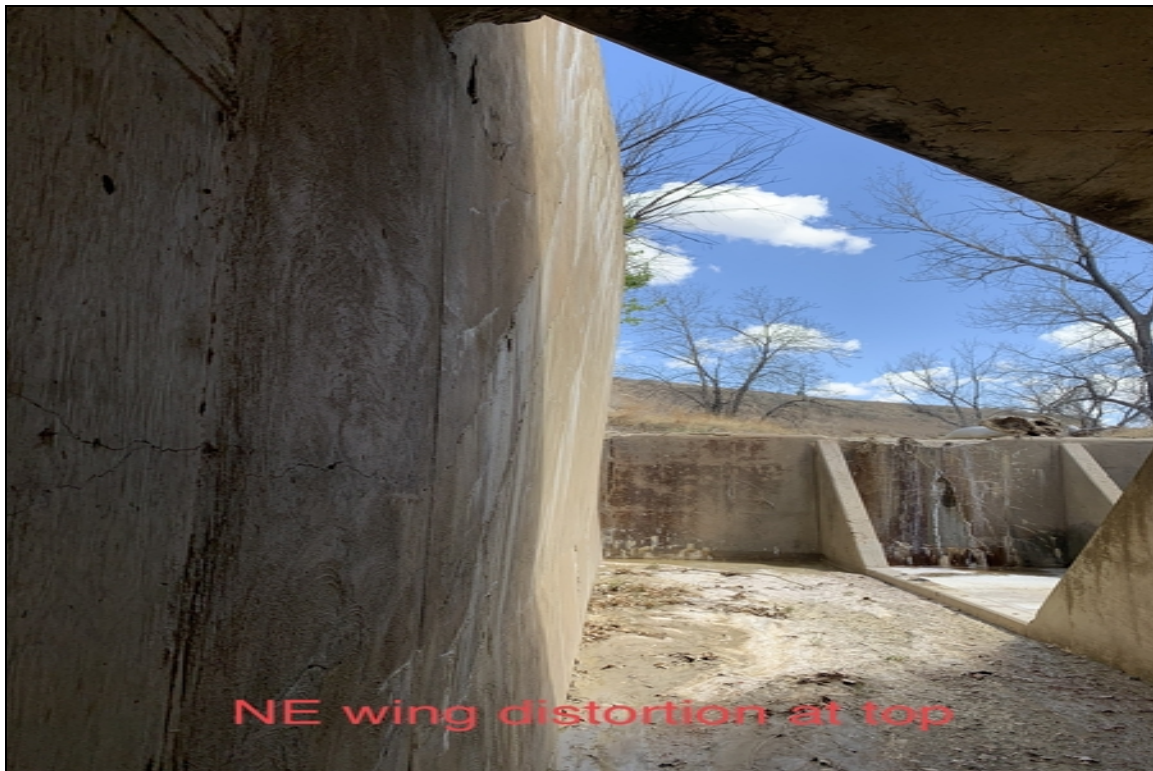
NW wing distortion at top
Not NW

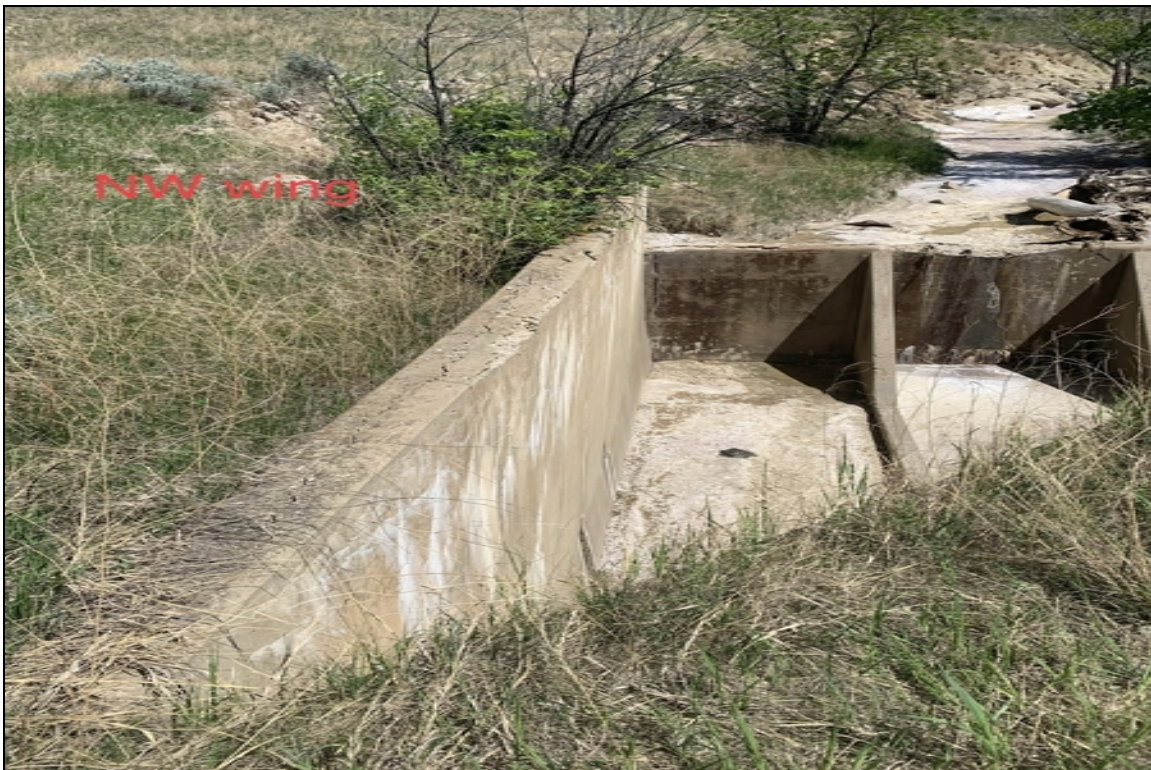
NW wing bow

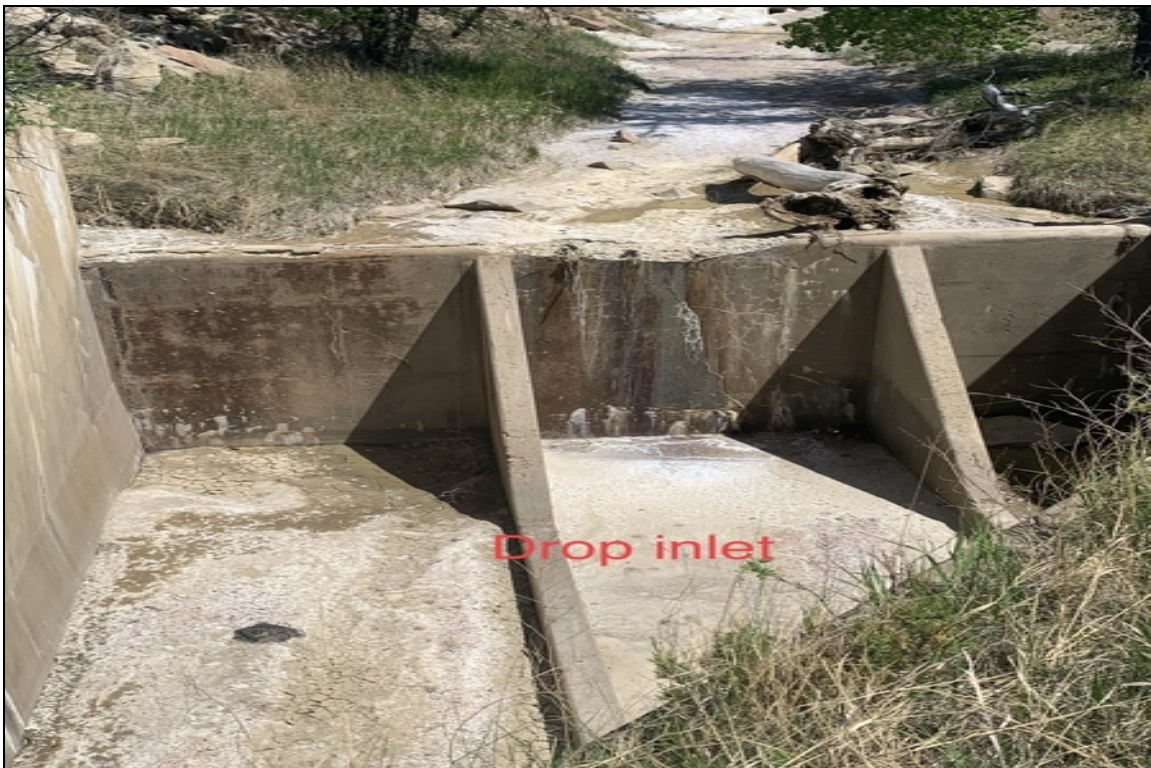
Drop inlet

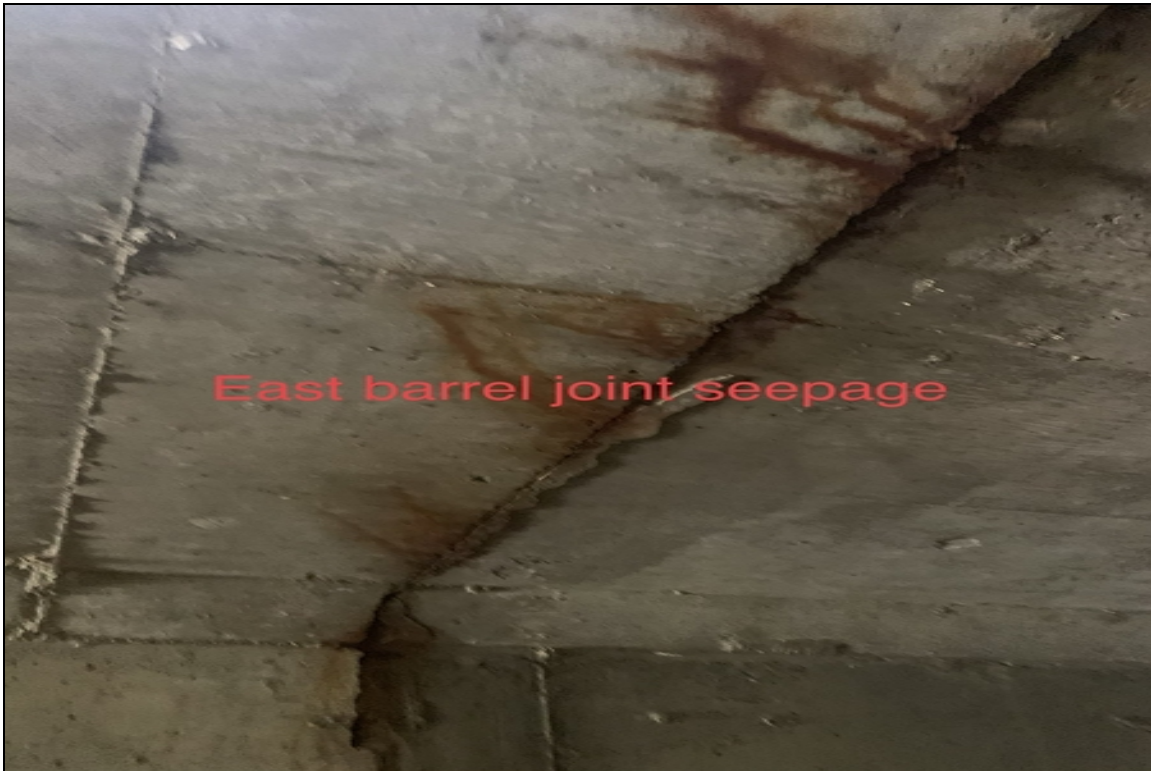
East barrel joint seepage roof

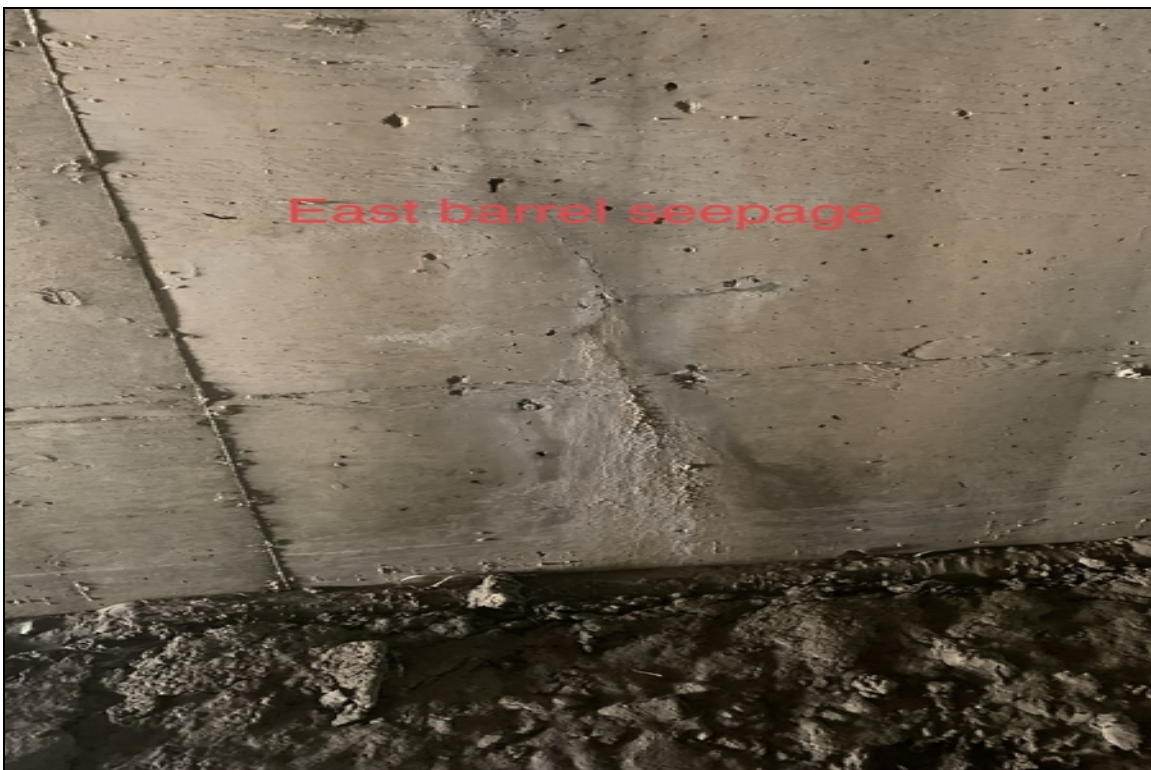
East barrel outside wall seepage

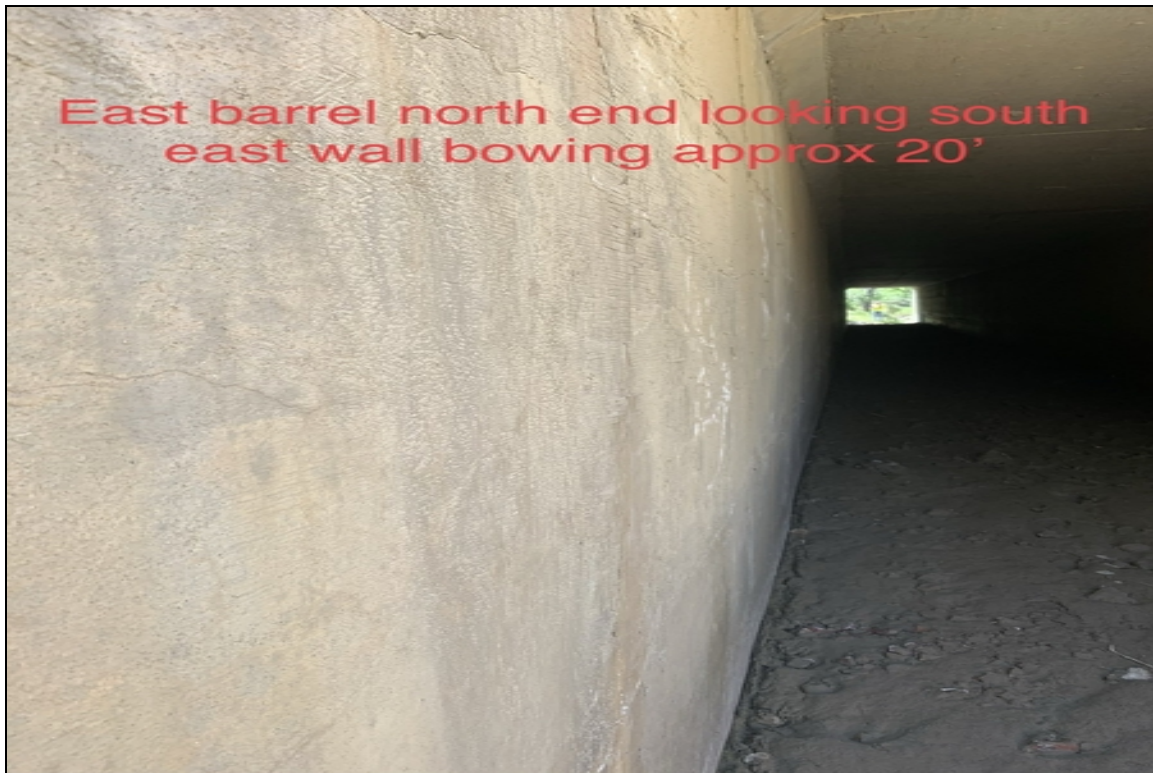
East barrel north end looking south
east wall bowing approx 20'

East barrel north end looking south wall bowing approx 20"

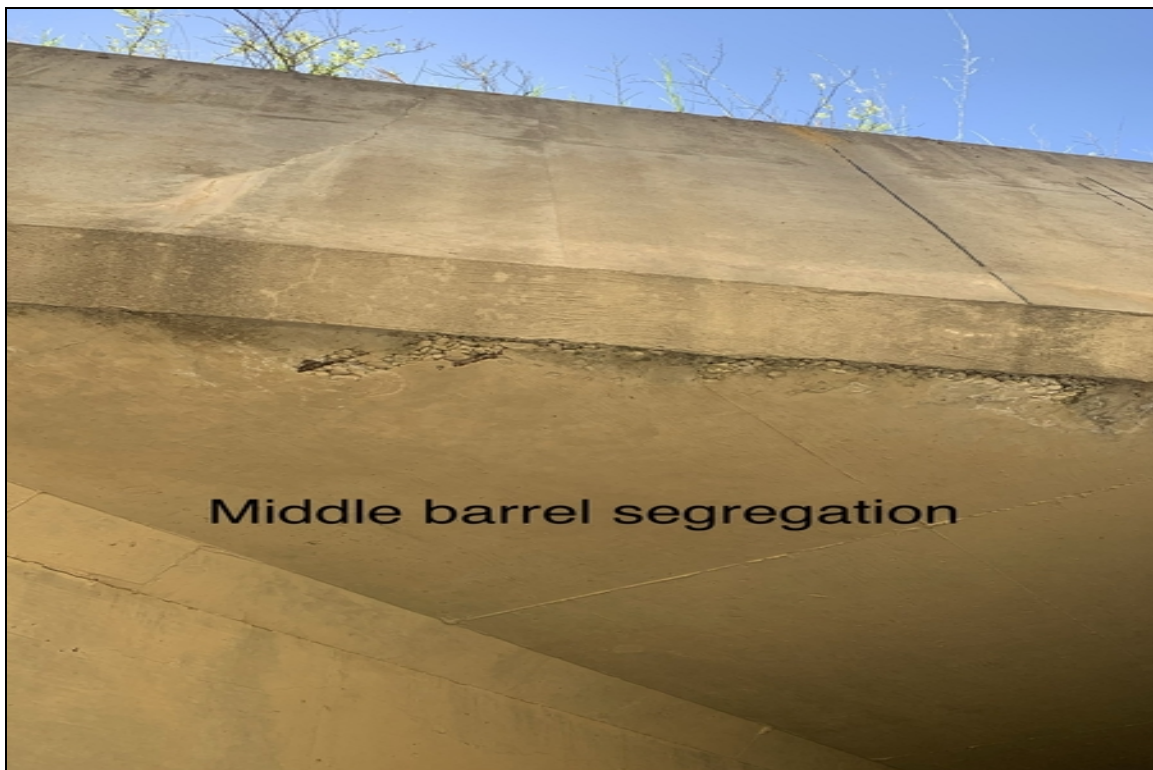
Middle barrel segregation

Middle barrel segregation under east headwall exposed rebar

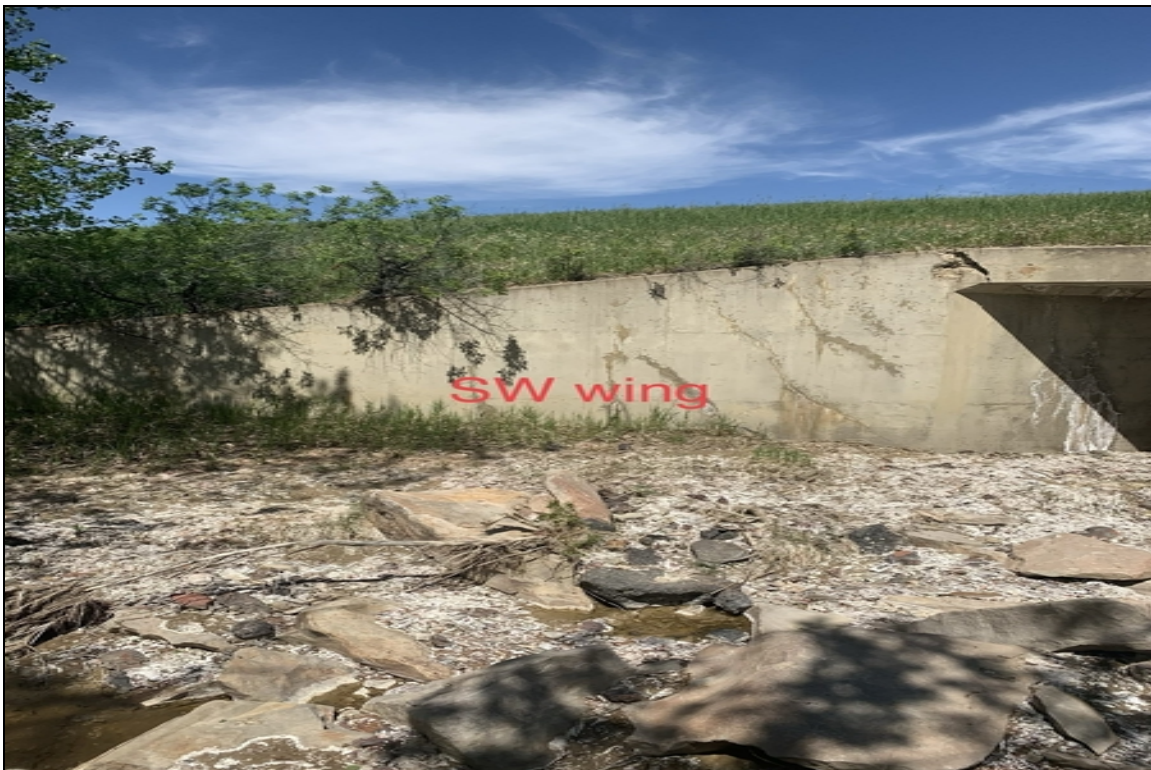
SW wing

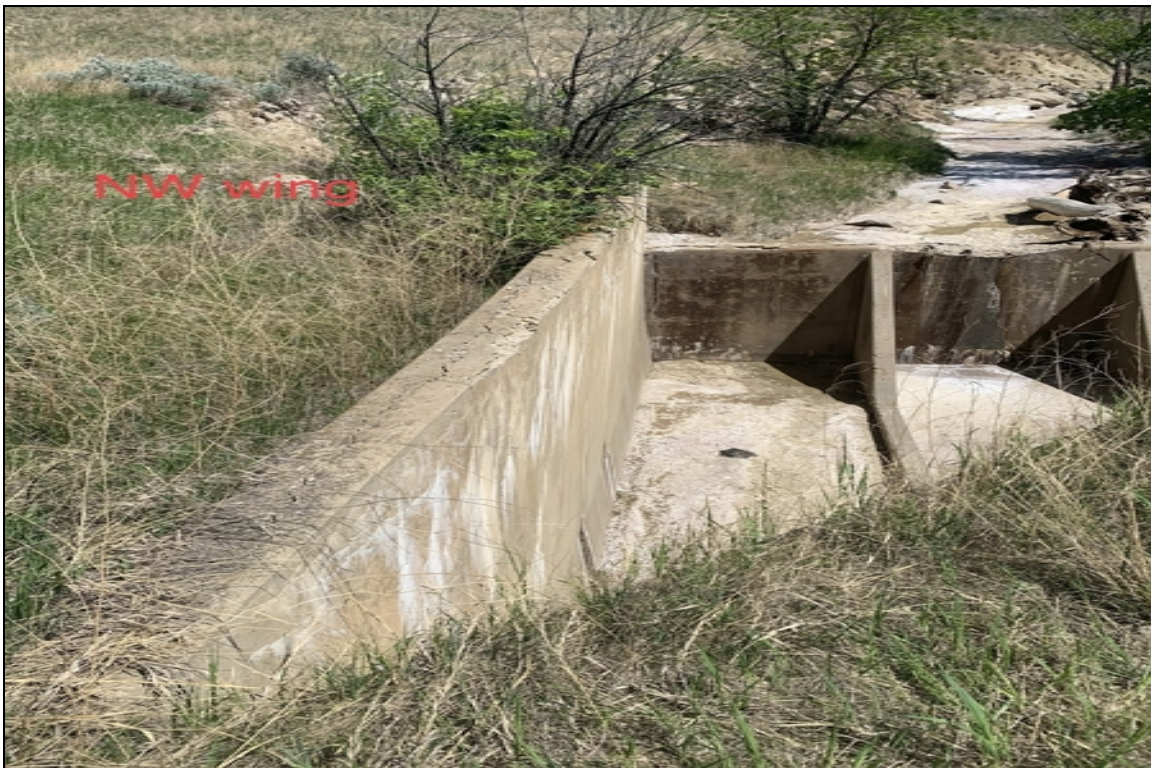
NW wing bow

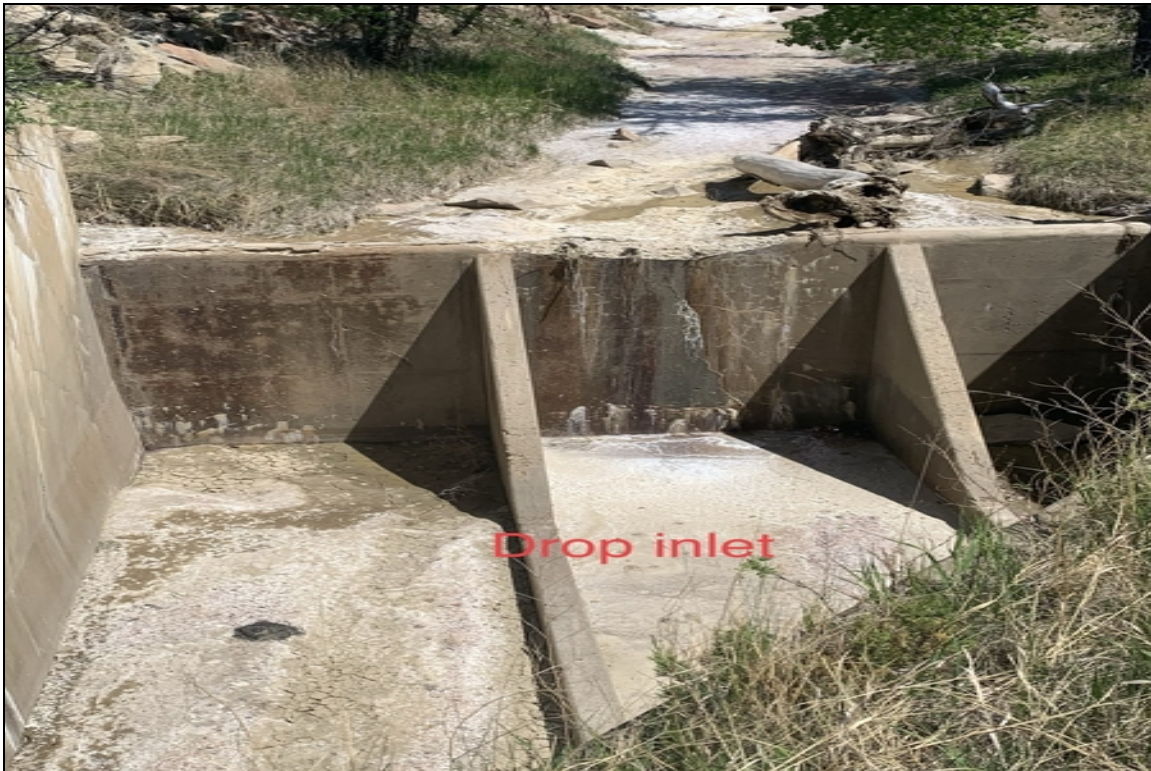
Drop inlet

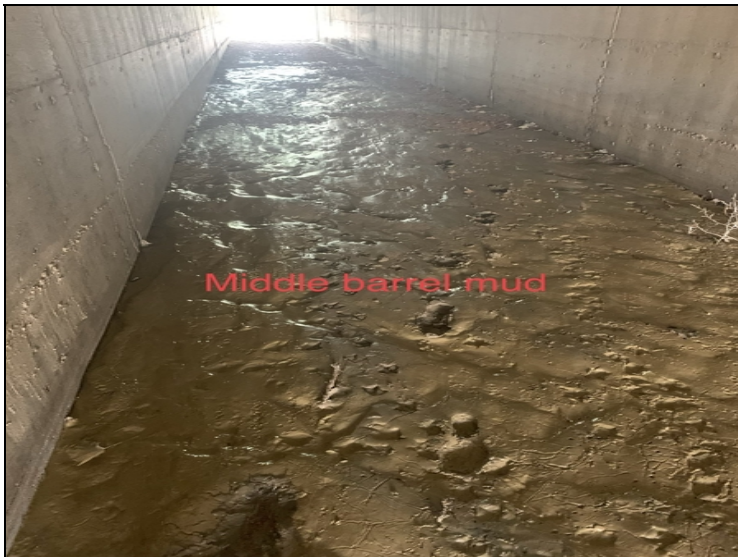
The East barrel has approximately 2 feet of silt material throughout the entire length of the barrel. The Center barrel has approximately 1 - 1.5 feet of silt material throughout the entire length of the barrel. The West barrel has approximately 1 foot of silt material throughout the entire length of the barrel.

Middle barrel mud

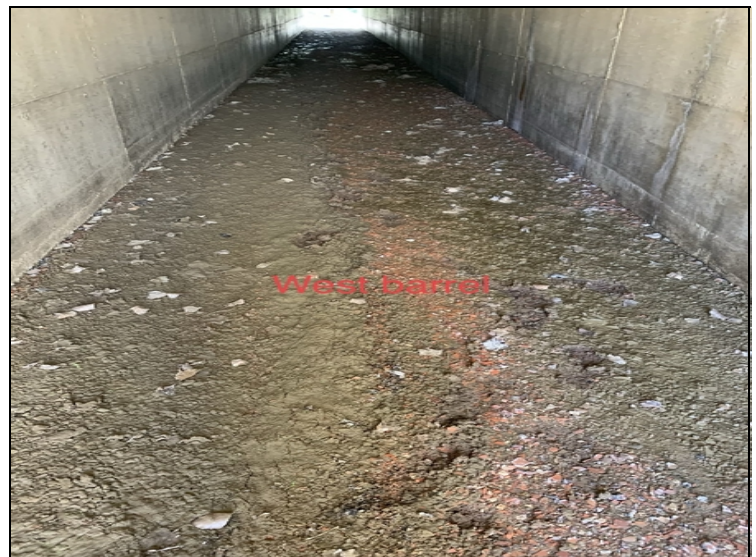
West barrel mud

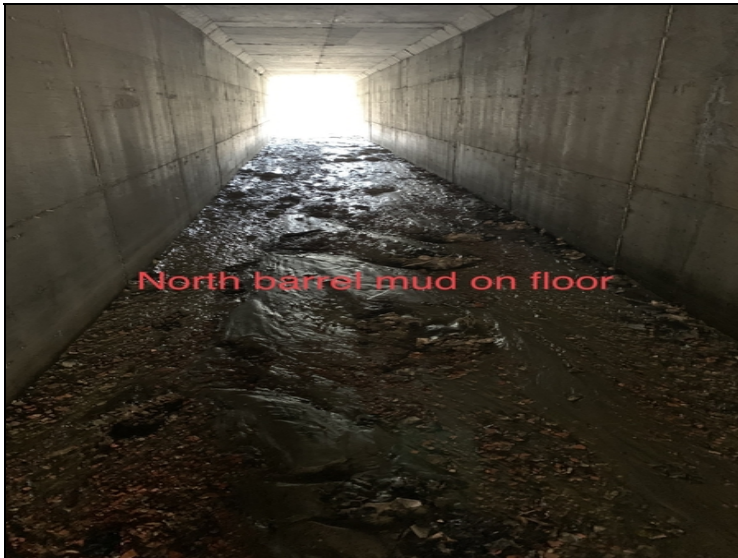
North barrel mud on floor

West barrel mud on floor
Not north

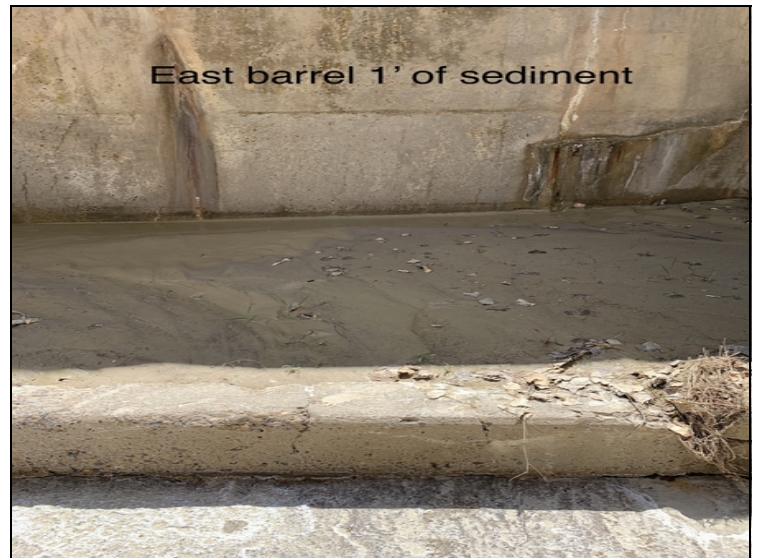
East barrel 1' of sediment

East barrel 1' sediment

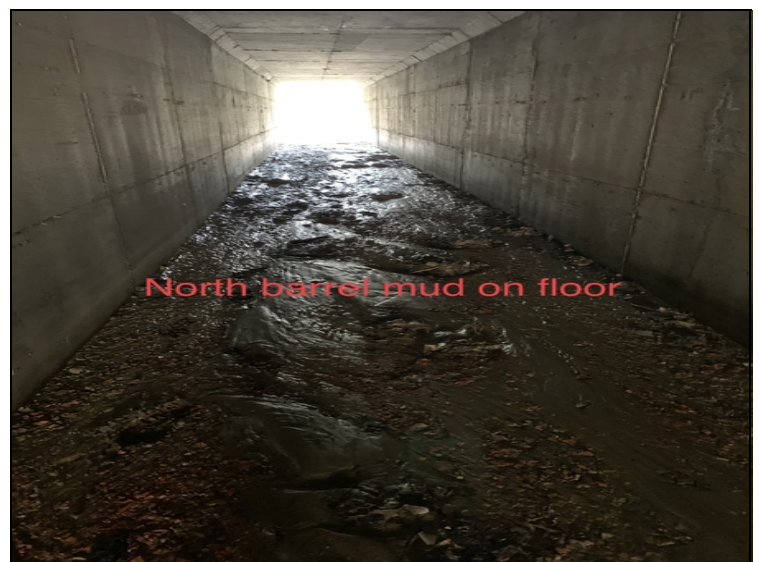
West barrel mud on floor
Not west
