UNDERWATER BRIDGE INSPECTION REPORT

Bridge No.: 0023-046.203	Inspection Start Date: 7/20/2023	Inspection Firm: Engineering Operations
County: McKenzie	Facility Carried: IRRFB ND Highway 23	Feature Intersected: Missouri River
Inspection Team: Sam Williams (Team Leader) Taylor White Jonathan Ivey Karl Davis Tyler Liebman

Bridge 0023-046.203 carries North Dakota Highway 23 over Missouri River in McKenzie County. The substructure consists of two reinforced concrete abutments and fourteen reinforced concrete piers (columns), all founded on steel pipe pile supported footings. Piers 2 through 15 were inspected under this contract. The bridge substructures are numbered from **west to east** in accordance with NDDOT's procedures. A Level 3 underwater inspection was performed from the high-water line to the channel bottom and found the substructure units to be in overall **good** condition.

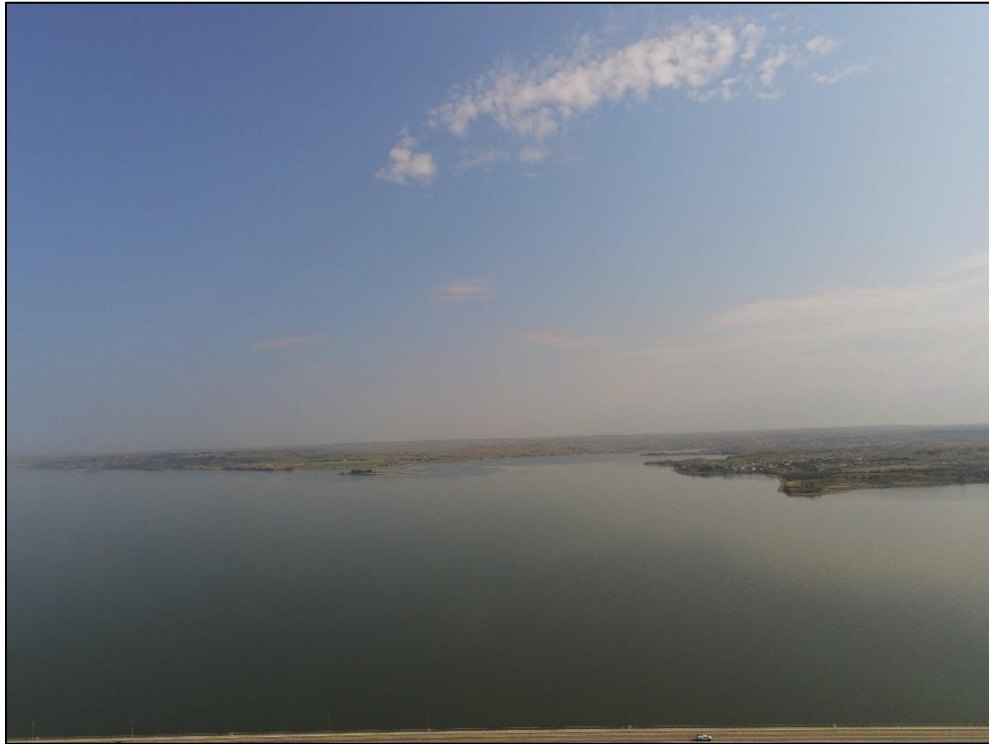
Channel Condition North (Upstream) of the Bridge

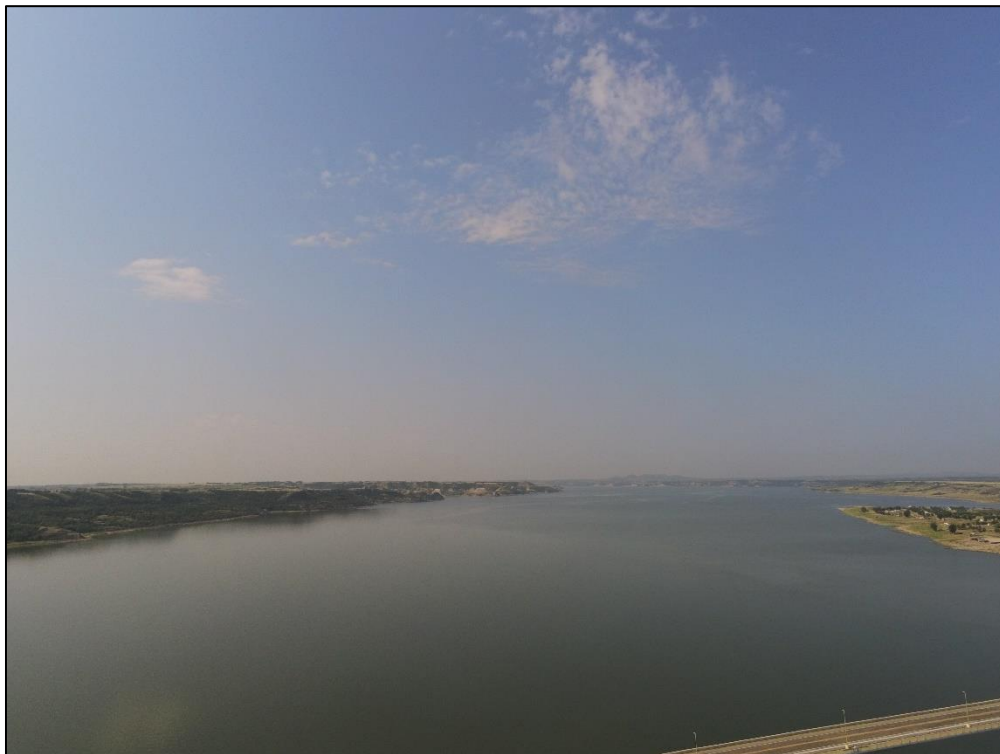
Channel Condition South (Downstream) of the Bridge
