Route:00011 Log:141.361

District 68, County 41 - Sargent

| IDENTIFICATION | |
|---|---|
| (8) Structure Number | 0011-141.391 |
| (6) Features Intersected | WILD RICE RIVER |

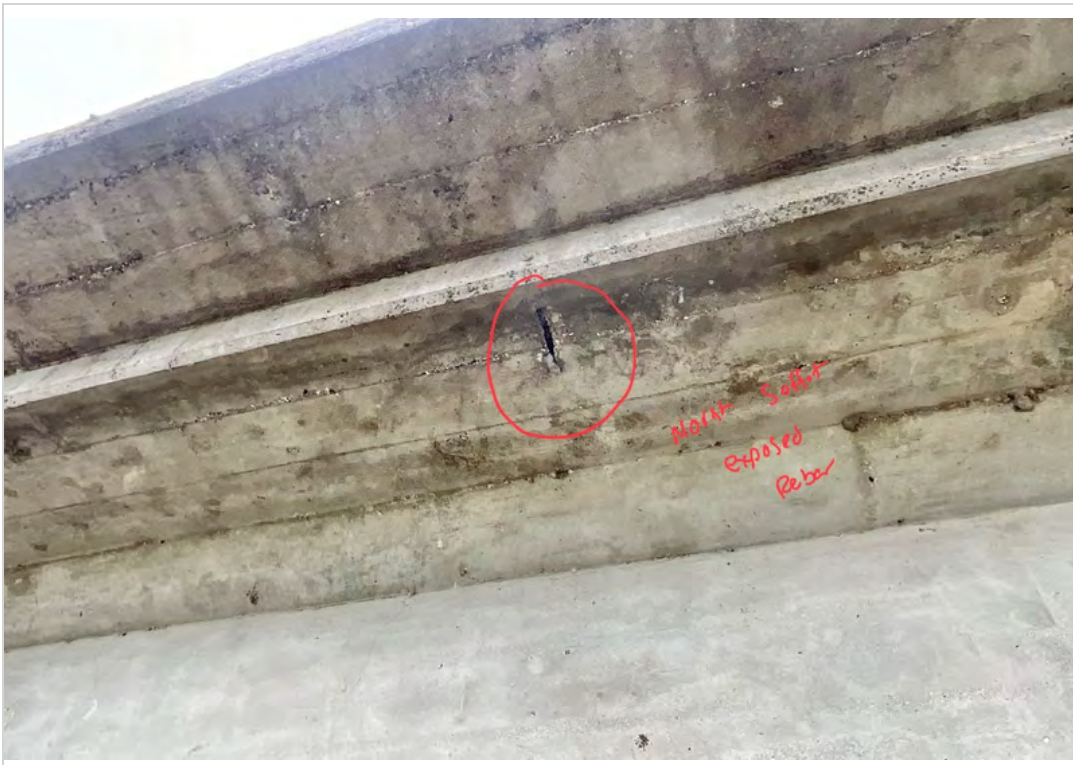
Facing South and Upwards. Exposed rebar to North Soffit of Top Flange Deck.

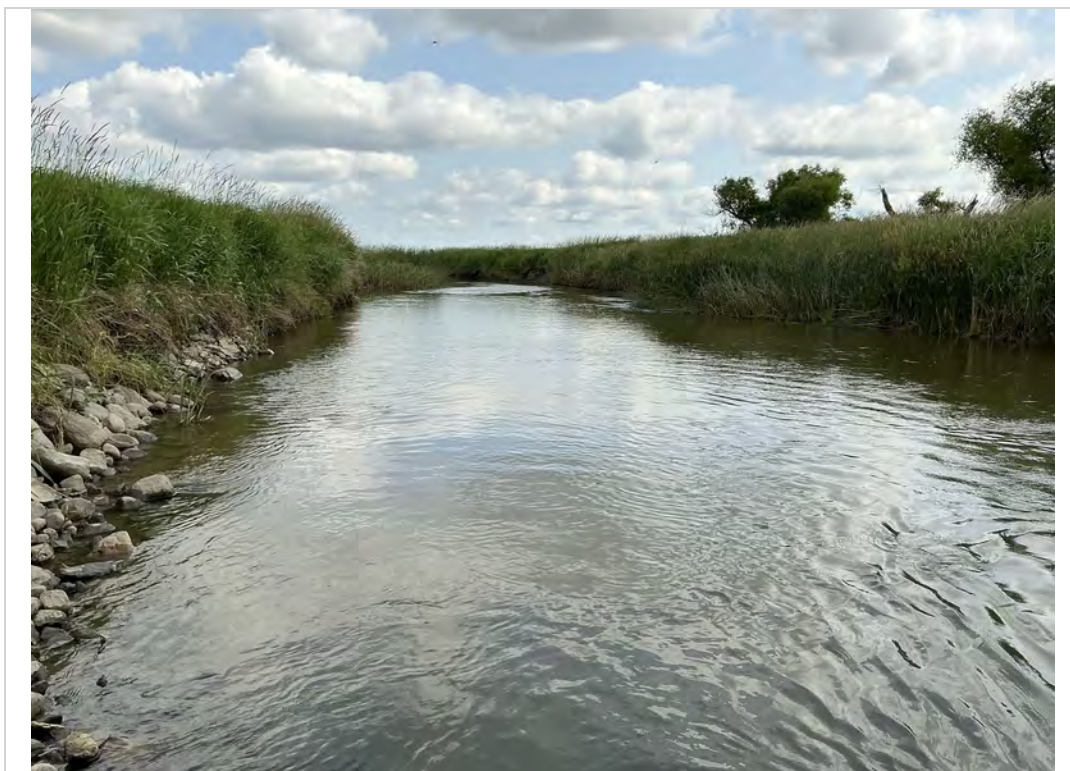
Uneven stream bed channel from Abutment to center of channel with an elevation difference estimated now 5', Previous 3'. Degradation along West Abutment and Aggradation along East Abutment.

Facing South. East Channel Bank Aggradation South of Structure.

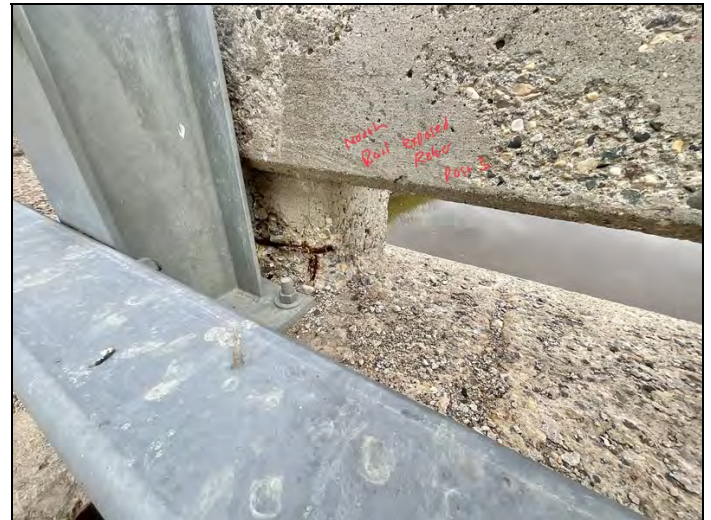
Facing NE. Exposed Rebar to North Railing at Post 3.

Recommendation to update Railing to current standards. See Photos.
